VEHICLE INSPECTION REPORT

GM65NMZ

Dacia Sandero 0.9 TCe Laureate Prime 5dr [Start Stop]

nama
 GRADE
5

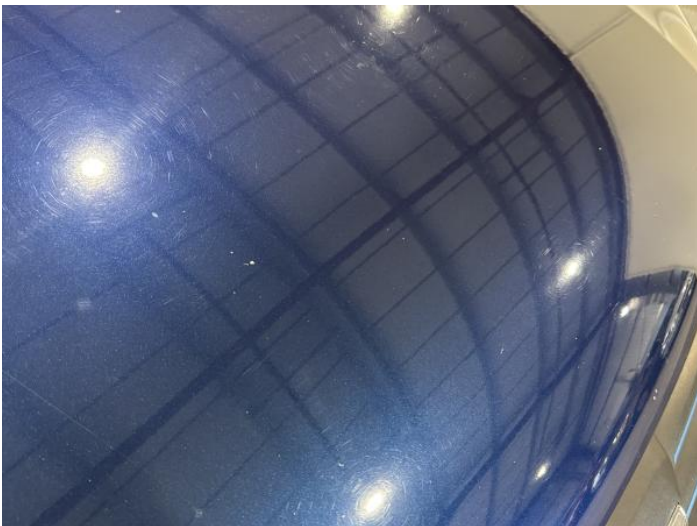
1: Bonnet
Chipped
Multiple Chips

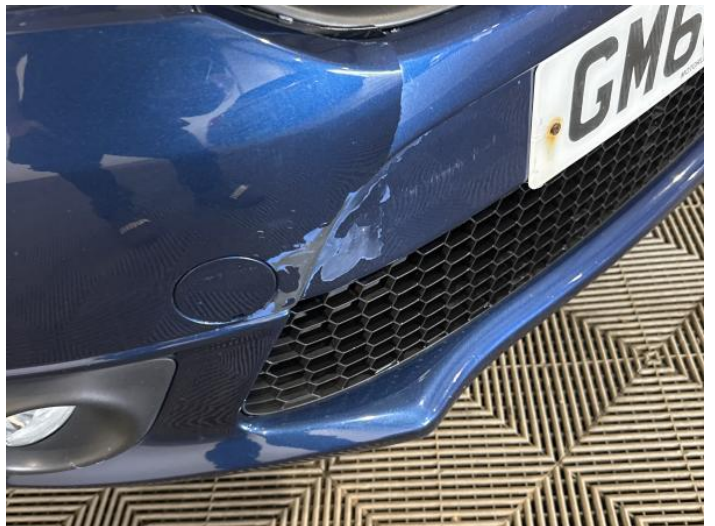
2: Bumper Front
Poor Previous Repair
Paint Flake

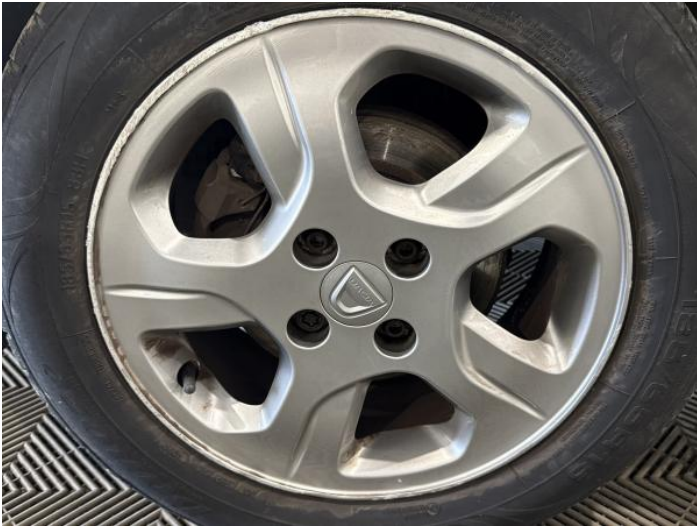
3: Wheel nsf
Scratched
Over 50mm

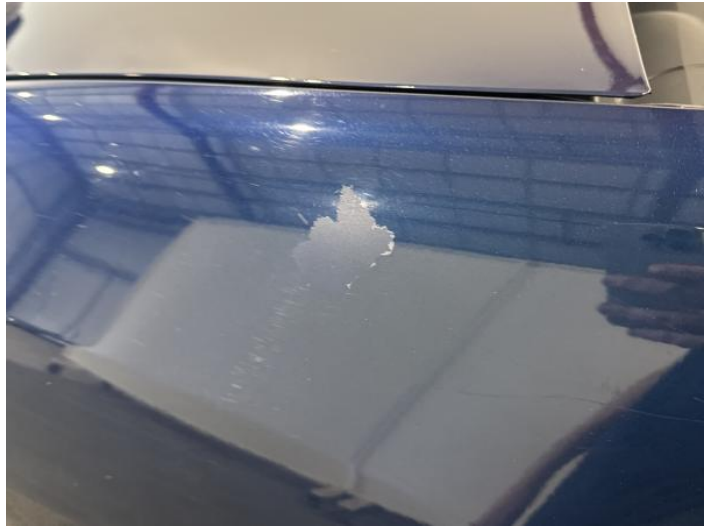
4: Wing nsf
Poor Previous Repair
Paint Flake

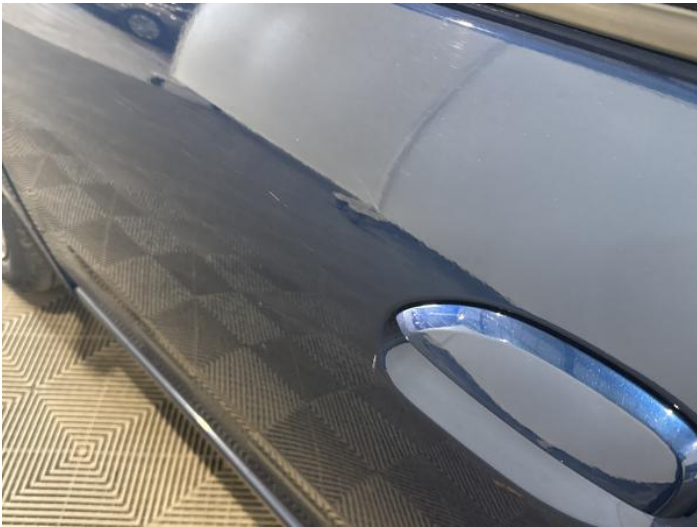
5: Door nsf
Scratched
Over 25mm Thru Paint

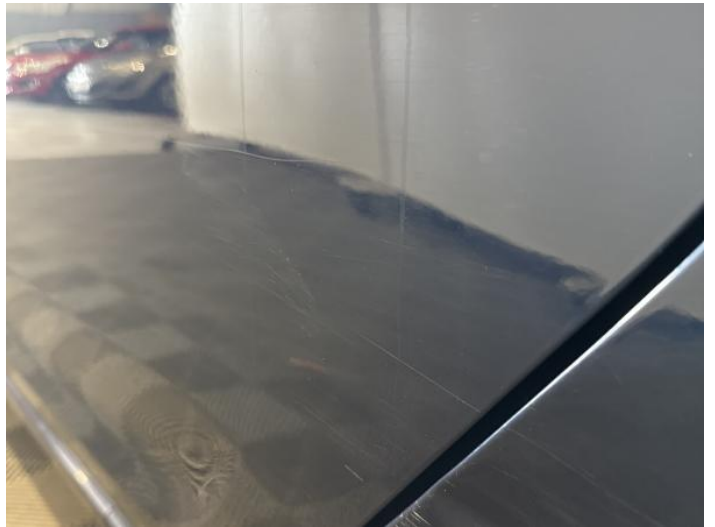
6: Door nsr
Scratched
Over 25mm Thru Paint

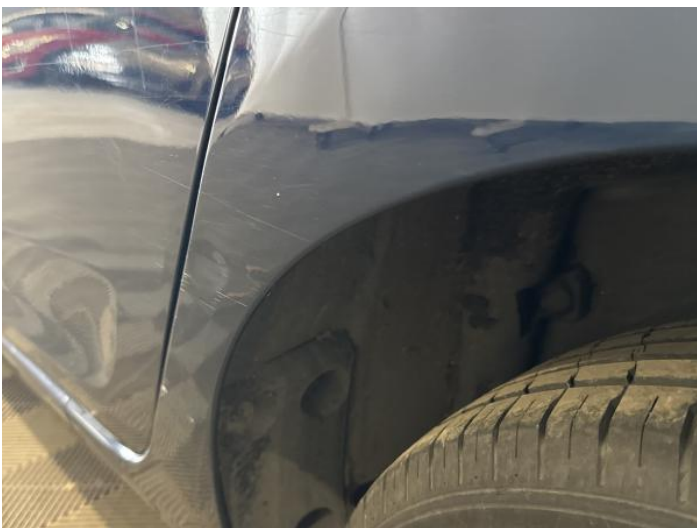
7: Qtr Panel nsr
Dented
With Paint Damage

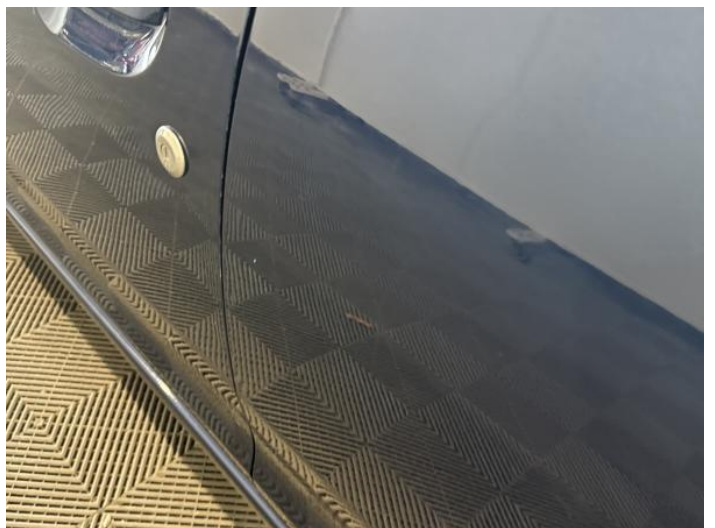
8: Door nsr
Dented
Between 10mm + 30mm

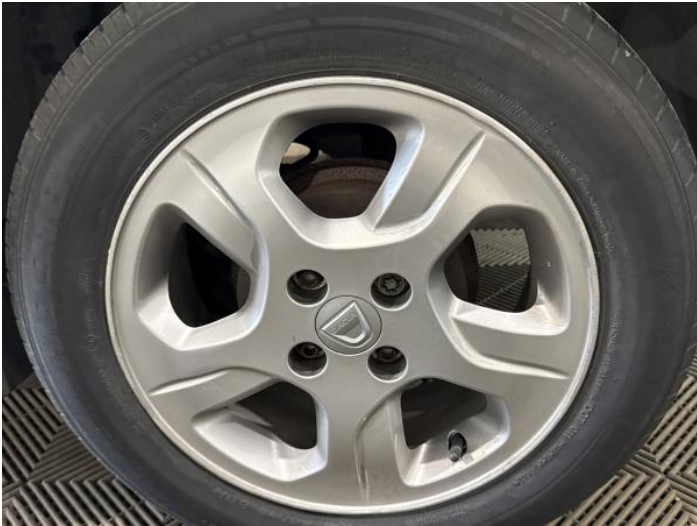
9: Wheel nsr
Scratched
Over 50mm

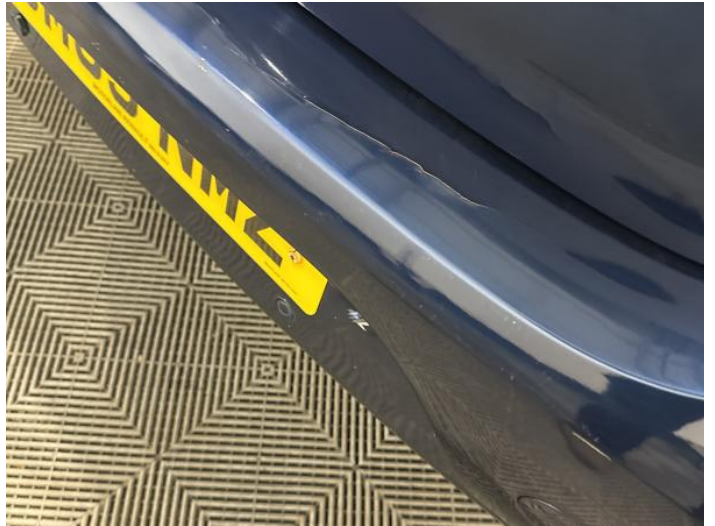
10: Bumper Rear
Dented
With Paint Damage

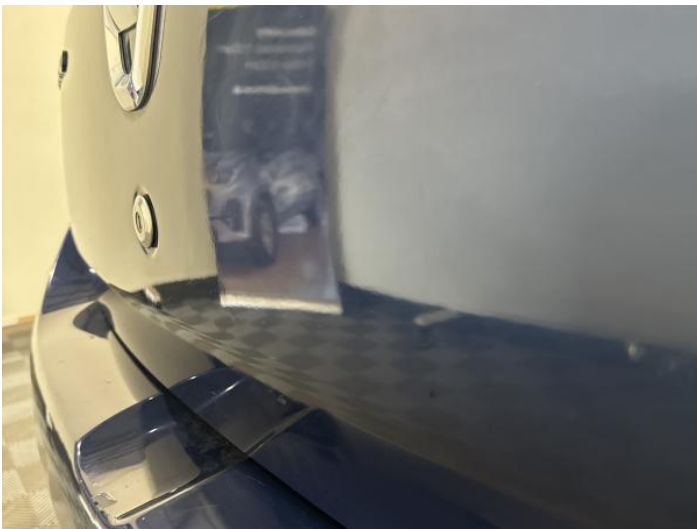
11: Tailgate
Poor Previous Repair
Rippled UpTo 30%

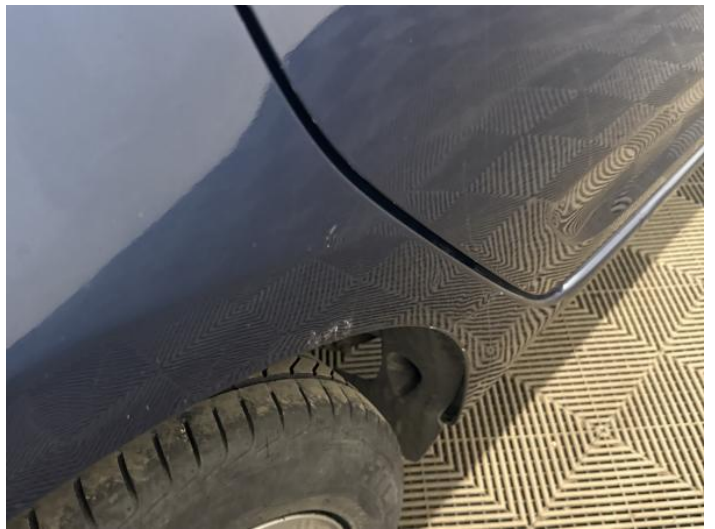
12: Qtr Panel osr
Scratched
Over 25mm Thru Paint

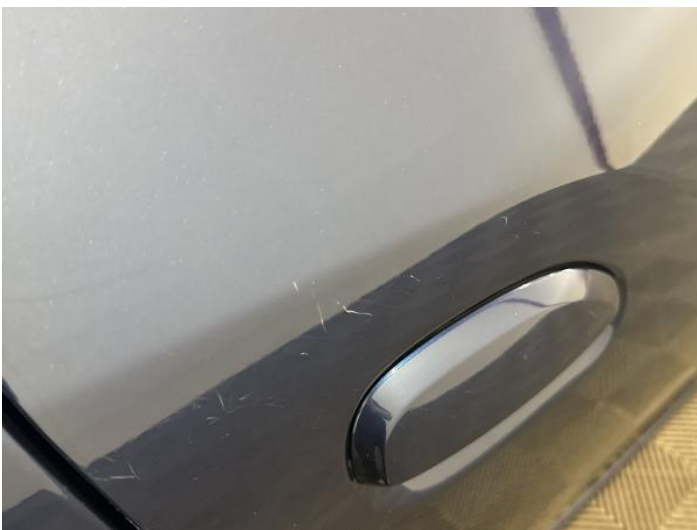
13: Door osr
Scratched
Over 25mm Thru Paint

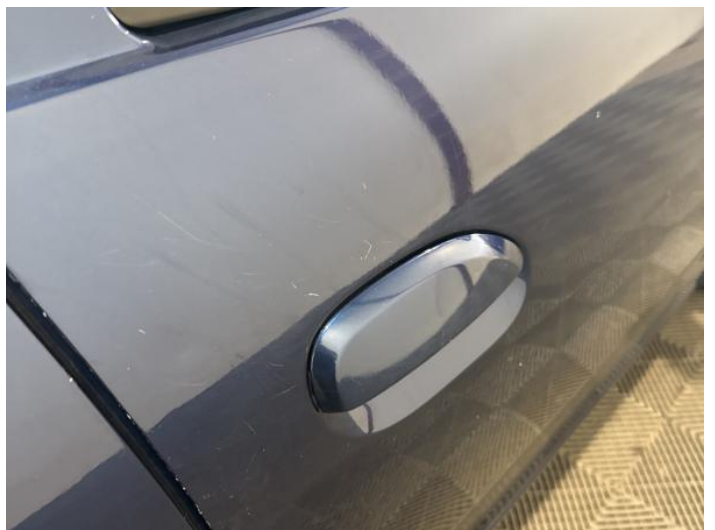
14: Door nsf
Dented
With Paint Damage

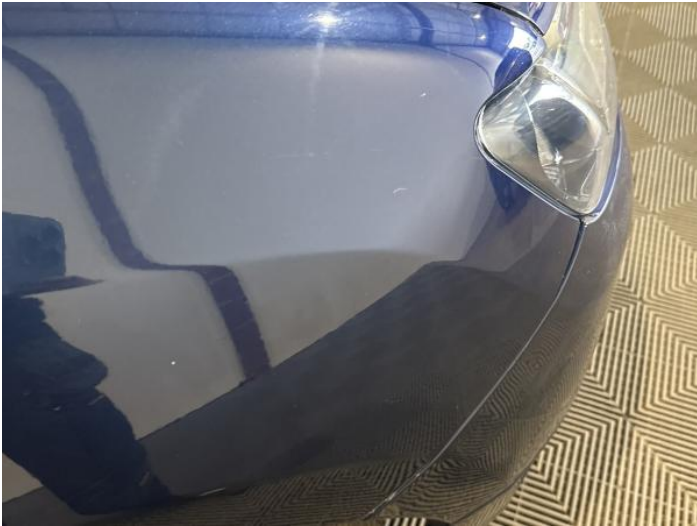
15: Wing of
Chipped
1 To 5

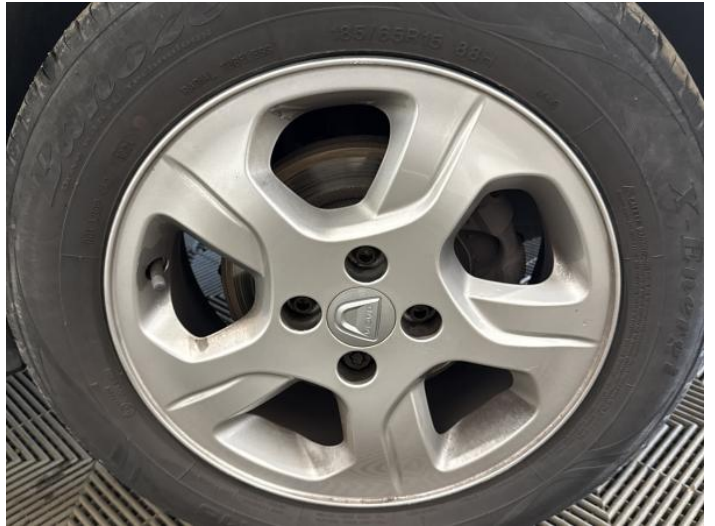
16: Wheel of
Scratched
Up To 50mm

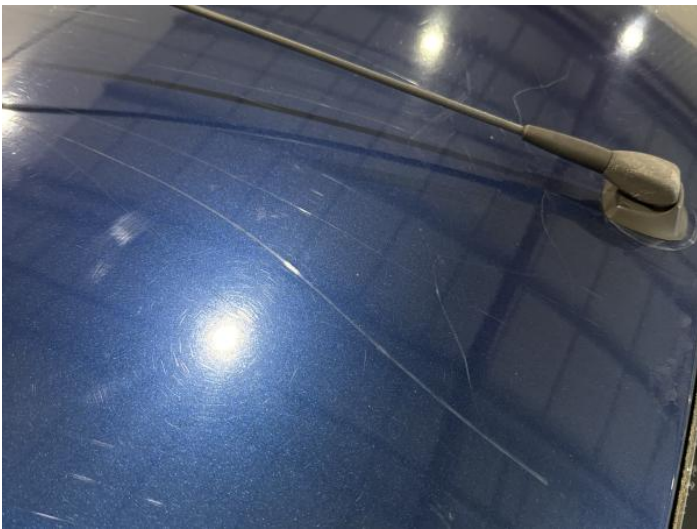
17: Roof
Scratched
Over 25mm Thru Paint
