# VEHICLE INSPECTION REPORT

**GU66DHF**

## Fiat 500x 1.4 Multiair Cross 5dr

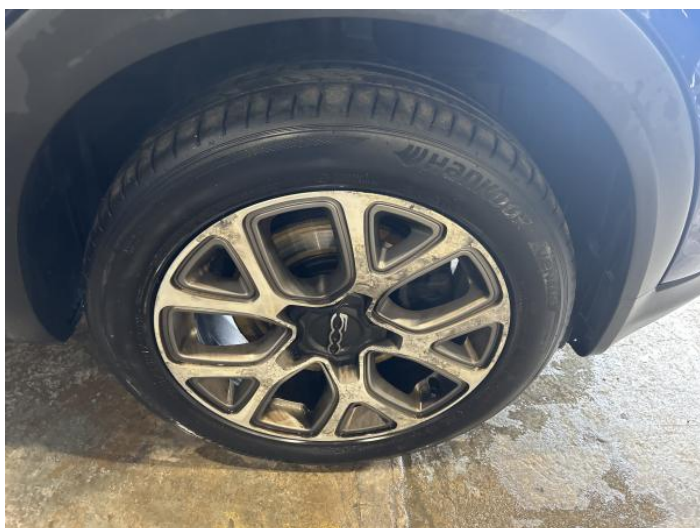
1: Wheel osf  
Corroded  
Light

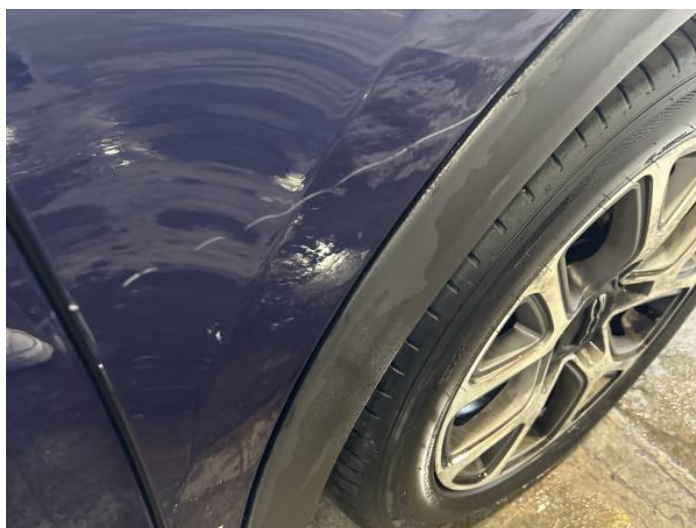
2: Wing osf  
Scratched  
Over 25mm Thru Paint

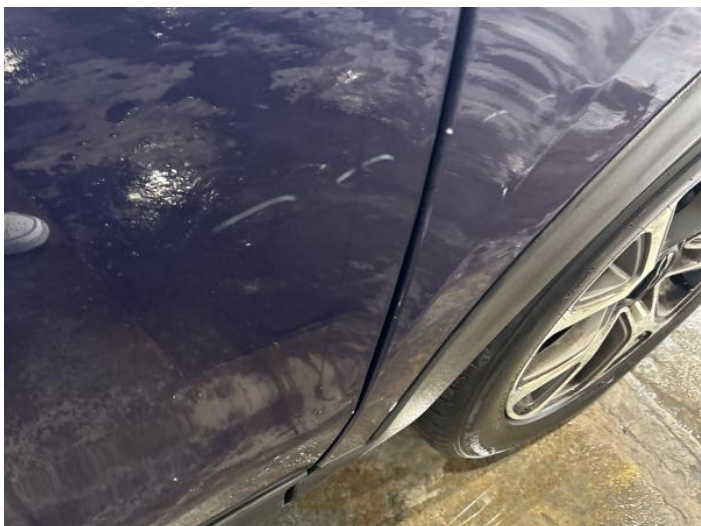
3: Door osf  
 Scratched  
 Over 25mm Thru Paint

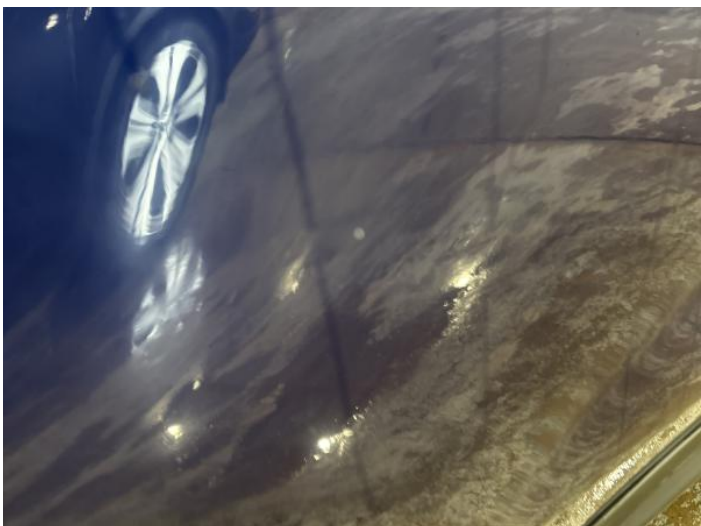
4: Door osr  
 Chipped  
 1 To 5

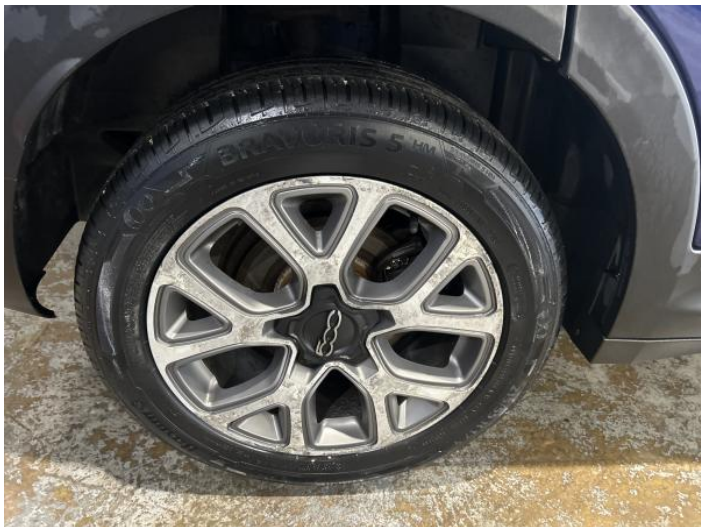
5: Wheel osr  
 Corroded  
 Light

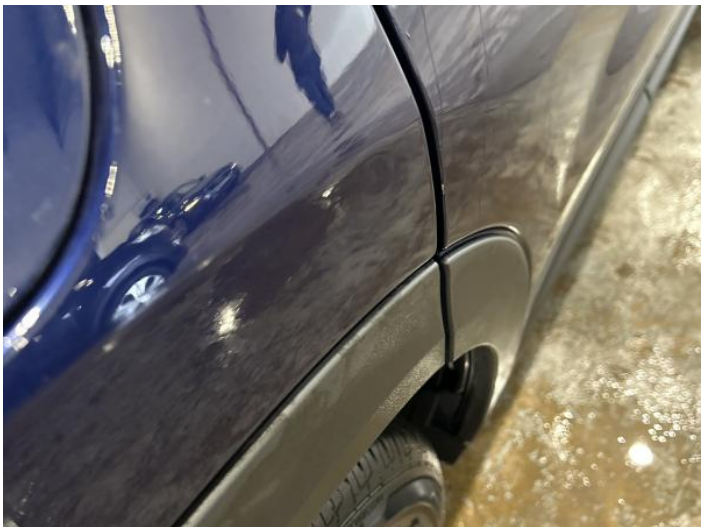
6: Qtr Panel osr  
 Dented  
 2 Or Less UpTo 10mm

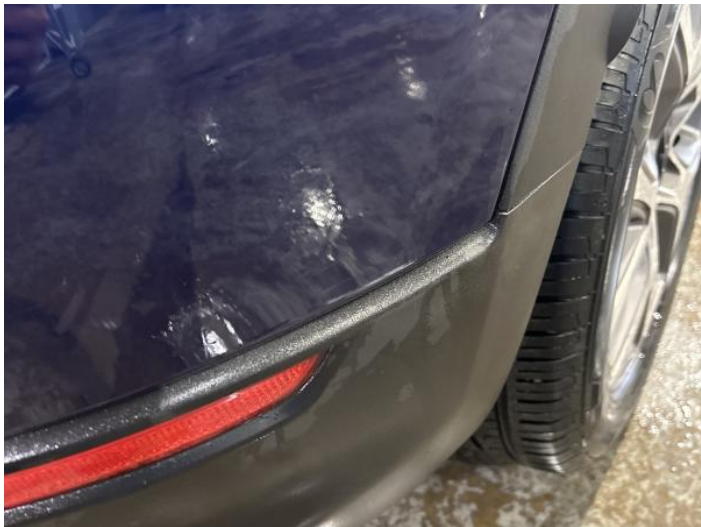
7: Bumper Rear  
 Scratched  
 25 to 100mm Thru Paint

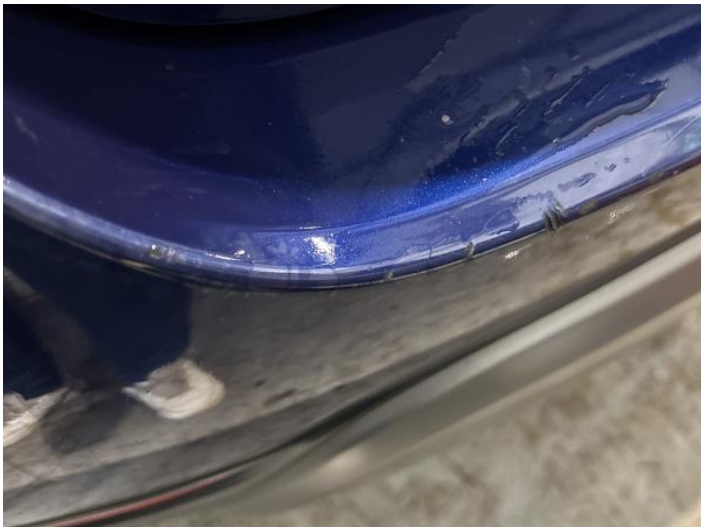
8: Bumper Rear  
 Chipped  
 Multiple Chips

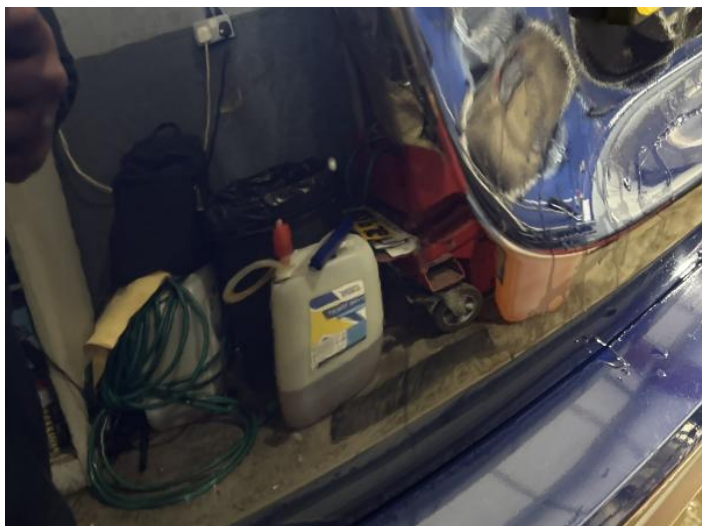
9: Tailgate  
Chipped  
1 To 5

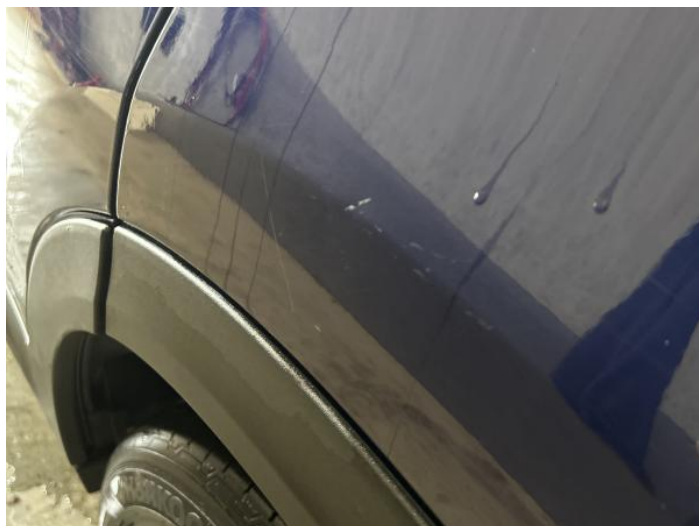
10: Qtr Panel nsr  
Scratched  
Over 25mm Not Thru Paint

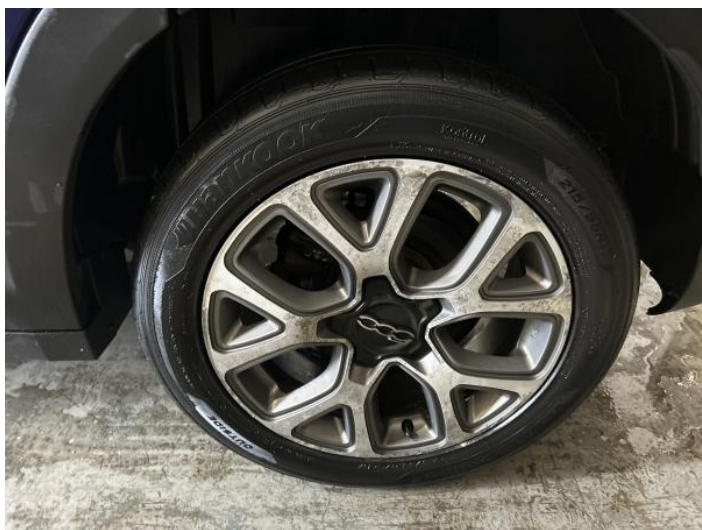
11: Wheel nsr  
Corroded  
Light

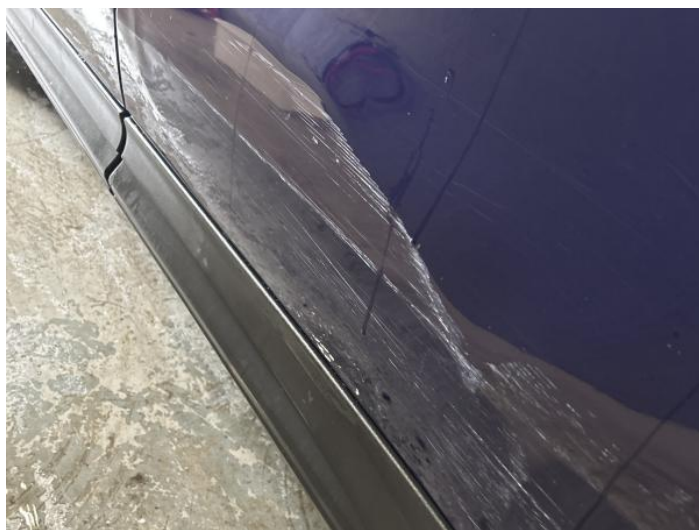
12: Door nsr  
Dented  
With Paint Damage

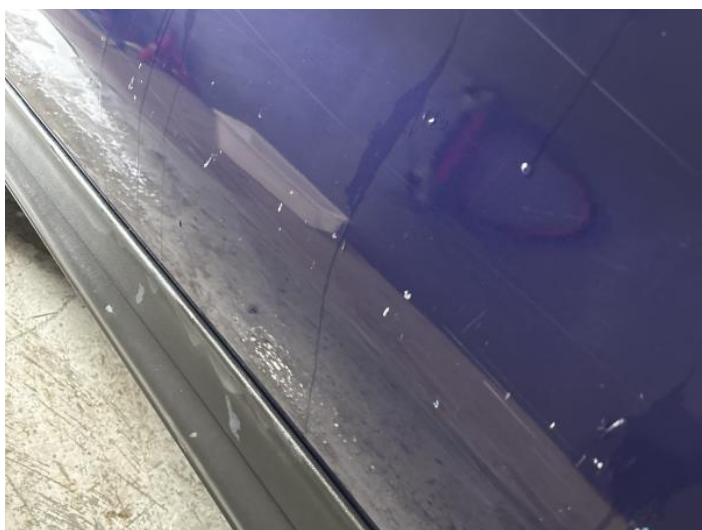
13: Door nsf  
Chipped  
Multiple Chips

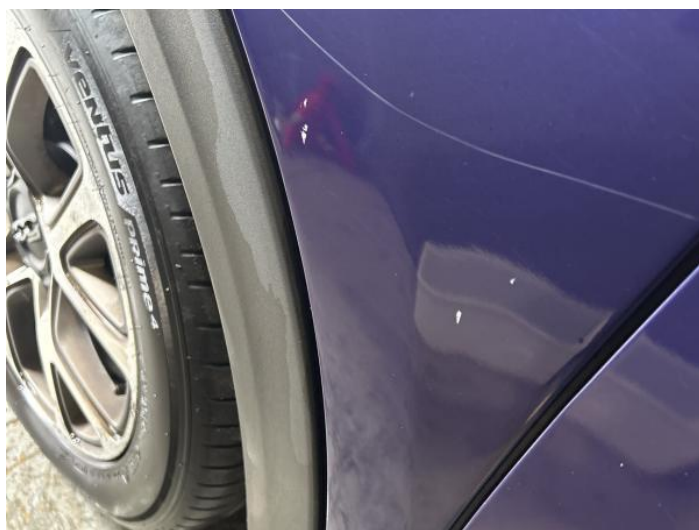
14: Wing nsf  
Chipped  
1 To 5

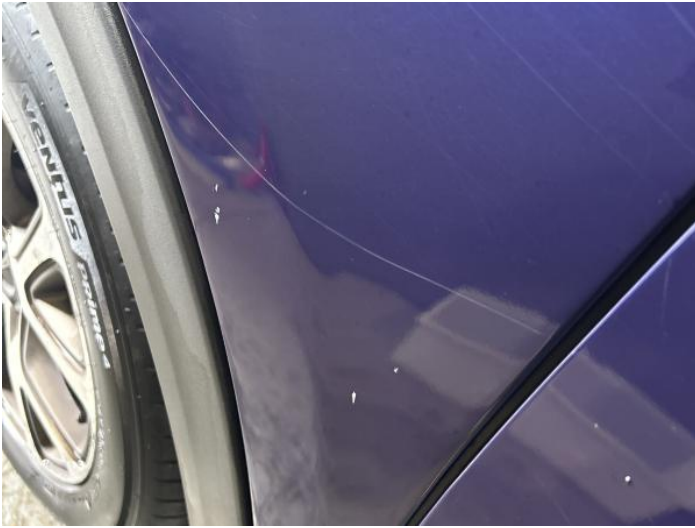
15: Wing nsf  
Scratched  
Over 25mm Not Thru Paint

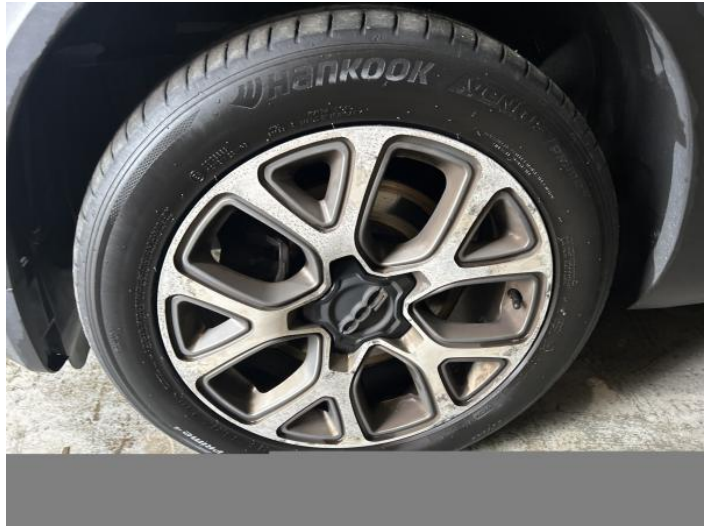
16: Wheel nsf  
Corroded  
Light

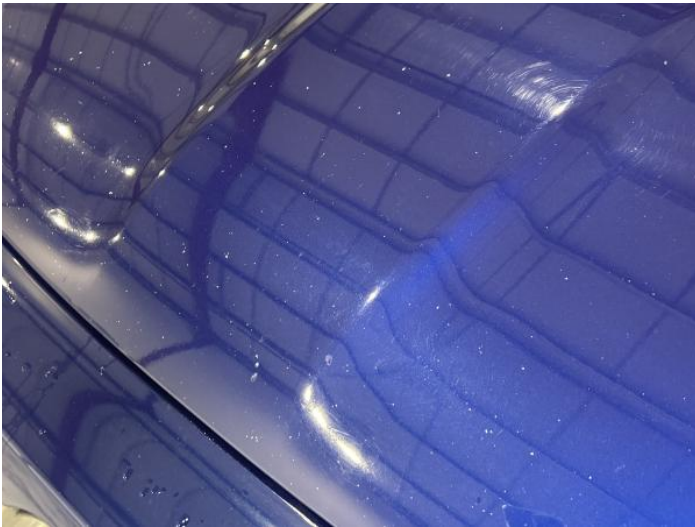
17: Bonnet  
Chipped  
Multiple Chips

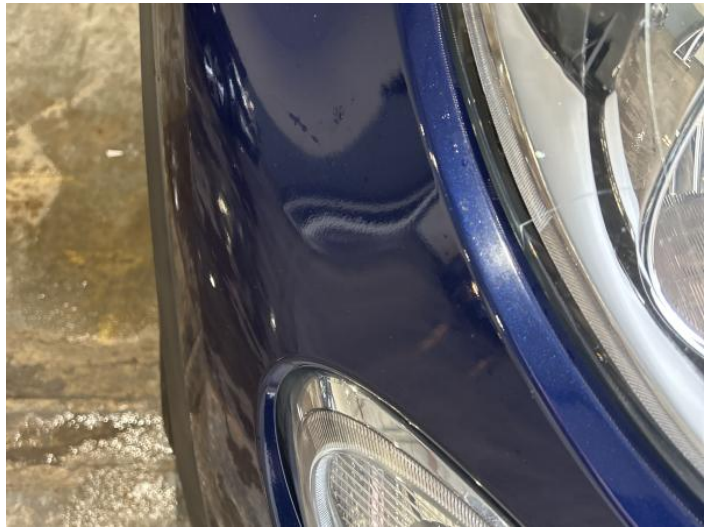
18: Bumper Front  
Poor Previous Repair  
Poor Paint
