VEHICLE INSPECTION REPORT

CN13VZY

Ford Focus 1.6 125 Zetec 5dr Powershift

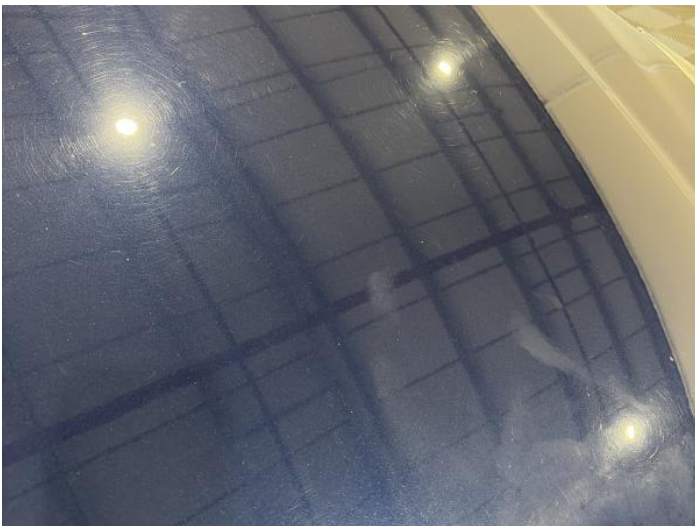
1: Bonnet
Scratched
Over 25mm Thru Paint

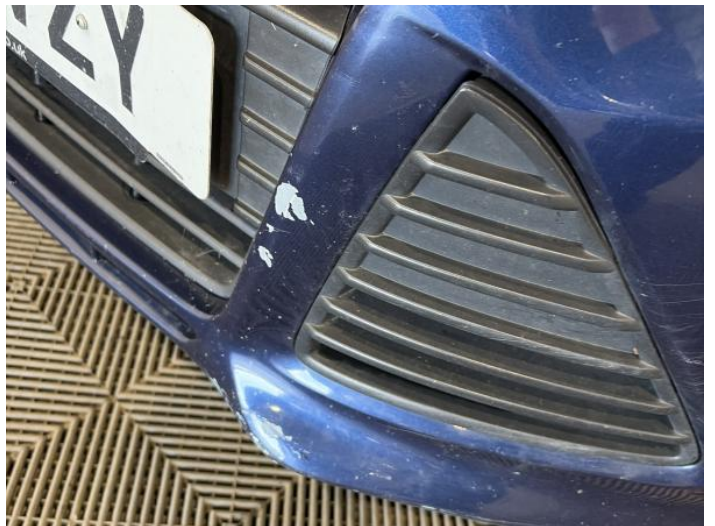
2: Bumper Front
Dented
With Paint Damage

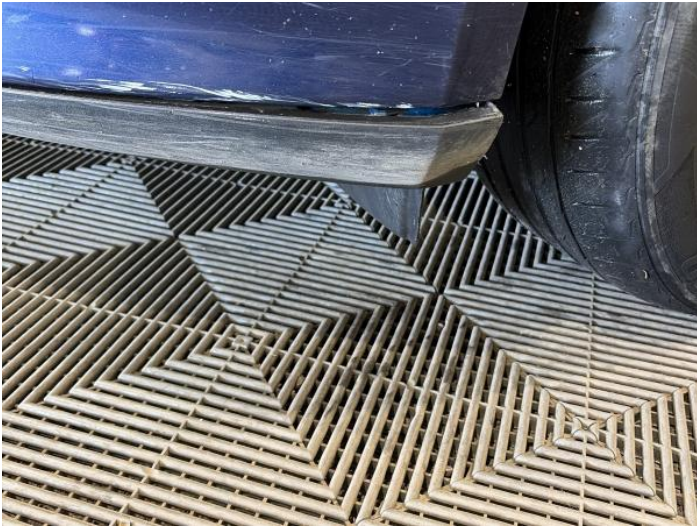
3: Bumper Front Moulding
Scuffed (Unpainted)
Over 100mm

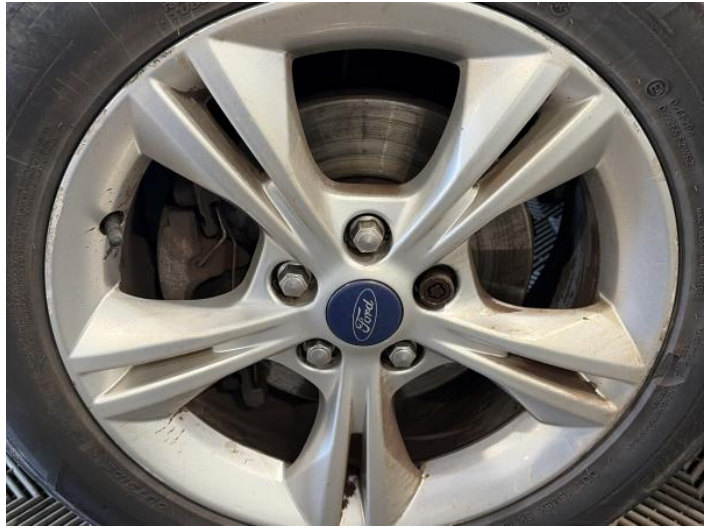
4: Wheel nsf
Scratched
Over 50mm

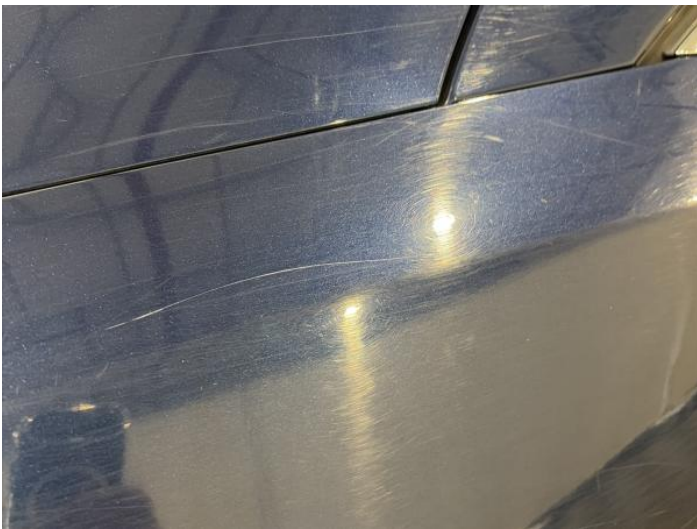
5: Wing nsf
Scratched
Over 25mm Thru Paint

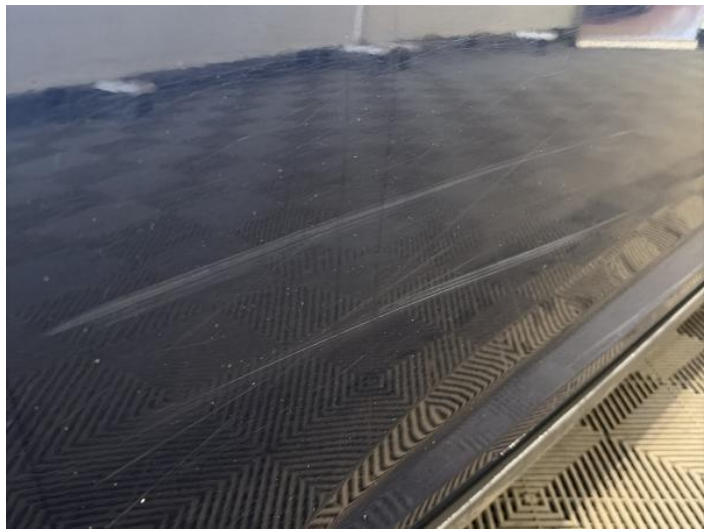
6: Door nsf
Scratched
Over 25mm Thru Paint

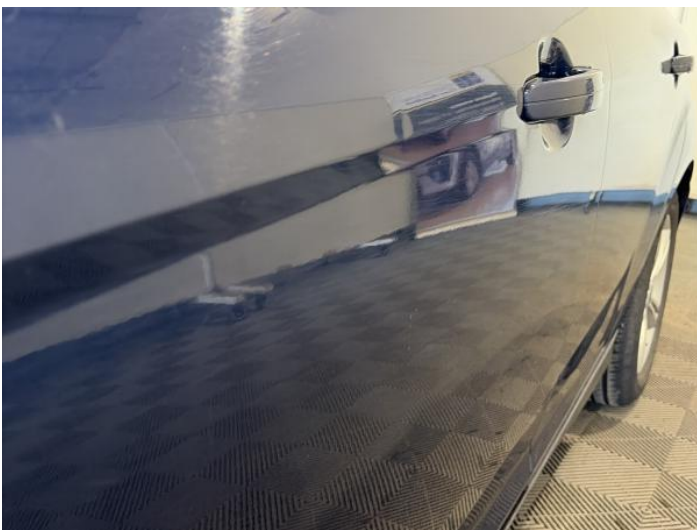
7: Door nsf
Dented
Between 10mm + 30mm

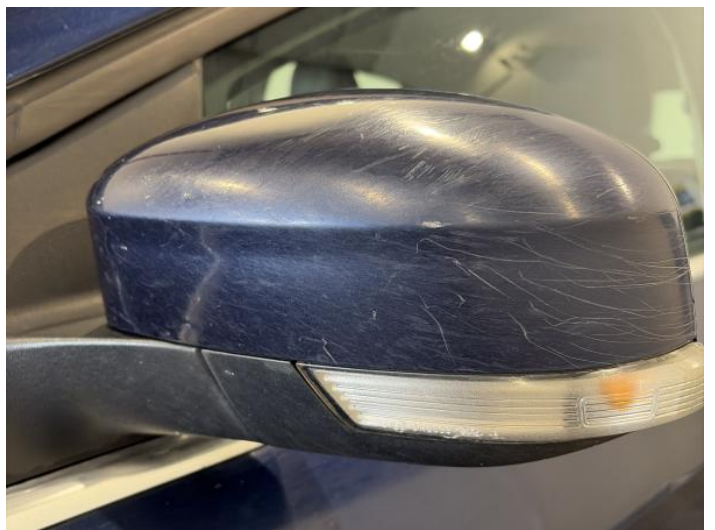
8: Door Mirror Assy nsf
Scratched (Painted)
Up To 25mm Thru Paint

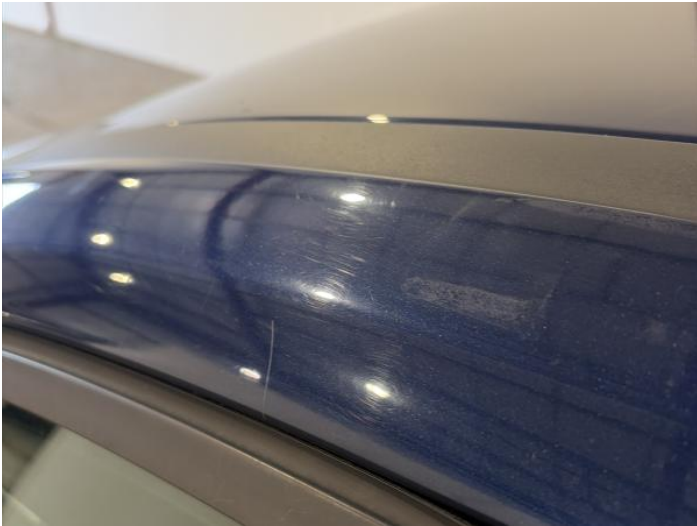
9: A Post ns
Scratched
UpTo 25mm Thru Paint

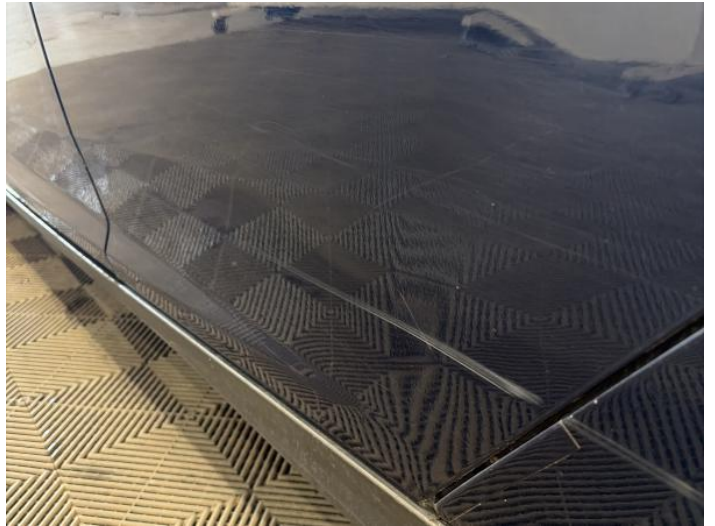
10: Door nsr
Scratched
Over 25mm Thru Paint

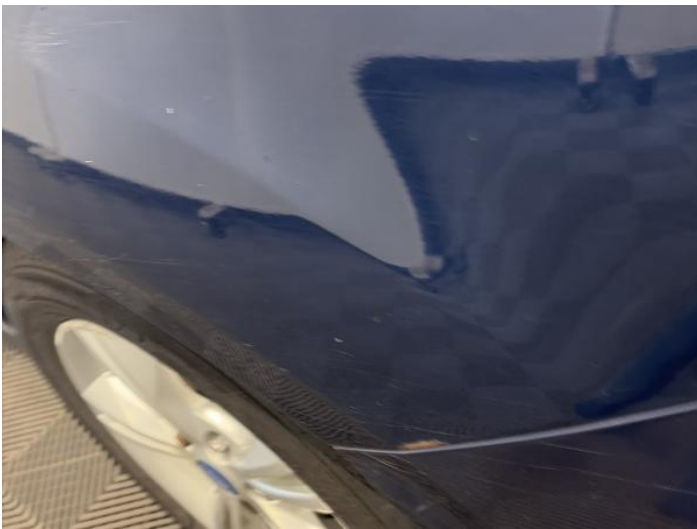
11: Qtr Panel nsr
Scratched
Rusted

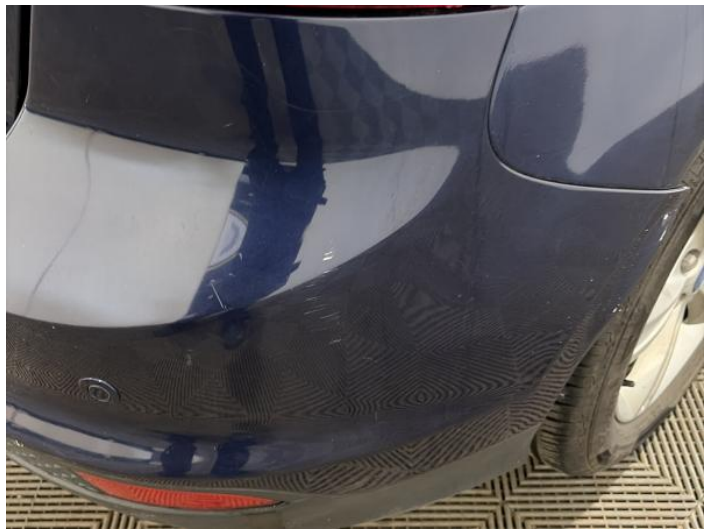
12: Bumper Rear
Scratched
Over 100mm Thru Paint

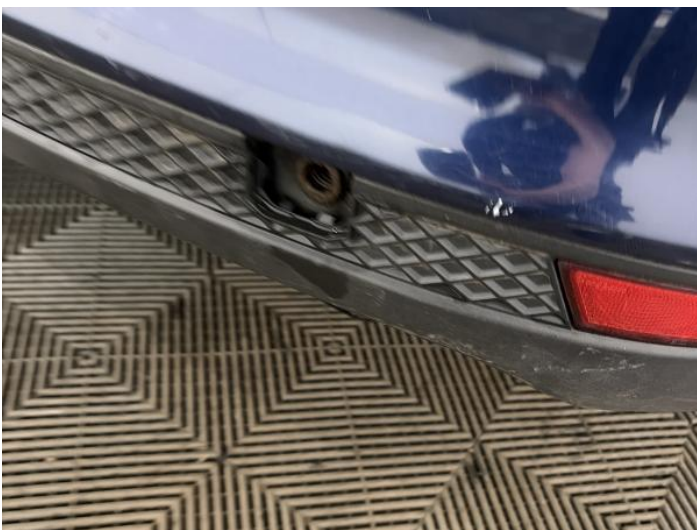
13: Rear TowEye Cvr
Missing
Replace

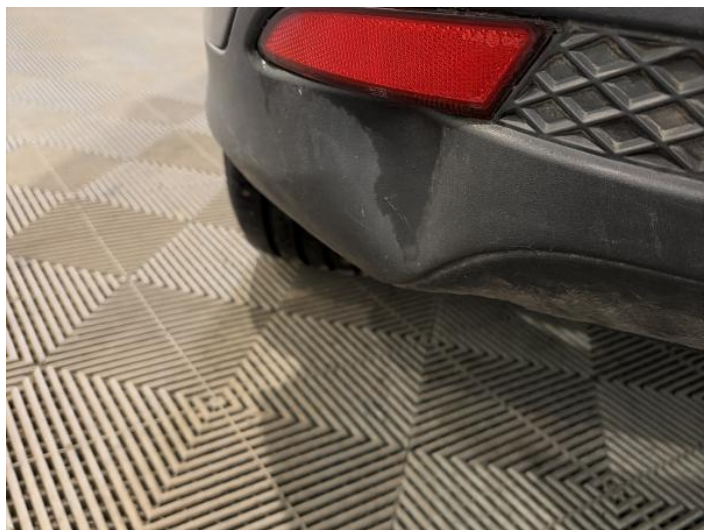
14: Bumper Rear Moulding
Scuffed (Unpainted)
Over 100mm

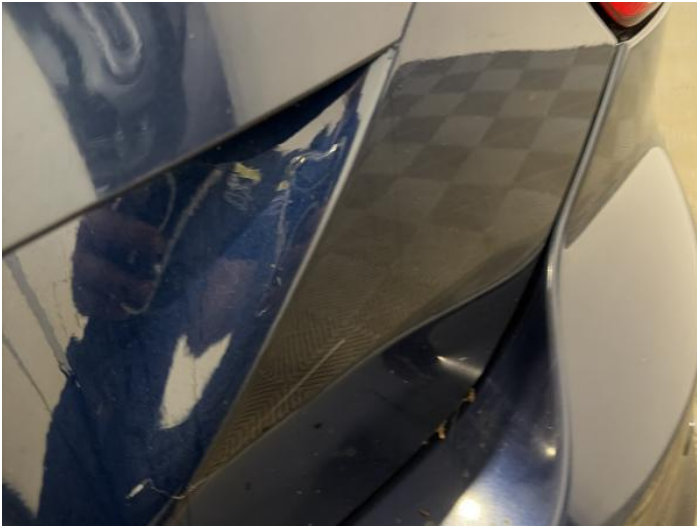
15: Tailgate
Scratched
Over 25mm Thru Paint

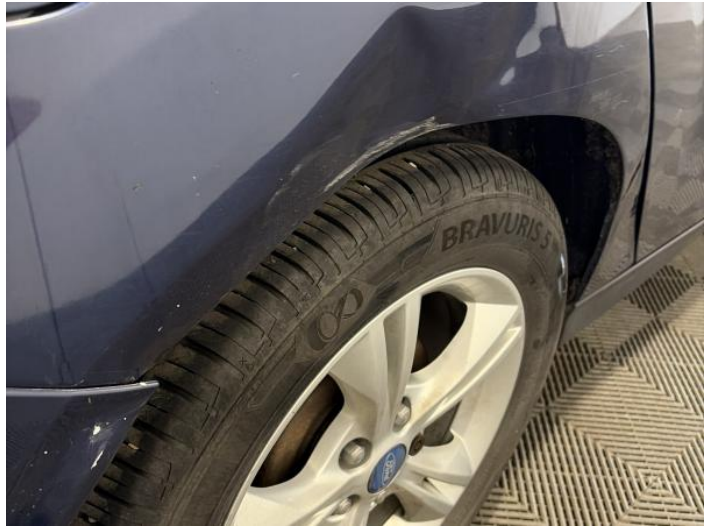
16: Qtr Panel osr
Dented
With Paint Damage

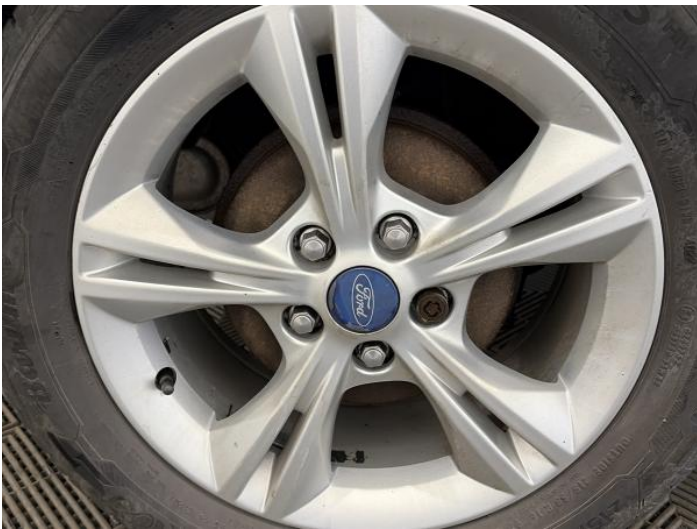
17: Wheel osr
Scratched
Up To 50mm

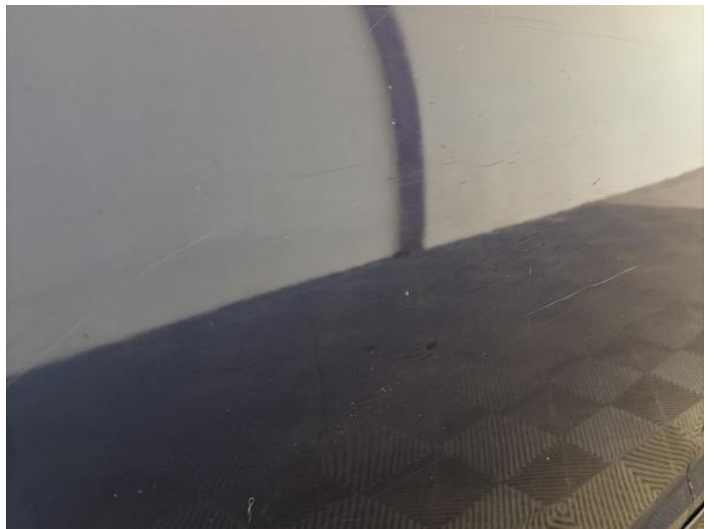
18: Door osr
Scratched
Over 25mm Thru Paint

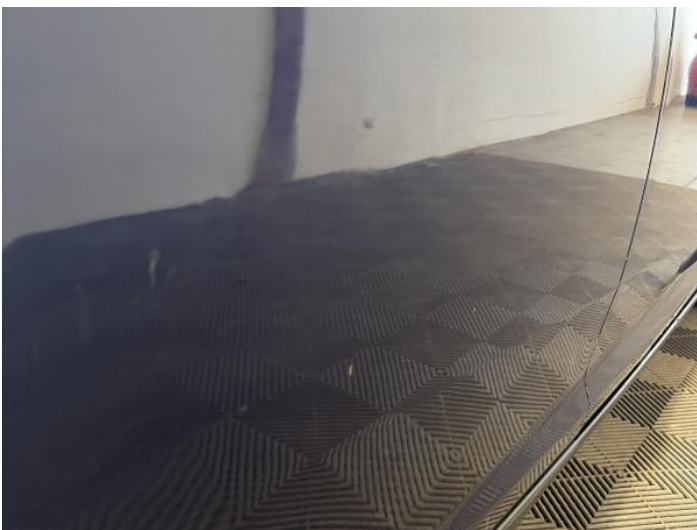
19: Door osr
Dented
Over 30mm

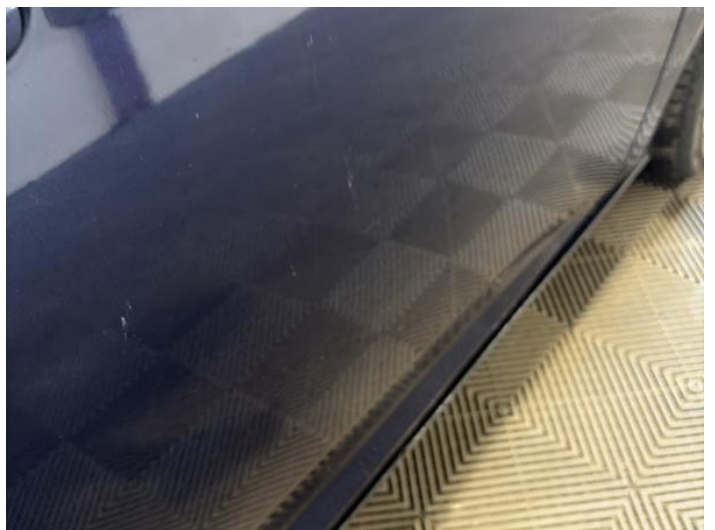
20: Door osf
Scratched
Over 25mm Thru Paint

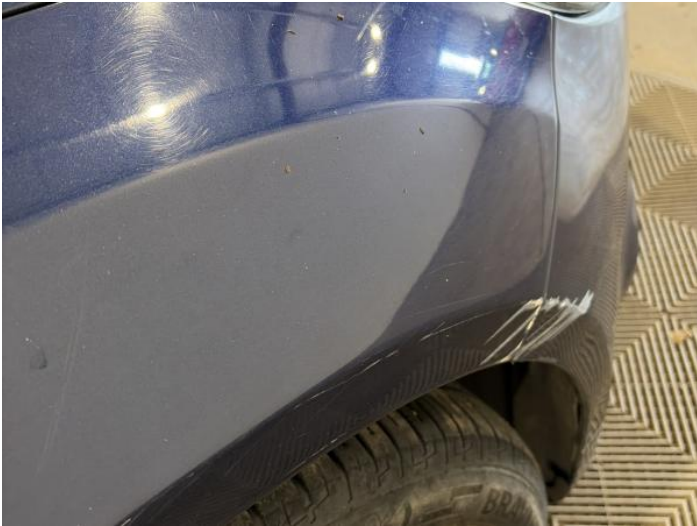
21: Wing osf
Dented
With Paint Damage

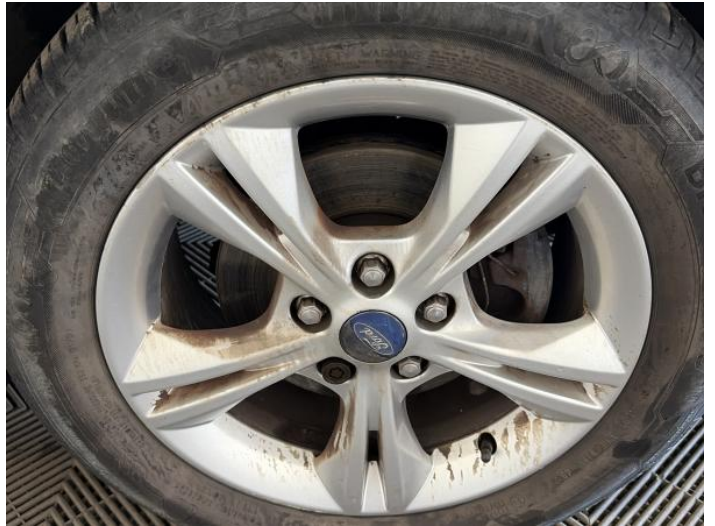
22: Wheel osf
Scratched
Over 50mm

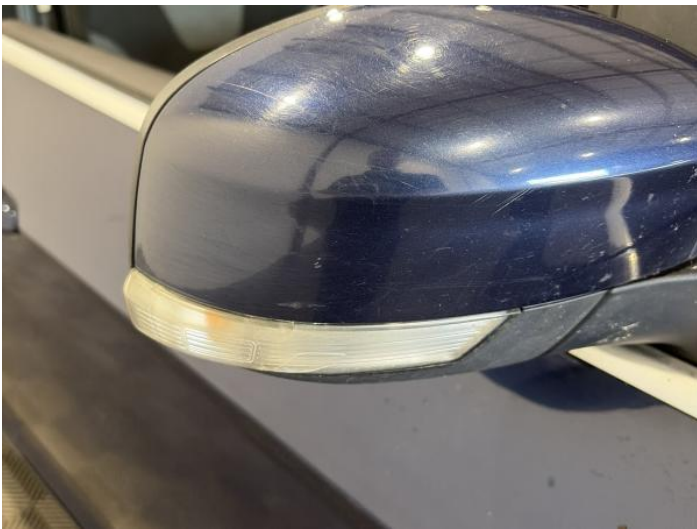
23: Flasher Side Repeater os
Broken
Replace

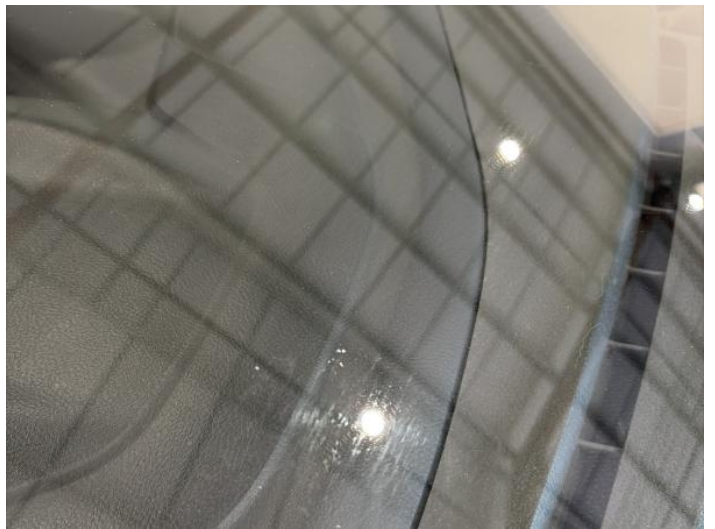
24: Screen Front
Chipped
UpTo 10mm

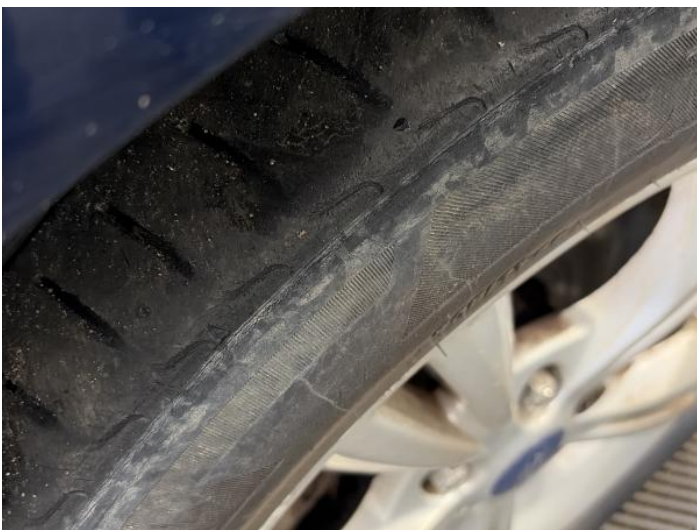
NSF	LAUFENN	Damaged
NSR	BARUM	5.0mm
OSF	BARUM	5.0mm
OSR	BARUM	5.0mm
Spare

25: Tyre nsf
Damaged
Replace

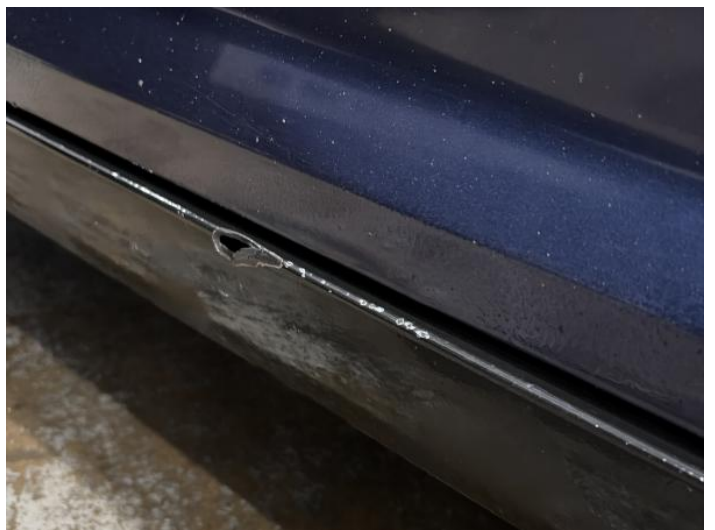
26: Sill Panel Trim os
Broken
Replace
