VEHICLE INSPECTION REPORT

LF11YNU

Kia Venga 1.4 1 5dr

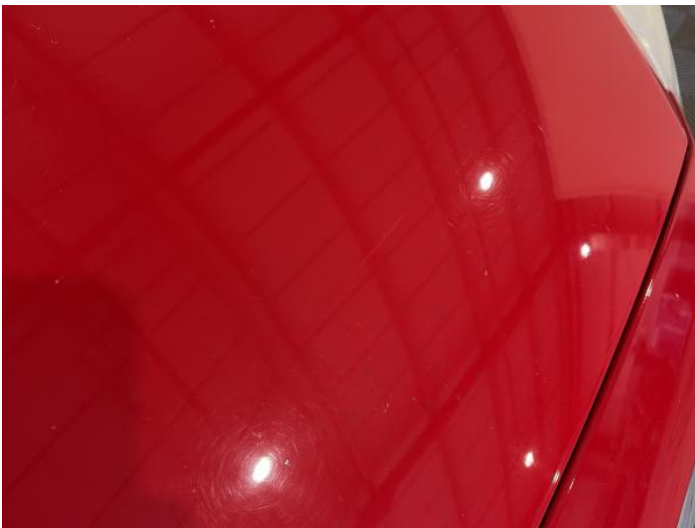
1: Bonnet
Chipped
Multiple Chips

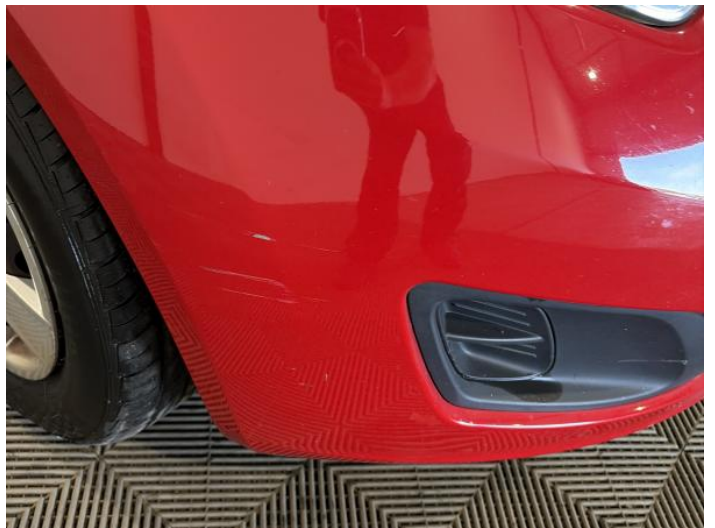
2: Bumper Front
Scratched
Over 100mm Thru Paint

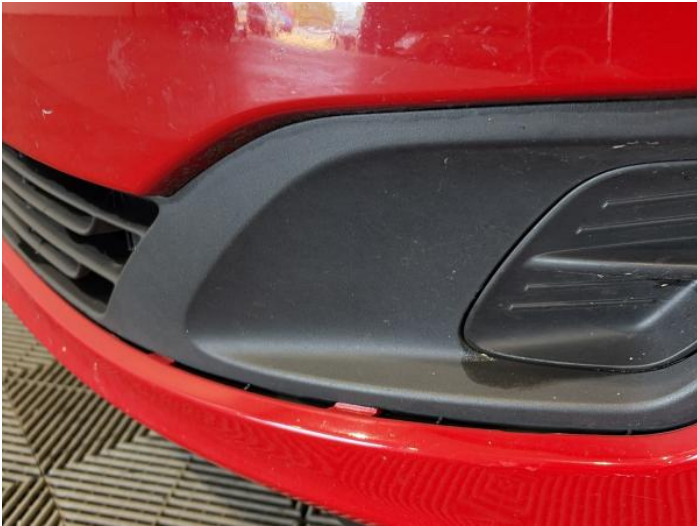
3: Bumper Front Moulding
Scuffed (Unpainted)
Over 100mm

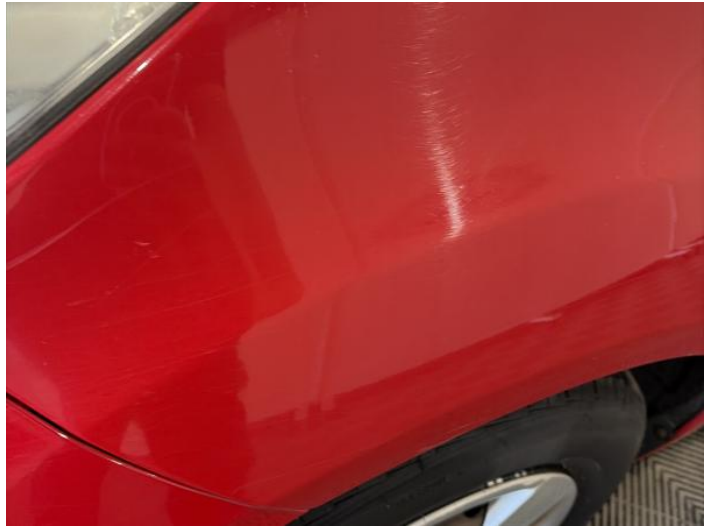
4: Wing nsf
Scratched
Over 25mm Thru Paint

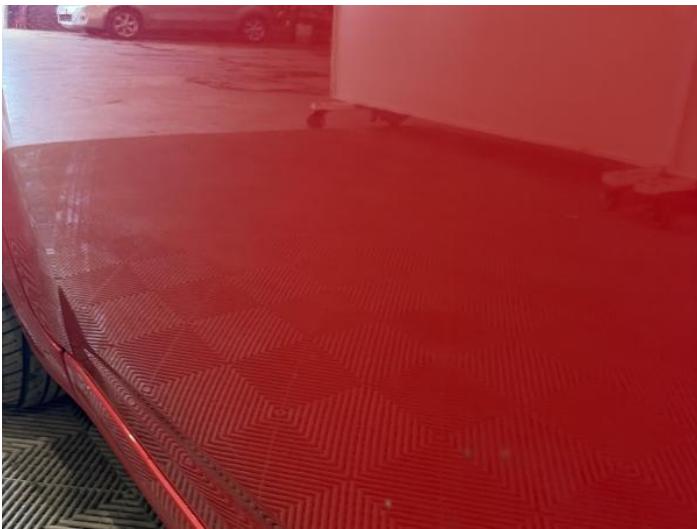
5: Door nsf
Dented
Between 10mm + 30mm

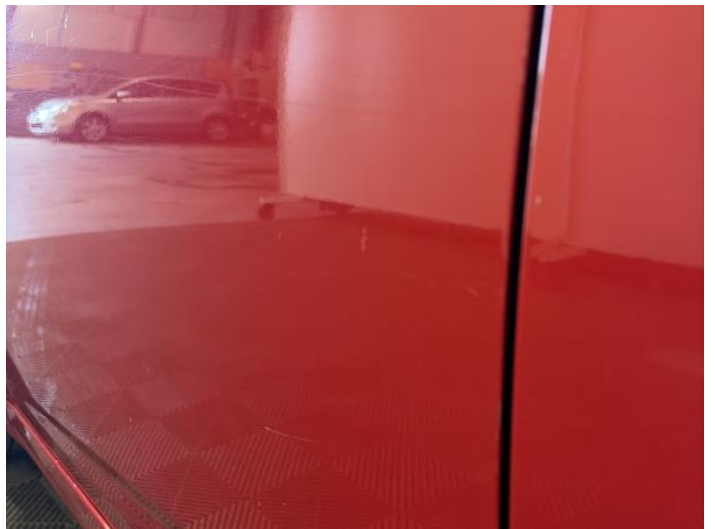
6: Door nsf
Scratched
Over 25mm Thru Paint

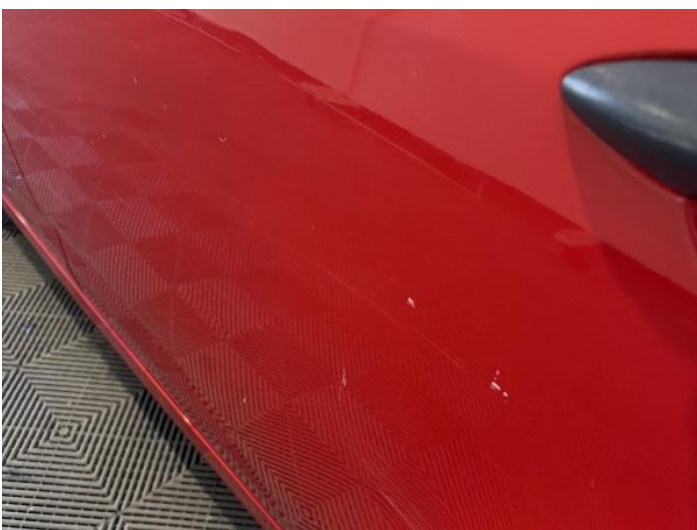
7: Door nsr
Dented
With Paint Damage

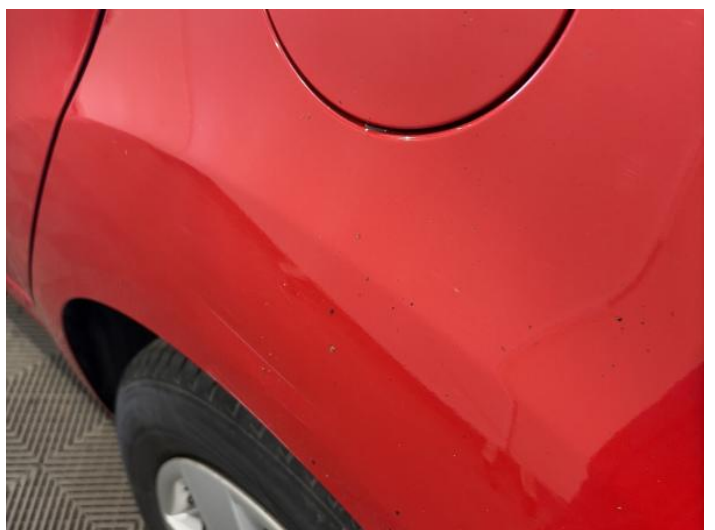
8: Qtr Panel nsr
Dented
With Paint Damage

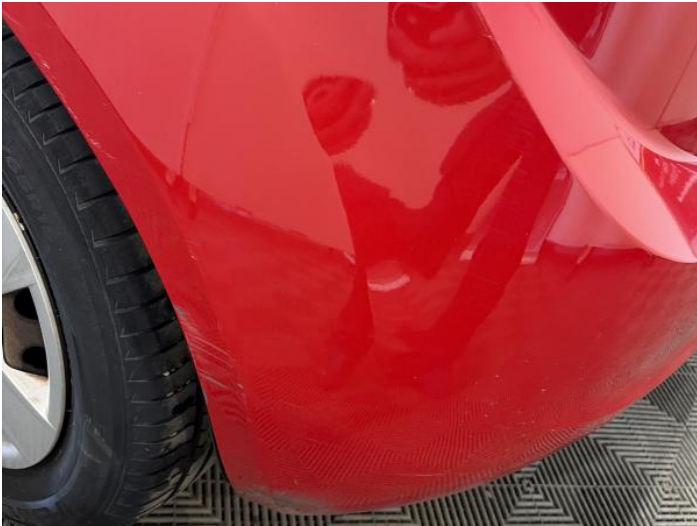
9: Bumper Rear
Scratched
25 to 100mm Thru Paint

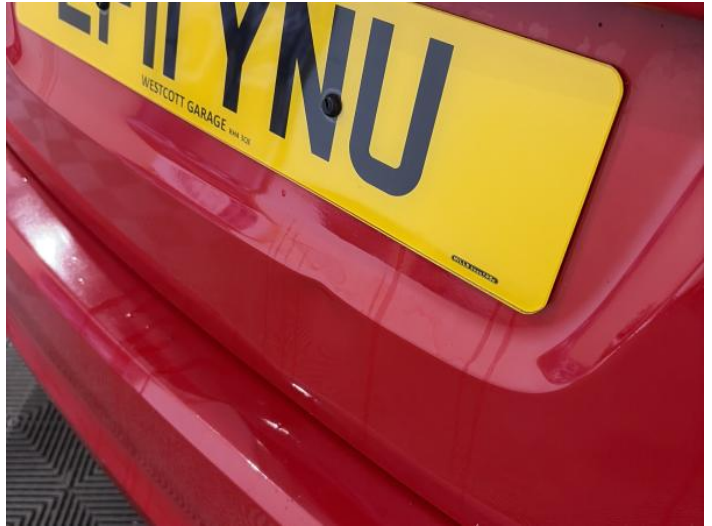
10: Tailgate
Dented
Over 30mm

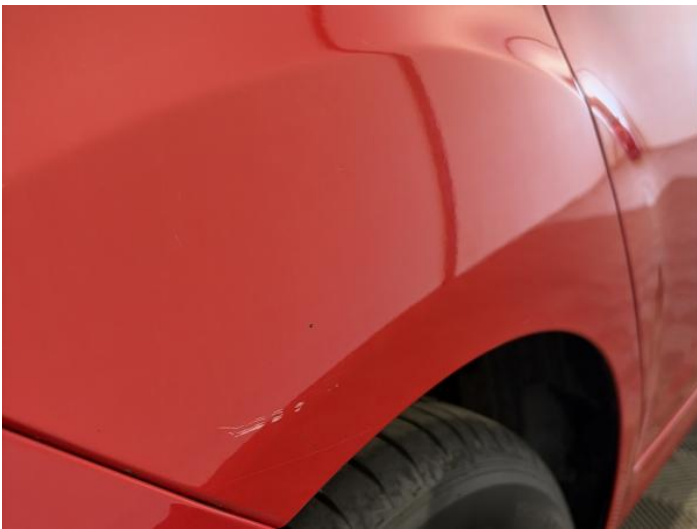
11: Qtr Panel osr
Scratched
Over 25mm Thru Paint

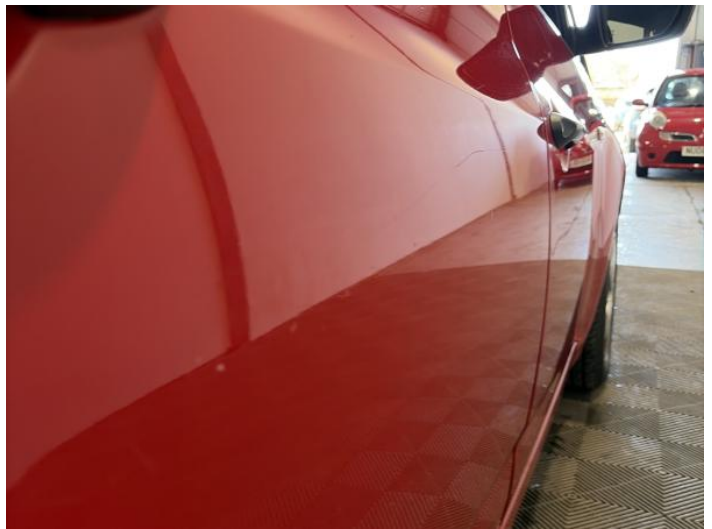
12: Door osr
Scratched
Over 25mm Thru Paint

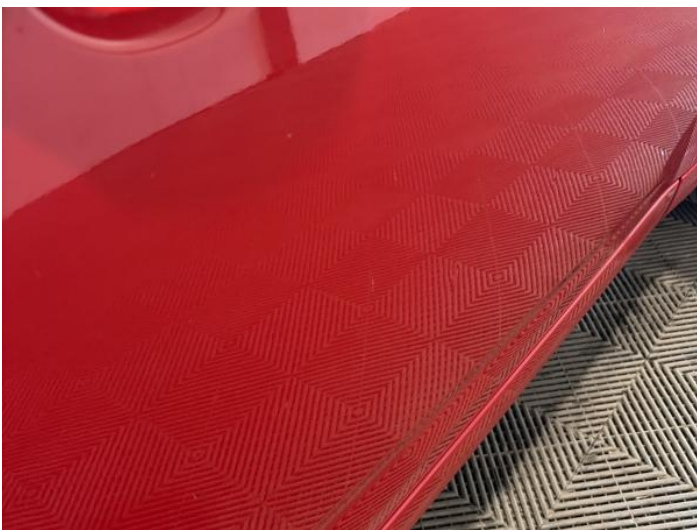
13: Door osf
Scratched
UpTo 25mm Thru Paint

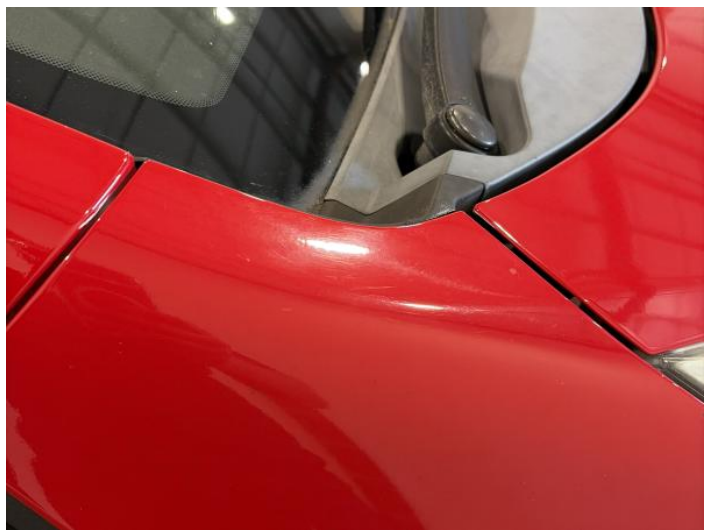
14: Wing osf
Chipped
1 To 5

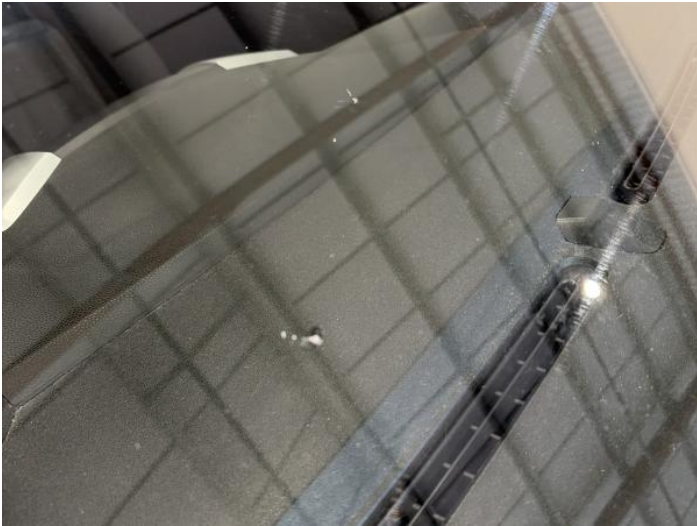
15: Screen Front
Chipped
Over 10mm

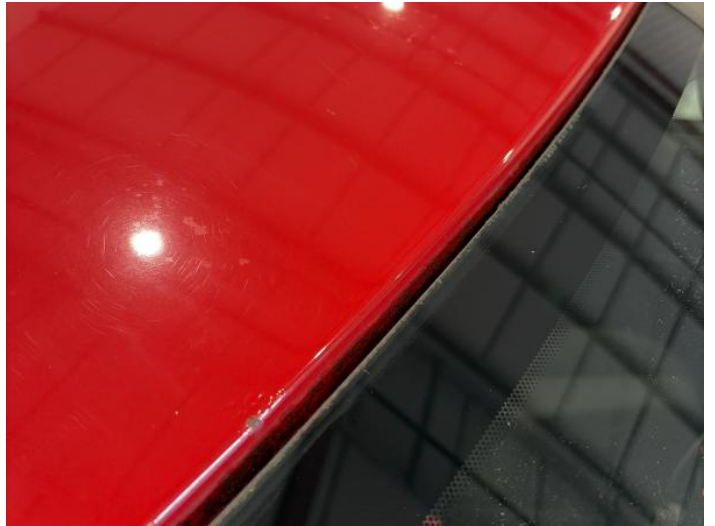
16: Roof
Chipped
Edge Chip

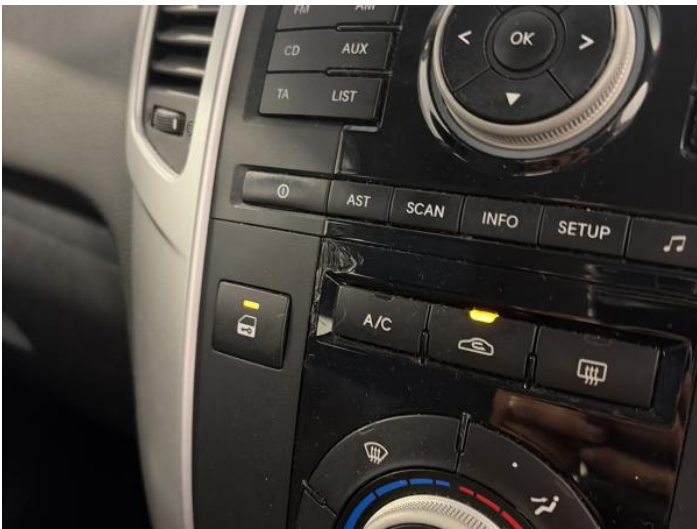
17: Centre Console Front
Scuffed
Over 25mm

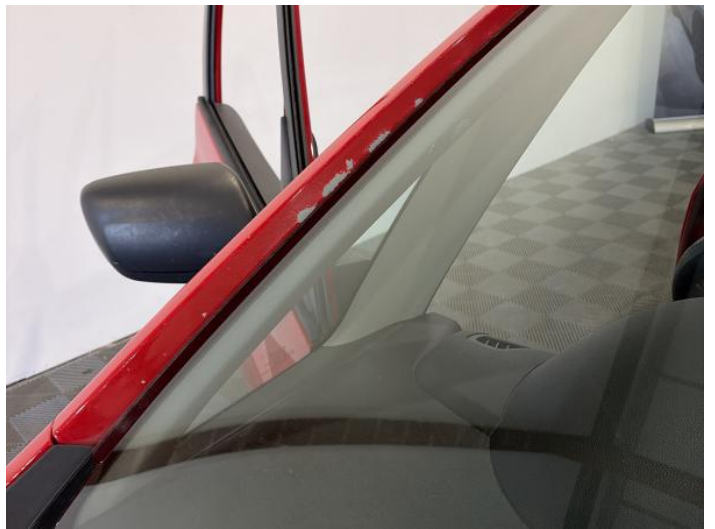
18: A Post os
Scratched
Over 25mm Thru Paint

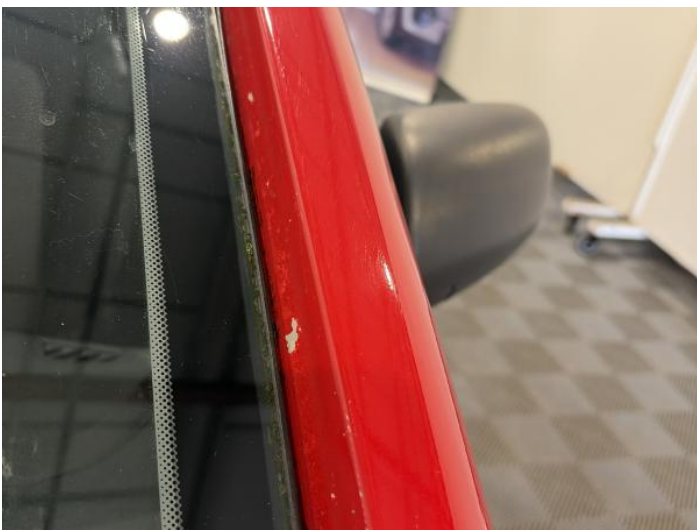
19: A Post ns
Scratched
Over 25mm Thru Paint
