VEHICLE INSPECTION REPORT

GX67XWT

Nissan Juke 1.2 DiG-T Tekna Pulse 5dr

nama
GRADE
4

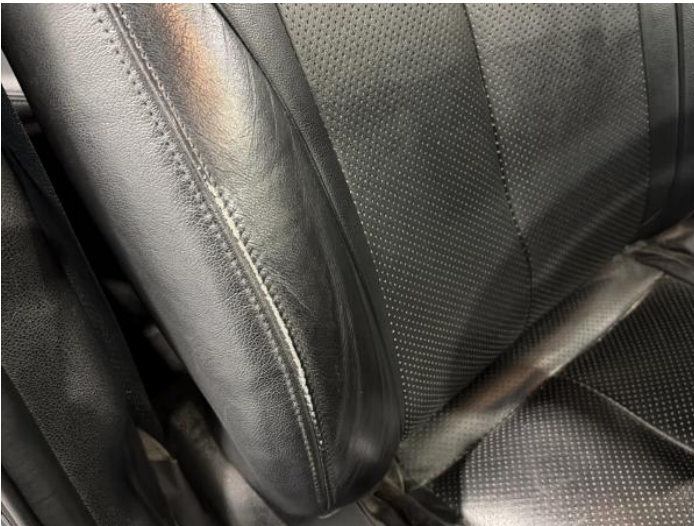
1: Seat Back Cover osf
Scuffed
Over 25mm

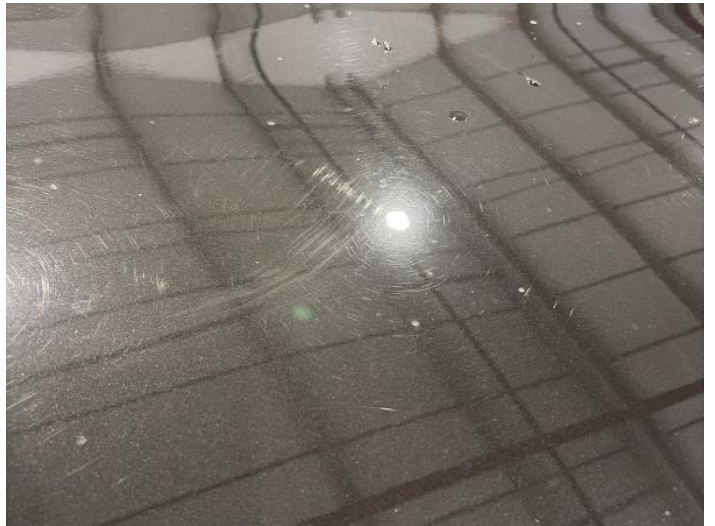
2: Bonnet
Scratched
Over 25mm Thru Paint

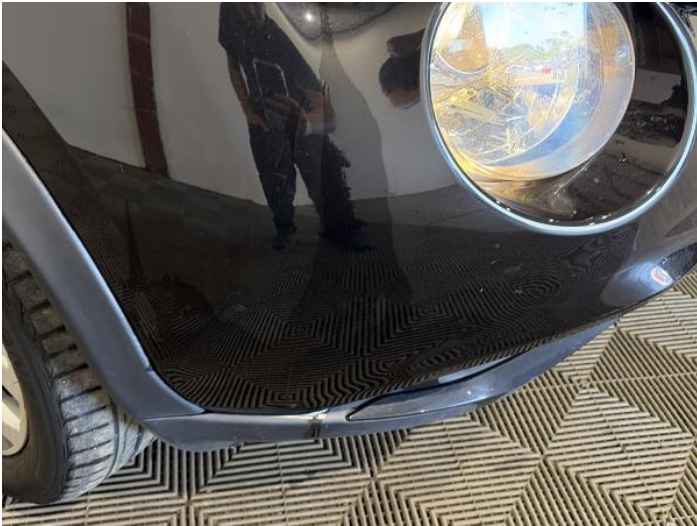
3: Bumper Front
Scratched
25 to 100mm Thru Paint

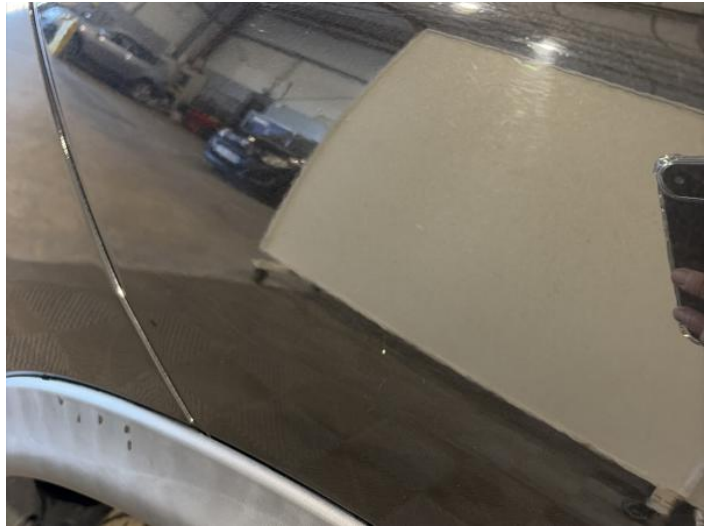
4: Wing nsf
Chipped
1 To 5

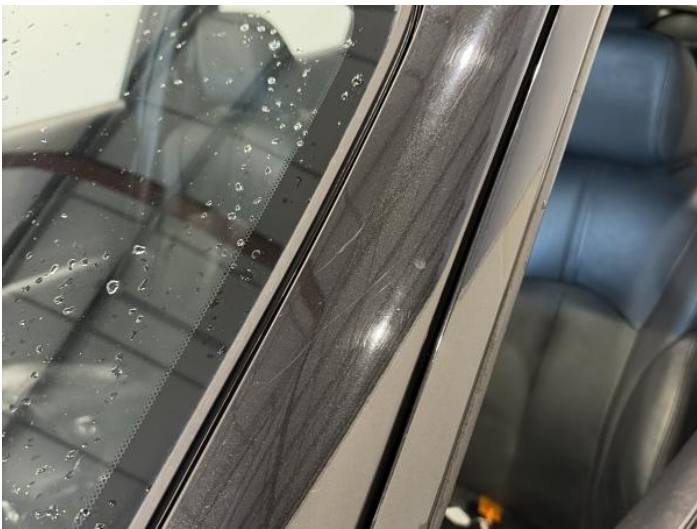
5: A Post ns
Scratched
UpTo 25mm Thru Paint

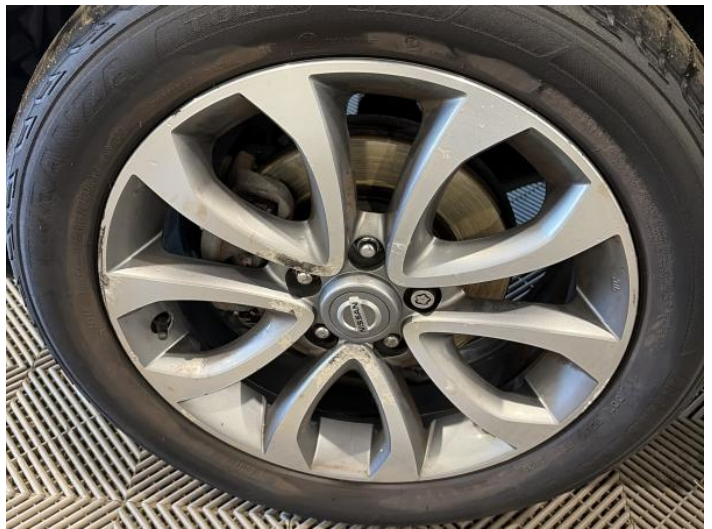
6: Wheel nsf
Scratched
Over 50mm

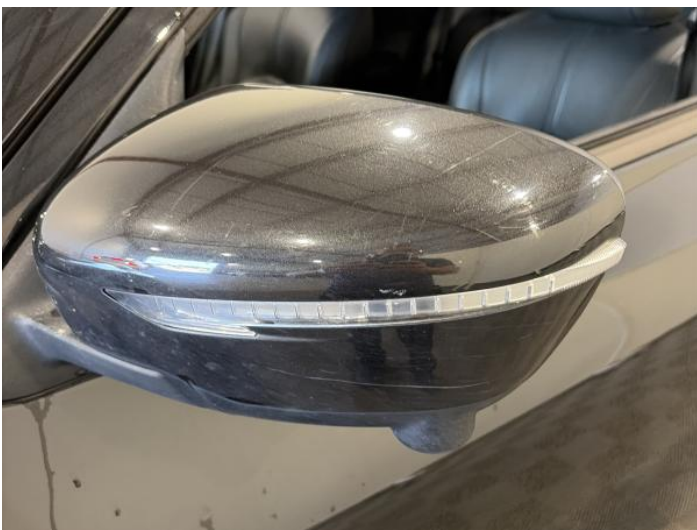
7: Door Mirror Assy nsf
Scratched (Painted)
Over 25mm Thru Paint

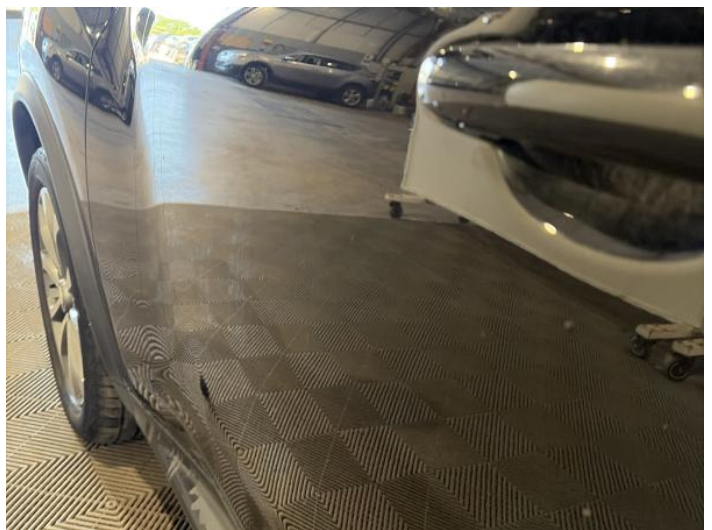
8: Door nsf
Dented
Between 10mm + 30mm

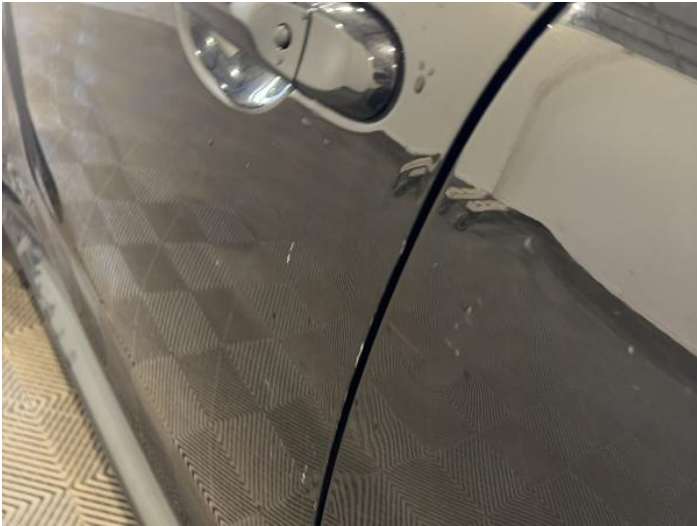
9: Door nsf
Scratched
Over 25mm Thru Paint

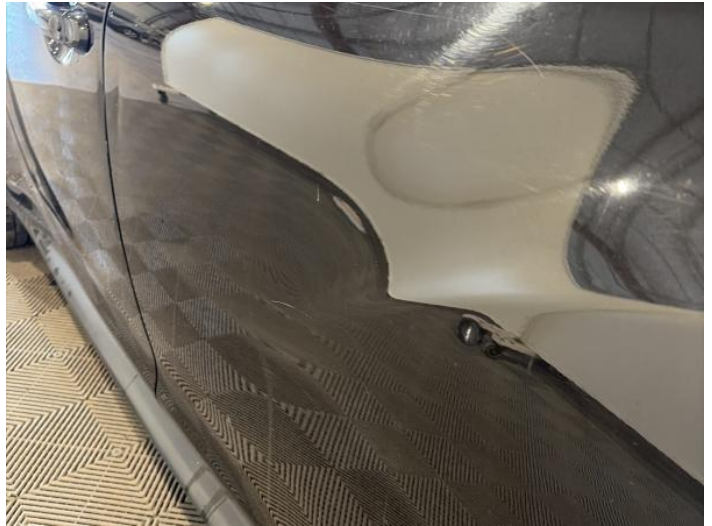
10: Door nsr
Dented
With Paint Damage

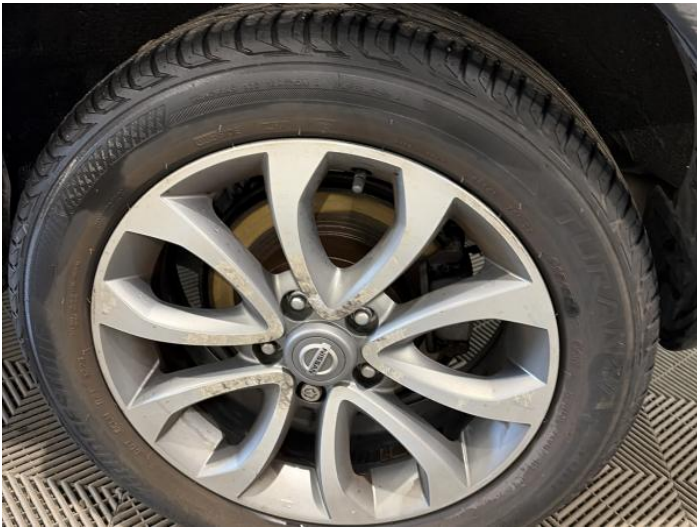
11: Wheel nsr
Scratched
Over 50mm

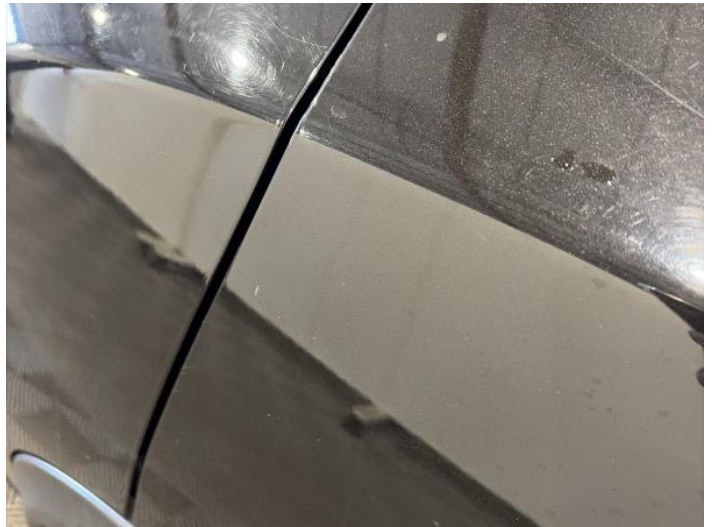
12: Qtr Panel nsr
Chipped
1 To 5

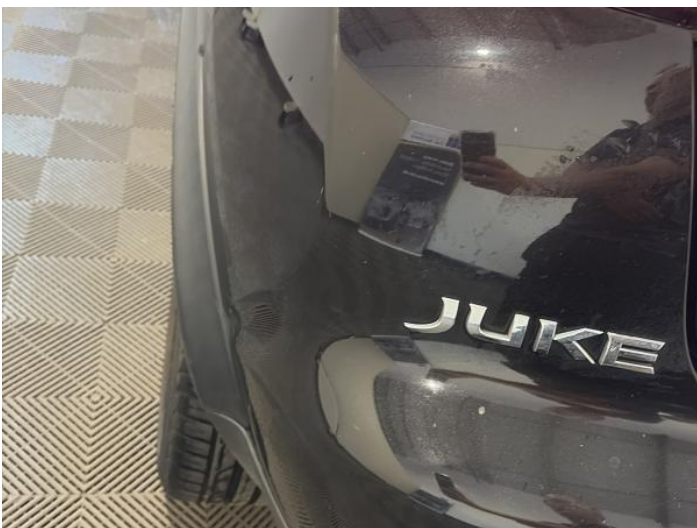
13: Bumper Rear
Scratched
Over 100mm Thru Paint

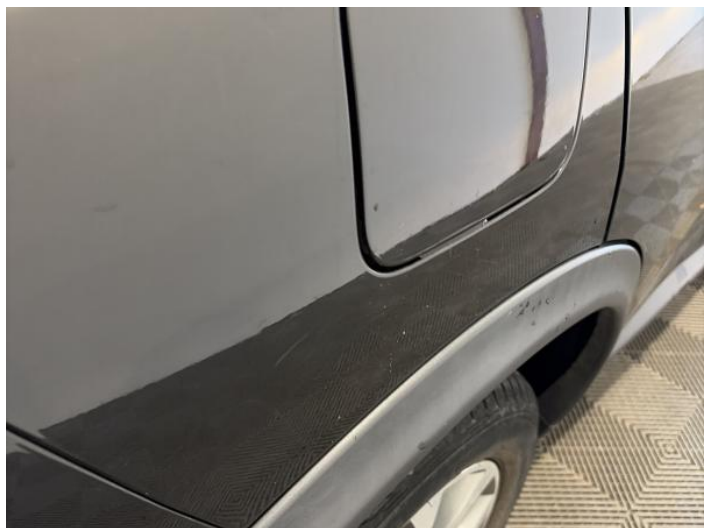
14: Qtr Panel osr
Scratched
UpTo 25mm Thru Paint

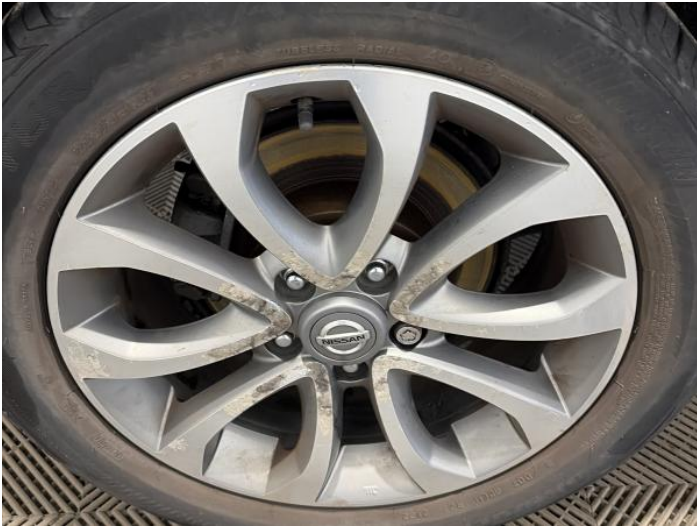
15: Wheel osf
Scratched
Over 50mm

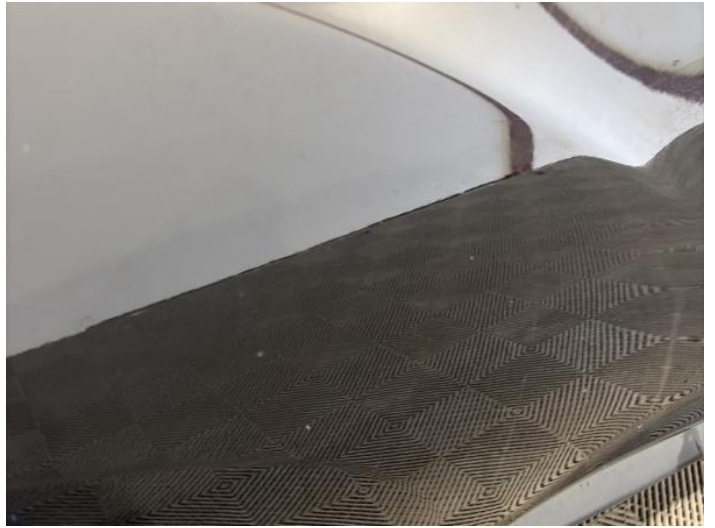
16: Door osf
Chipped
1 To 5

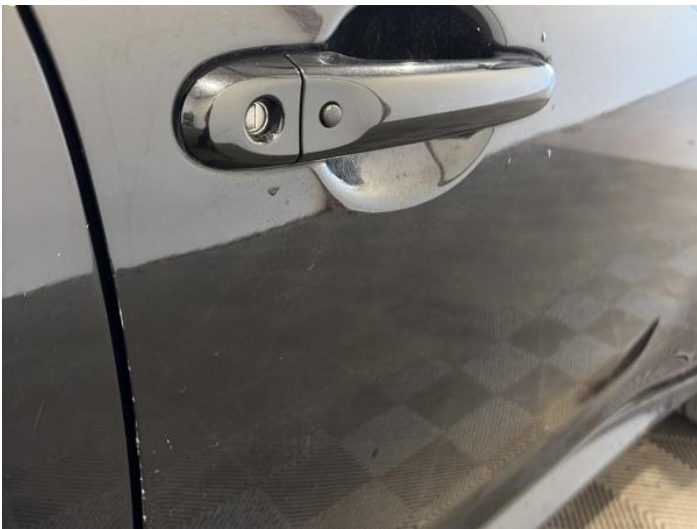
17: Door osf
Chipped
Edge Chip

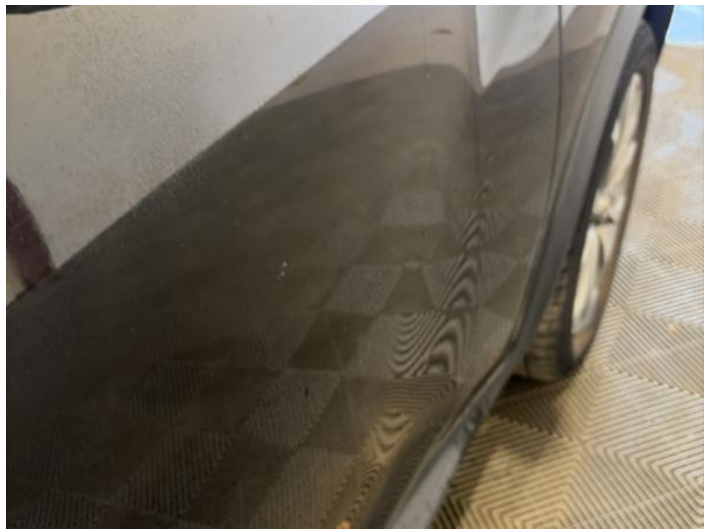
18: Door osf
Dented
Between 10mm + 30mm

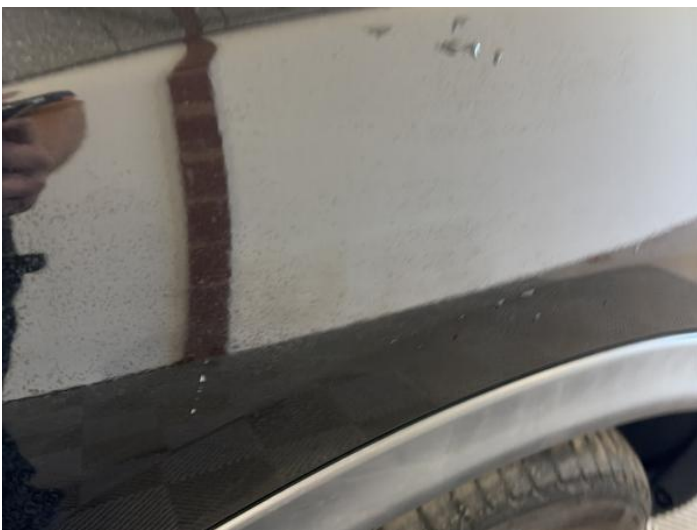
19: Wing osf
Chipped
1 To 5

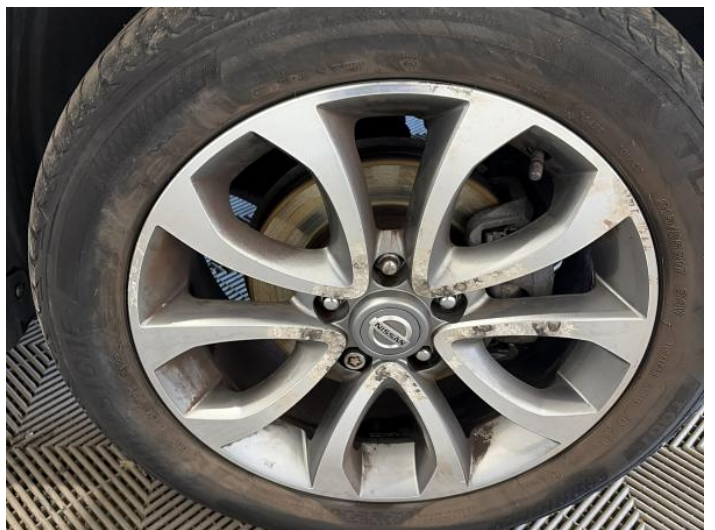
20: Wheel osf
Scratched
Over 50mm

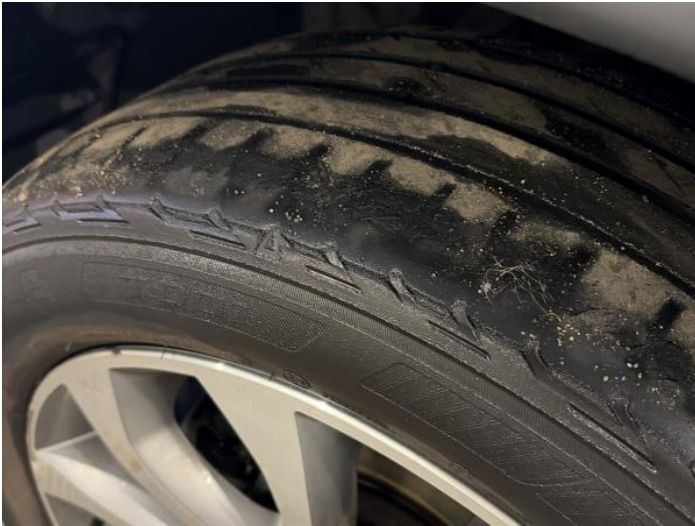
NSF	BRIDGESTONE	Damaged
NSR	BRIDGESTONE	5.0mm
OSF	BRIDGESTONE	2.0mm
OSR	BRIDGESTONE	5.0mm
Spare

21: Tyre nsf
 Damaged
 Replace
