VEHICLE INSPECTION REPORT

LN67DZC

Nissan X-Trail 1.6 dCi N-Vision 5dr 4WD [7 Seat]

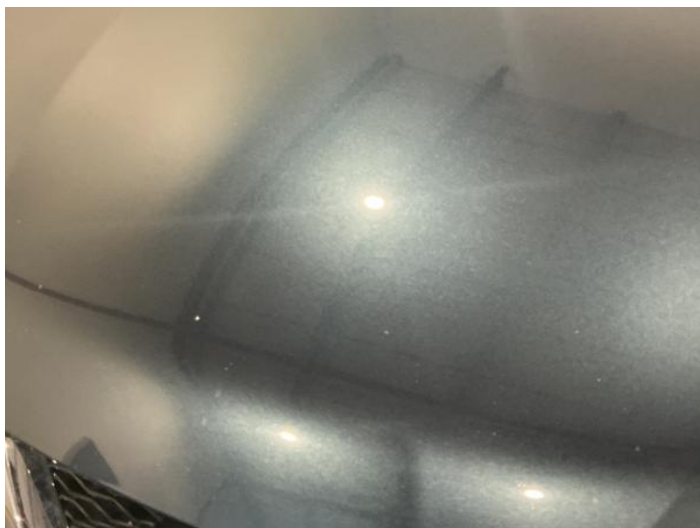
1: Bonnet
Chipped
1 To 5

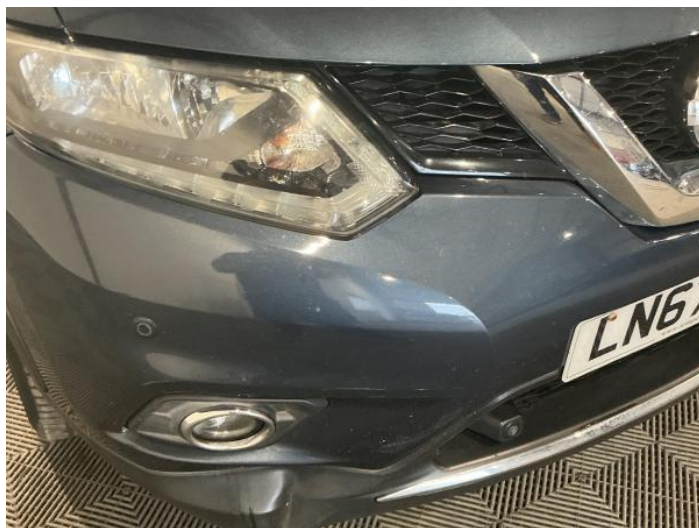
2: Bumper Front
Scratched
Over 100mm Thru Paint

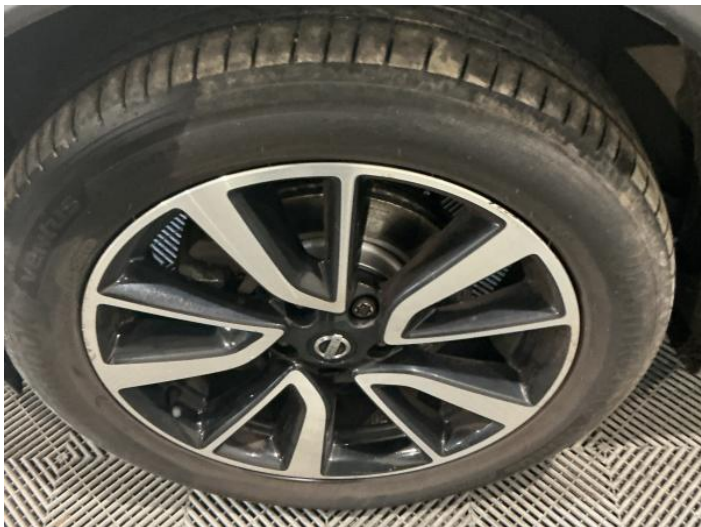
3: Wheel nsf
Scratched
Up To 50mm

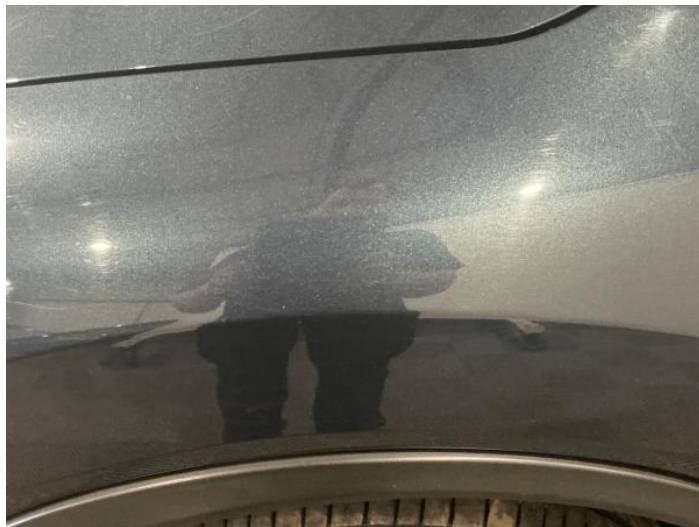
4: Wing nsf
Chipped
1 To 5

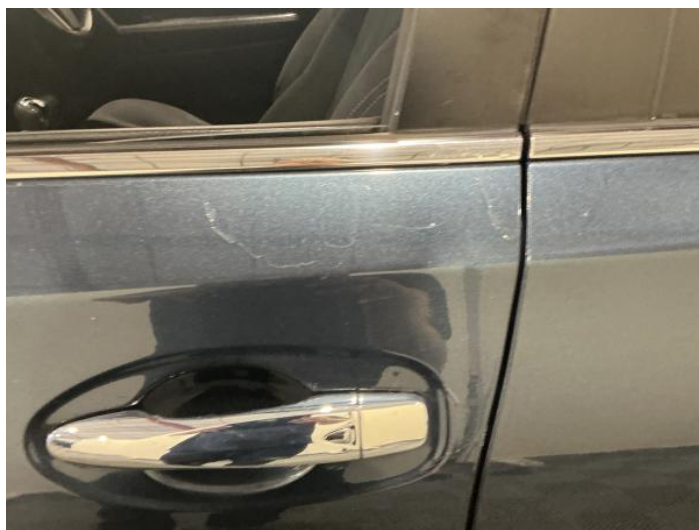
6: Door nsf
Poor Previous Repair
Paint Flake

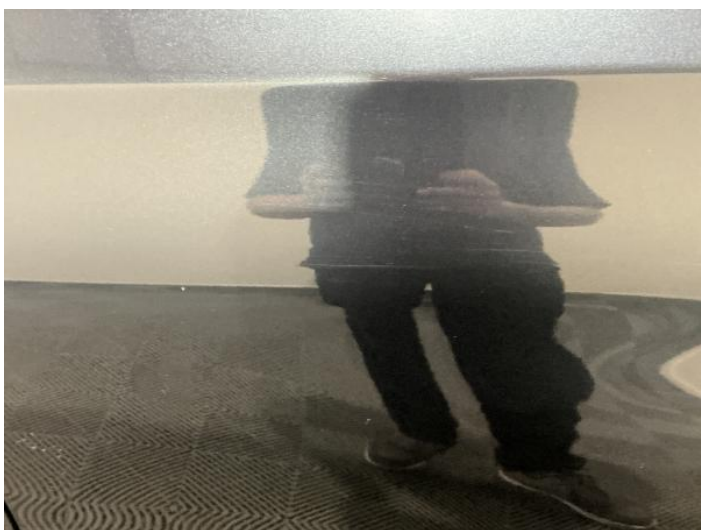
7: Door nsr
Chipped
1 To 5

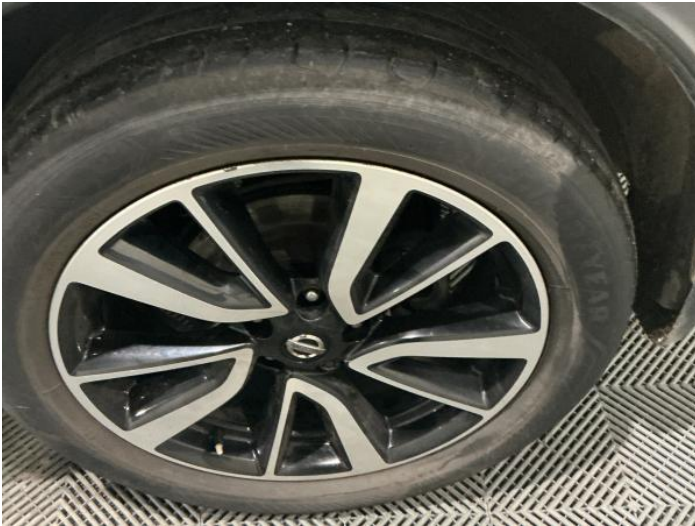
9: Wheel nsr
Scratched
Up To 50mm

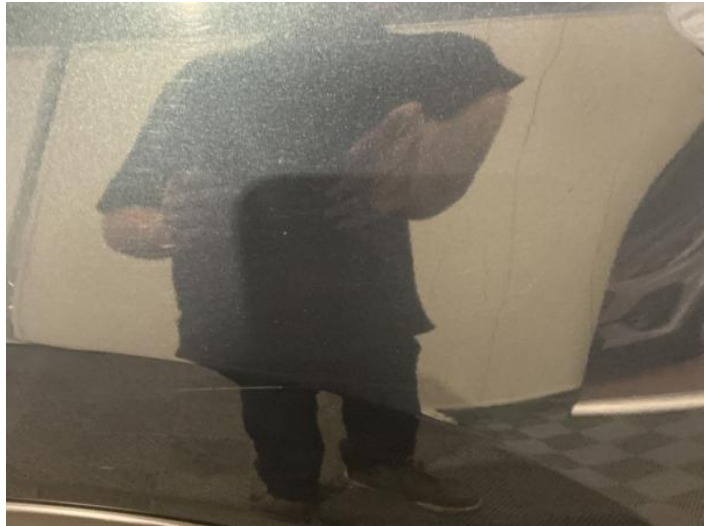
10: Qtr Panel nsr
Scratched
Over 25mm Thru Paint

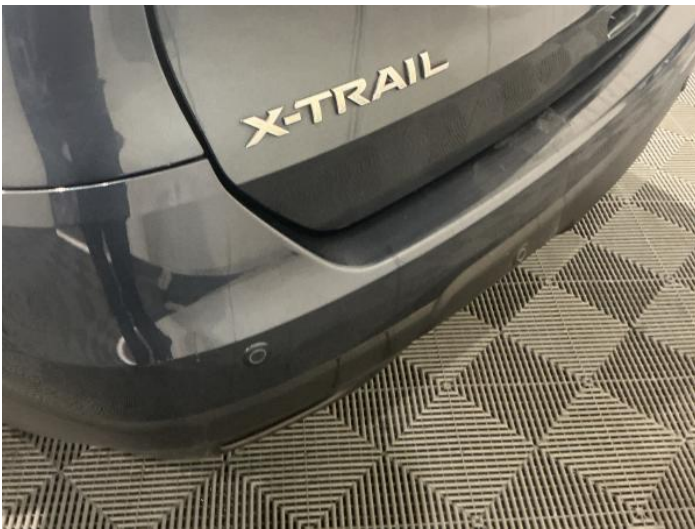
11: Bumper Rear
Dented
With Paint Damage

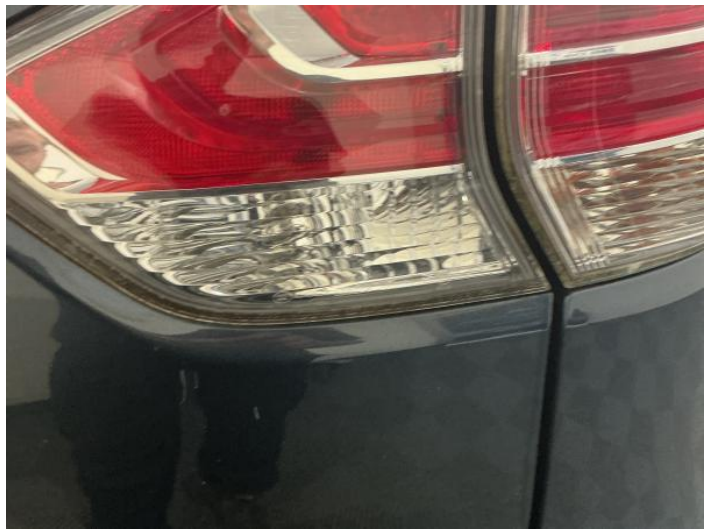
12: Boot Lid
Scratched
UpTo 25mm Thru Paint

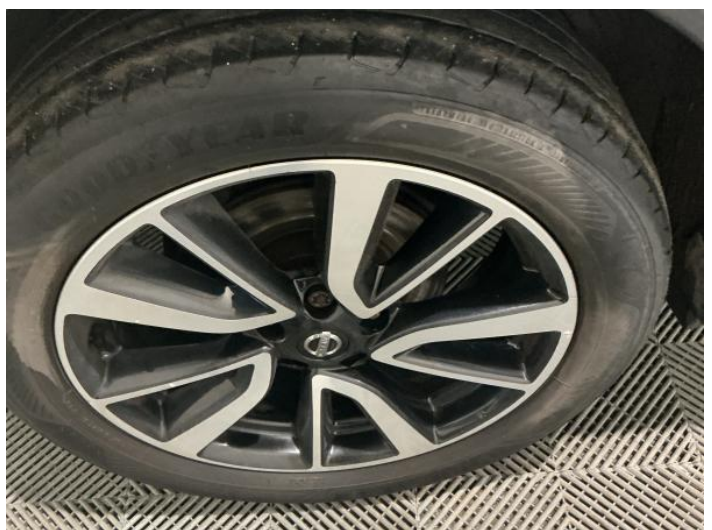
14: Wheel osr
Scratched
Up To 50mm

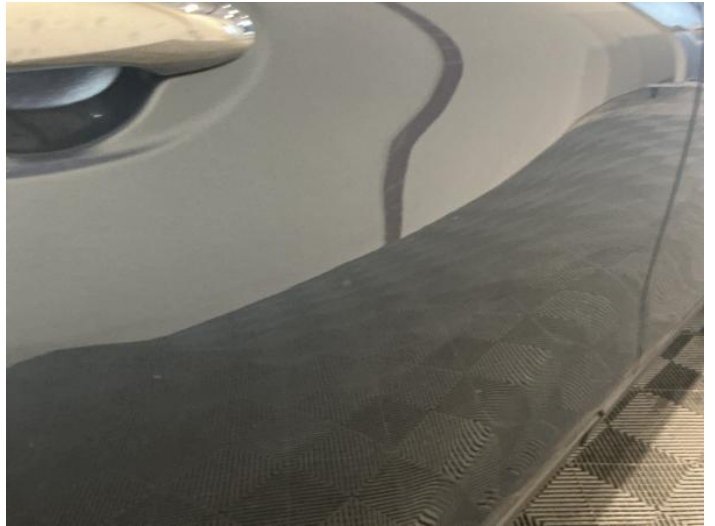
15: Qtr Panel osr
Scratched
Over 25mm Not Thru Paint

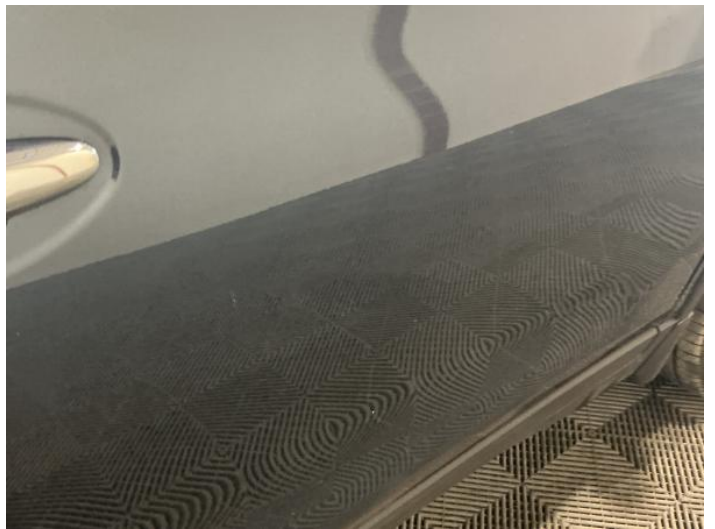
17: Door osr
Scratched
Over 25mm Not Thru Paint

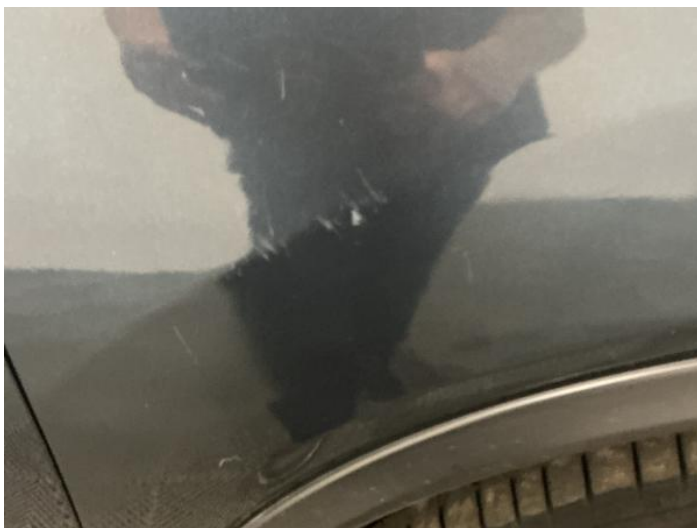
19: Wing osf
Poor Previous Repair
Poor Paint

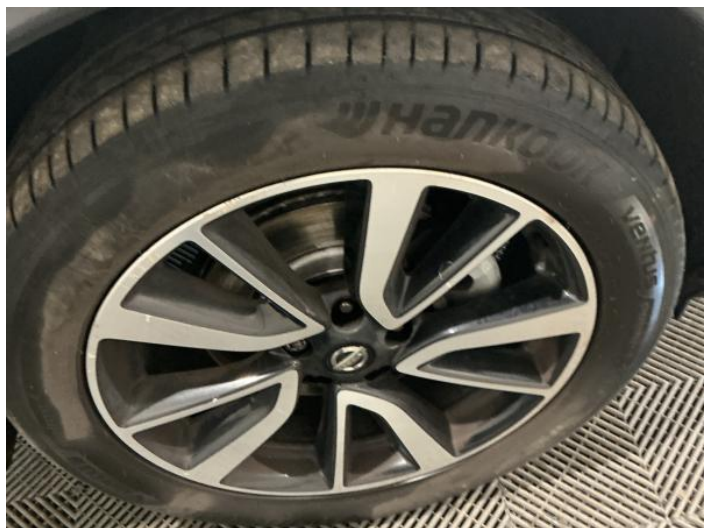
20: Wheel osf
Scratched
Over 50mm
