VEHICLE INSPECTION REPORT

GX62LYR

Volvo XC60 D4 [163] SE Lux Nav 5dr

nama
GRADE
4

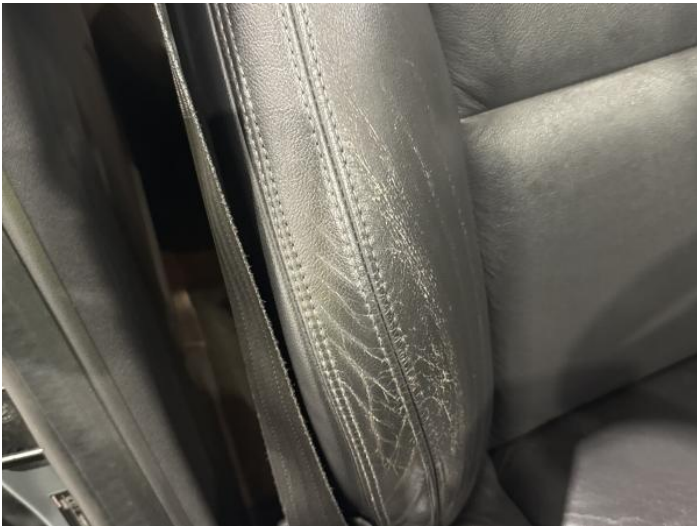
1: Seat Back Cover osf
Scuffed
Over 25mm

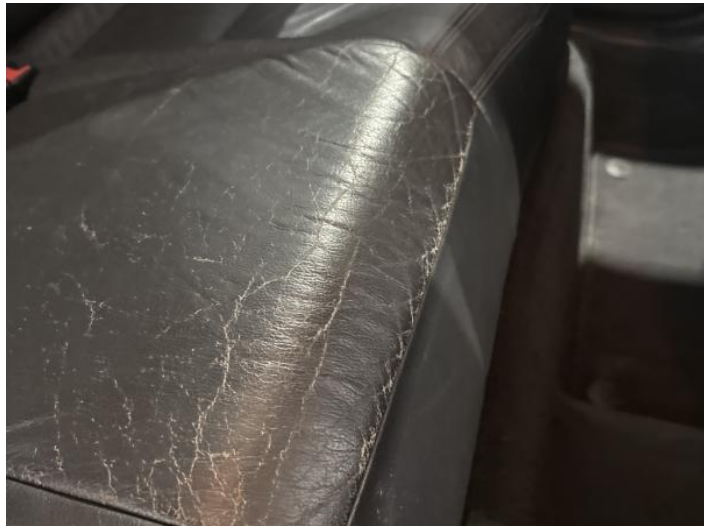
2: Seat Back Cover osr
Scuffed
Over 25mm

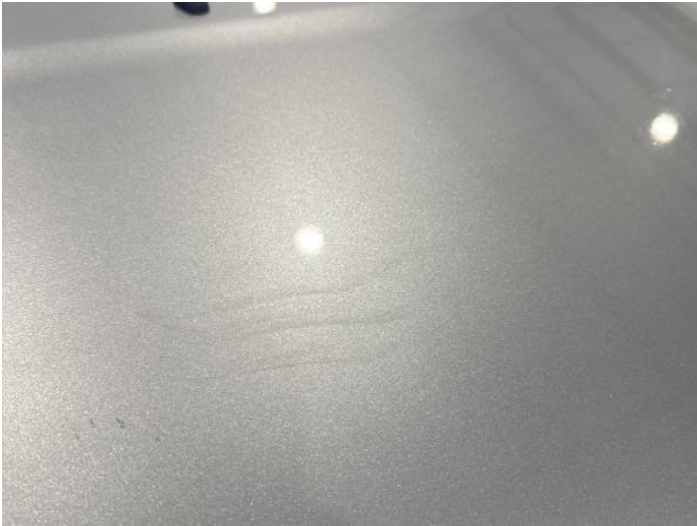
3: Bonnet
Scratched
Over 25mm Thru Paint

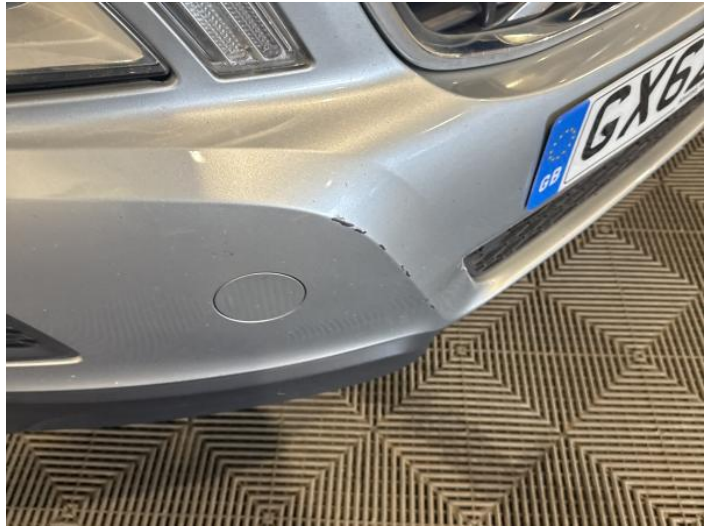
4: Bumper Front
Scratched
Over 100mm Thru Paint

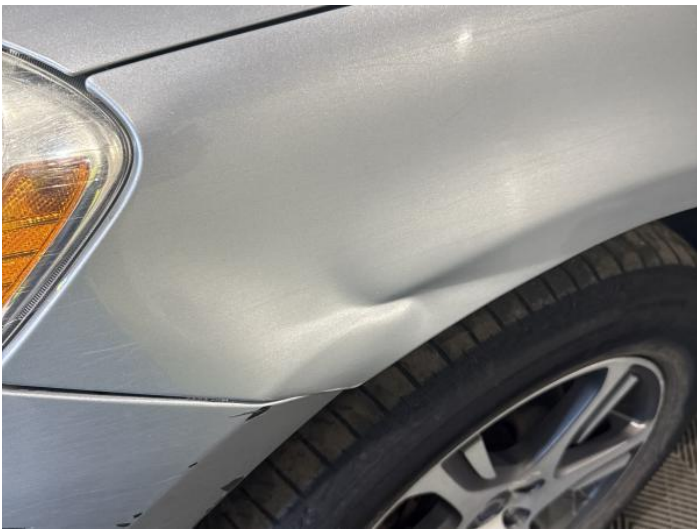
5: Wing nsf
Dented
Over 30mm

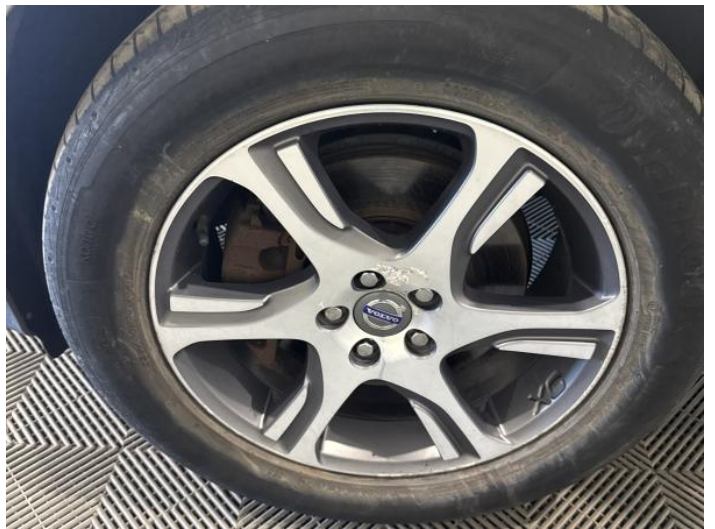
6: Wheel nsf
Scratched
Over 50mm

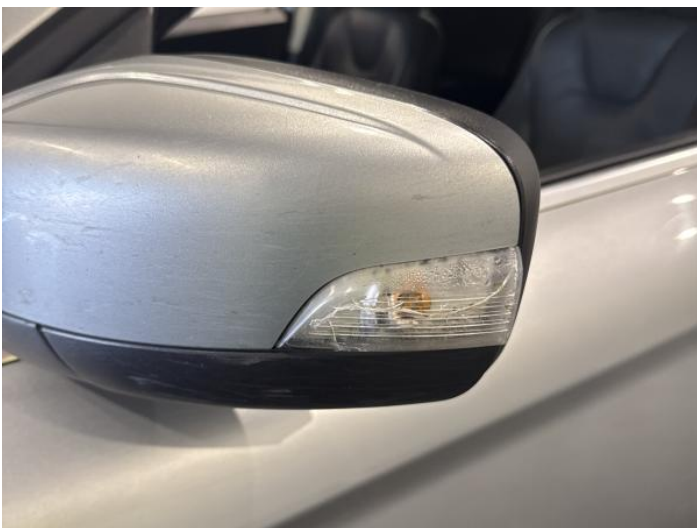
7: Flasher Side Repeater ns
Broken
Replace

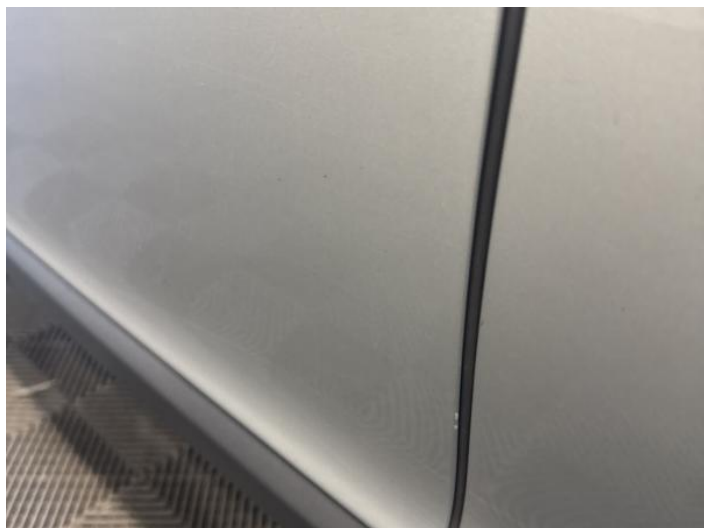
8: Door nsf
Chipped
Edge Chip

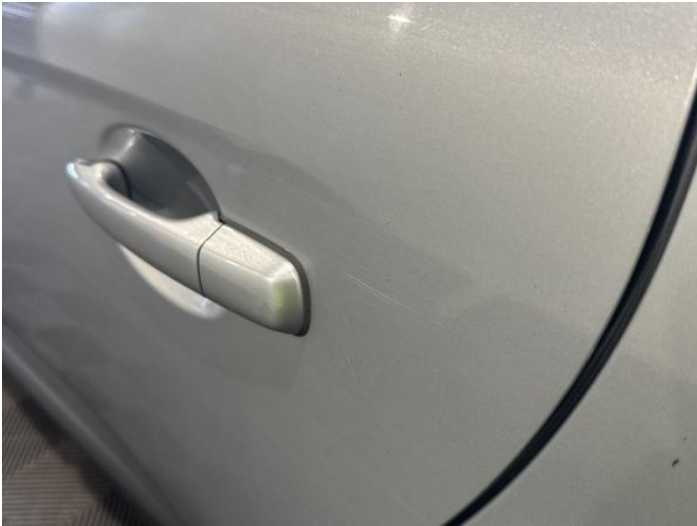
9: Door nsr
Scratched
Over 25mm Thru Paint

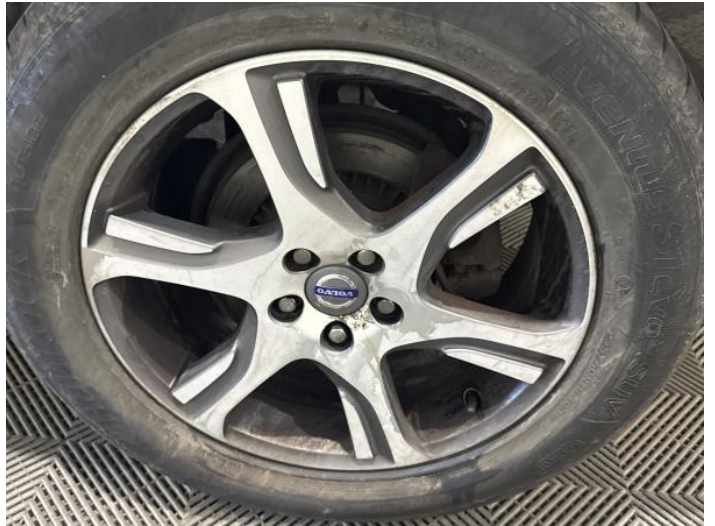
10: Wheel nsr
Scratched
Over 50mm

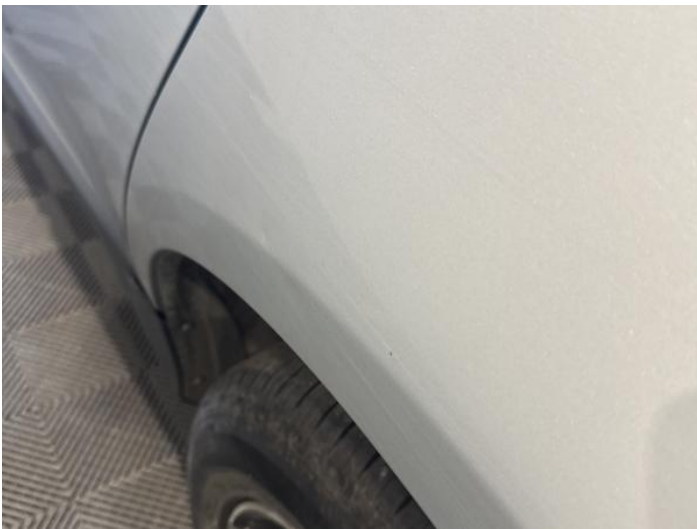
11: Qtr Panel nsr
Dented
Between 10mm + 30mm

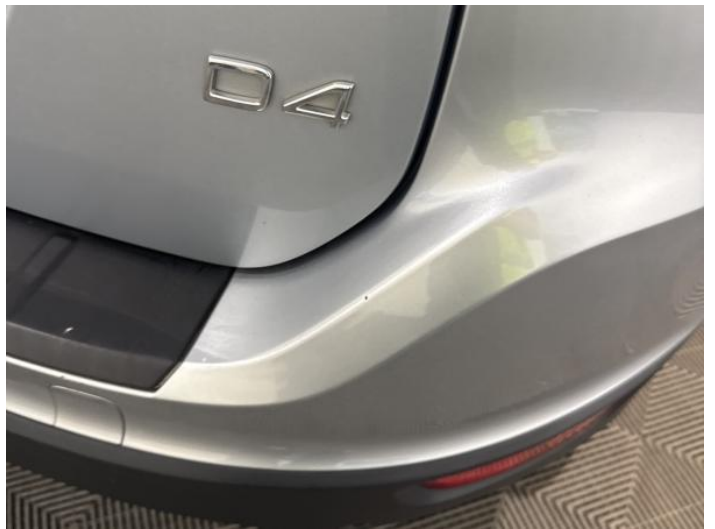
12: Bumper Rear
Chipped
1 To 5

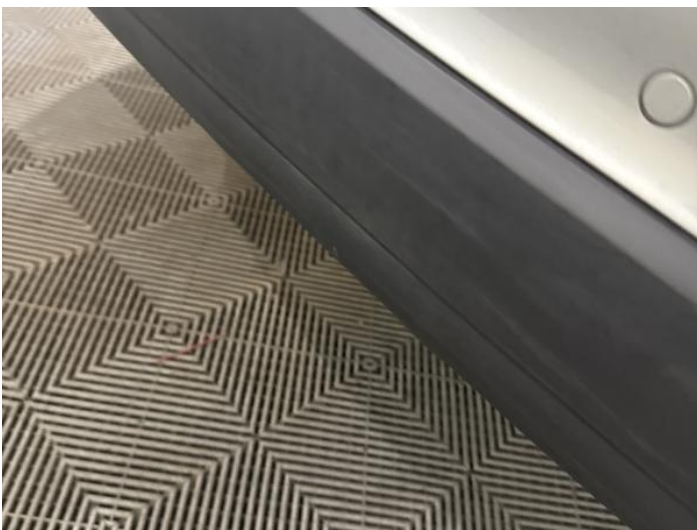
13: Bumper Rear Moulding
Scuffed (Unpainted)
Over 100mm

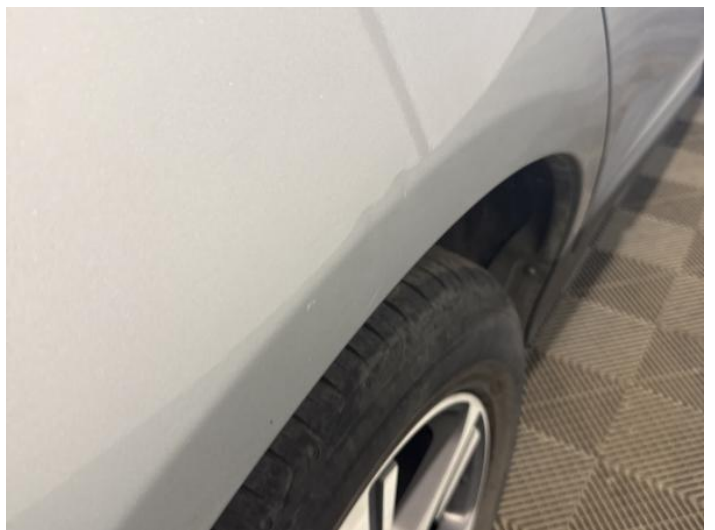
14: Qtr Panel osr
Dented
Between 10mm + 30mm

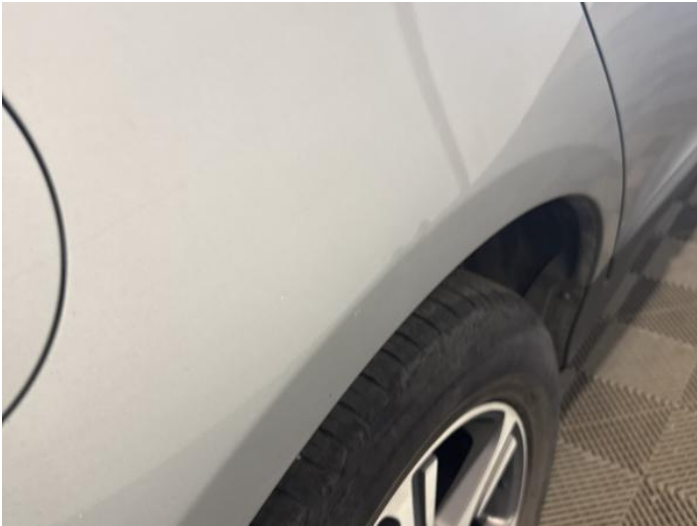
15: Qtr Panel osr
Chipped
1 To 5

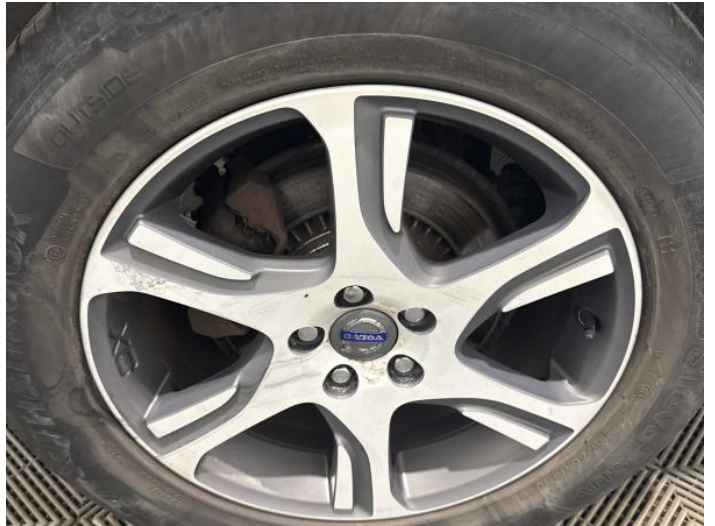
16: Wheel osr
Scratched
Over 50mm

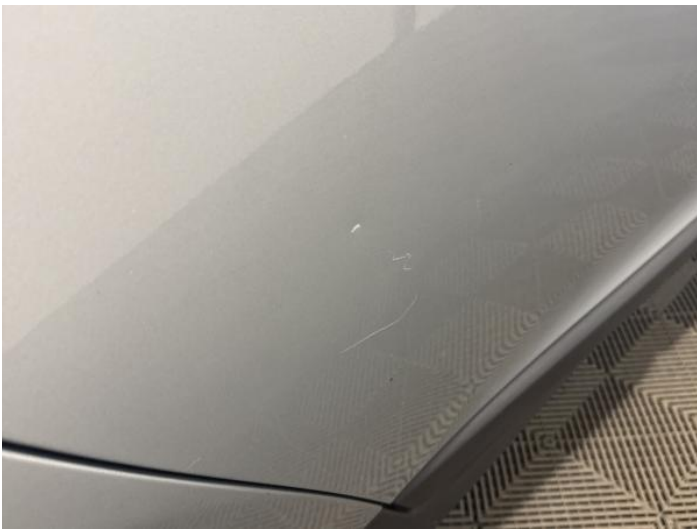
17: Door osr
Scratched
Over 25mm Thru Paint

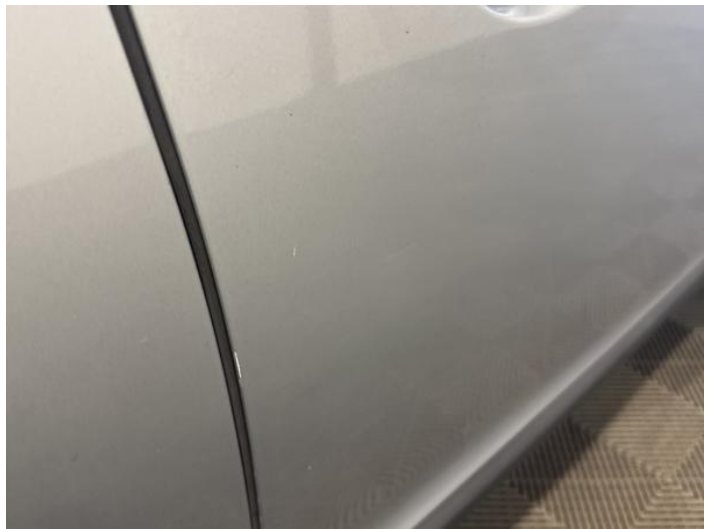
18: Door osf
Chipped
Edge Chip

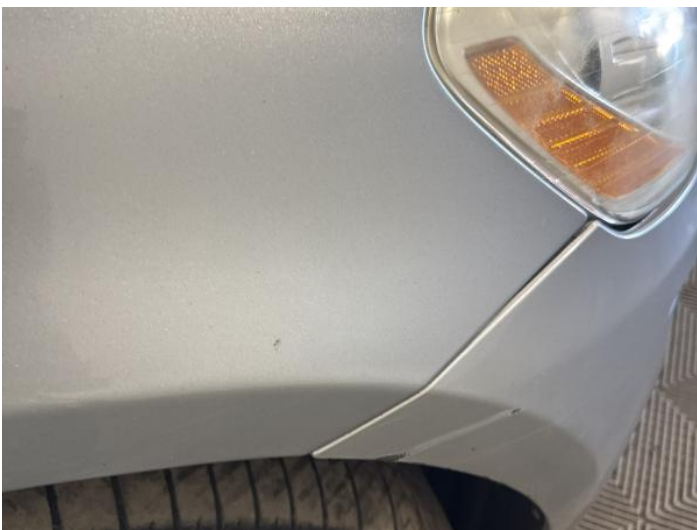
19: Wing osf
Chipped
1 To 5

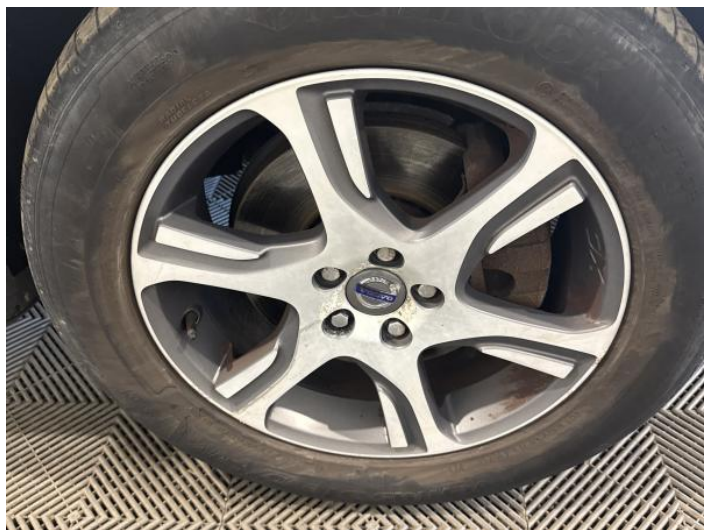
20: Wheel osf
Scratched
Over 50mm

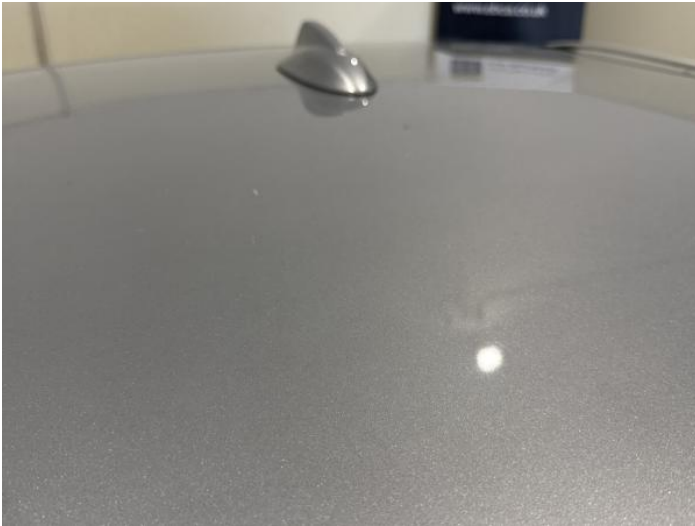
21: Roof
Dented
Over 30mm
