VEHICLE INSPECTION REPORT

RJ13KKA

Volkswagen Touran 1.6 TDI 105 SE 5dr

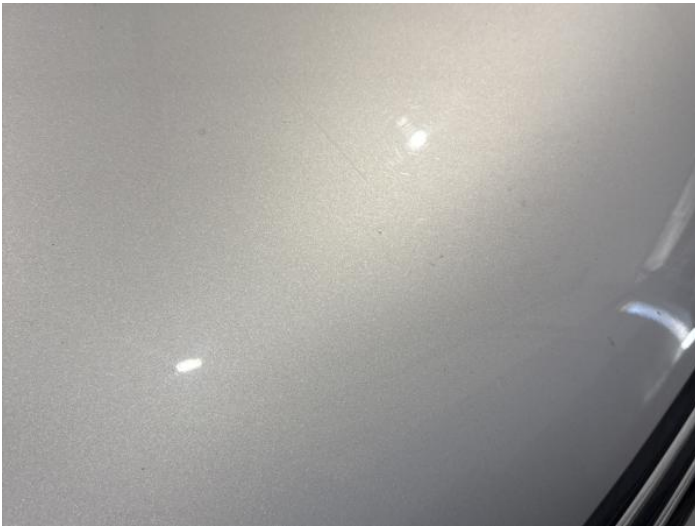
1: Bonnet
Chipped
Multiple Chips

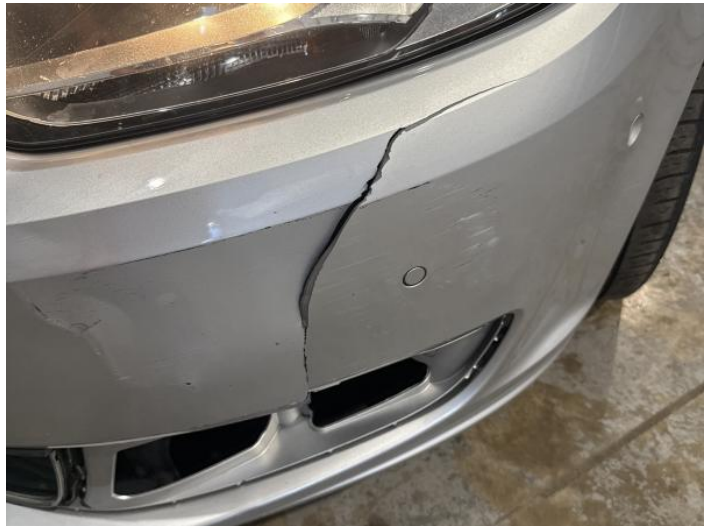
2: Bumper Front
Cracked
Over 25mm

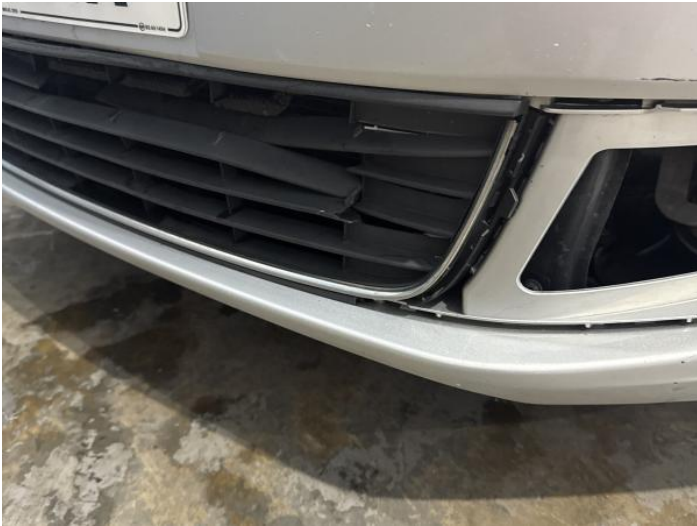
3: Bumper Front Grill
Broken
Replace

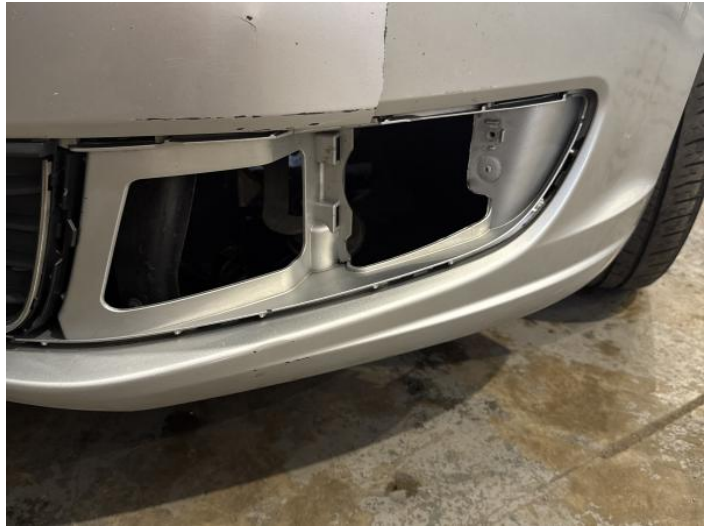
4: Fog Lamp Surround ns
Missing
Replace

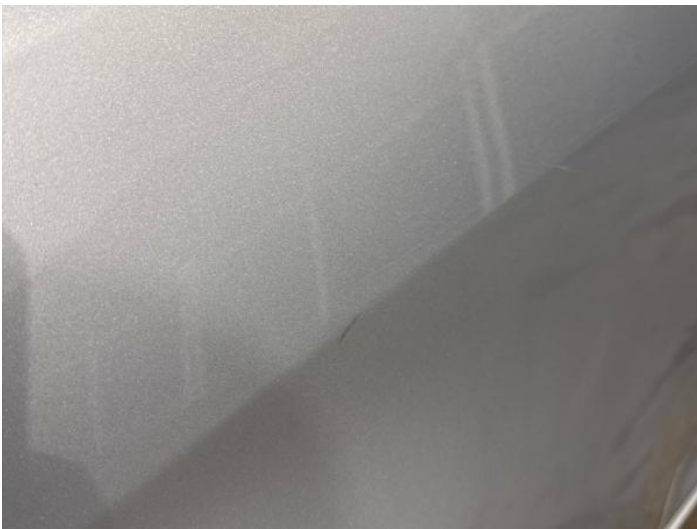
5: Wing nsf
Scratched
UpTo 25mm Thru Paint

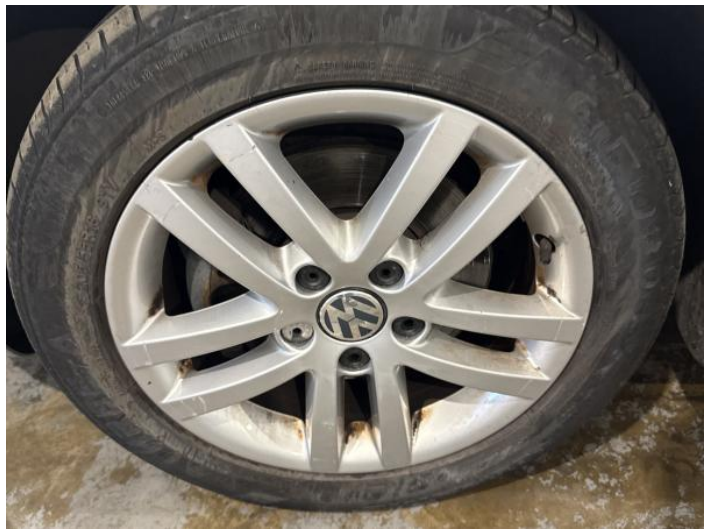
6: Wheel nsf
Scratched
Over 50mm

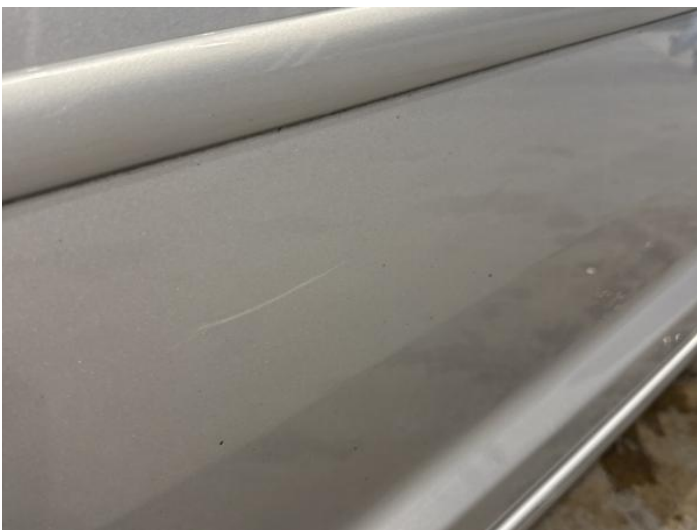
7: Door nsf
Scratched
Over 25mm Thru Paint

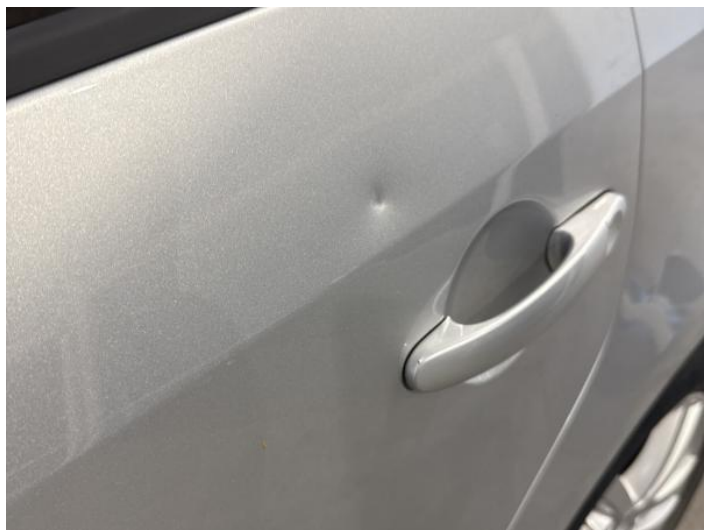
8: Door nsr
Dented
Between 10mm + 30mm

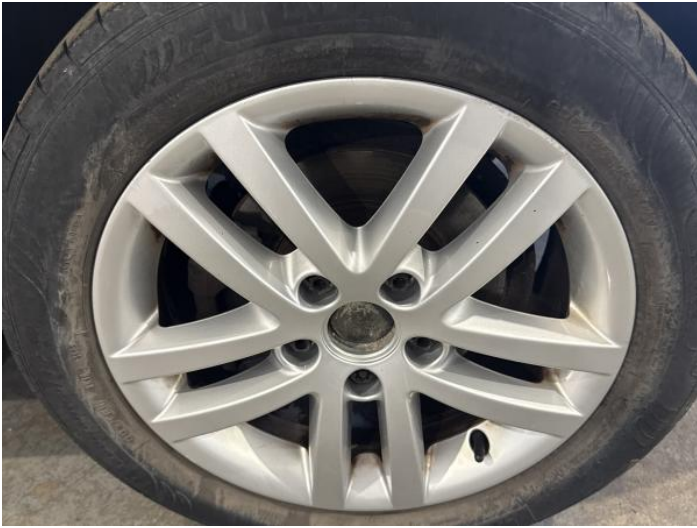
9: Wheel nsr
Scratched
Over 50mm

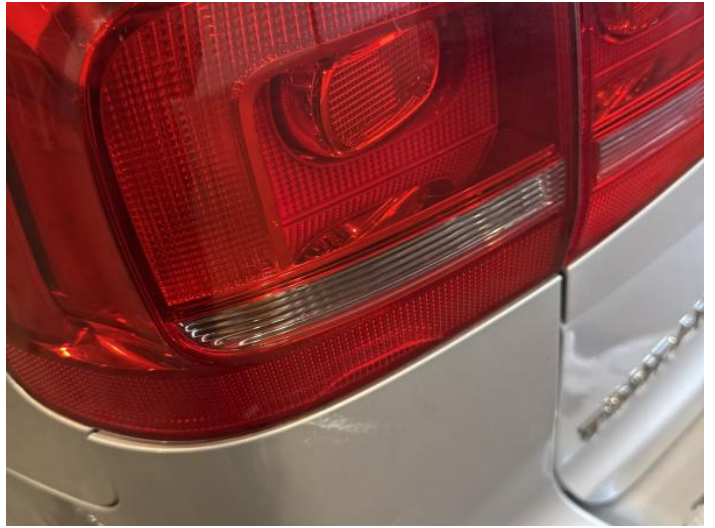
10: Lamp nsr
Broken
Replace

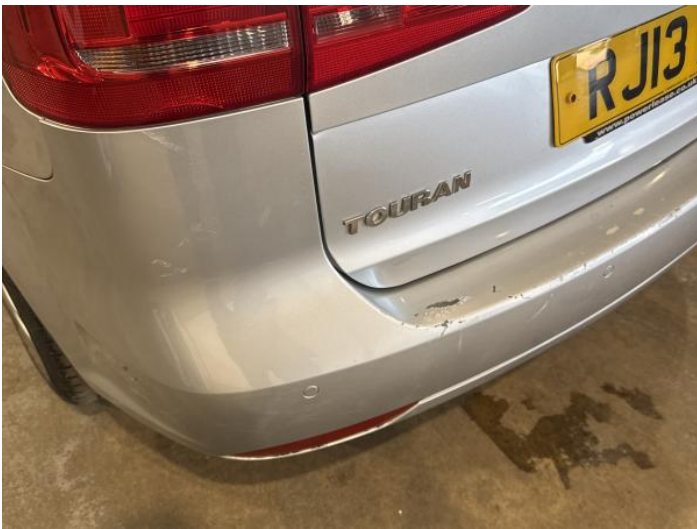
11: Bumper Rear
Dented
With Paint Damage

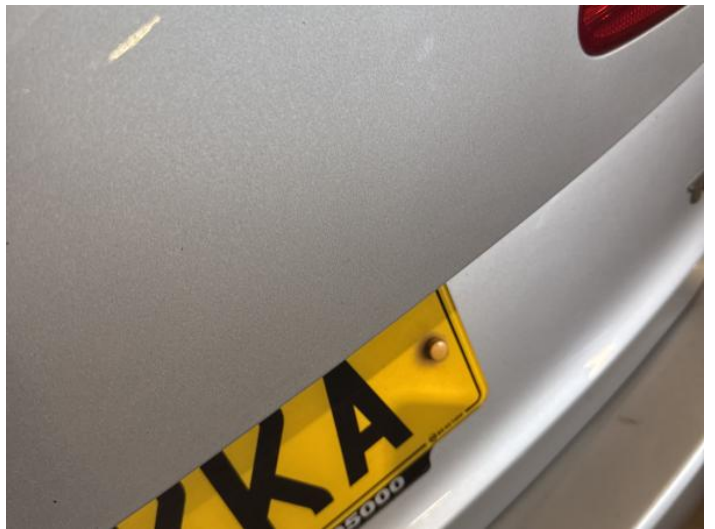
12: Tailgate
Scratched
Up To 25mm Thru Paint

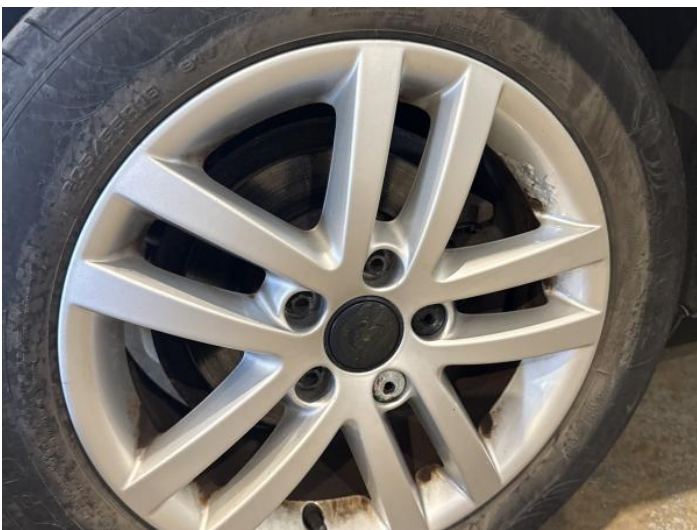
13: Wheel osr
Corroded
Light

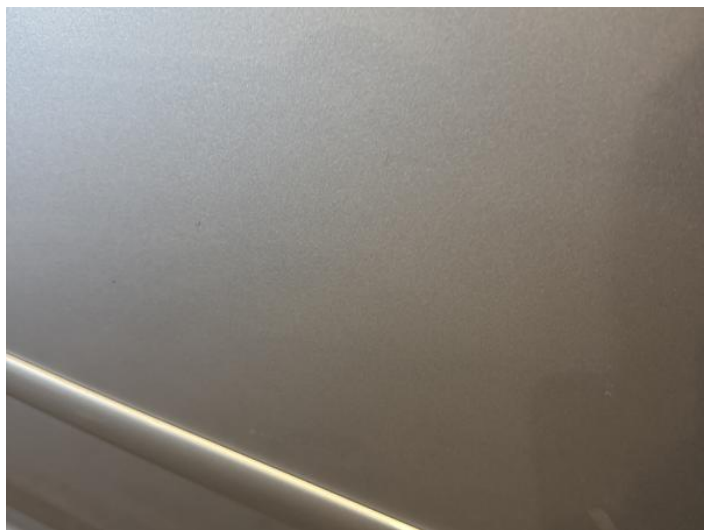
14: Door osr
Chipped
1 To 5

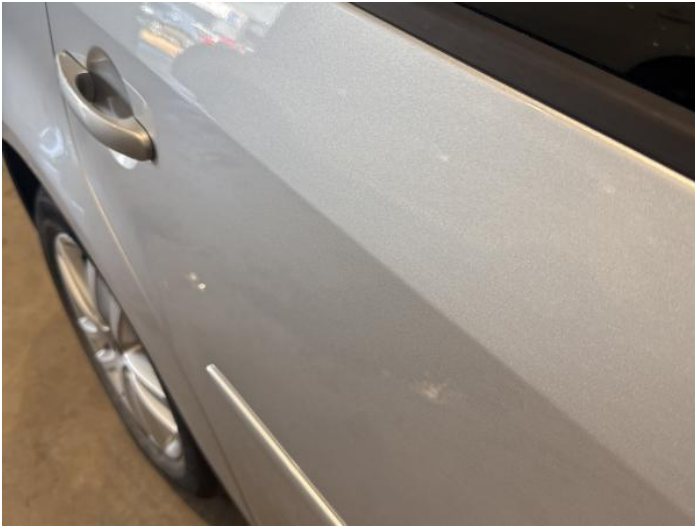
15: Door osr
Dented
2 Or Less UpTo 10mm

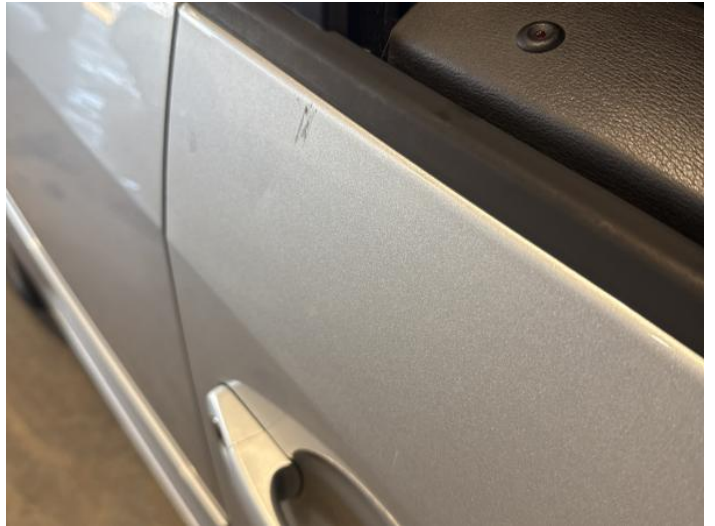
16: Door osf
Dented
Over 30mm

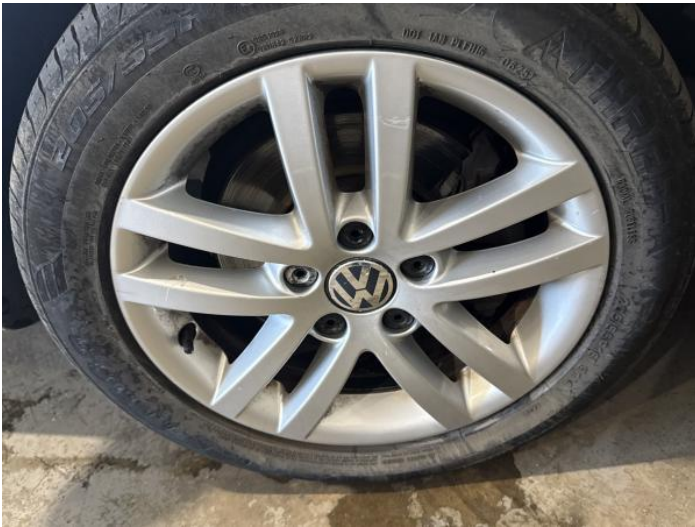
17: Wheel osf
Scratched
Over 50mm

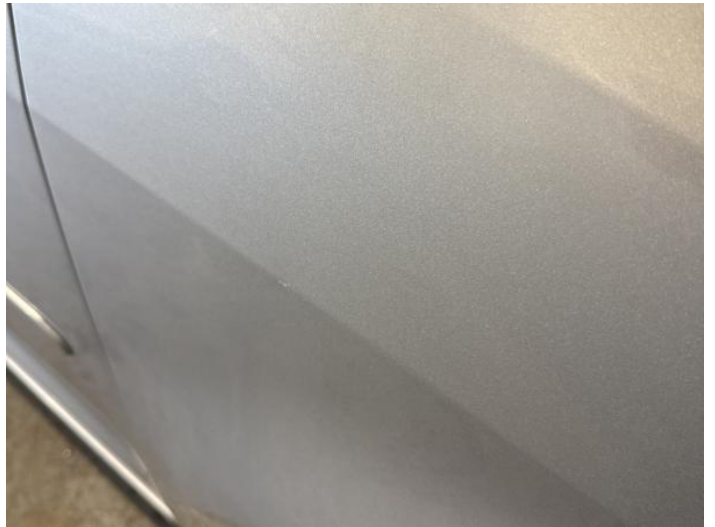
18: Wing osf
Chipped
1 To 5

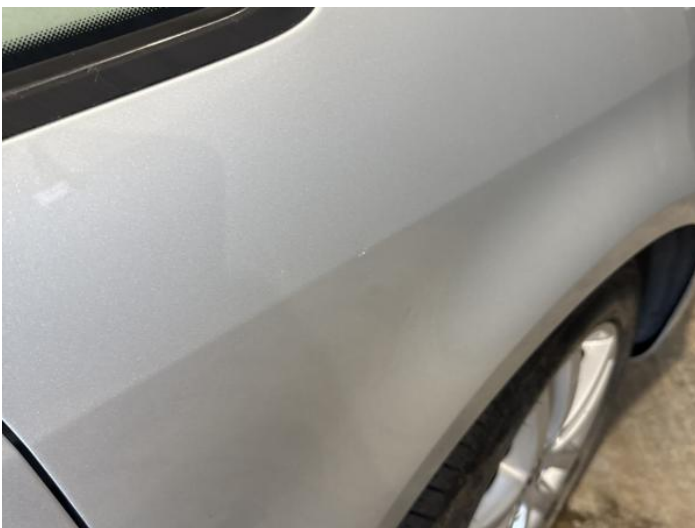
19: Wing osf
Dented
2 Or Less UpTo 10mm
