# VEHICLE INSPECTION REPORT

**LO11UPK**

## Nissan Qashqai 2.0 Tekna 5dr 4WD CVT

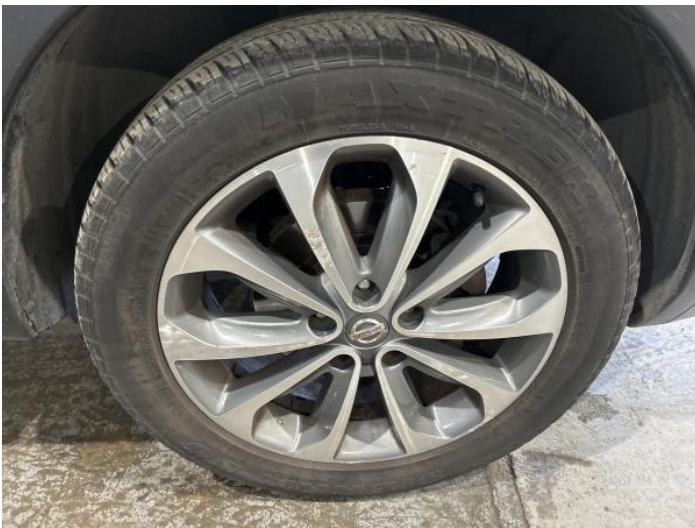
1: Wheel osf  
Corroded  
Light

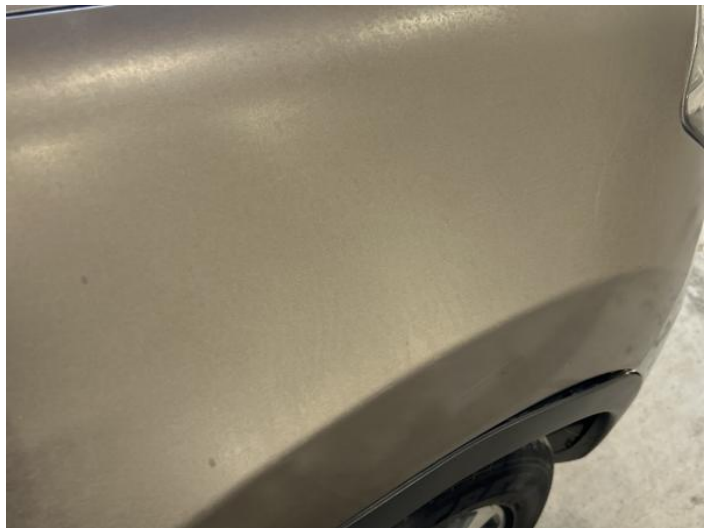
2: Wing osf  
Poor Previous Repair  
Poor Paint

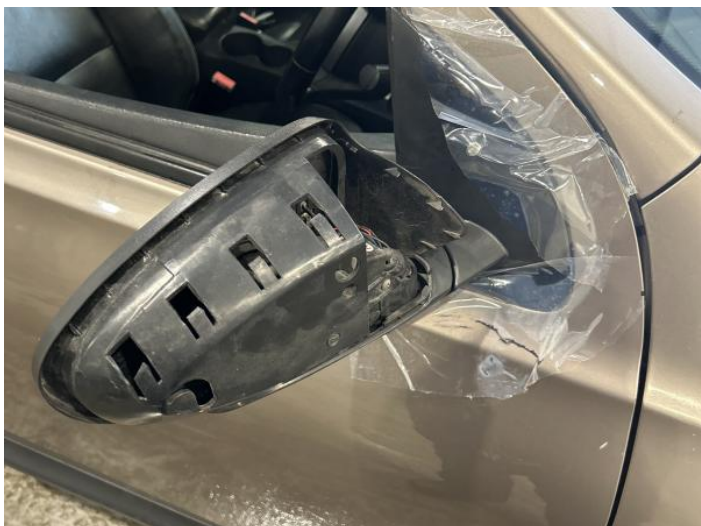
3: Door Mirror Assy osf  
Broken  
Replace

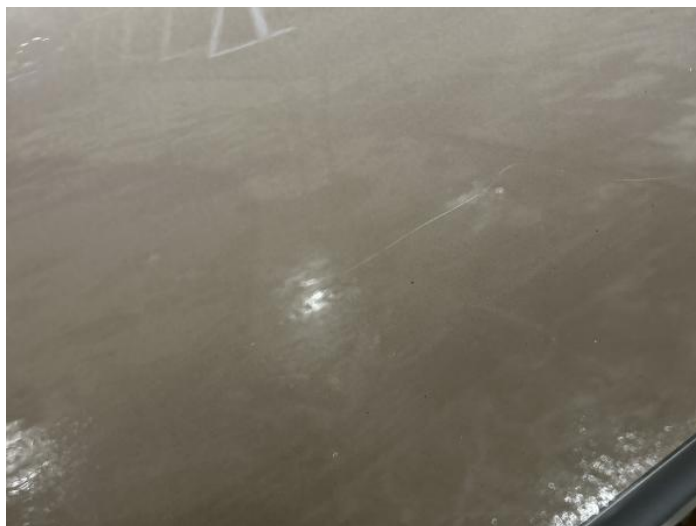
4: Door osf  
Scratched  
Over 25mm Thru Paint

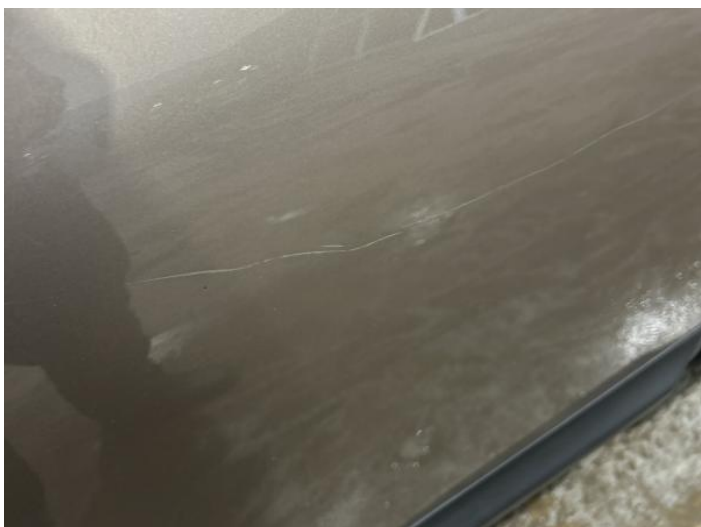
5: Door osr  
Scratched  
Over 25mm Thru Paint

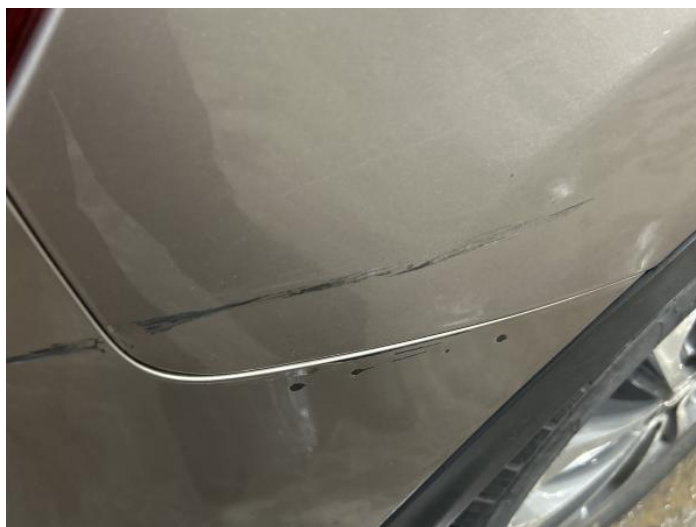
6: Qtr Panel osr  
Scratched  
Over 25mm Thru Paint

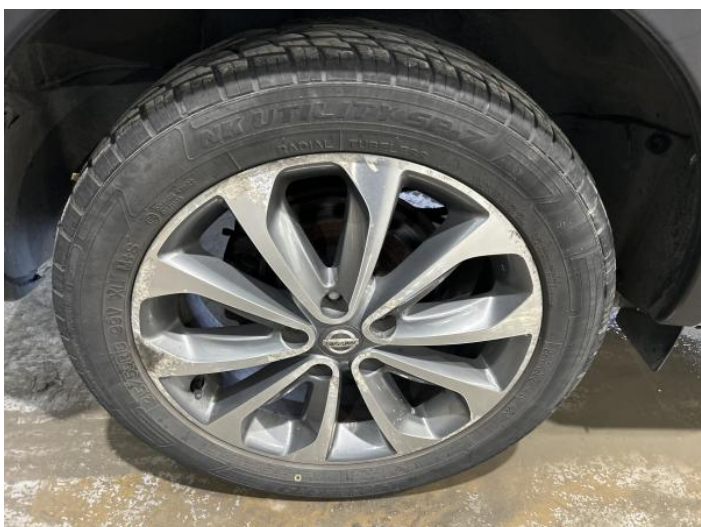
7: Wheel osr  
Corroded  
Light

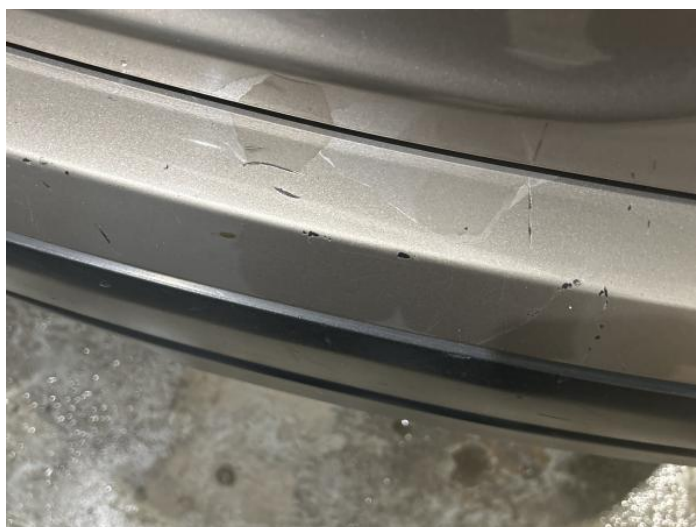
8: Bumper Rear  
Poor Previous Repair  
Paint Flake

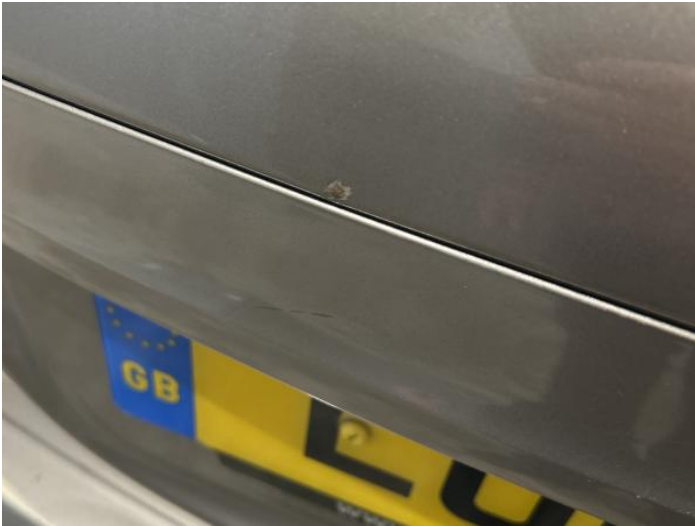
9: Tailgate  
Chipped  
1 To 5

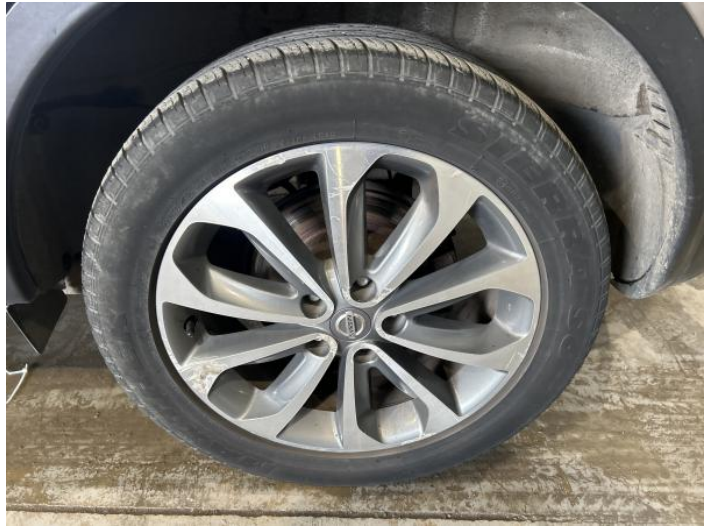
10: Wheel nsr  
Corroded  
Light

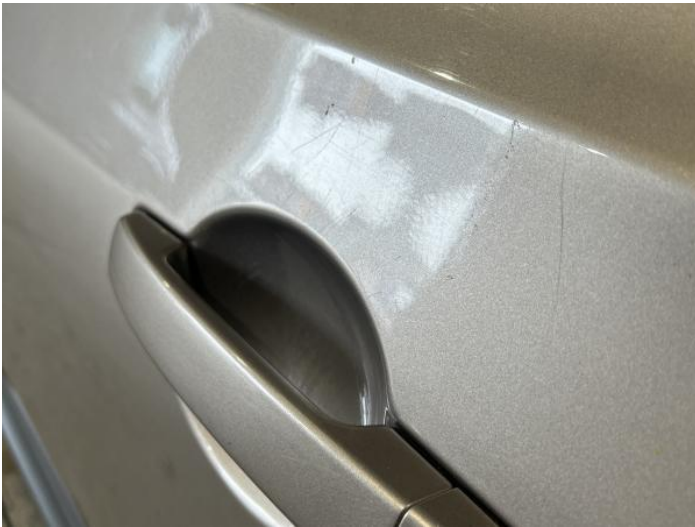
11: Door nsr  
Scratched  
Over 25mm Not Thru Paint

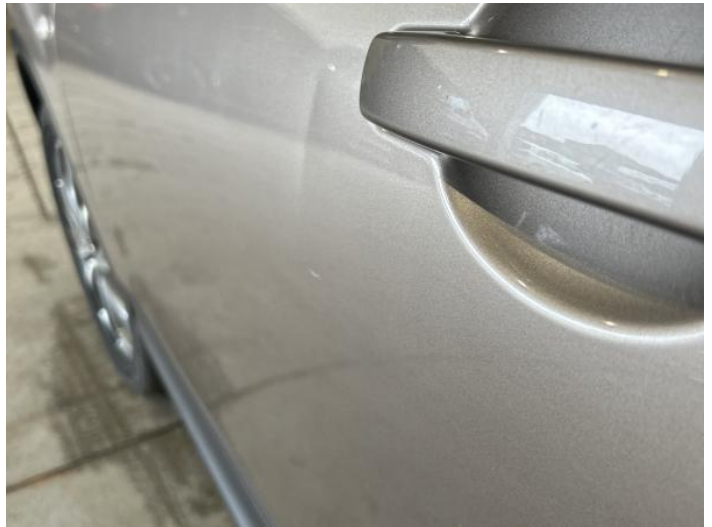
12: Door nsf  
Dented  
Over 30mm

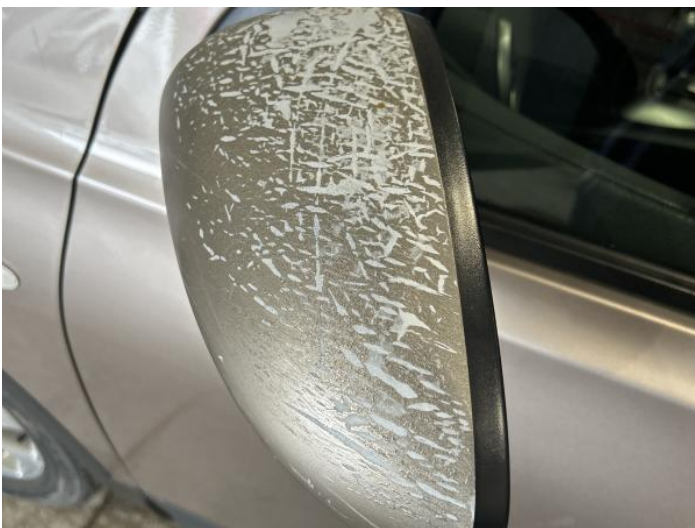
13: Door Mirror Assy nsf  
Scratched (Painted)  
Over 25mm Thru Paint

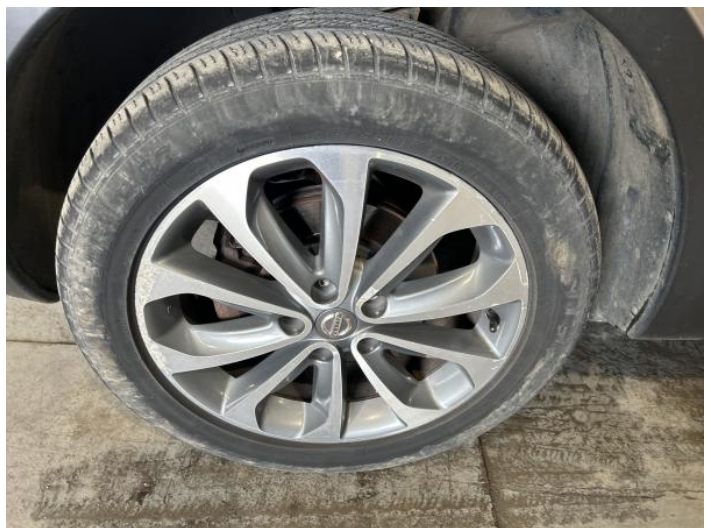
14: Wheel nsf  
Corroded  
Light

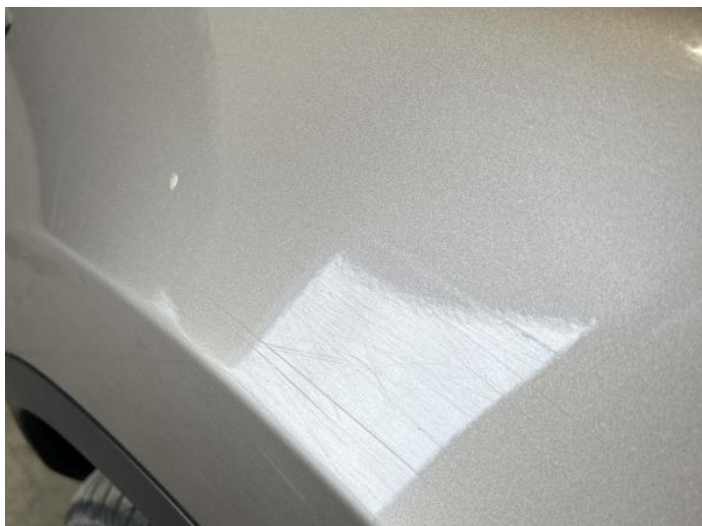
15: Wing nsf  
Scratched  
Over 25mm Not Thru Paint

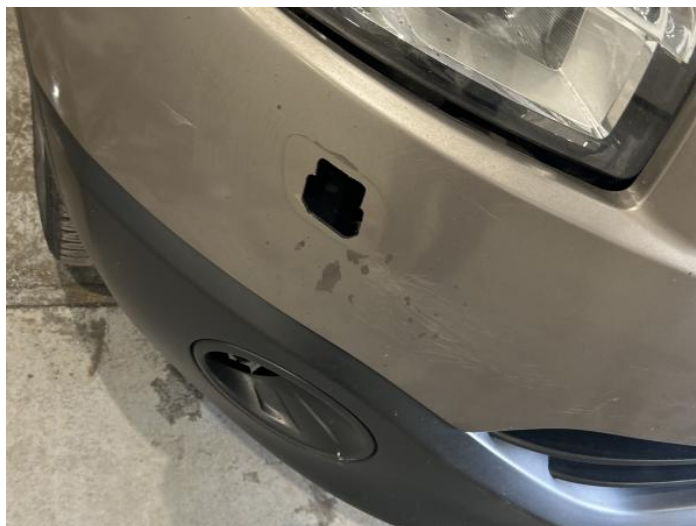
16: Bumper Front  
Scratched  
Over 100mm Thru Paint

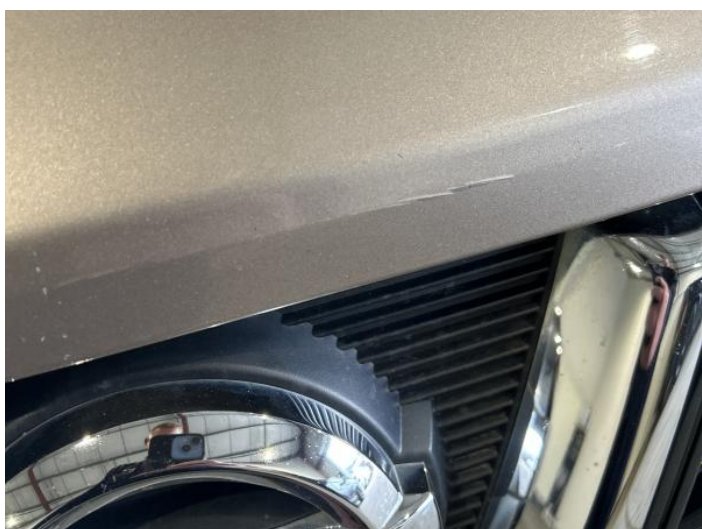
17: Bonnet  
Scratched  
Over 25mm Thru Paint

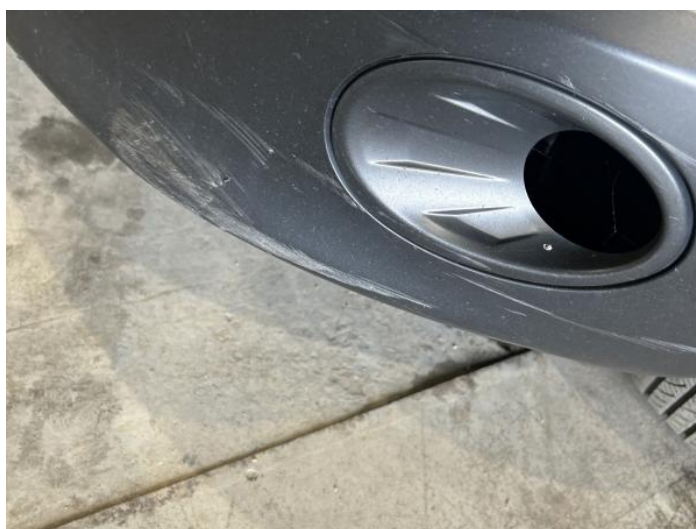
18: Bumper Front Moulding  
Scuffed (Unpainted)  
Over 100mm

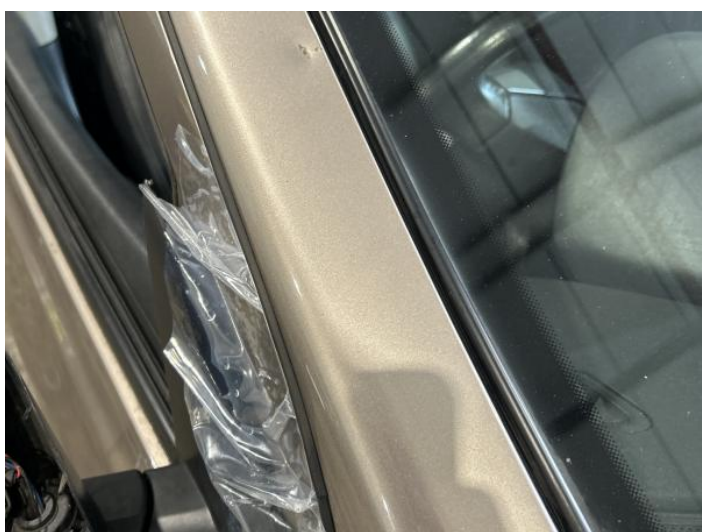
19: A Post os  
Dented  
With Paint Damage
