VEHICLE INSPECTION REPORT

GX68VRD

Mitsubishi Eclipse Cross 1.5 2 5dr

nama
 GRADE
3

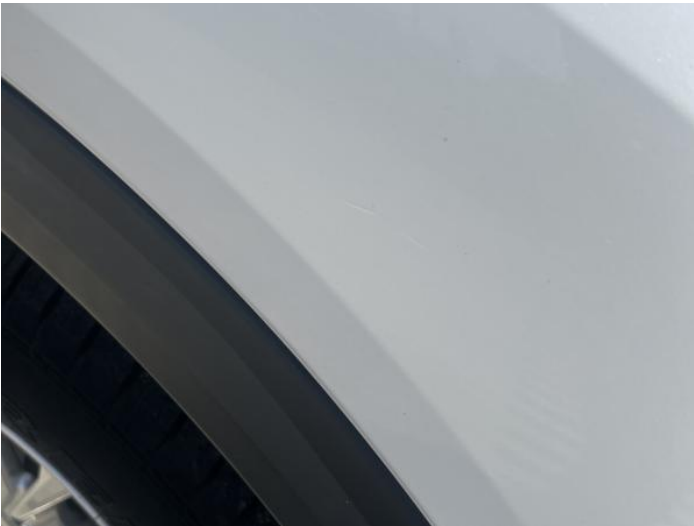
1: Wing osf
Scratched
UpTo 25mm Thru Paint

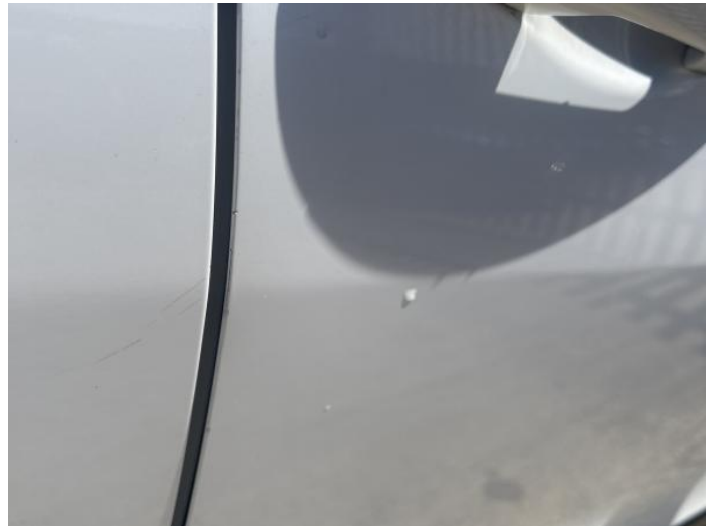
2: Door osf
Chipped
Edge Chip

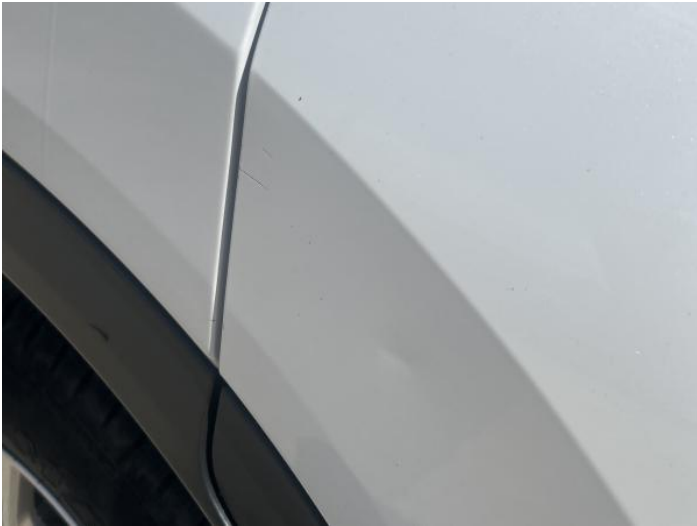
3: Door osr
Dented
With Paint Damage

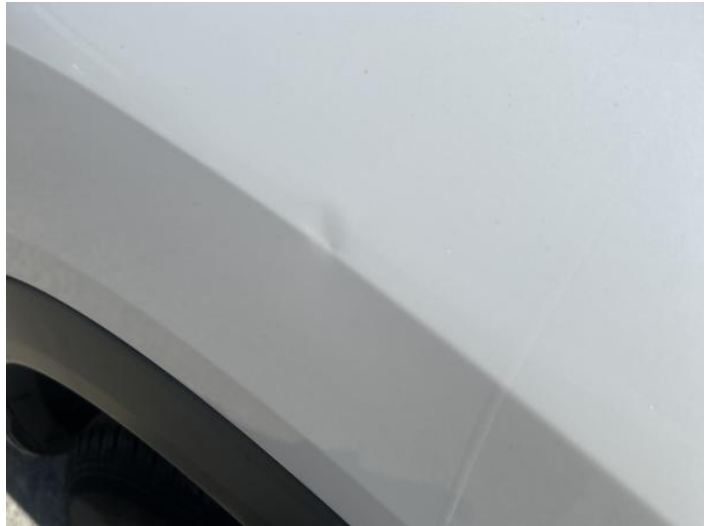
4: Qtr Panel osr
Dented
Between 10mm + 30mm

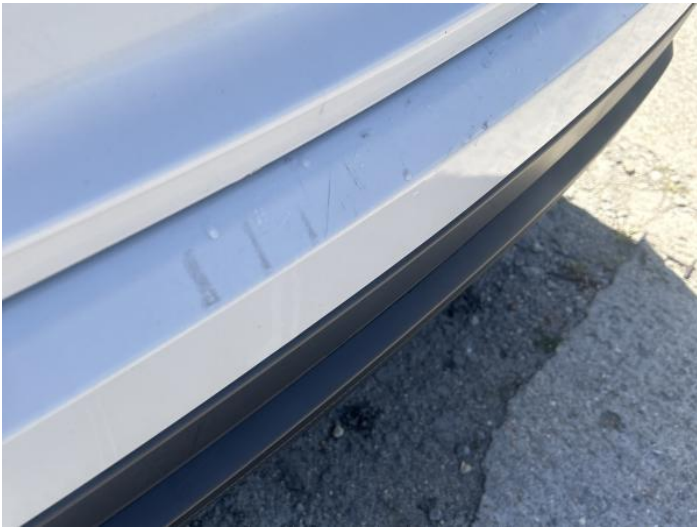
5: Bumper Rear
Scratched
25 to 100mm Thru Paint

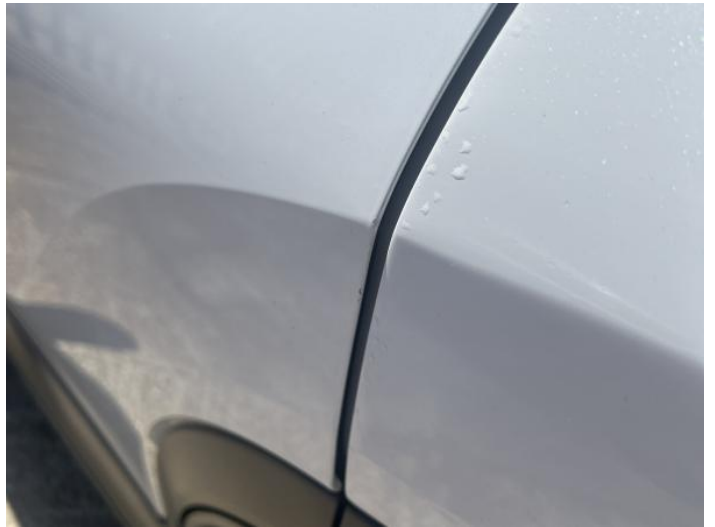
6: Door nsr
Chipped
Edge Chip

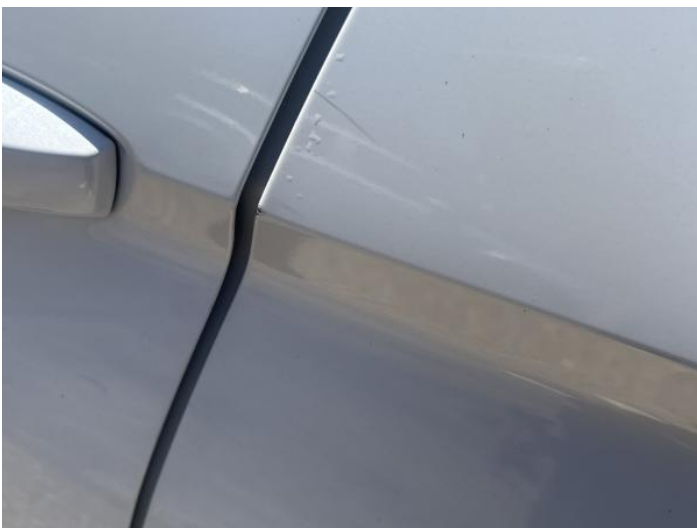
7: Door nsr
Chipped
1 To 5

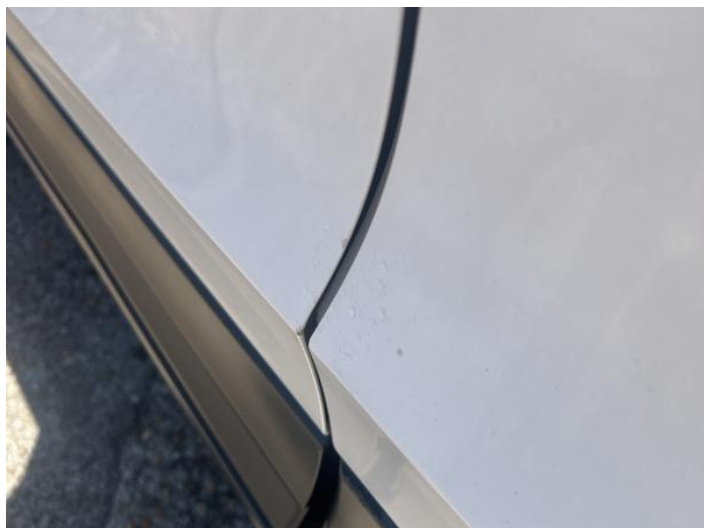
8: Door nsf
Chipped
Edge Chip

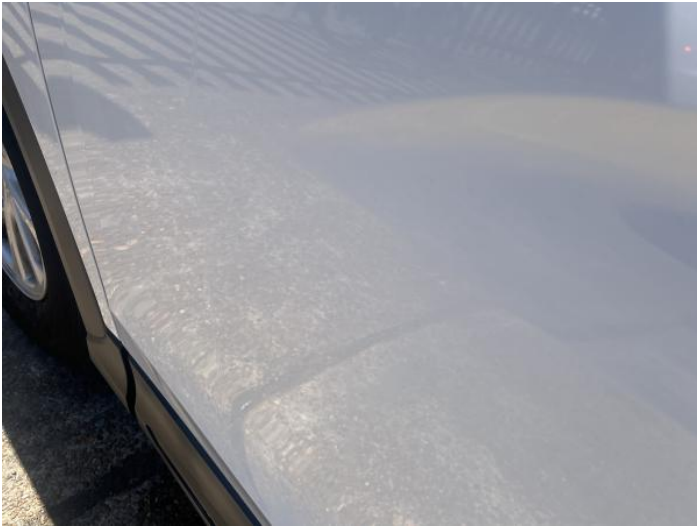
9: Door nsf
Dented
Between 10mm + 30mm

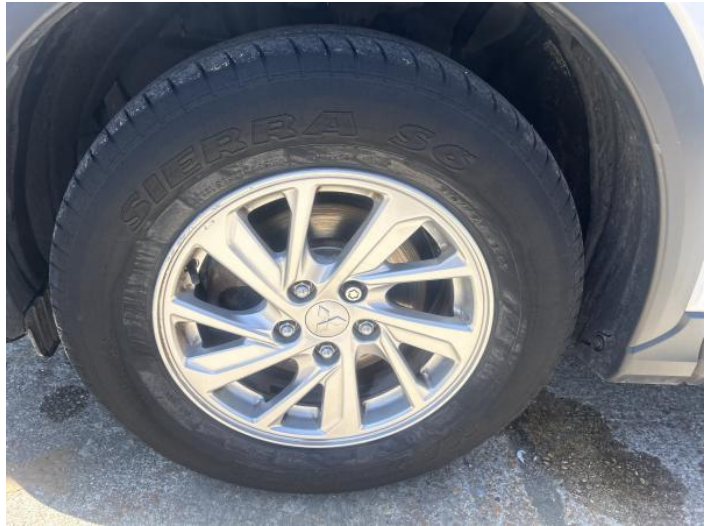
10: Wheel nsf
Scratched
Over 50mm

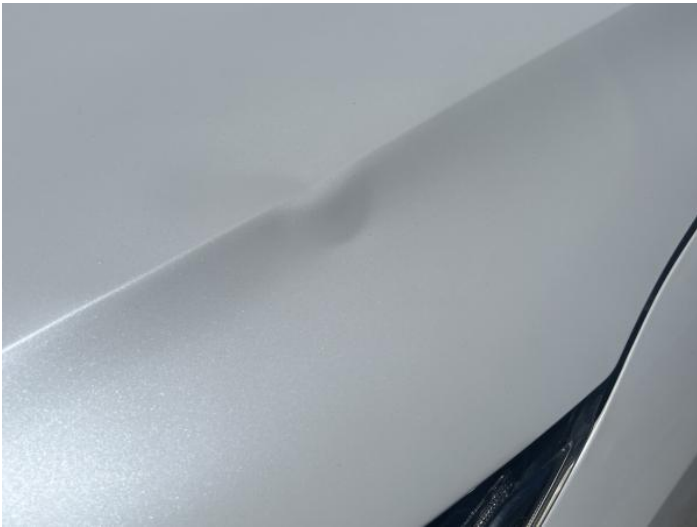
11: Bonnet
Dented
Over 30mm

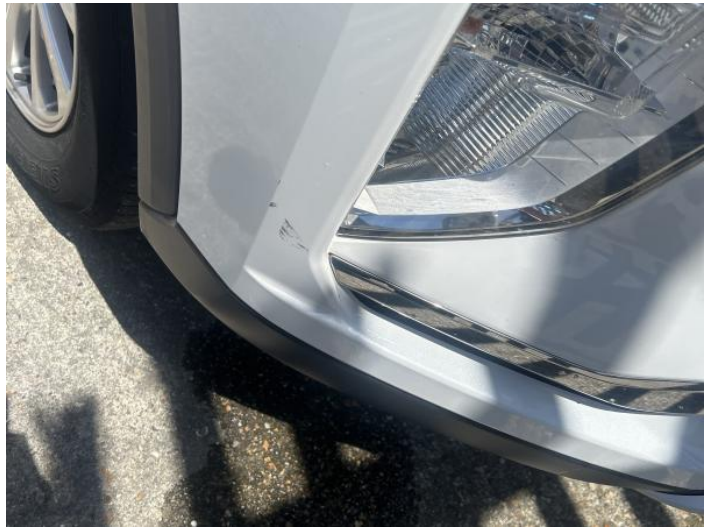
12: Bumper Front
Scratched
25 to 100mm Thru Paint

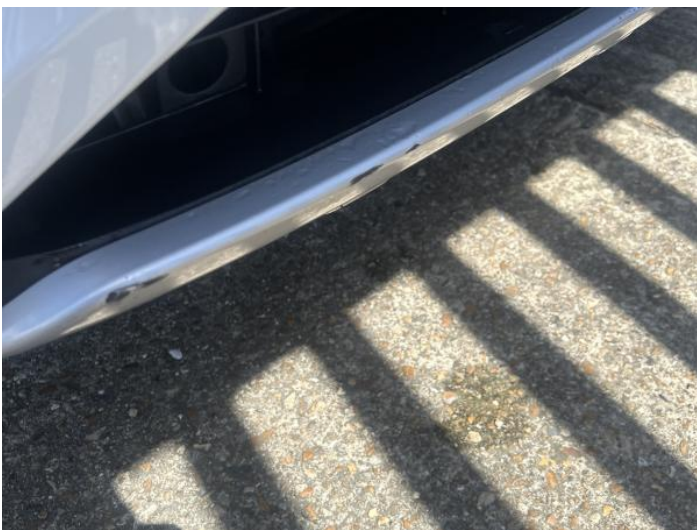
13: Bumper Front Moulding
Scratched (Painted)
Over 25mm Thru Paint

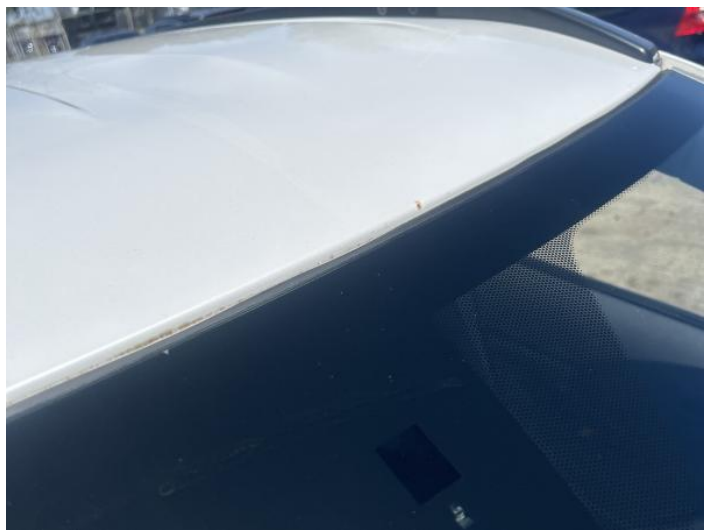
14: Roof
Chipped
1 To 5
