VEHICLE INSPECTION REPORT

VK12JKU

Hyundai I40 1.6 GDi [135] Blue Drive Active 5dr

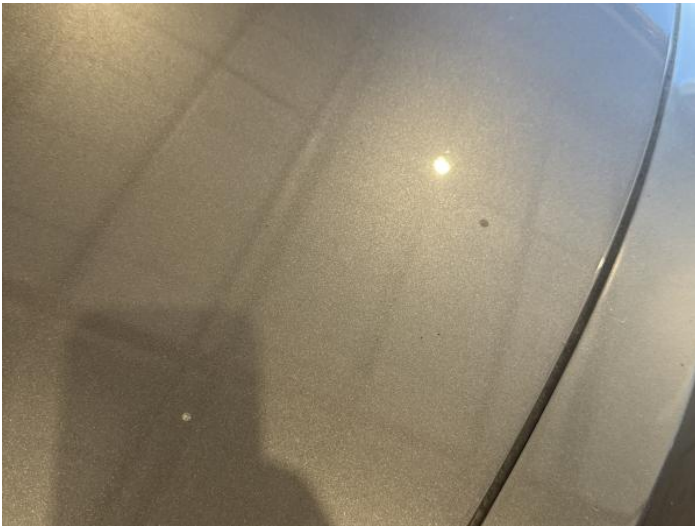
1: Bonnet
Chipped
1 To 5

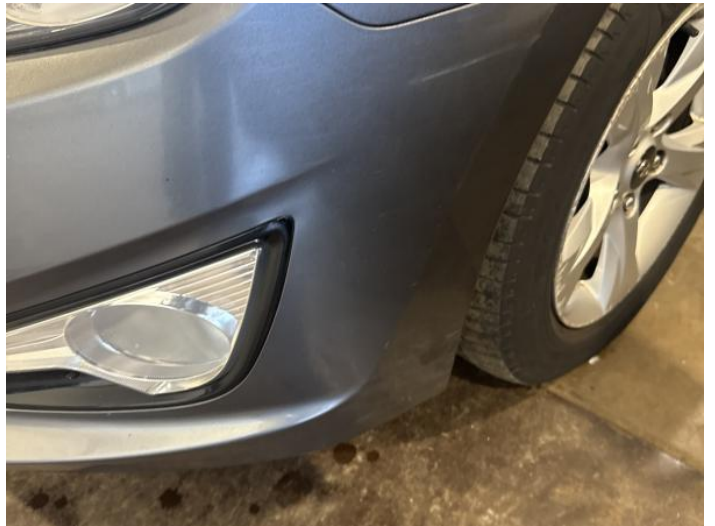
2: Bumper Front
Scratched
25 to 100mm Thru Paint

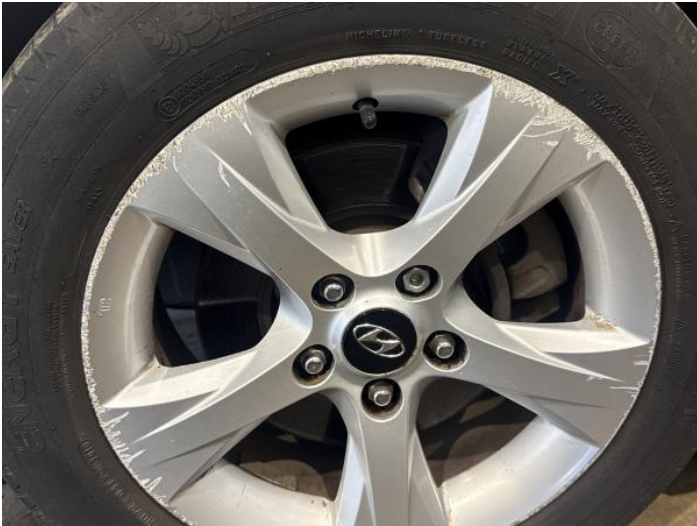
3: Wheel nsf
Scratched
Over 50mm

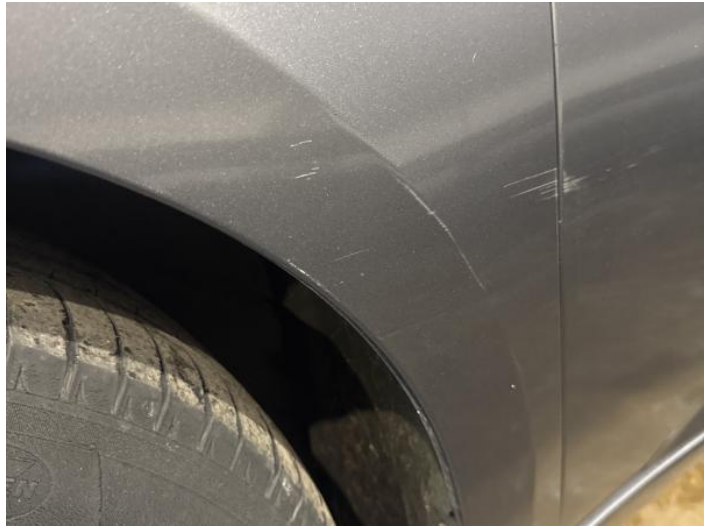
4: Wing nsf
Scratched
Over 25mm Thru Paint

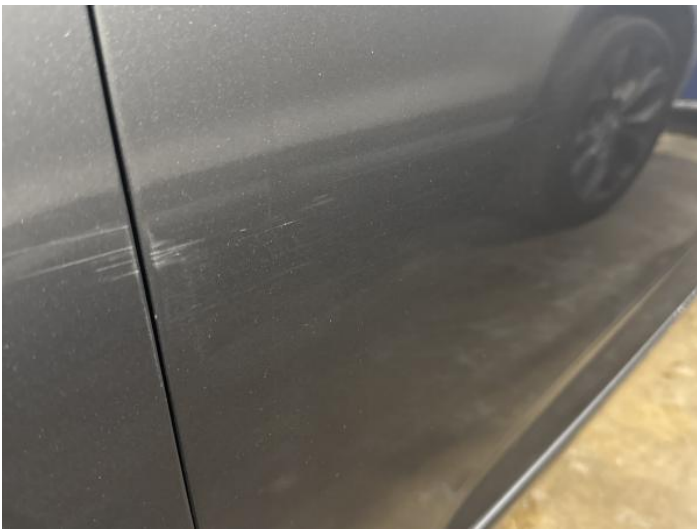
5: Door nsf
Dented
With Paint Damage

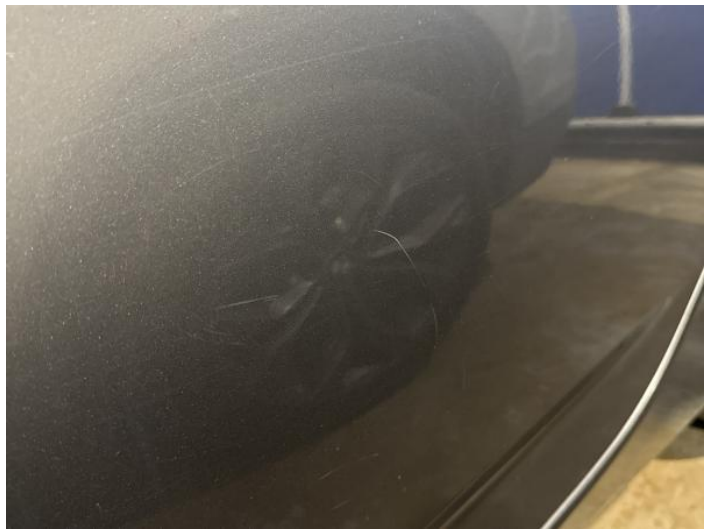
6: Door nsr
Scratched
Over 25mm Thru Paint

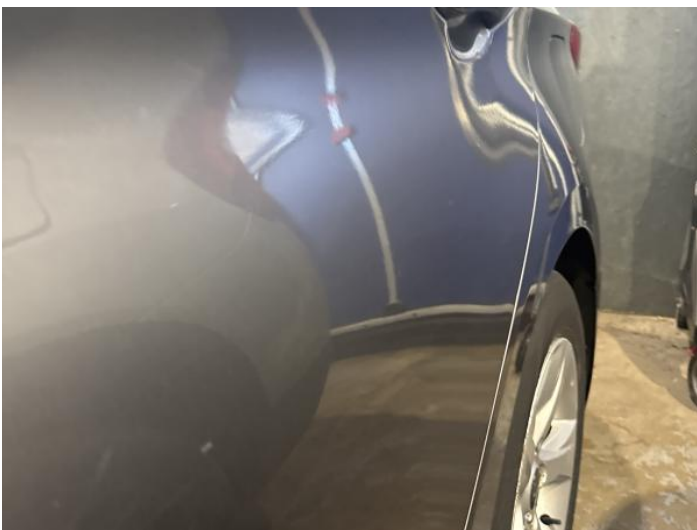
7: Door nsr
Dented
Between 10mm + 30mm

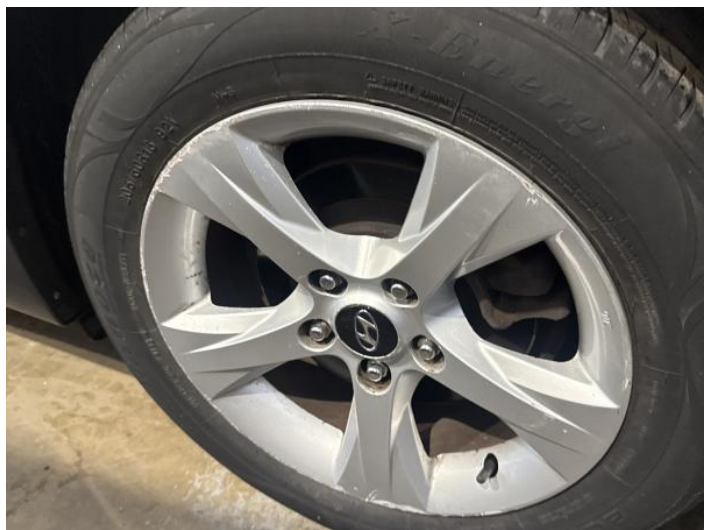
8: Wheel nsr
Scratched
Over 50mm

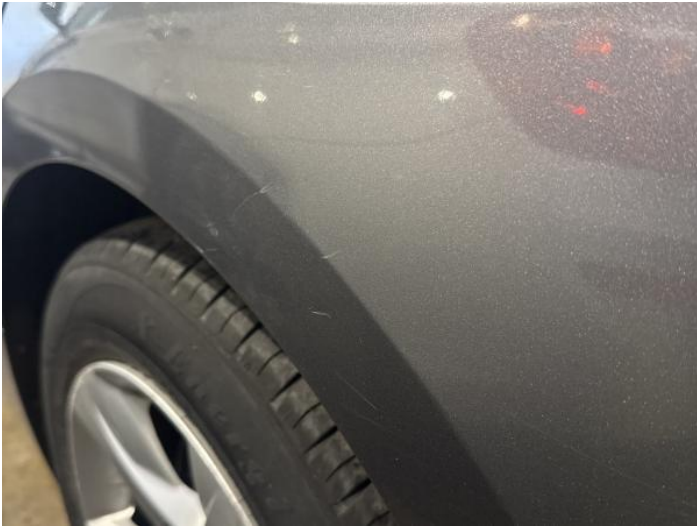
9: Qtr Panel nsr
Dented
With Paint Damage

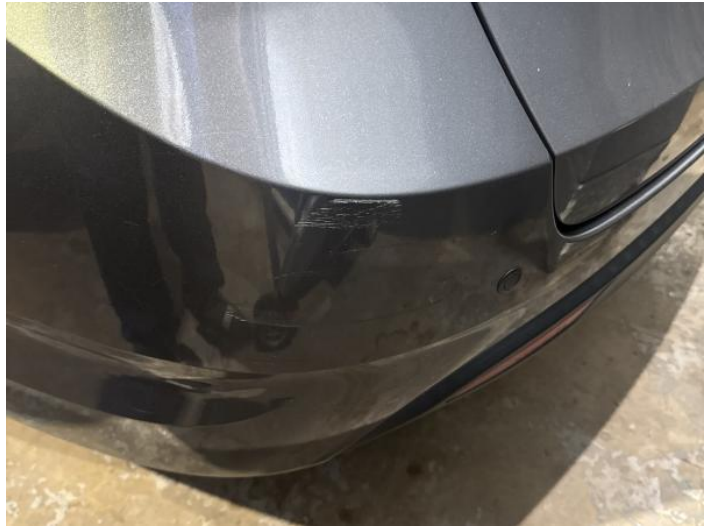
10: Bumper Rear
Dented
With Paint Damage

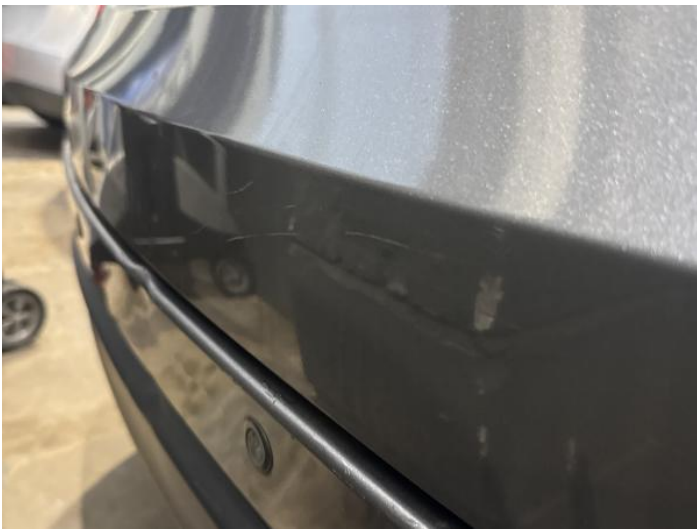
11: Tailgate
Scratched
Over 25mm Thru Paint

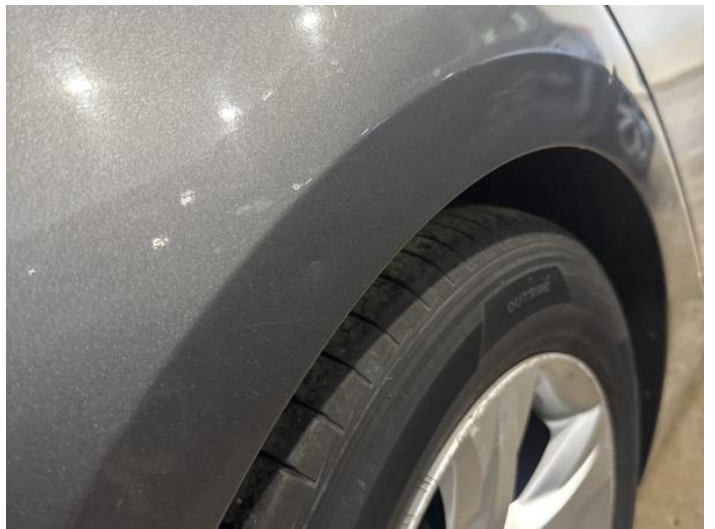
12: Qtr Panel osr
Dented
Between 10mm + 30mm

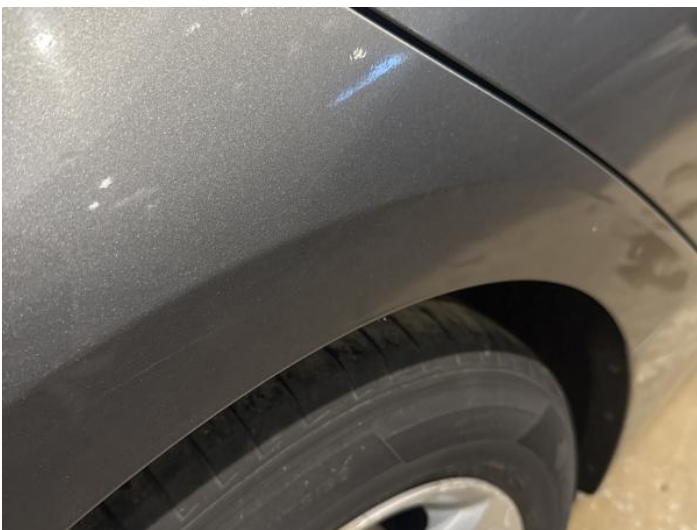
13: Qtr Panel osr
Scratched
UpTo 25mm Thru Paint

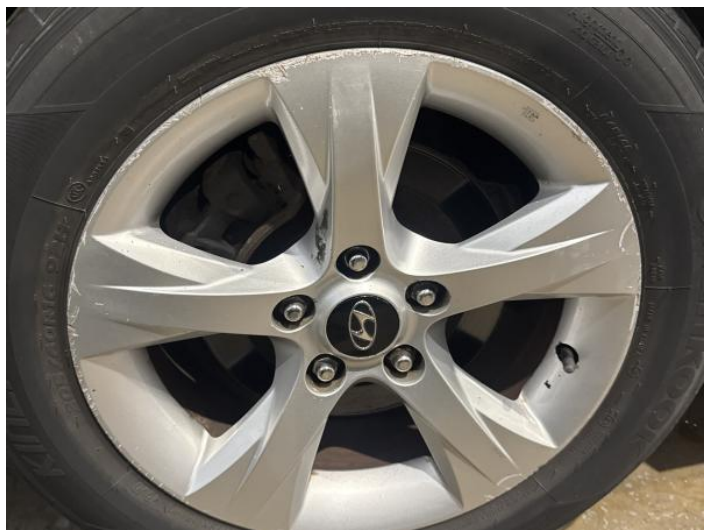
14: Wheel osr
Scratched
Over 50mm

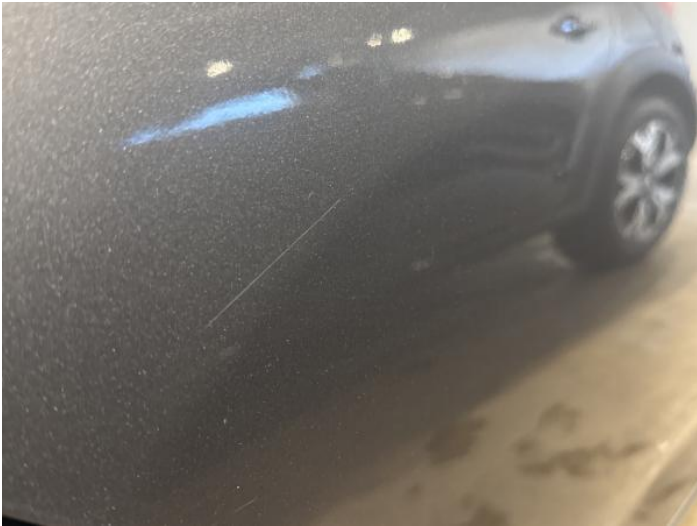
15: Door osr
Scratched
Over 25mm Thru Paint

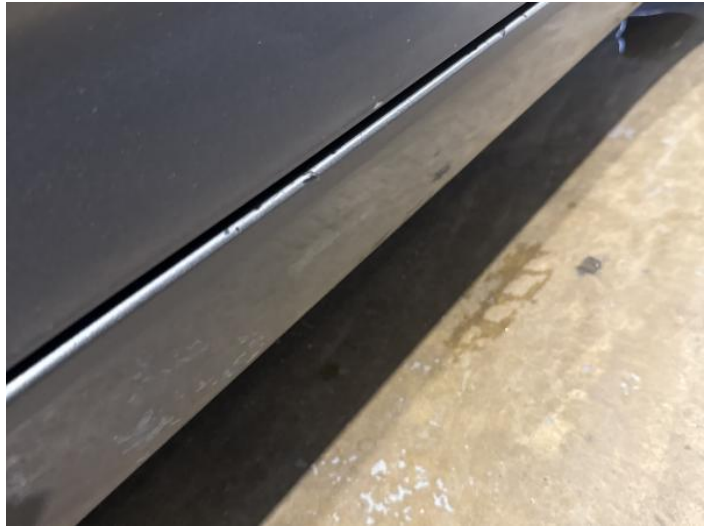
16: Sill Panel Trim ns
Scratched (Painted)
Over 25mm Thru Paint

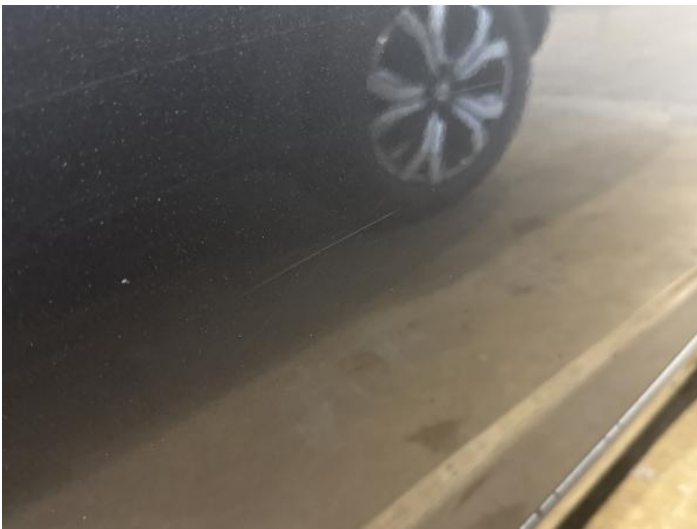
17: Door osf
Scratched
Over 25mm Thru Paint

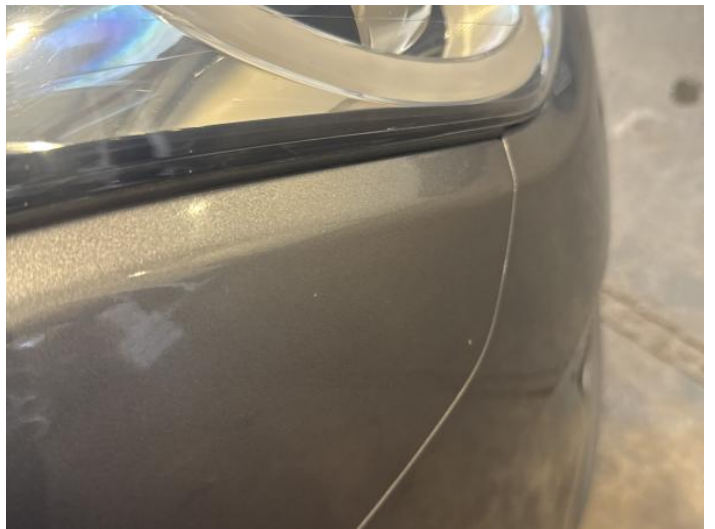
18: Wing osf
Chipped
1 To 5

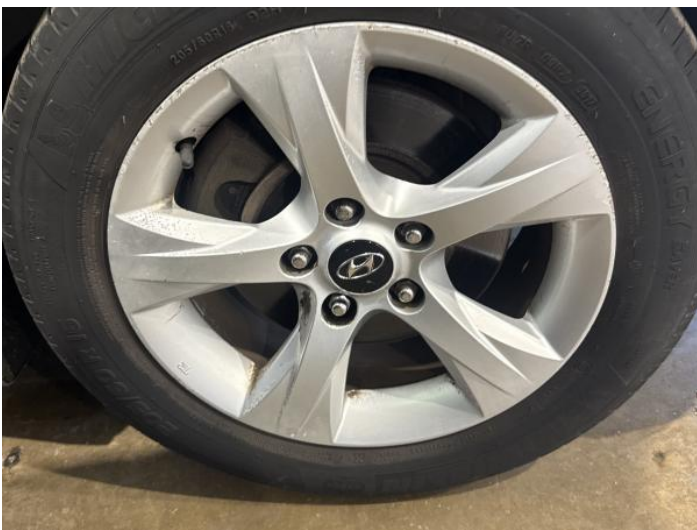
19: Wheel osf
Scratched
Over 50mm

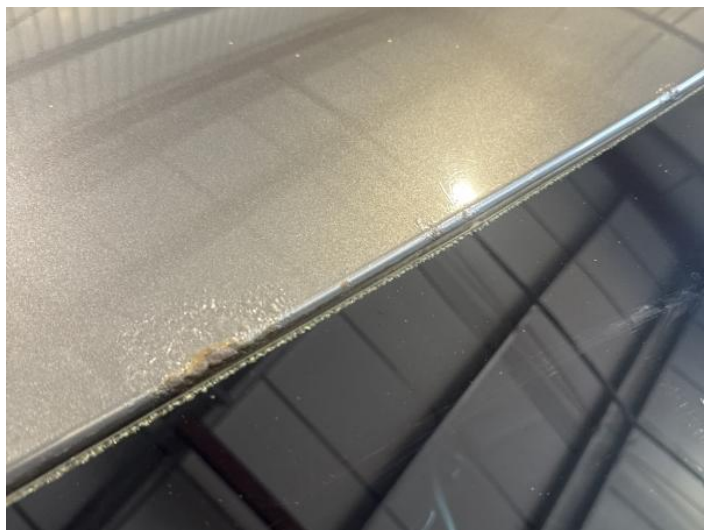
20: Roof
Rusted
Over 5mm

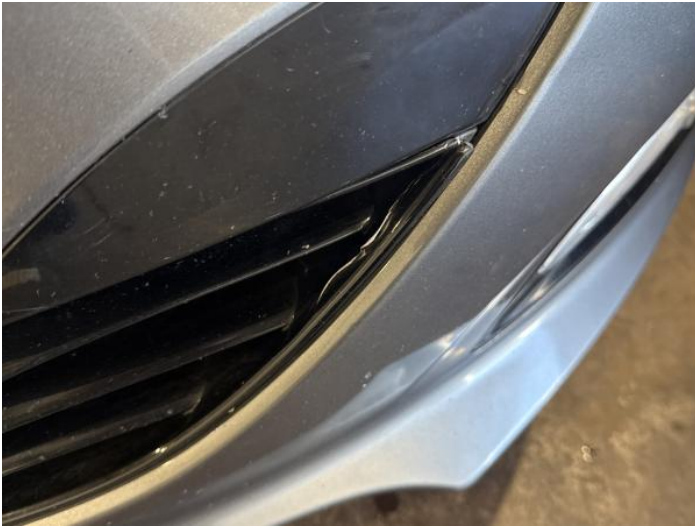
21: Bumper Front Grill
Broken
Replace
