# VEHICLE INSPECTION REPORT

**SN69HKC**

## Volvo V90 2.0 D4 R DESIGN 5dr Geartronic

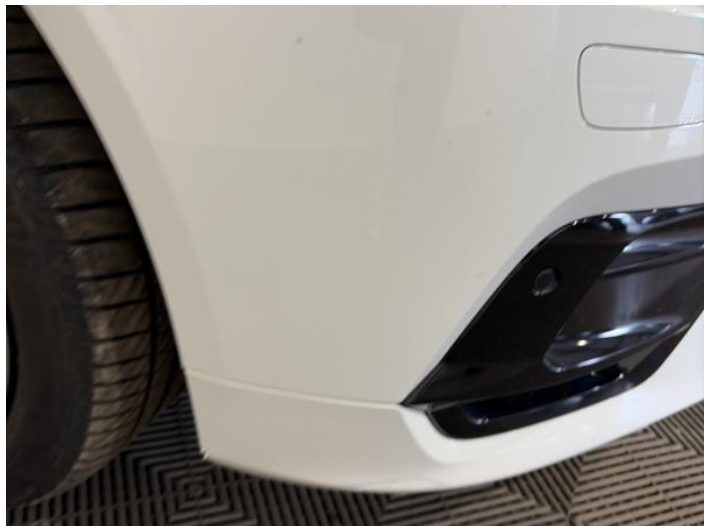
2: Bumper Front  
Dented  
With Paint Damage

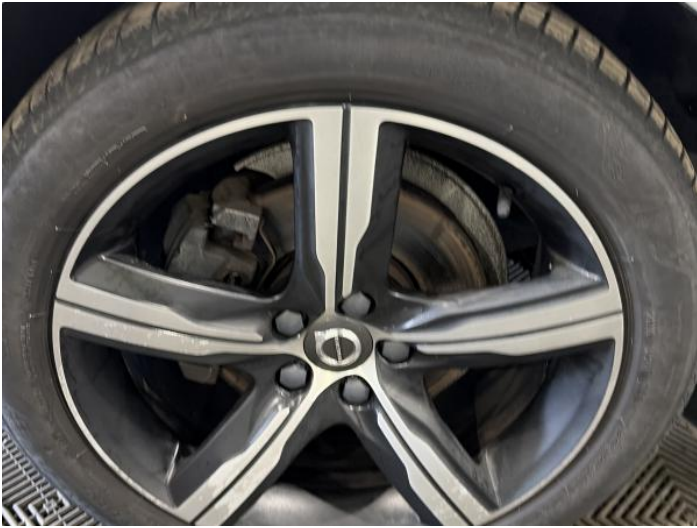
3: Wheel nsf  
Scratched  
Over 50mm

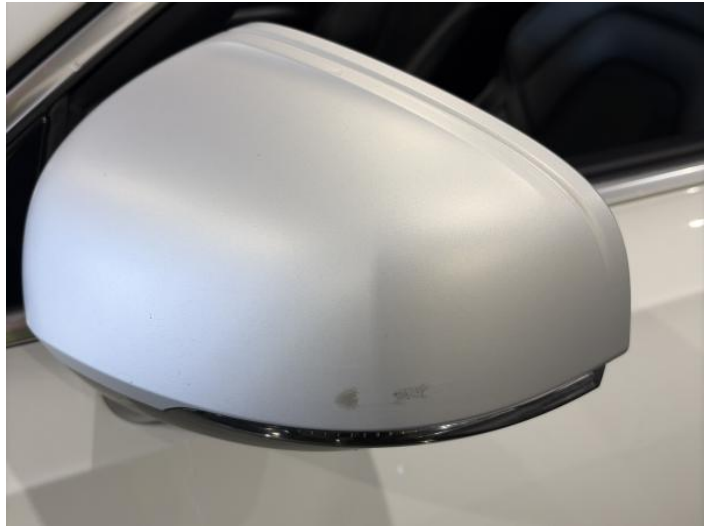
4: Door Mirror Assy nsf  
Scratched (Painted)  
UpTo 25mm Thru Paint

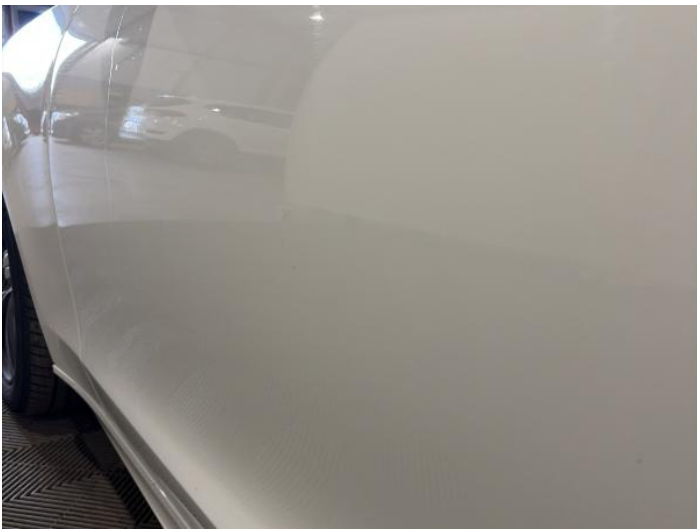
5: Door nsf  
Dented  
Between 10mm + 30mm

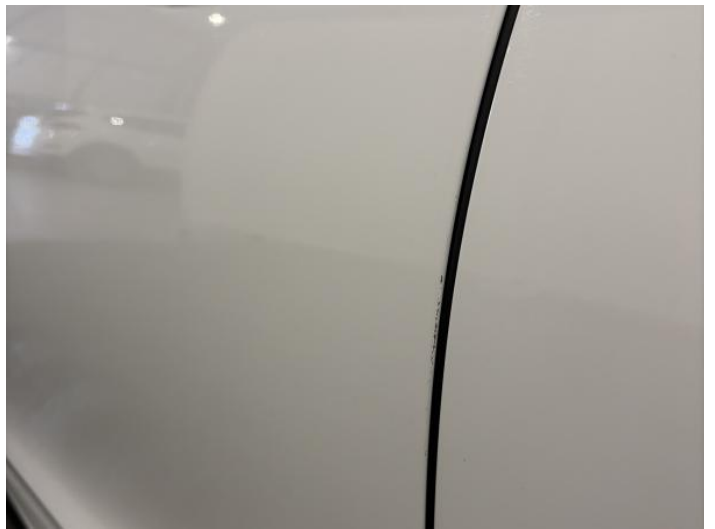
6: Door nsf  
Chipped  
Edge Chip

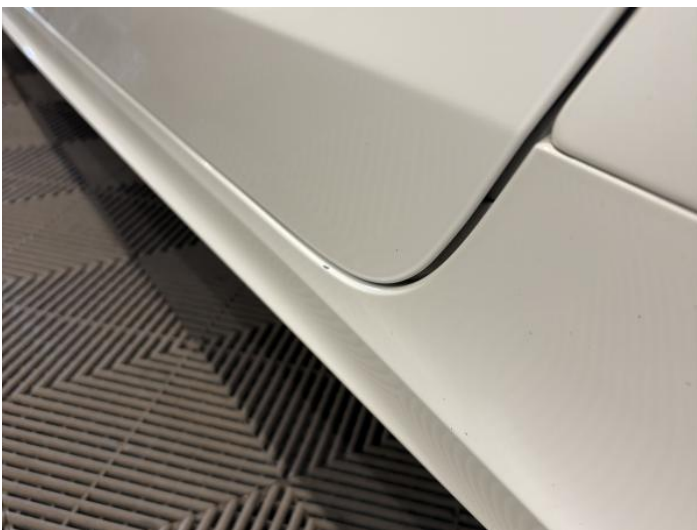
7: Sill ns  
Scratched  
UpTo 25mm Thru Paint

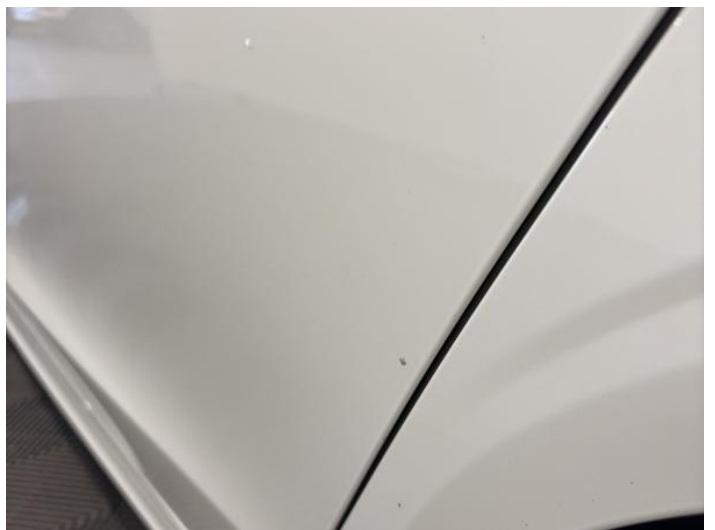
8: Door nsr  
Chipped  
1 To 5

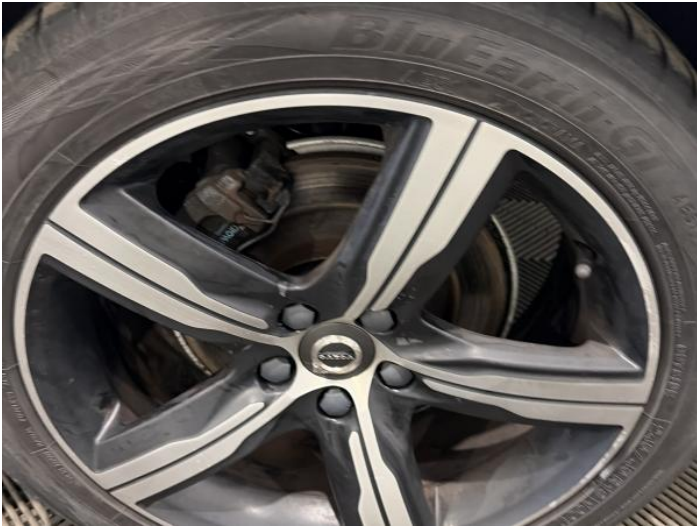
9: Wheel nsr  
Scratched  
Over 50mm

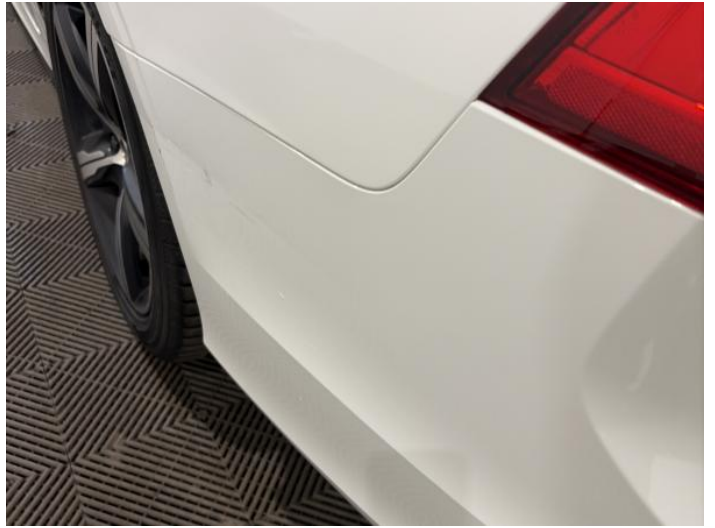
10: Bumper Rear  
Dented  
With Paint Damage

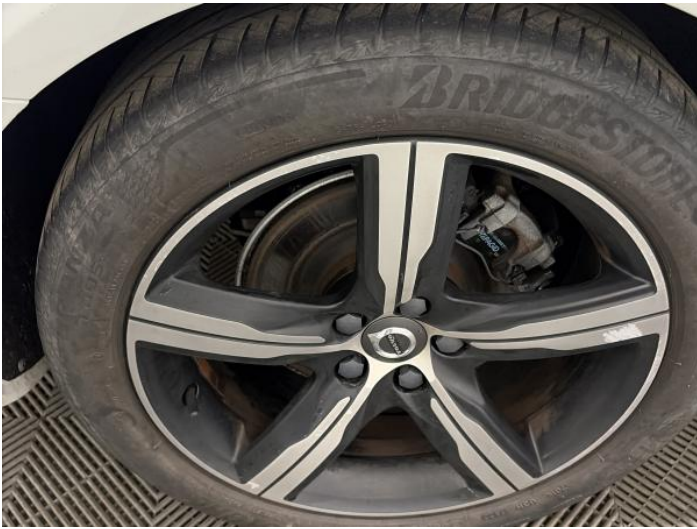
11: Wheel osr  
Scratched  
Over 50mm

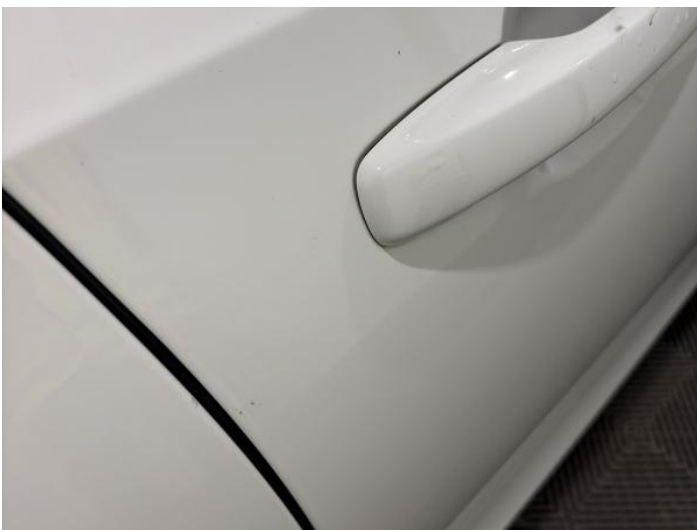
13: Door osf  
Chipped  
1 To 5

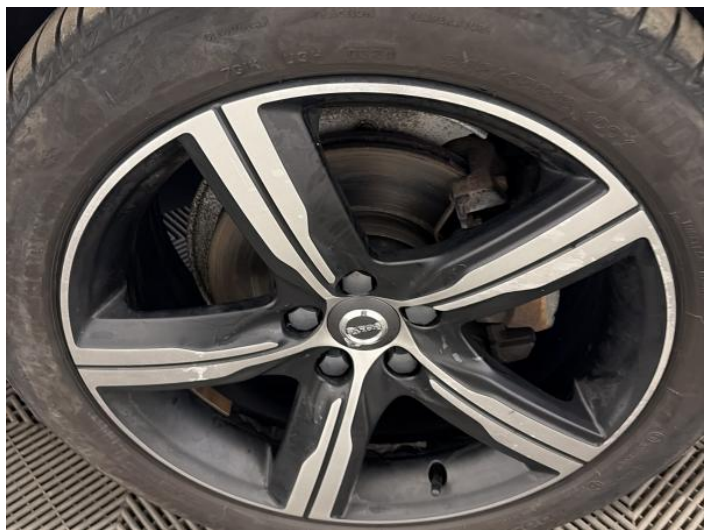
14: Wheel osf  
Scratched  
Over 50mm

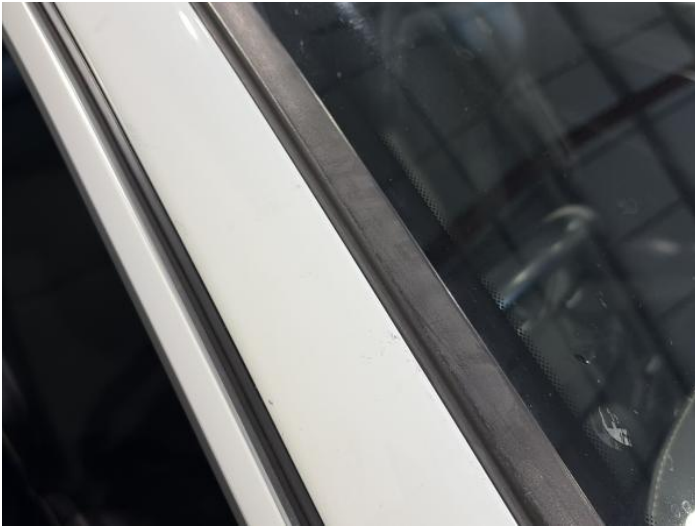
15: A Post ns  
Chipped  
1 To 5

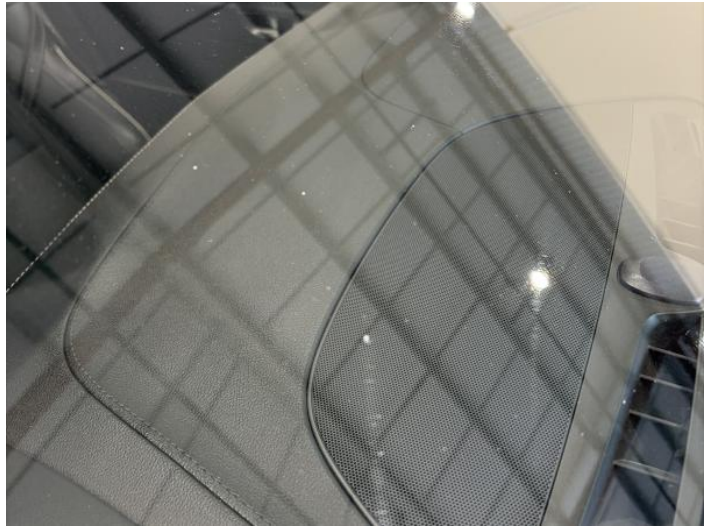
16: Screen Front  
Chipped  
UpTo 10mm
