VEHICLE INSPECTION REPORT

WO15XGP

Jeep Renegade 1.4 Multiair Longitude 5dr

nama
 GRADE
3

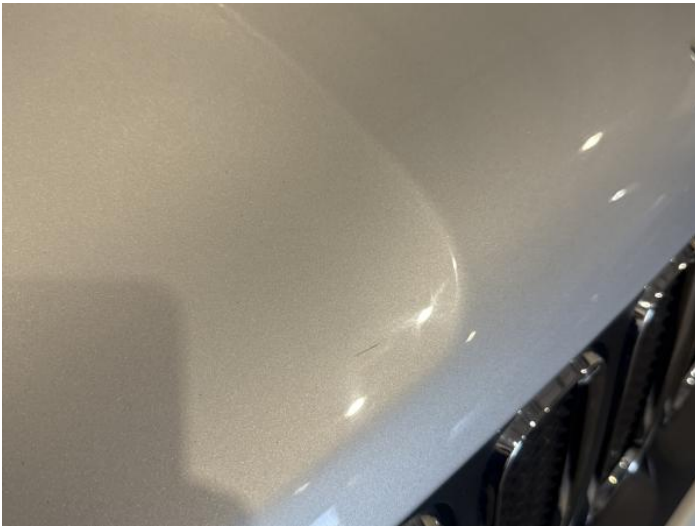
1: Bonnet
Scratched
UpTo 25mm Thru Paint

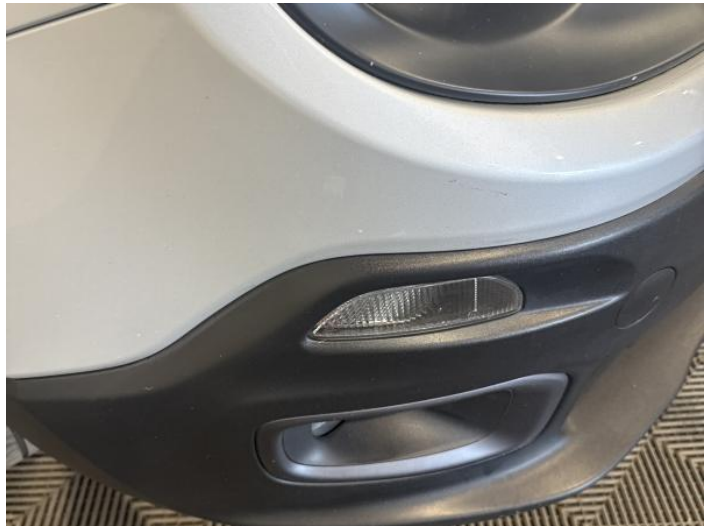
2: Bumper Front
Scratched
25 to 100mm Thru Paint

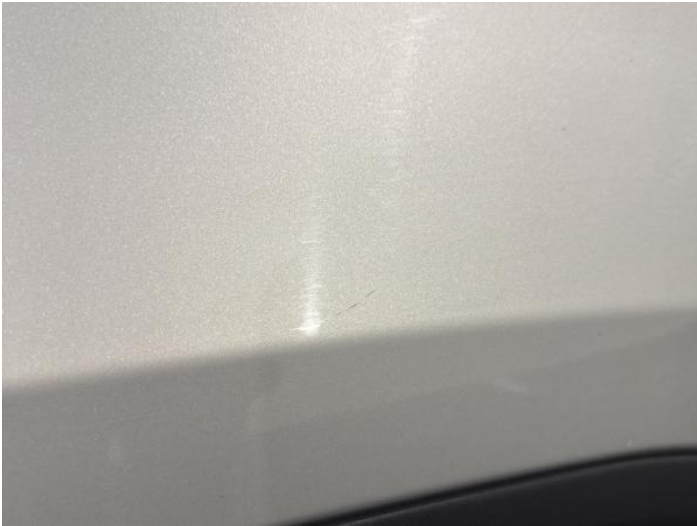
3: Wing nsf
Scratched
UpTo 25mm Thru Paint

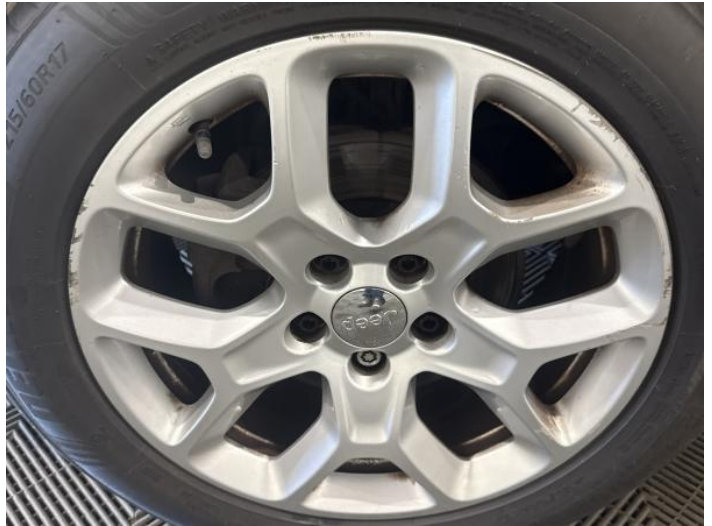
4: Wheel nsf
Scratched
Over 50mm

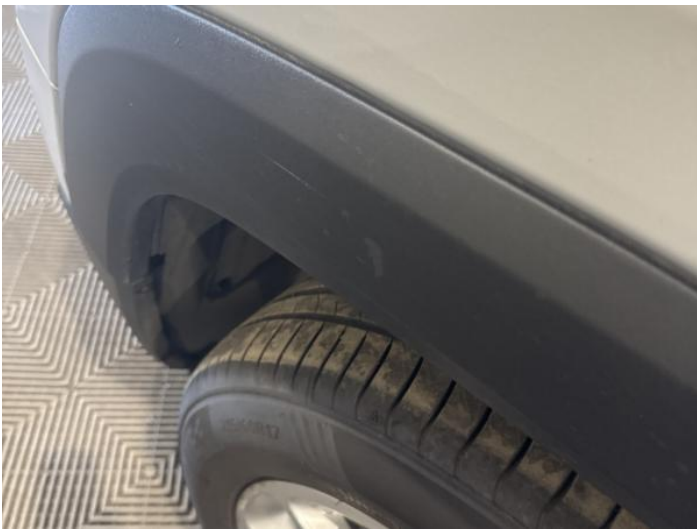
5: Wing Front Arch Extension ns
Scuffed (Unpainted)
Over 100mm

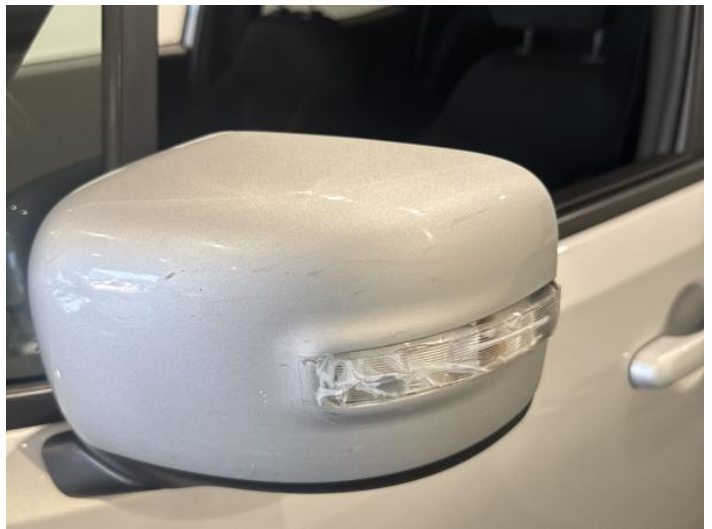
6: Flasher Side Repeater ns
Broken
Replace

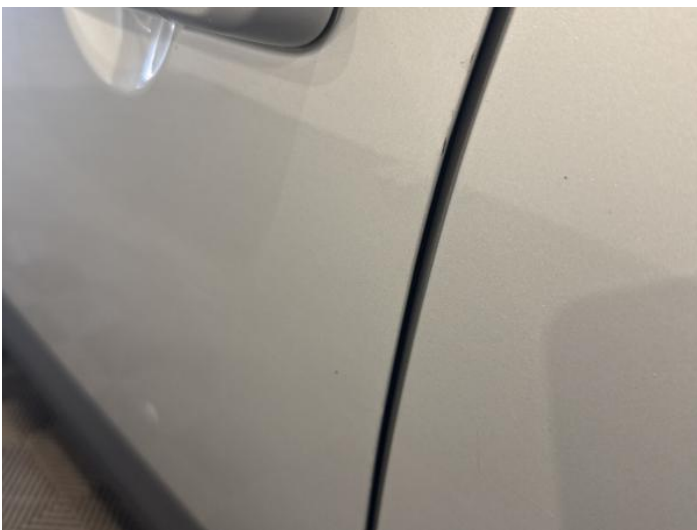
7: Door nsf
Chipped
1 To 5

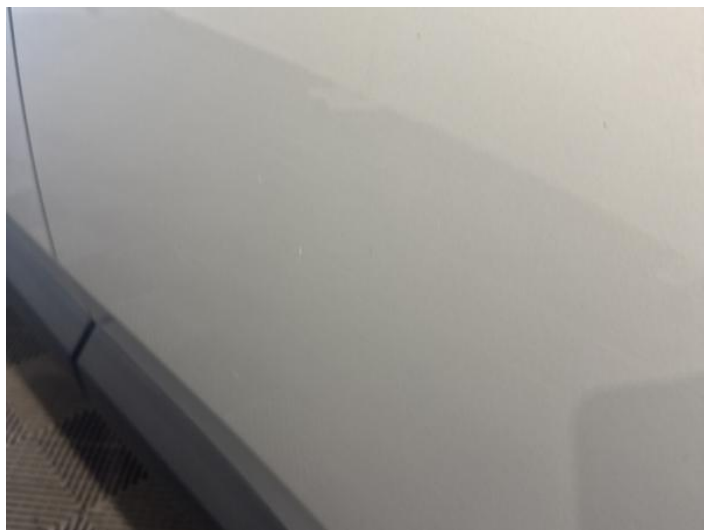
8: Door nsr
Chipped
1 To 5

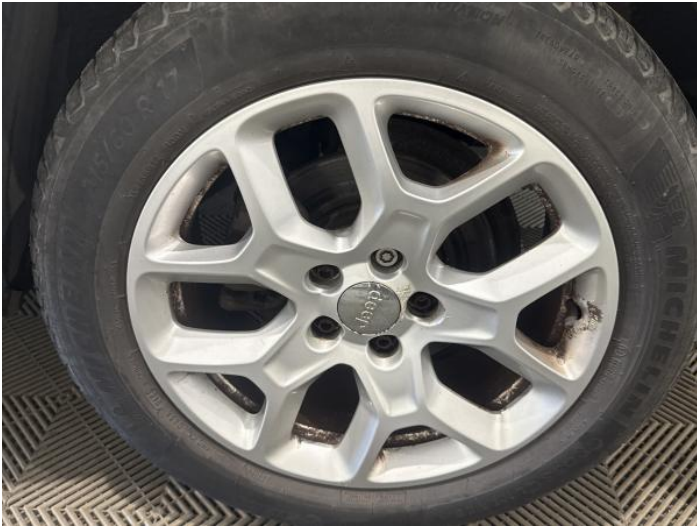
9: Wheel nsr
Scratched
Up To 50mm

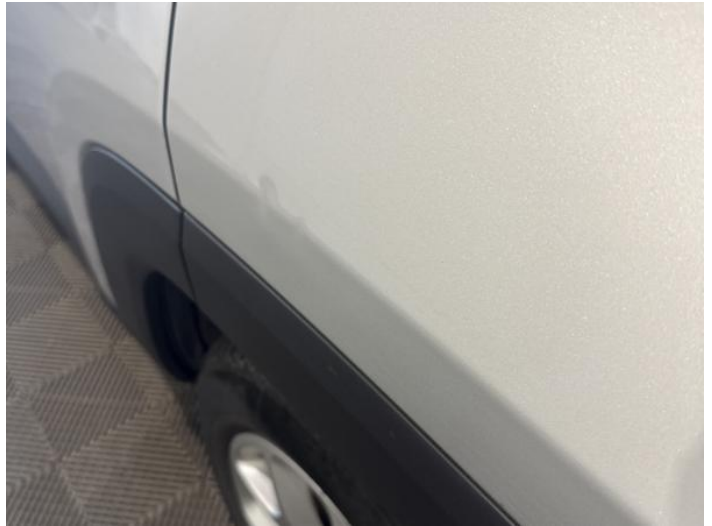
10: Qtr Panel nsr
Dented
Over 30mm

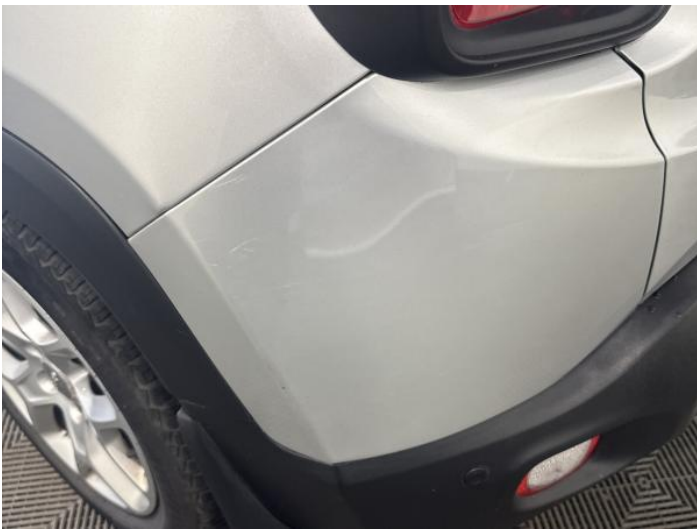
11: Bumper Rear
Scratched
25 to 100mm Thru Paint

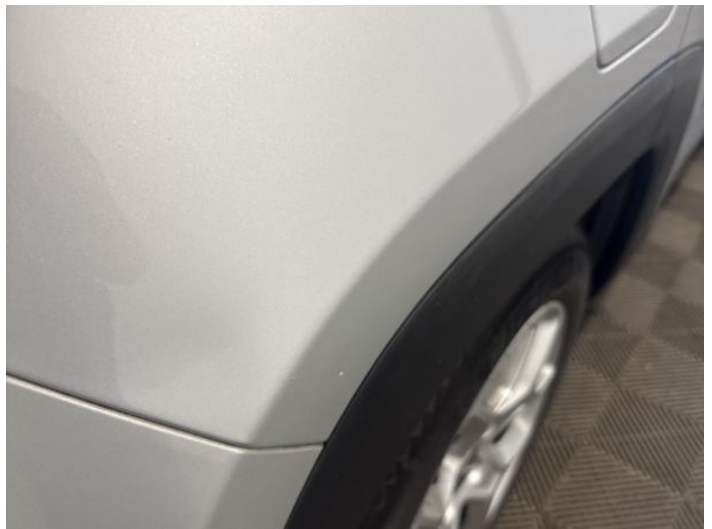
12: Qtr Panel osr
Dented
Over 30mm

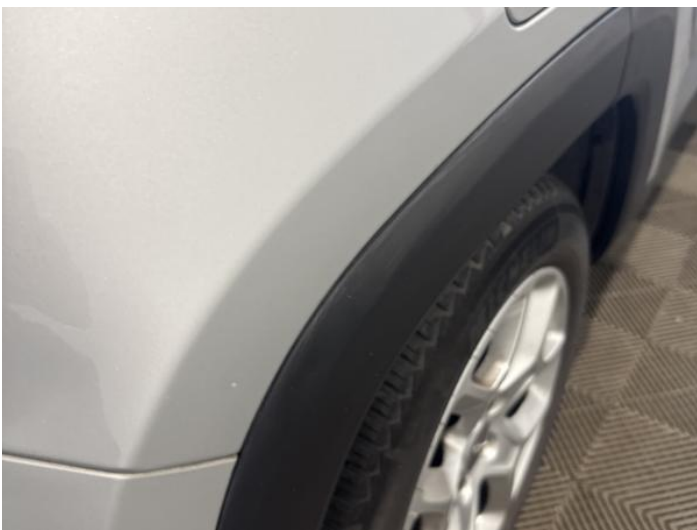
13: Qtr Panel osr
Chipped
1 To 5

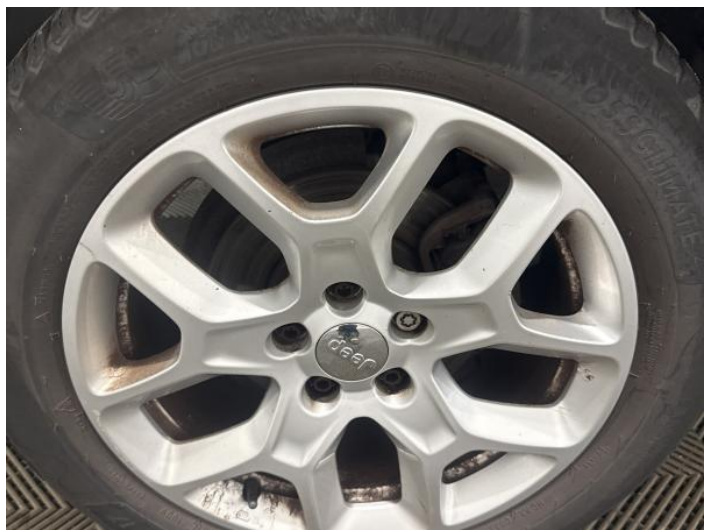
14: Wheel osr
Scratched
Over 50mm

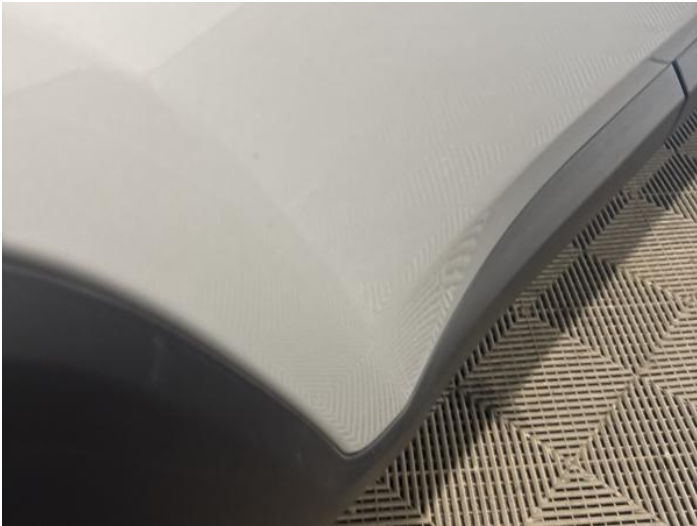
15: Door osr
Scratched
Over 25mm Thru Paint

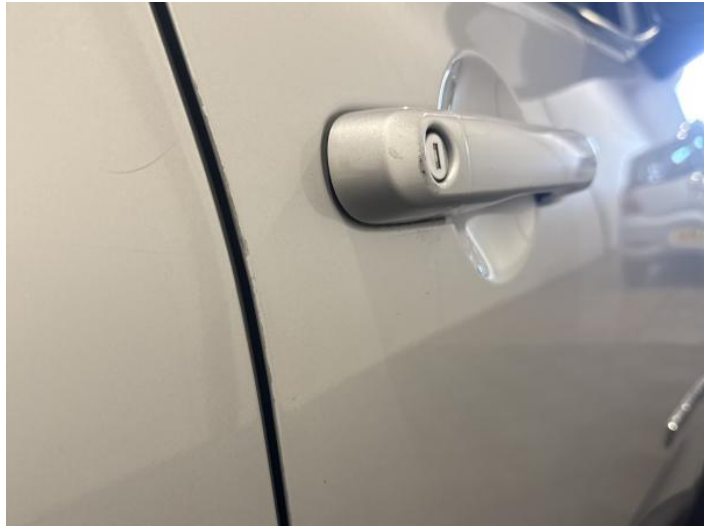
16: Door osf
Chipped
Edge Chip

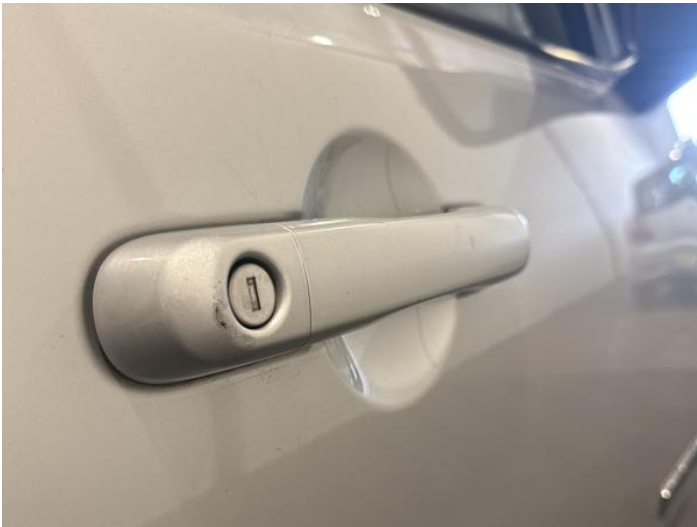
17: Handle Outer osf
Scratched (Painted)
UpTo 25mm Thru Paint

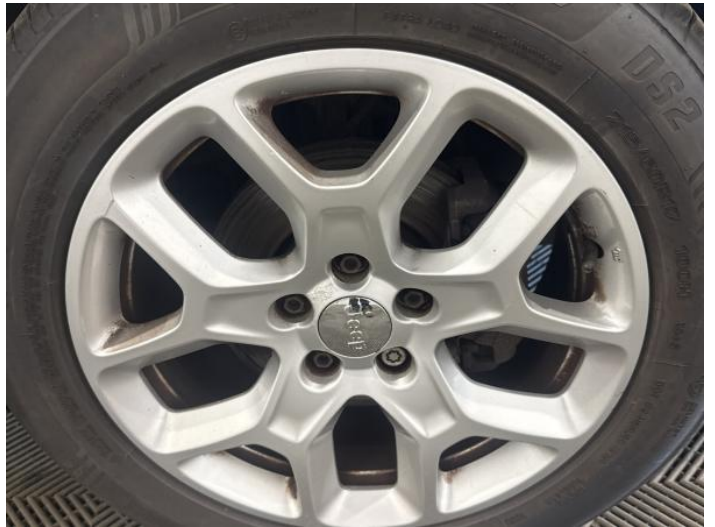
18: Wheel osf
Scratched
Up To 50mm

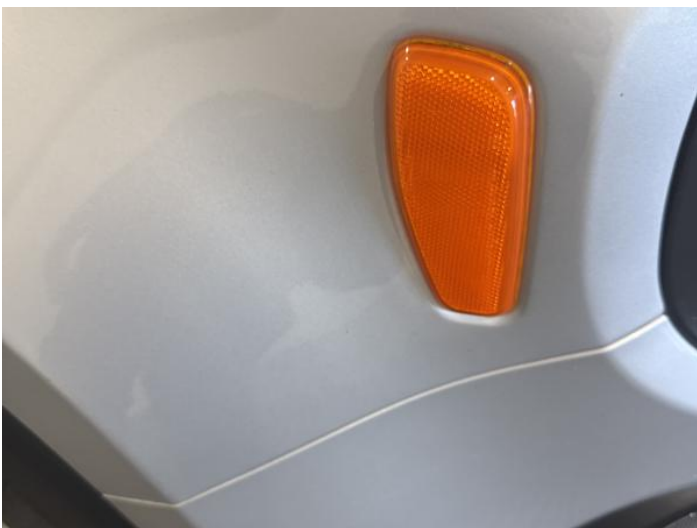
19: Wing osf
Chipped
1 To 5

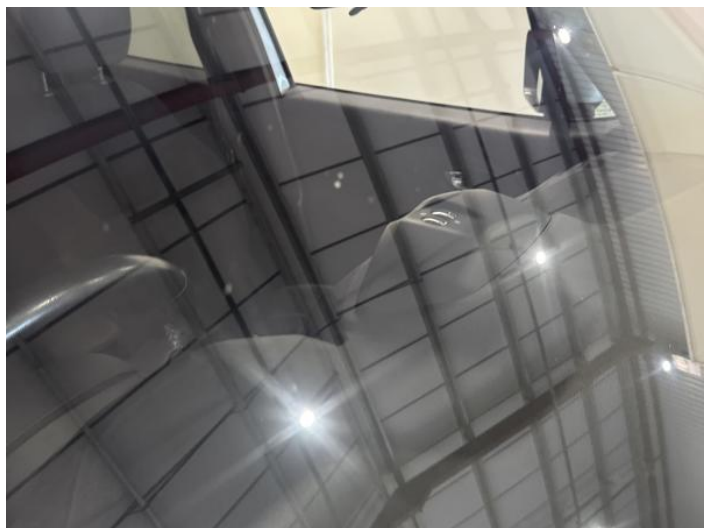
20: Screen Front
Chipped
UpTo 10mm
