VEHICLE INSPECTION REPORT

SY68VKX

Hyundai Tucson 1.6 CRDi 136 Premium SE 5dr 2WD

nama
GRADE
4

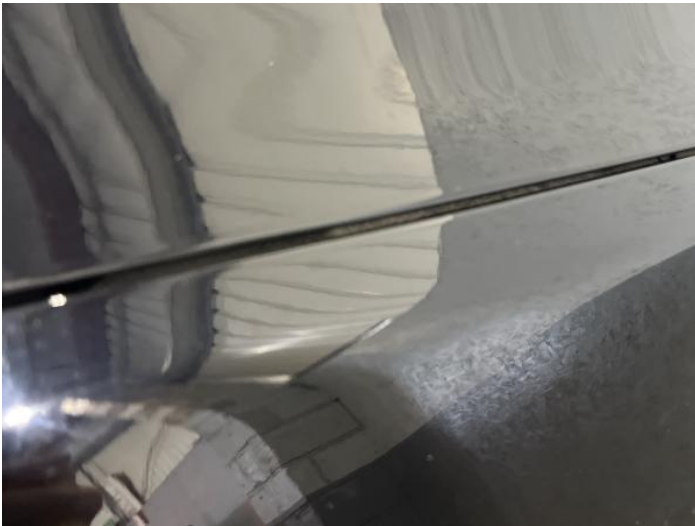
1: Wing of
Scratched
Over 25mm Thru Paint

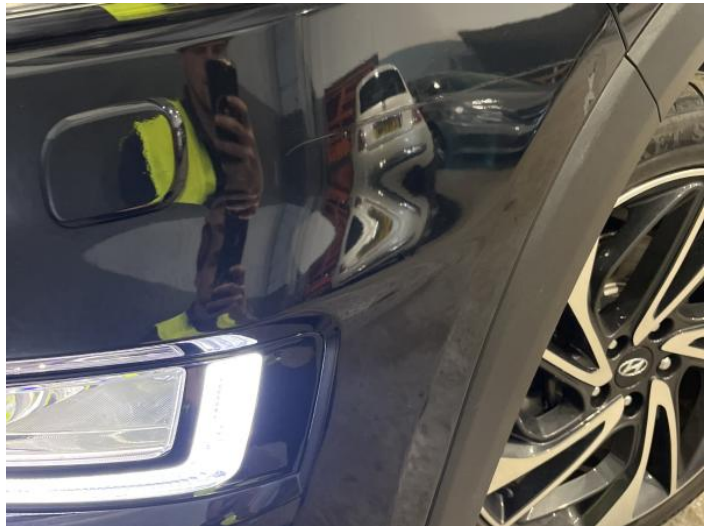
2: Bumper Front
Poor Previous Repair
Paint Flake

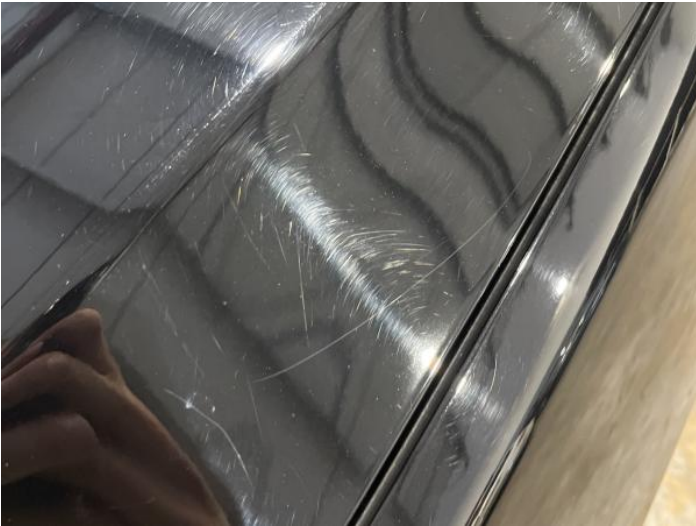
3: Bonnet
Scratched
Over 25mm Thru Paint

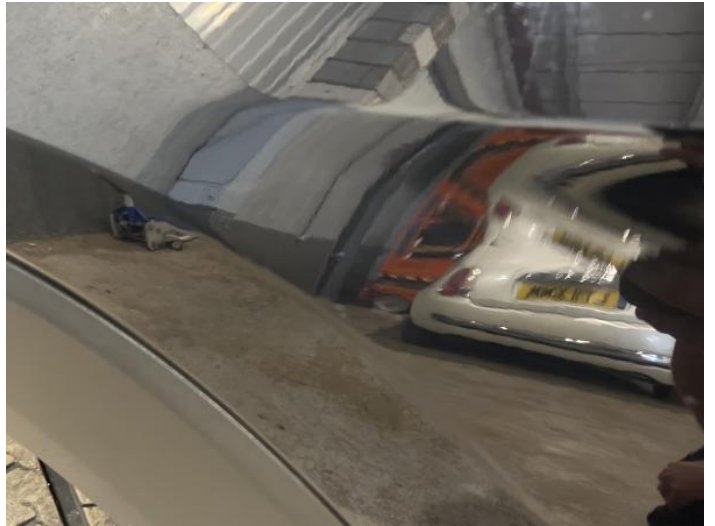
4: Wing nsf
Scratched
UpTo 25mm Thru Paint

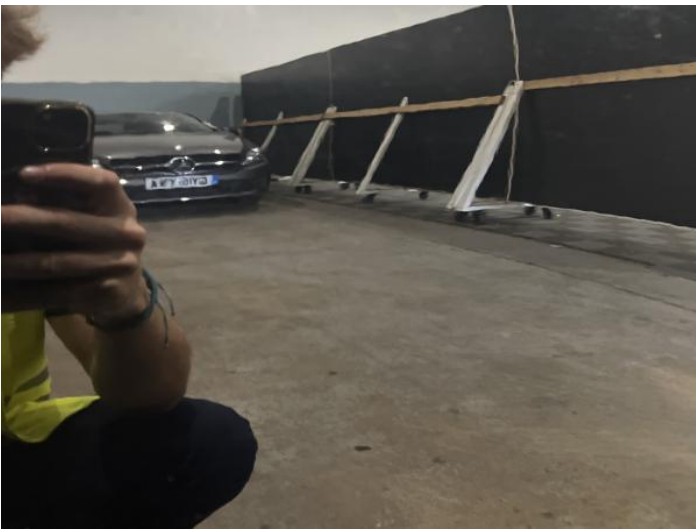
5: Door nsr
Scratched
Over 25mm Thru Paint

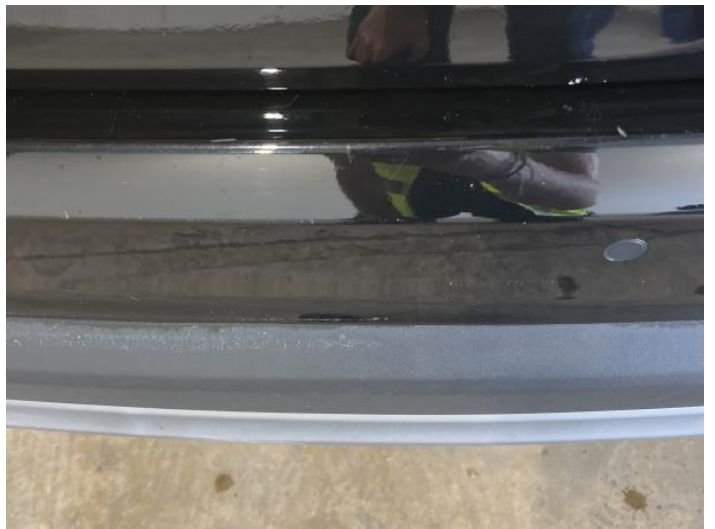
6: Bumper Rear
Scratched
25 to 100mm Thru Paint

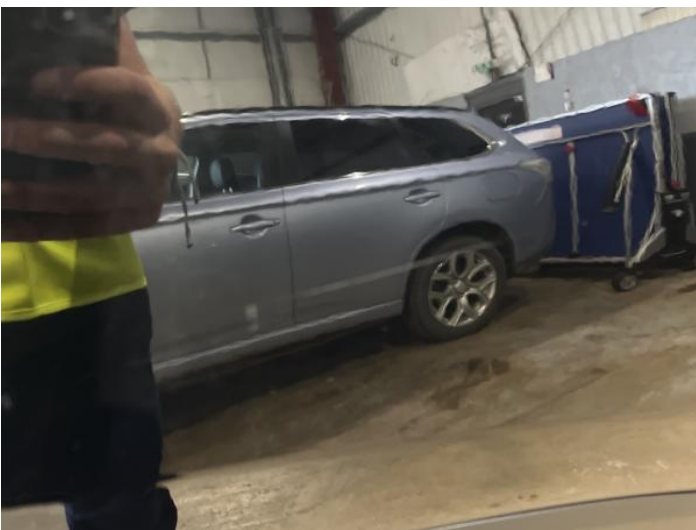
7: Qtr Panel osr
Scratched
Over 25mm Thru Paint

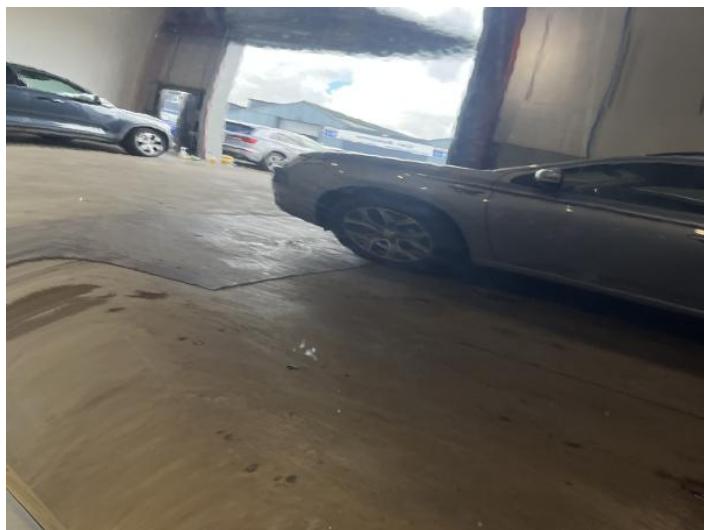
8: Door nsr
Scratched
Over 25mm Thru Paint

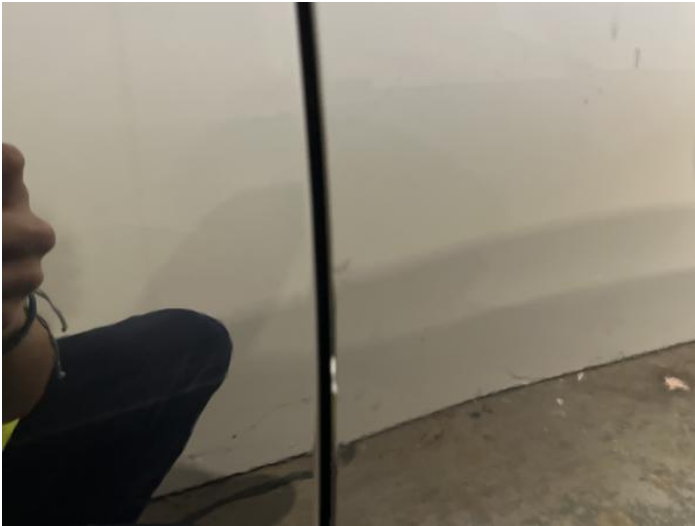
9: Door osf
Chipped
Edge Chip

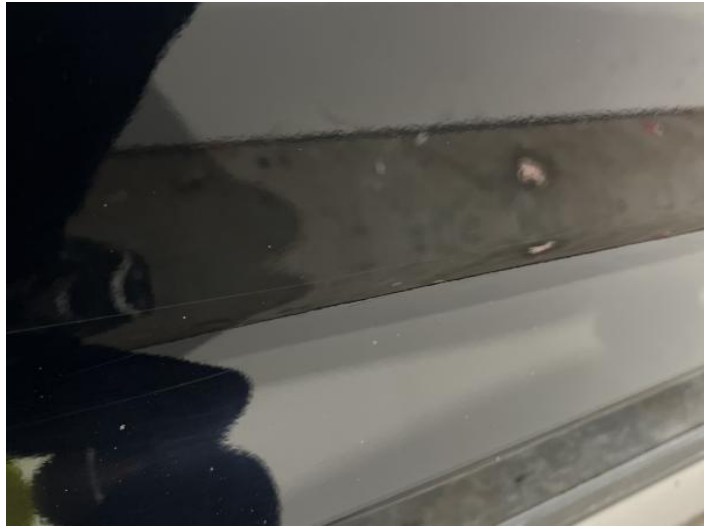
10: Door osf
Scratched
Over 25mm Thru Paint

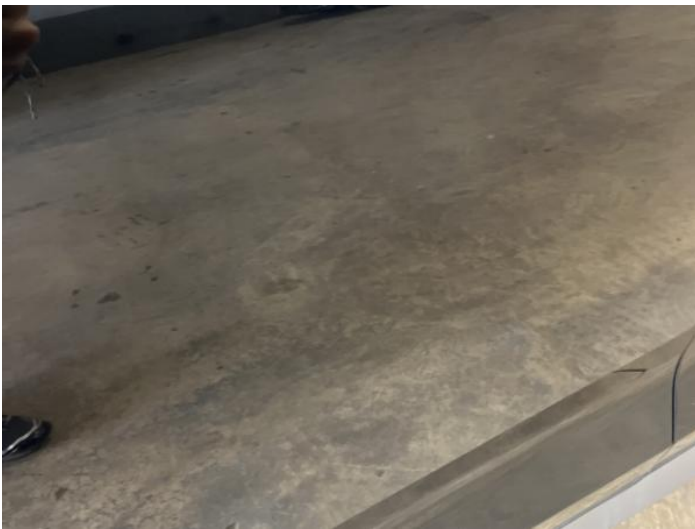
11: Door osf
Scratched
Over 25mm Thru Paint
