VEHICLE INSPECTION REPORT

KN65LVA

Volkswagen Tiguan 2.0 TDi BlueMotion Tech R-Line 184 5dr DSG [NAV]

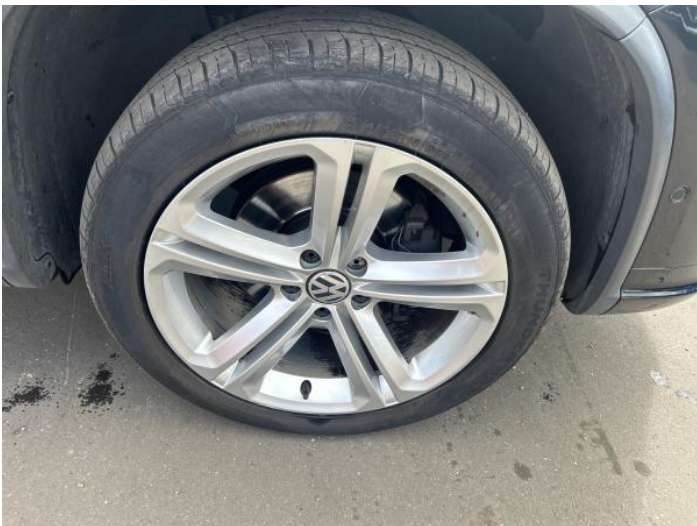
1: Wheel of
Scratched
Up To 50mm

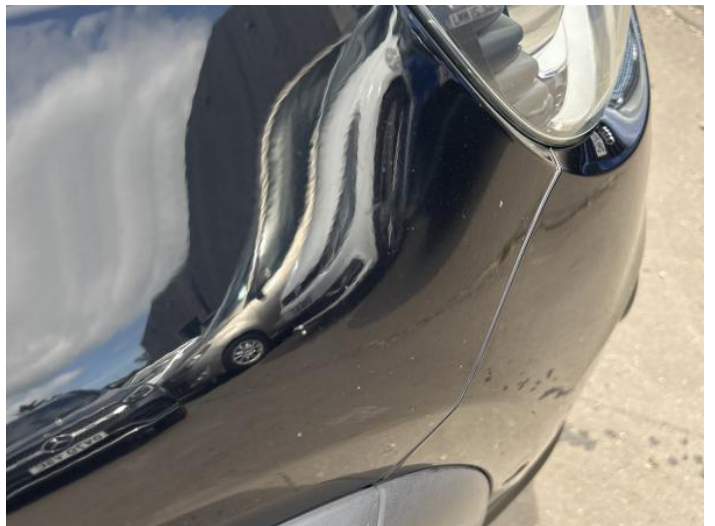
2: Wing of
Chipped
1 To 5

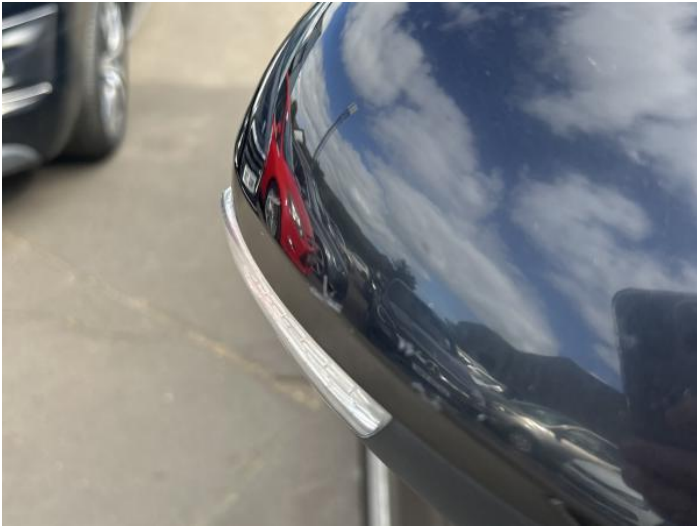
3: Door Mirror Assy osf
Scratched (Painted)
UpTo 25mm Thru Paint

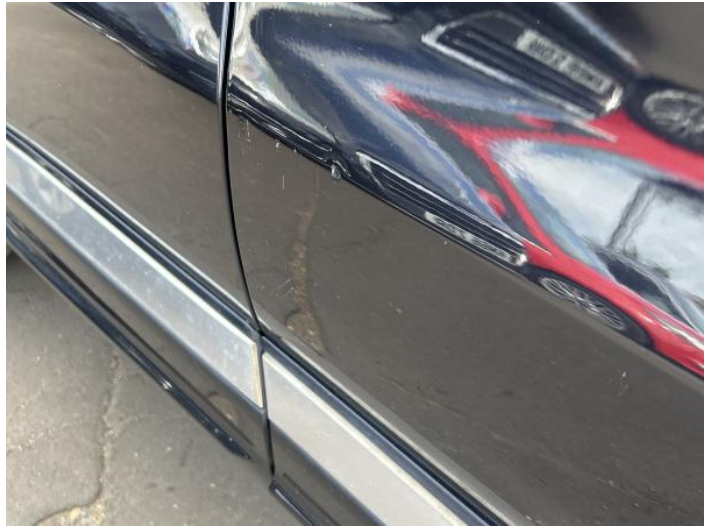
4: Door osf
Dented
With Paint Damage

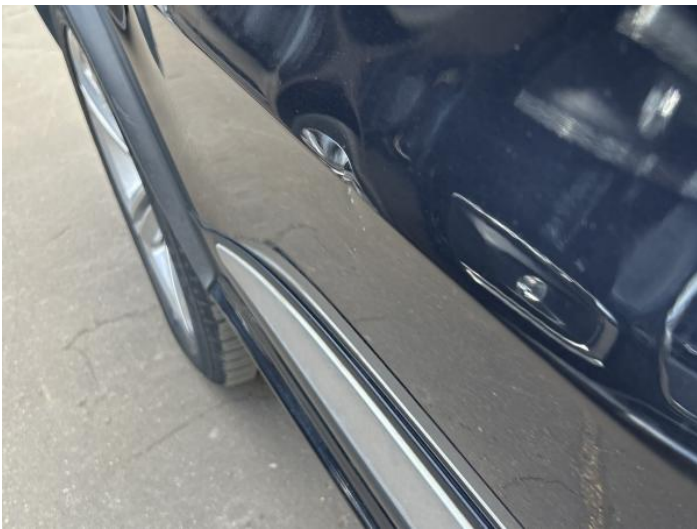
5: Door osr
Dented
Between 10mm + 30mm

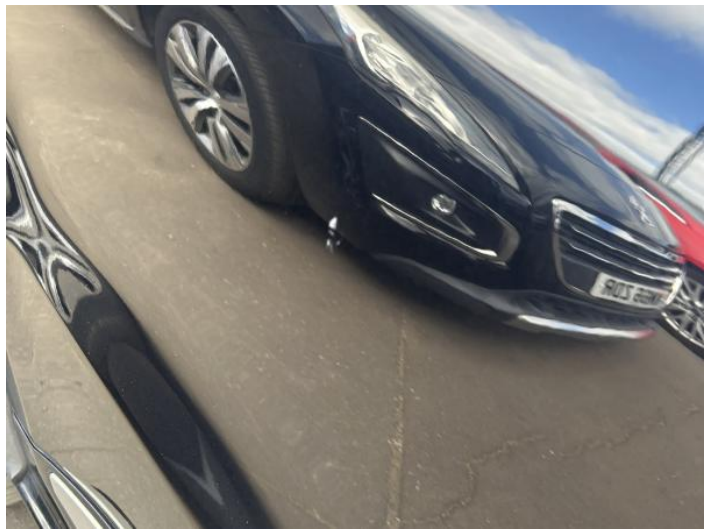
6: Door osr
Chipped
1 To 5

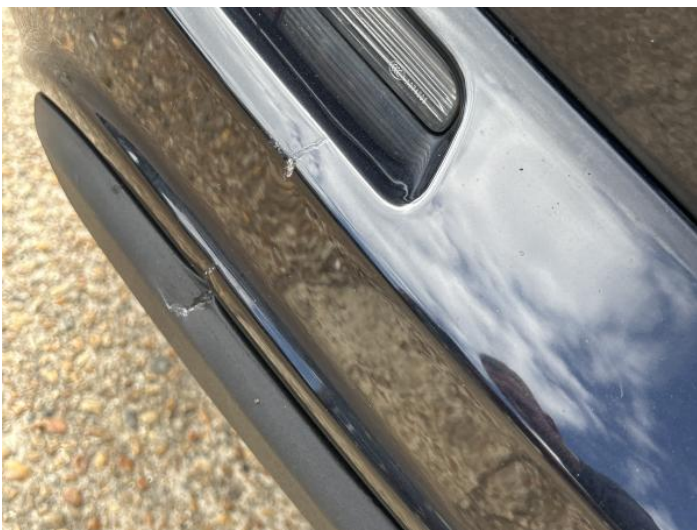
7: Bumper Rear
Dented
With Paint Damage

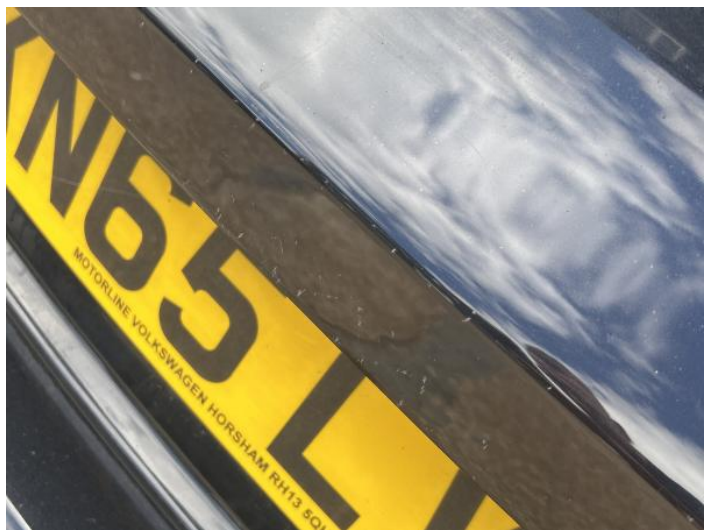
8: Tailgate
Chipped
Multiple Chips

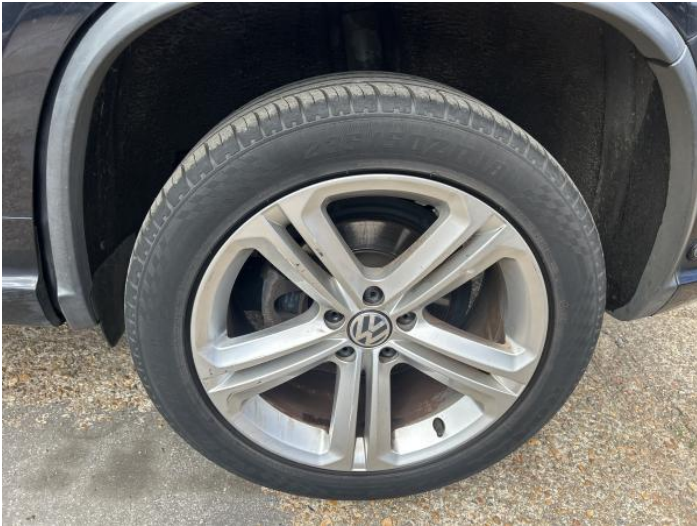
9: Wheel nsr
Scratched
Over 50mm

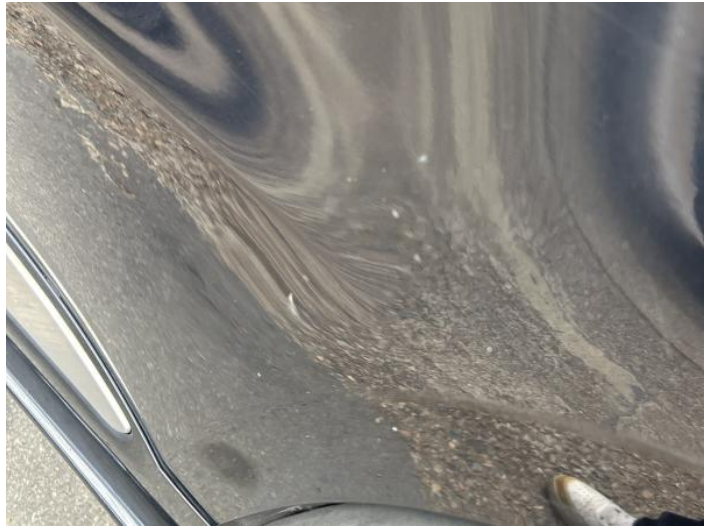
10: Door nsr
Chipped
1 To 5

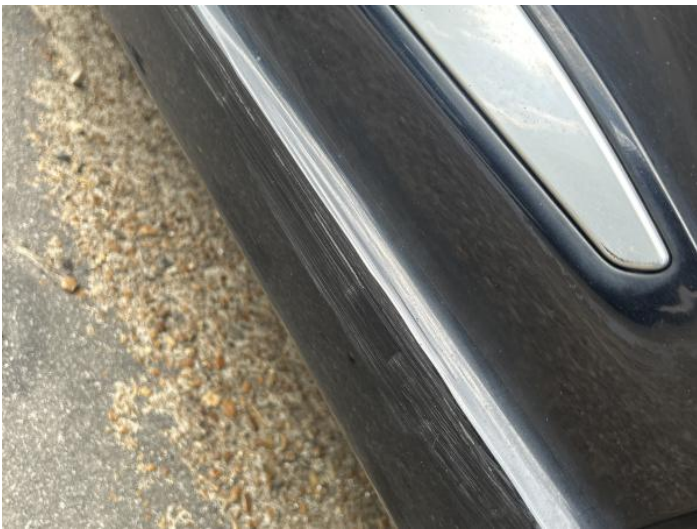
11: Door Moulding nsr
Scratched (Painted)
Over 25mm Thru Paint

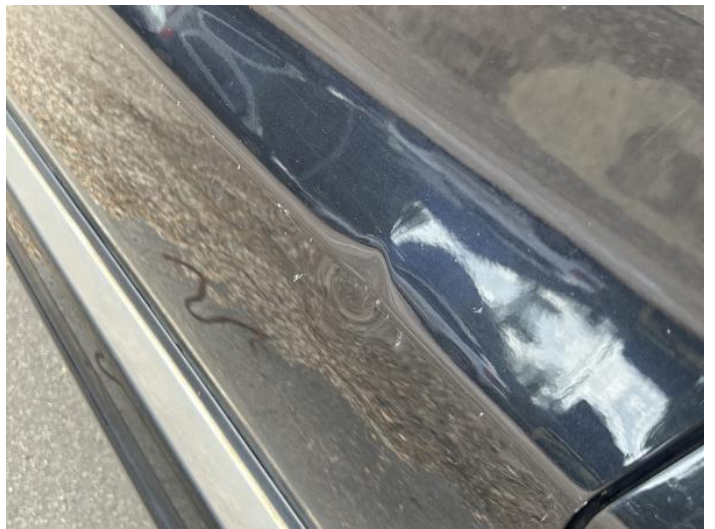
12: Door nsf
Dented
With Paint Damage

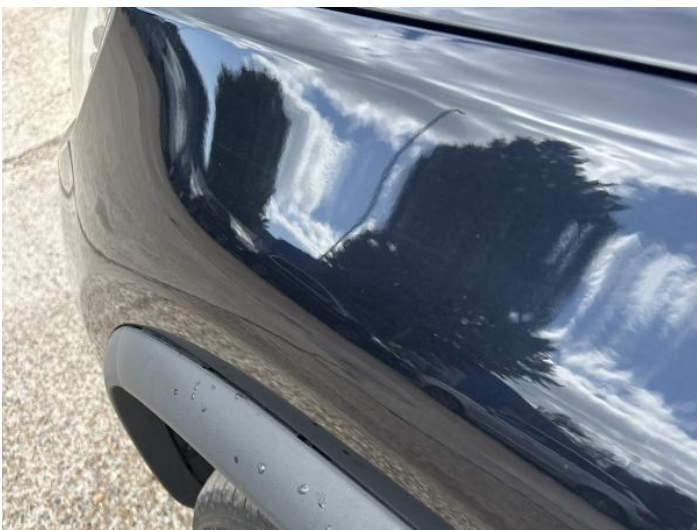
13: Wing nsf
Dented
Between 10mm + 30mm

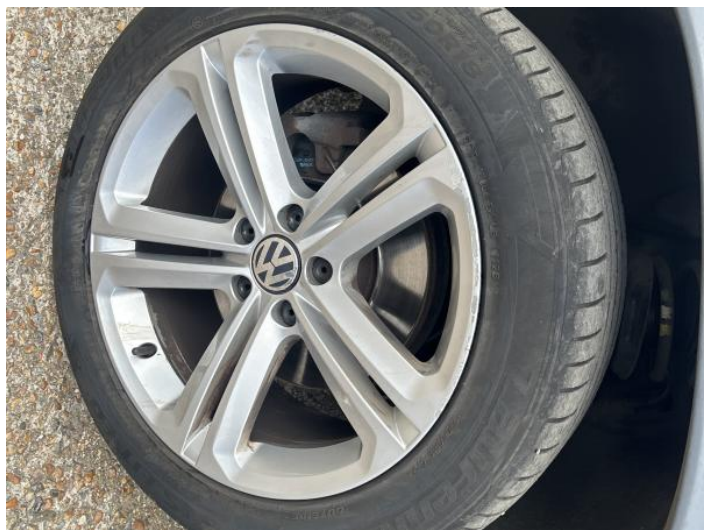
14: Wheel nsf
Scratched
Over 50mm

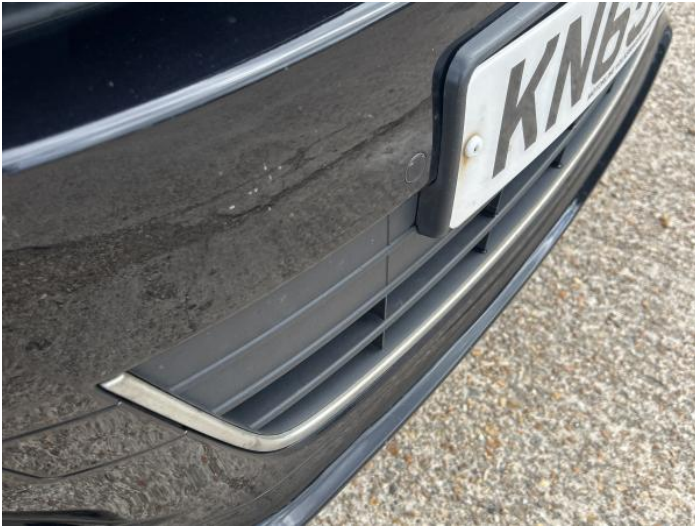
15: Bumper Front
Chipped
Multiple Chips

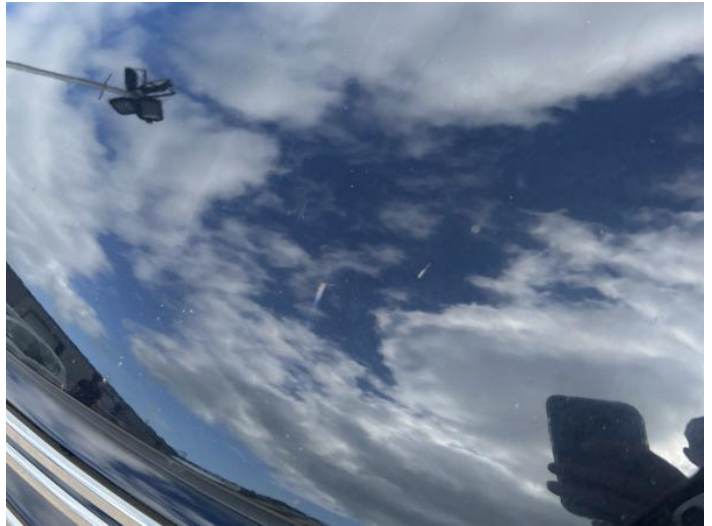
16: Bonnet
Chipped
1 To 5

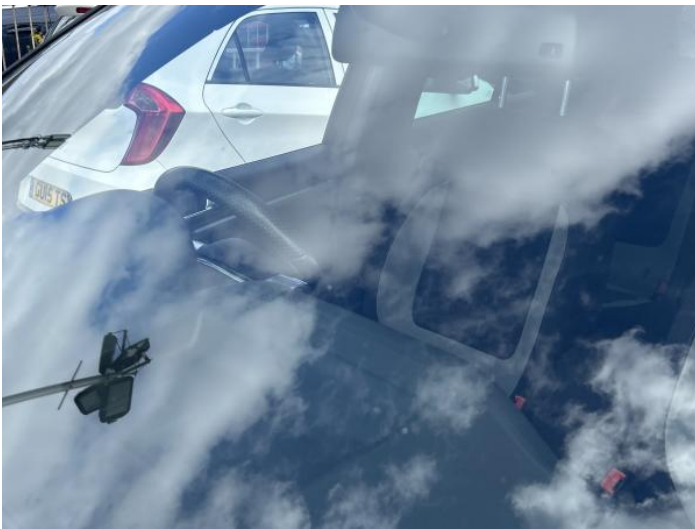
17: Screen Front
Chipped
Up To 10mm

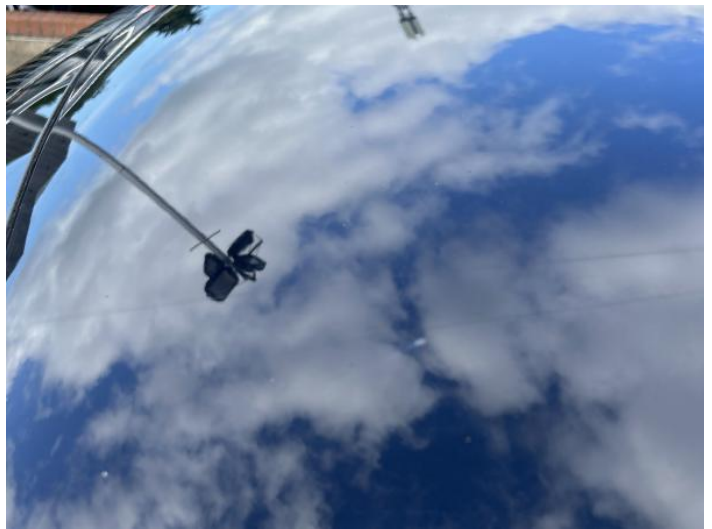
18: Roof
Chipped
1 To 5
