VEHICLE INSPECTION REPORT

EA13BYF

Ford Galaxy 2.0 TDCi 163 Titanium X 5dr

nama
GRADE
5

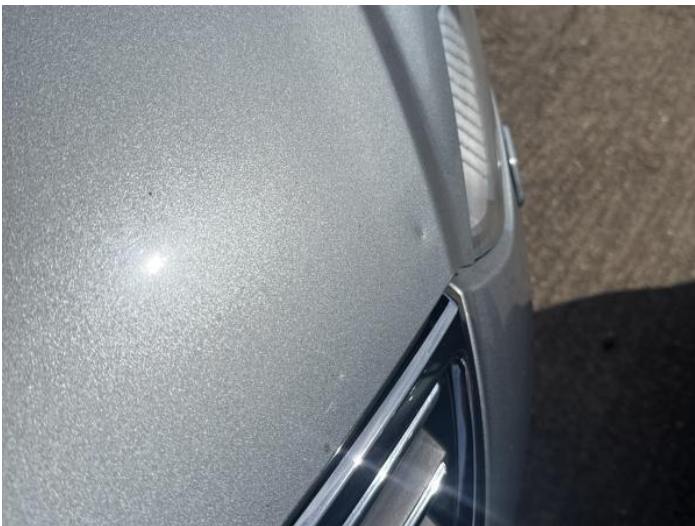
1: Bonnet
Dented
Between 10mm + 30mm

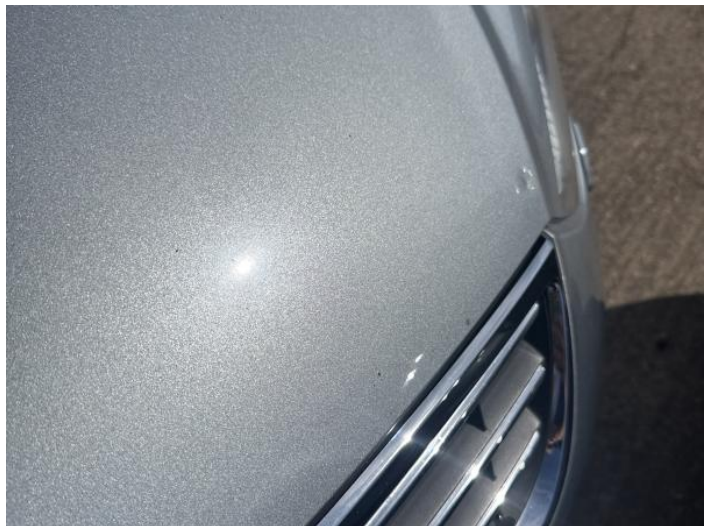
2: Bonnet
Chipped
1 To 5

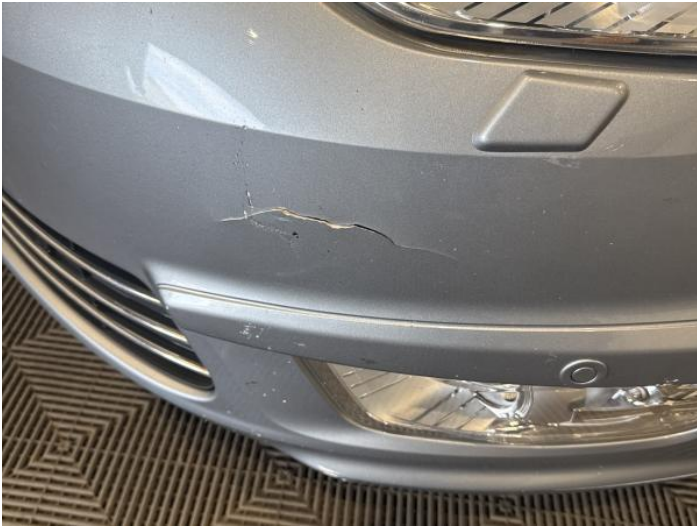
3: Bumper Front
Cracked
Over 25mm

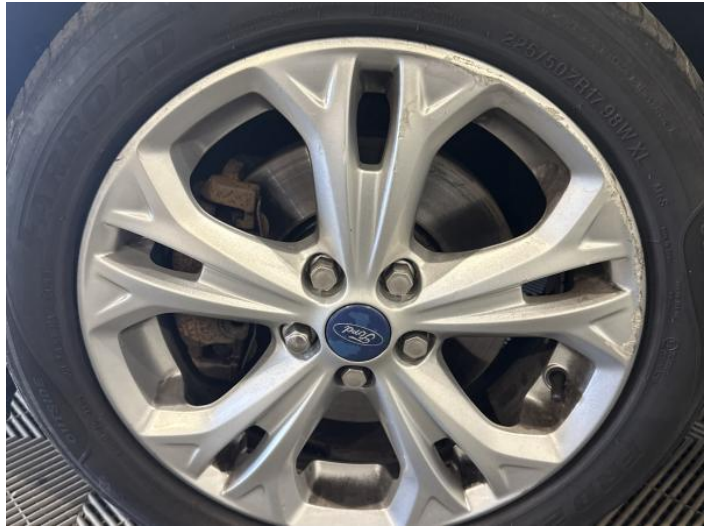
4: Wheel nsf
Scratched
Over 50mm

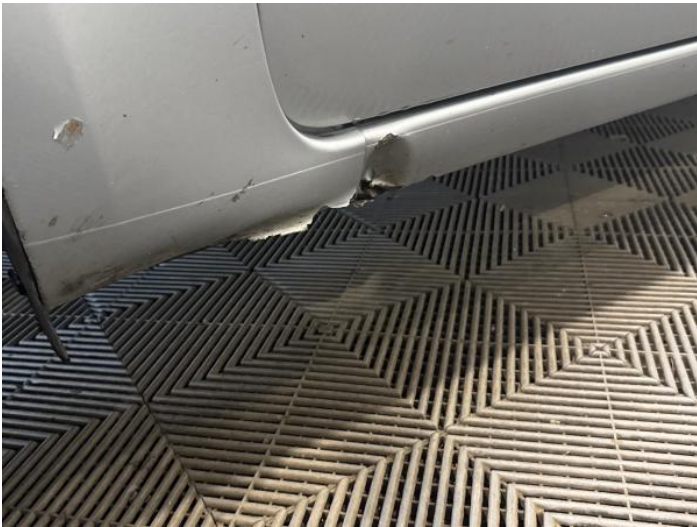
5: Sill ns
Dented
With Paint Damage

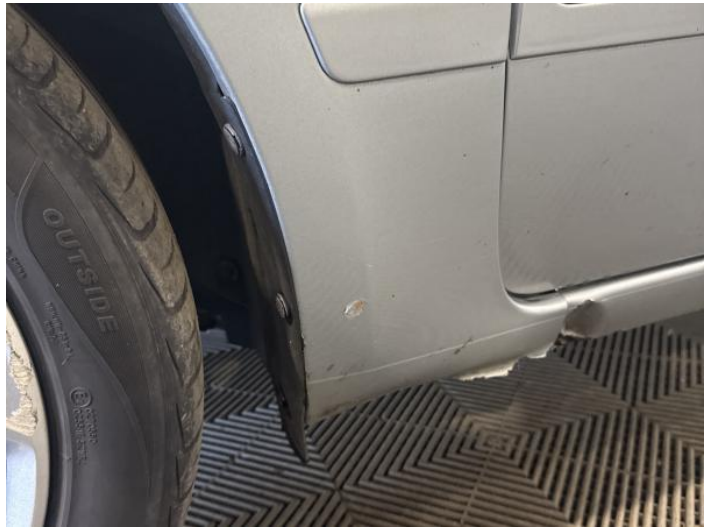
6: Wing nsf
Scratched
Rusted

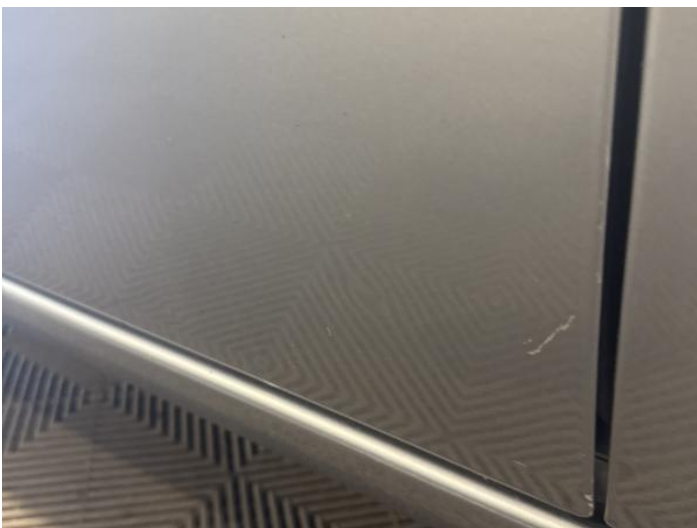
7: Door nsf
Scratched
Over 25mm Thru Paint

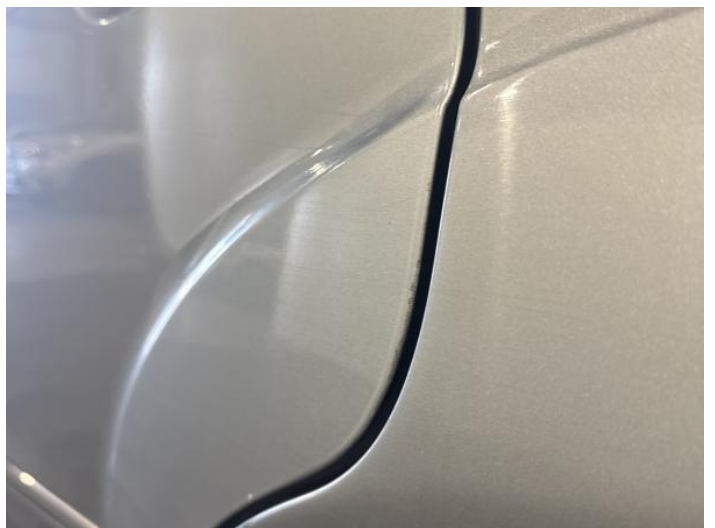
8: Door nsr
Chipped
Edge Chip

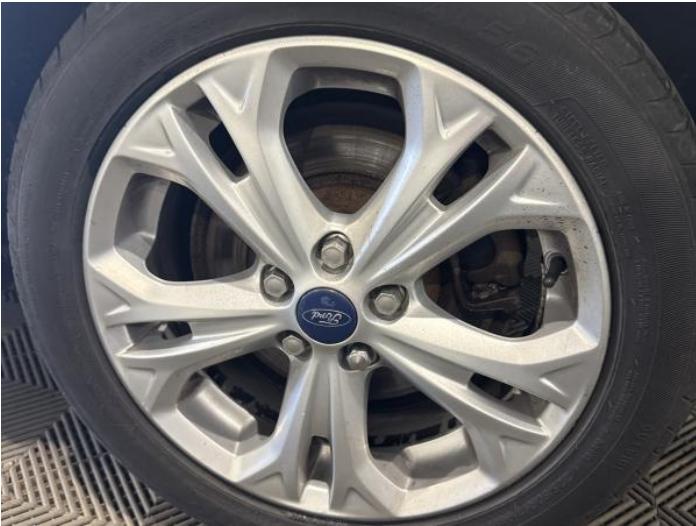
9: Wheel osr
Scratched
Up To 50mm

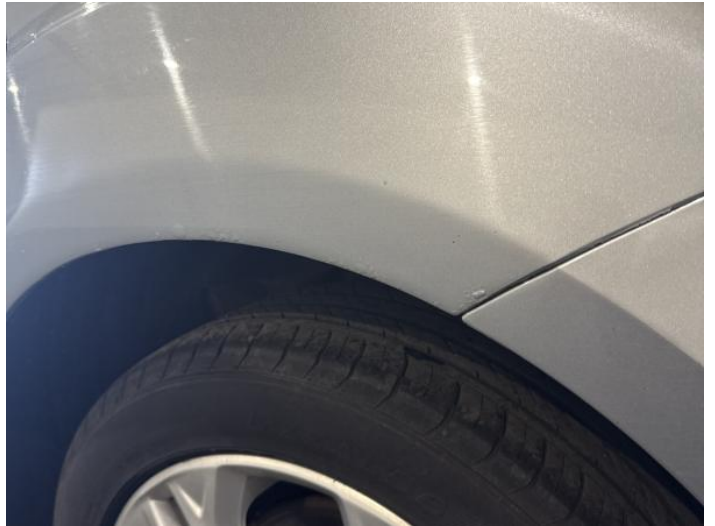
10: Qtr Panel nsr
Rusted
Over 5mm

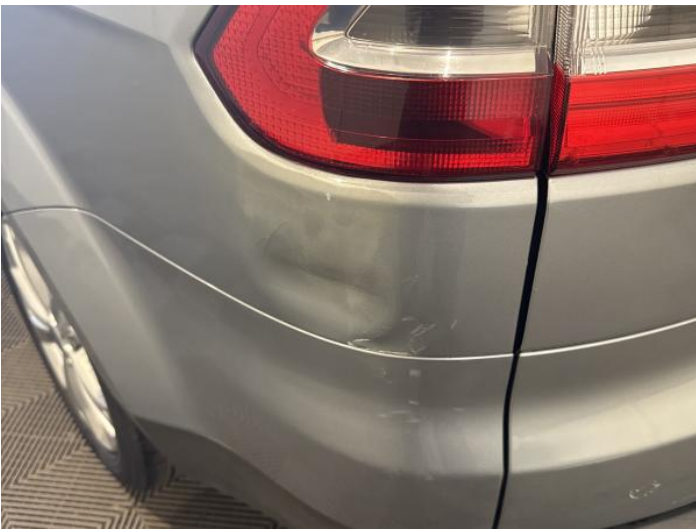
11: Qtr Panel nsr
Dented
With Paint Damage

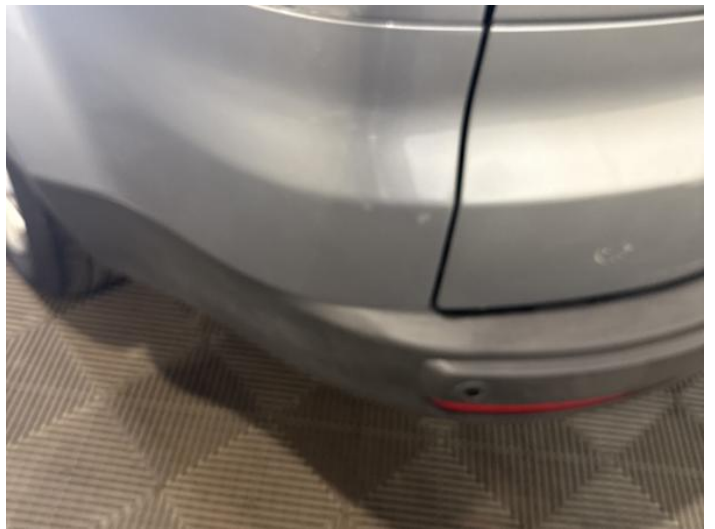
12: Bumper Rear
Scratched
Over 100mm Thru Paint

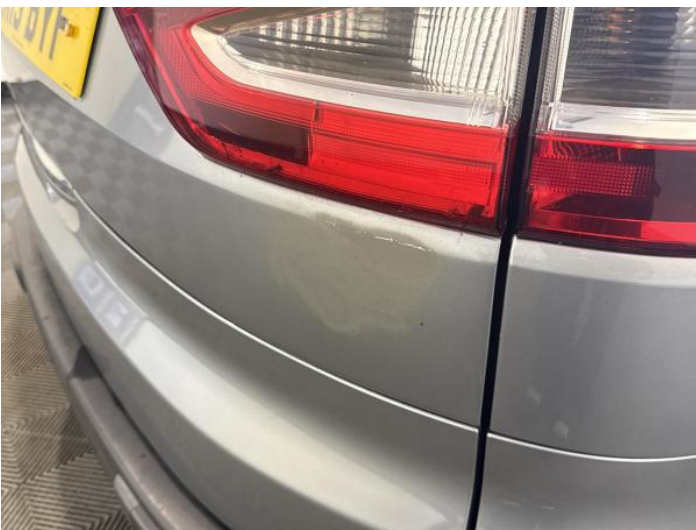
13: Tailgate
Dented
With Paint Damage

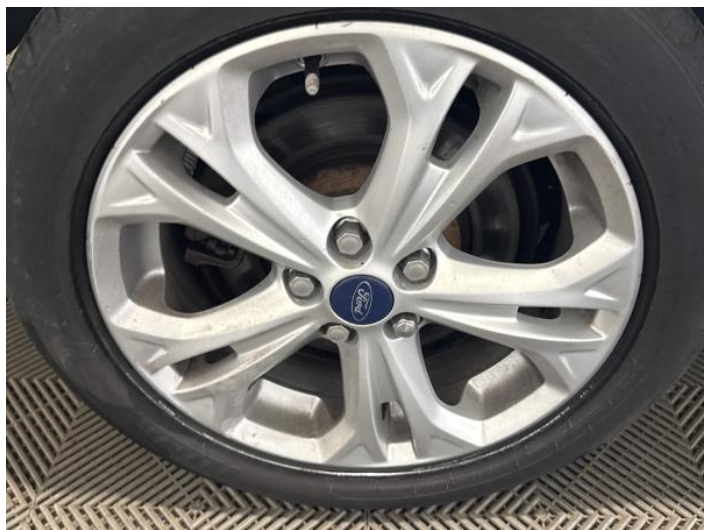
14: Wheel osr
Scratched
Up To 50mm

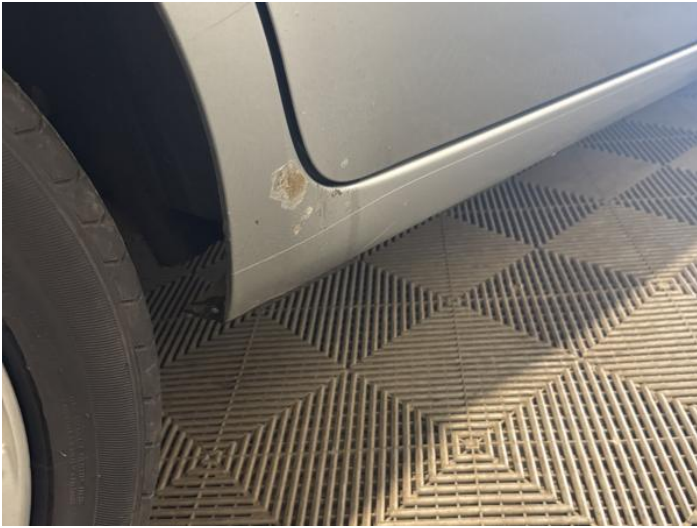
15: Qtr Panel osr
Scratched
Rusted

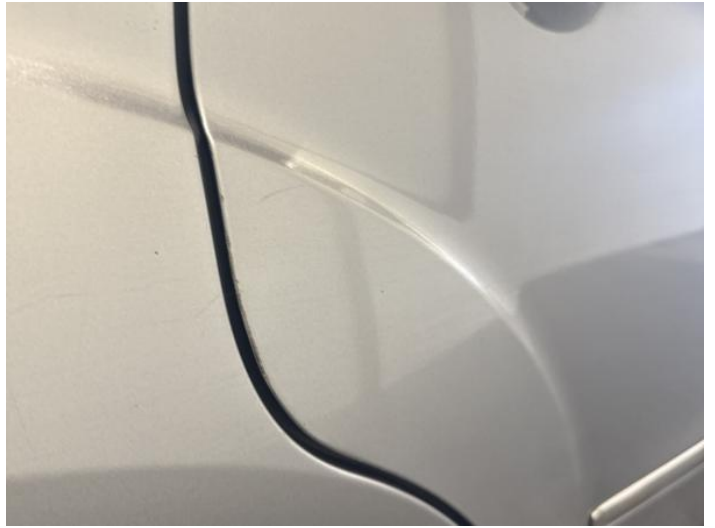
16: Door osr
Chipped
Edge Chip

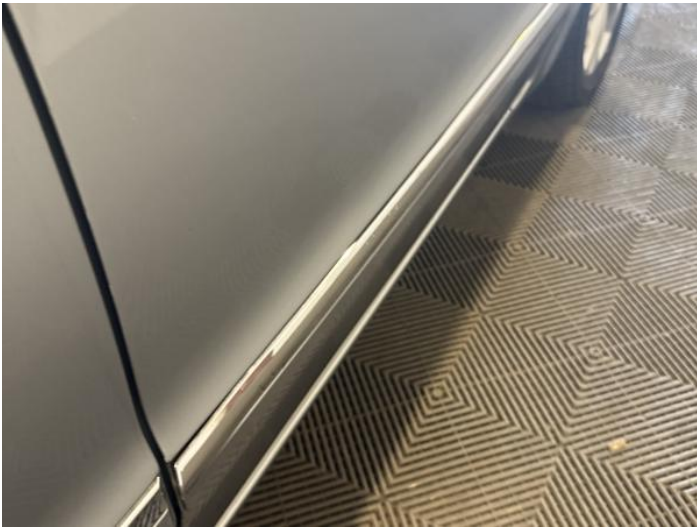
17: Door osf
Scratched
Over 25mm Thru Paint

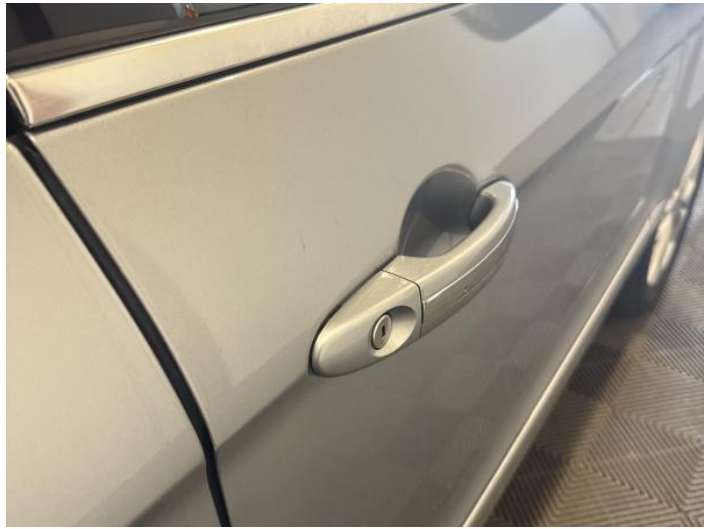
18: Door osf
Dented
Between 10mm + 30mm

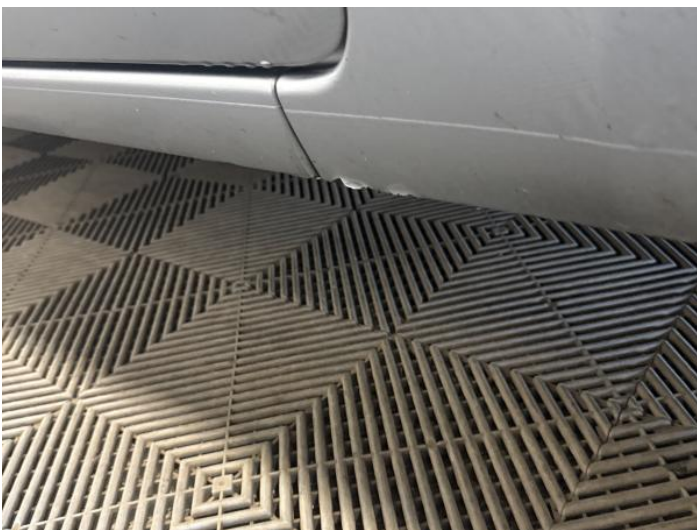
19: Sill os
Rusted
Over 5mm

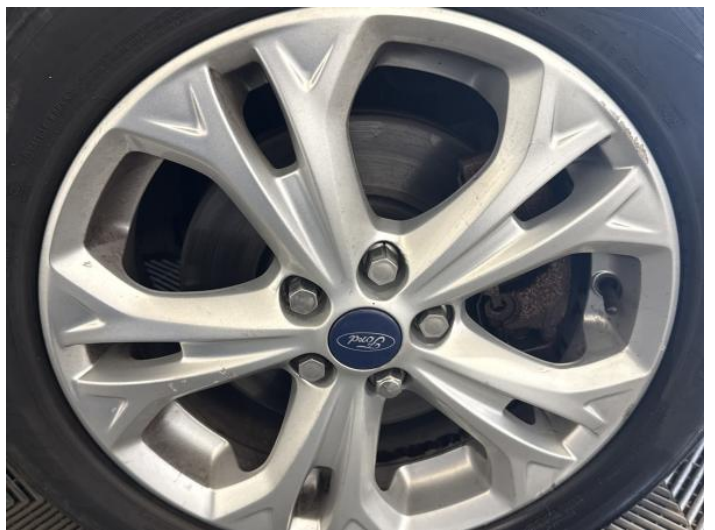
20: Wheel osf
Scratched
Over 50mm

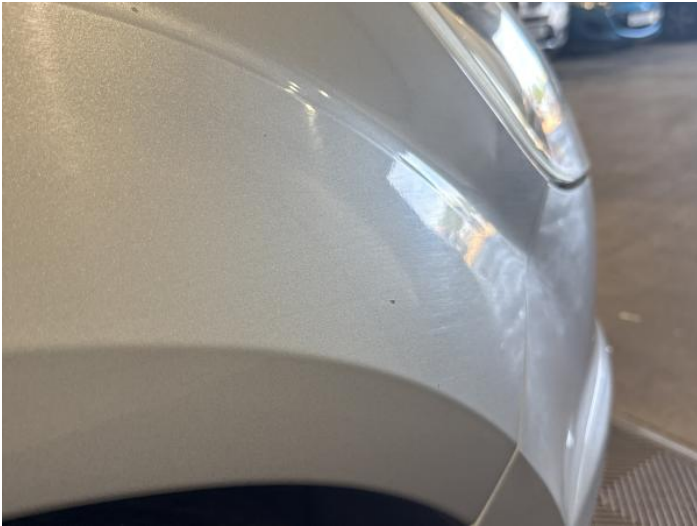
21: Wing osf
Chipped
1 To 5

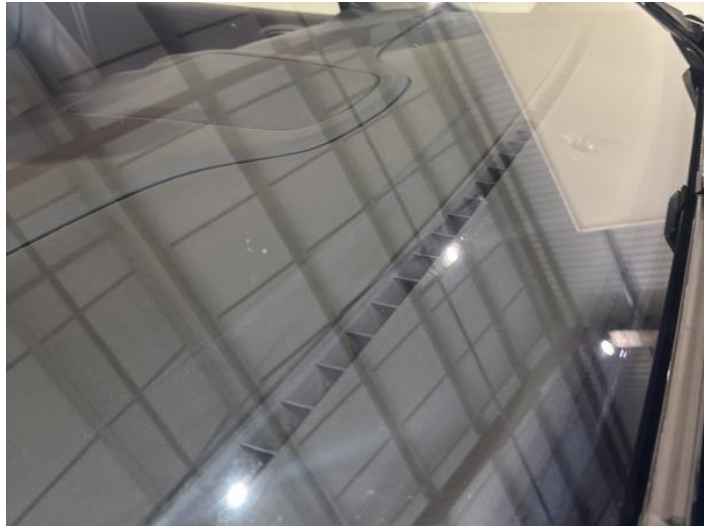
22: Screen Front
Chipped
UpTo 10mm

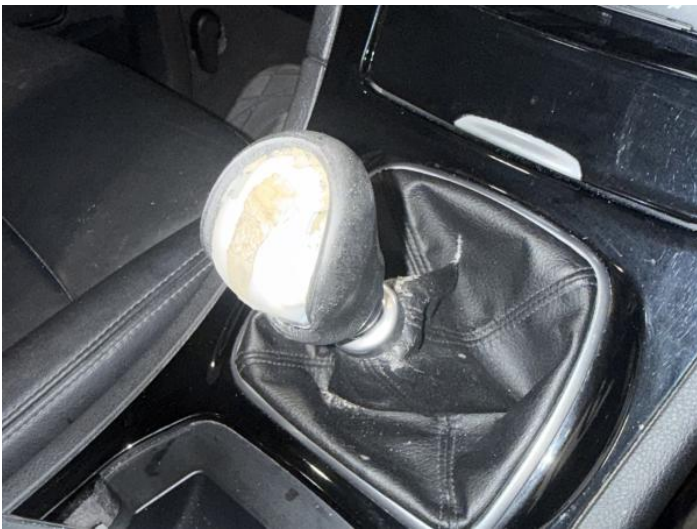
23: Switches And Controls
Broken
Replace

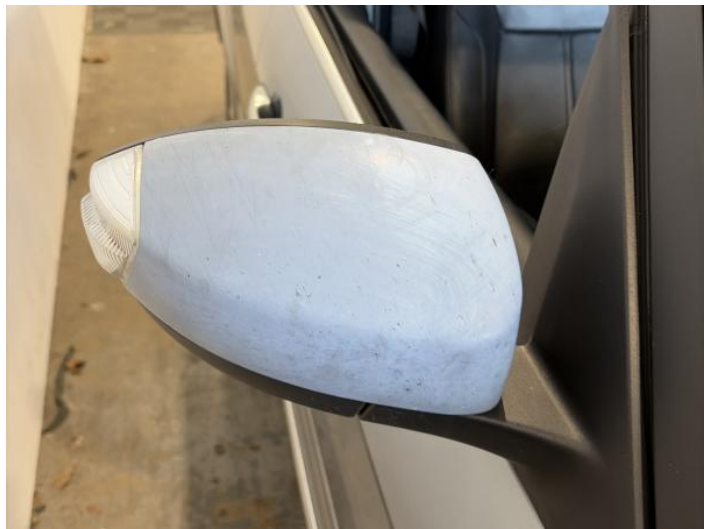
24: Door Mirror Assy osf
Scratched (Painted)
Over 25mm Thru Paint
