# VEHICLE INSPECTION REPORT

**GK16DXO**

## Volkswagen Passat 2.0 TDI S 5dr DSG

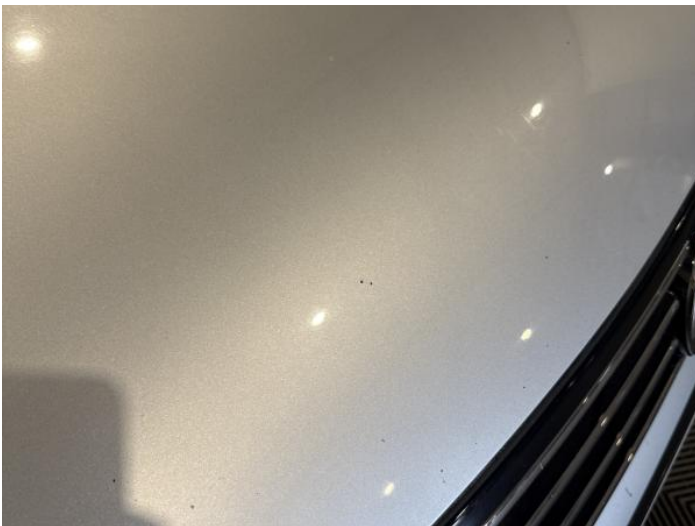
1: Bonnet  
Chipped  
Multiple Chips

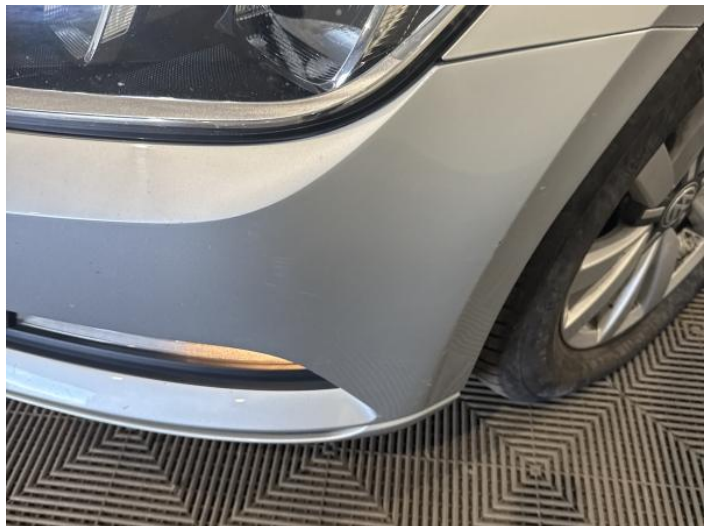
2: Bumper Front  
Scratched  
25 to 100mm Thru Paint

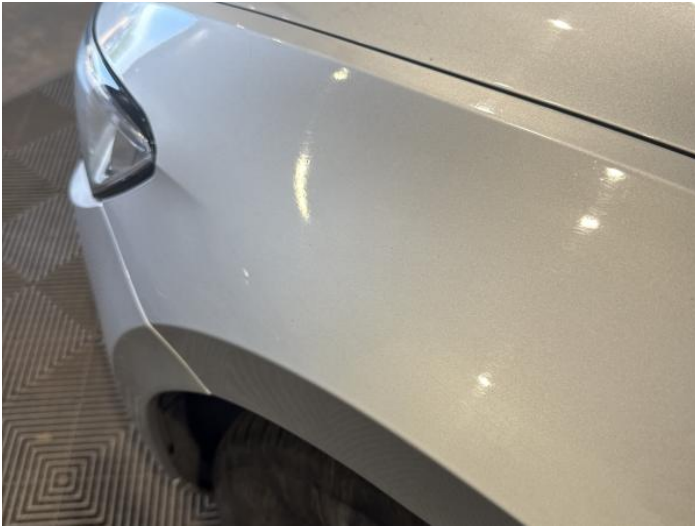
3: Wing nsf  
Poor Previous Repair  
Poor Paint

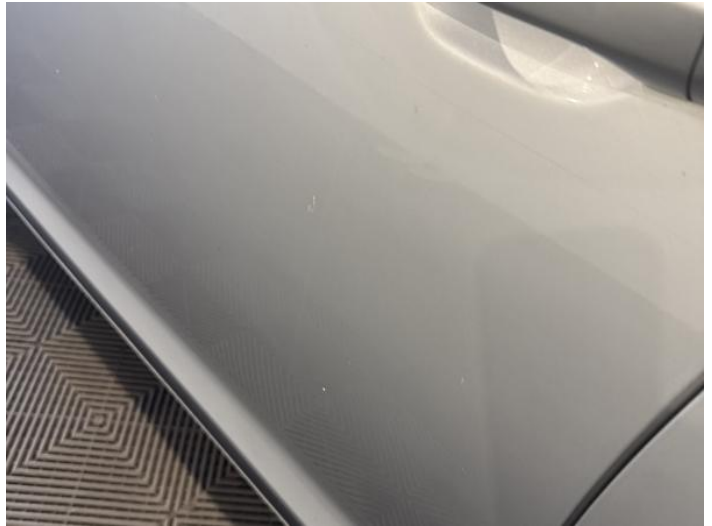
4: Door nsf  
Scratched  
Over 25mm Thru Paint

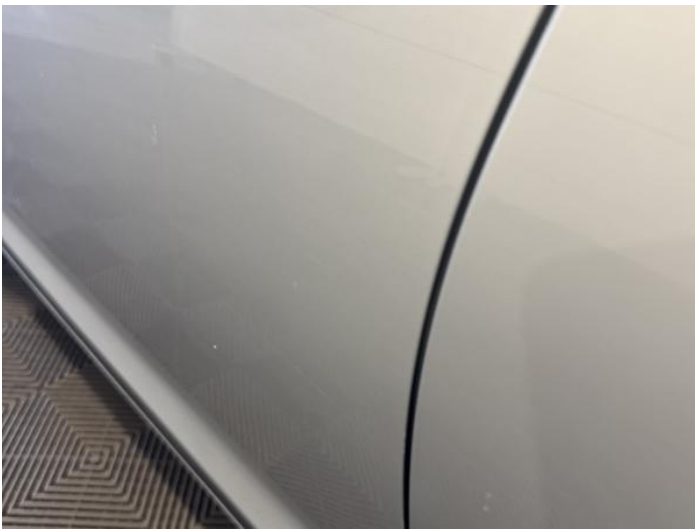
5: Door nsf  
Dented  
Over 30mm

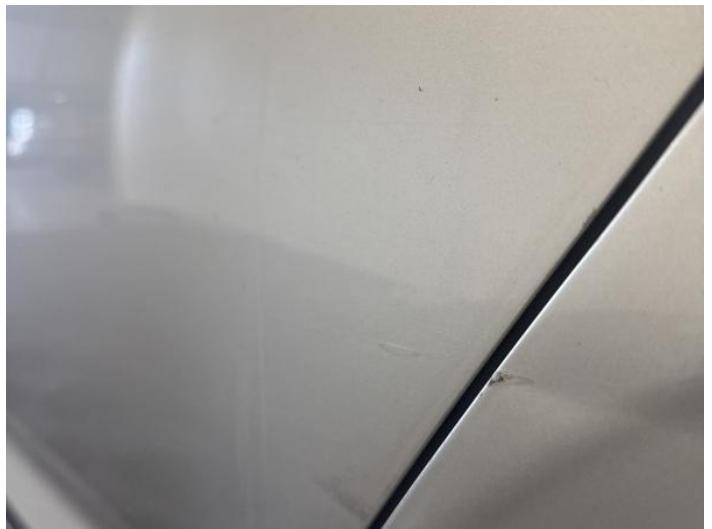
6: Door nsr  
Scratched  
Over 25mm Thru Paint

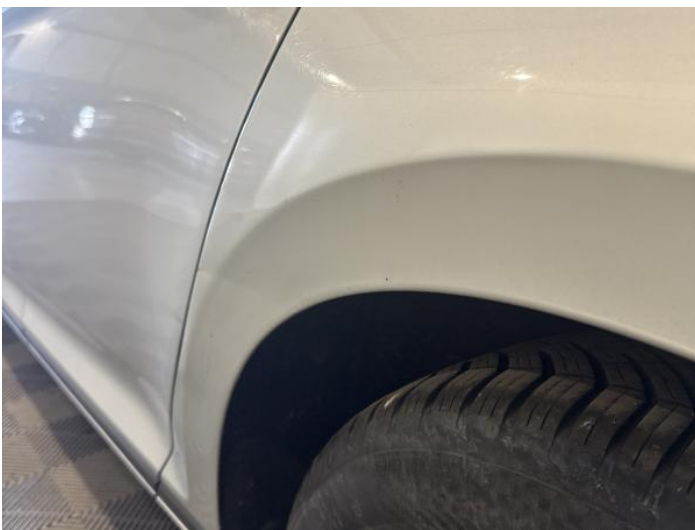
7: Qtr Panel nsr  
Dented  
With Paint Damage

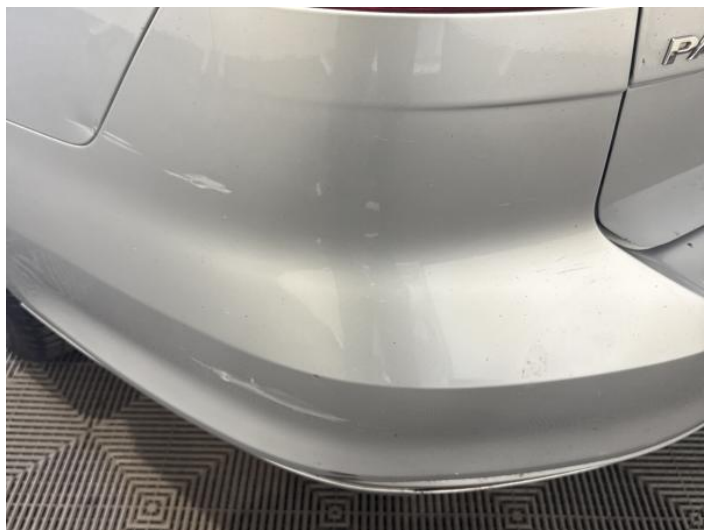
8: Bumper Rear  
Scratched  
25 to 100mm Thru Paint

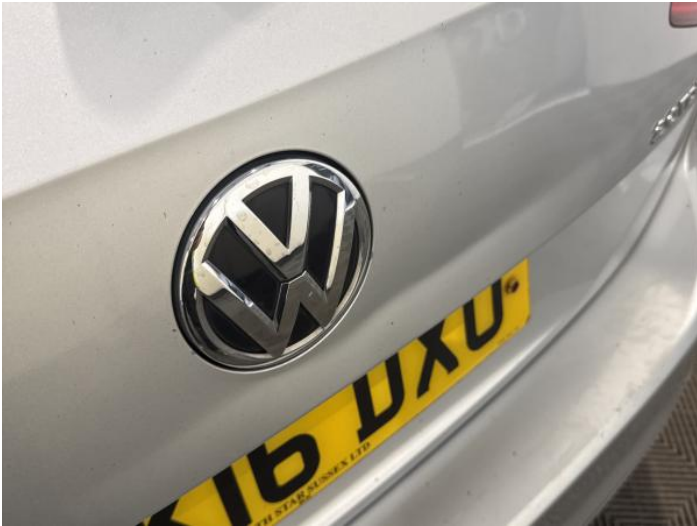
9: Tailgate  
Dented  
Over 30mm

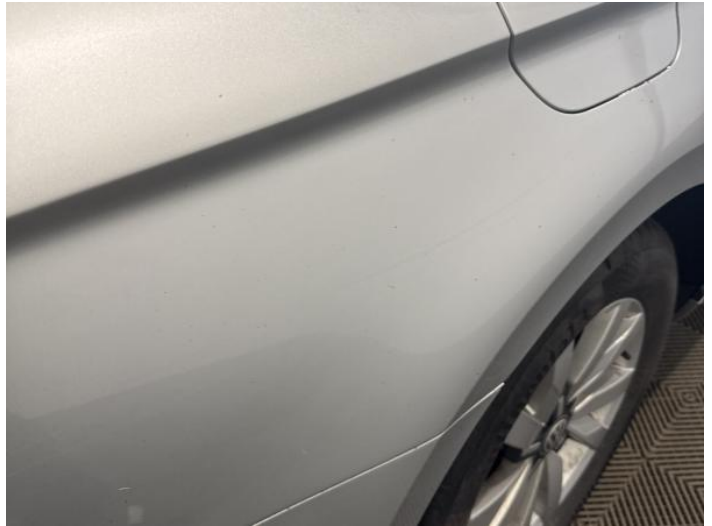
10: Qtr Panel osr  
Scratched  
Over 25mm Thru Paint

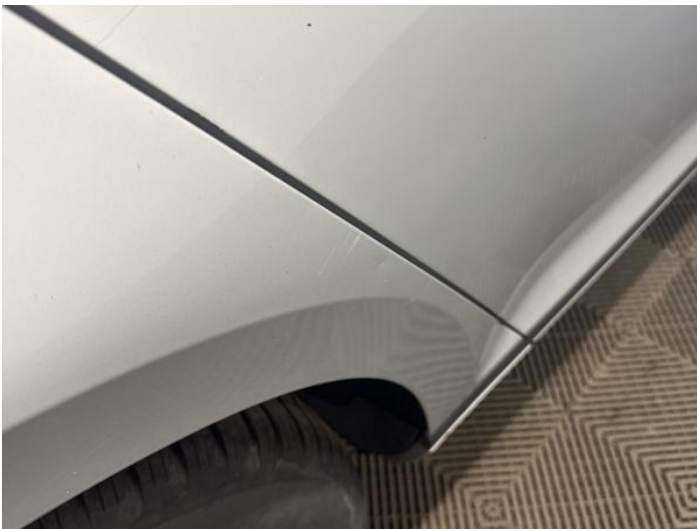
11: Qtr Panel osr  
Dented  
Between 10mm + 30mm

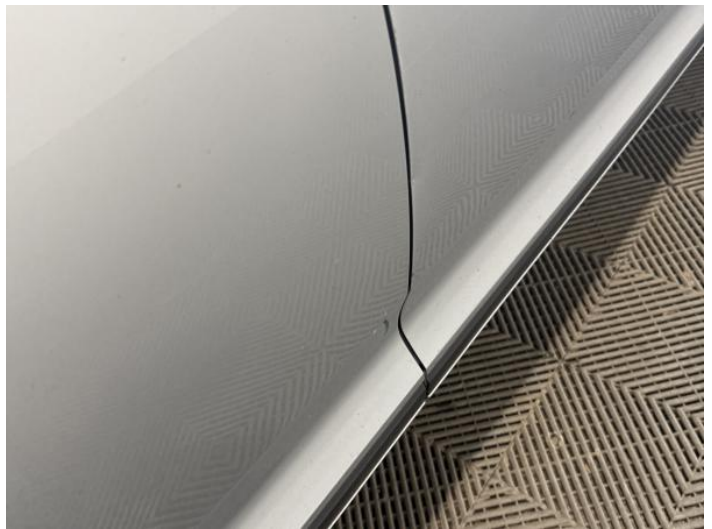
12: Door osr  
Chipped  
1 To 5

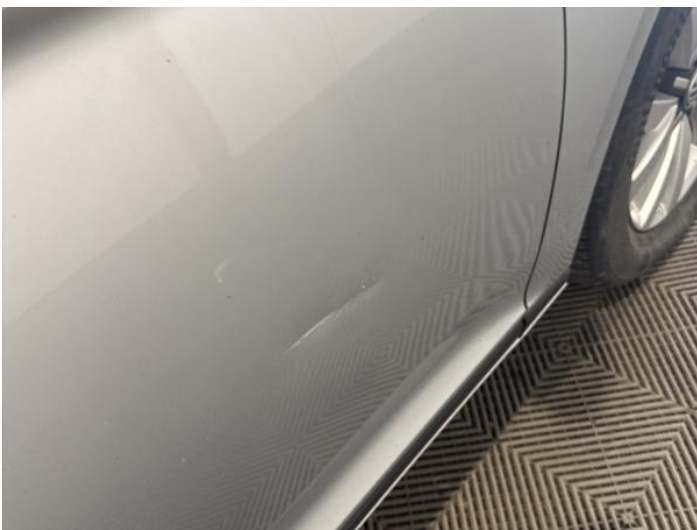
13: Door osf  
Dented  
With Paint Damage

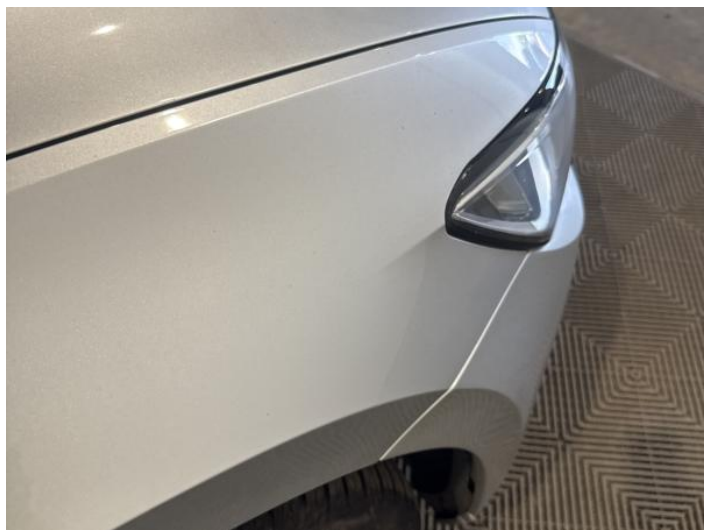
14: Wing osf  
Chipped  
1 To 5

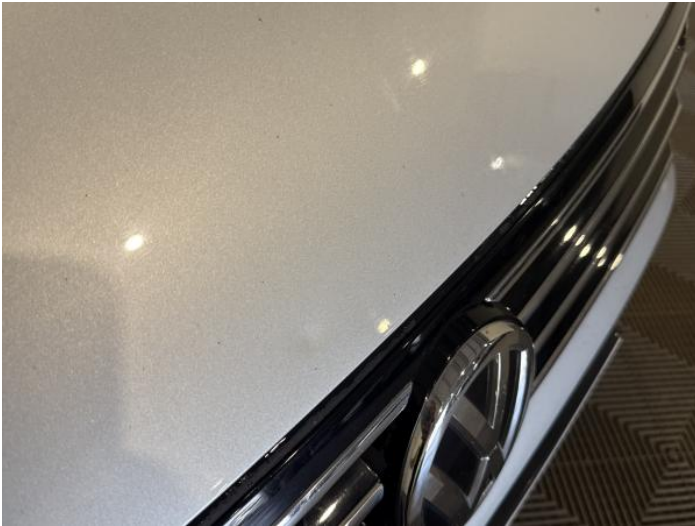
15: Bonnet  
Dented  
Between 10mm + 30mm
