# VEHICLE INSPECTION REPORT

**WM14VTO**

## Fiat 500 1.2 S 3dr

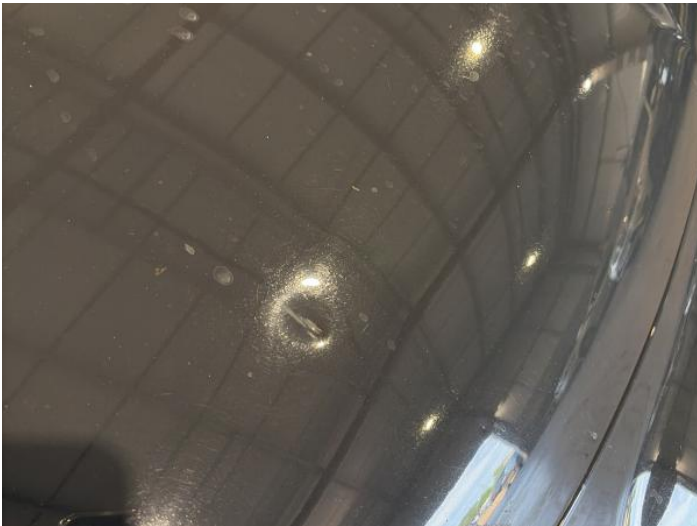
1: Bonnet  
Dented  
With Paint Damage

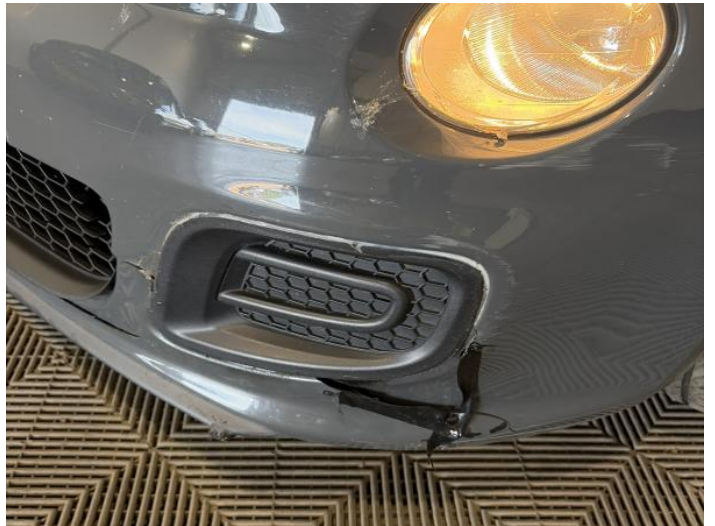
2: Bumper Front  
Cracked  
Over 25mm

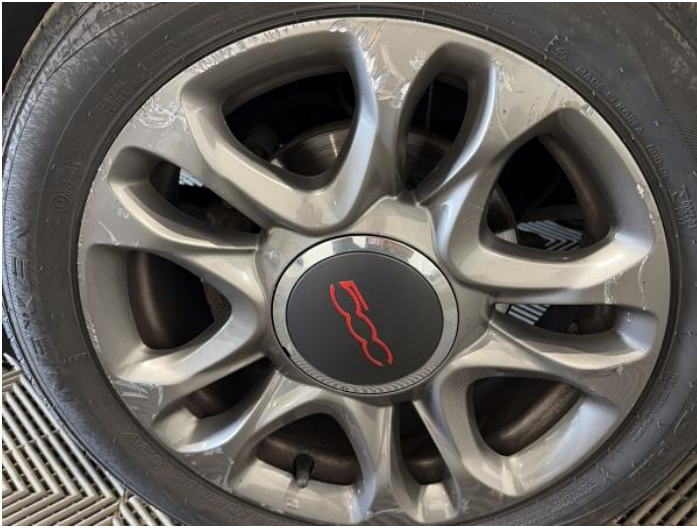
3: Wheel nsf  
Scratched  
Over 50mm

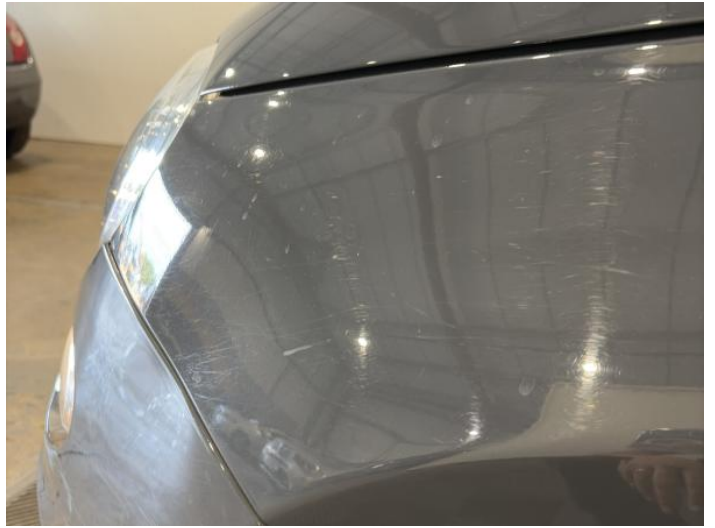
4: Wing nsf  
Scratched  
UpTo 25mm Thru Paint

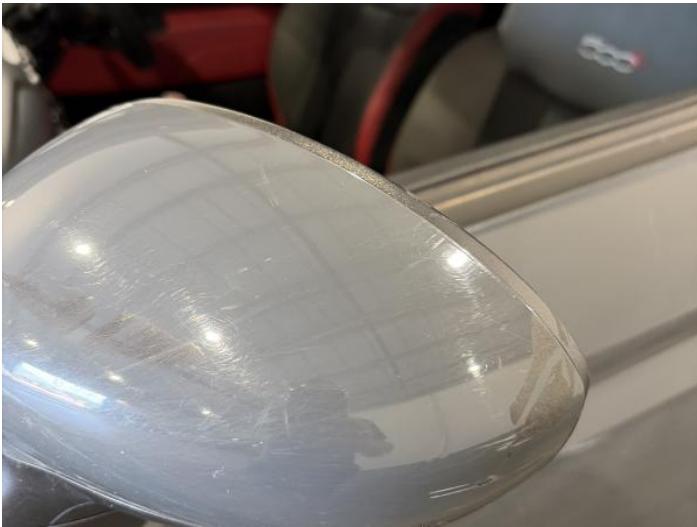
5: Door Mirror Assy osf  
Scratched (Painted)  
Over 25mm Thru Paint

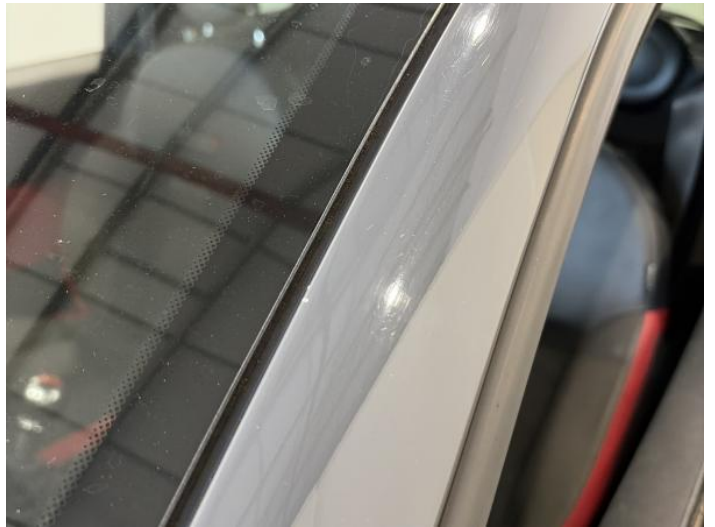
6: A Post ns  
Chipped  
1 To 5

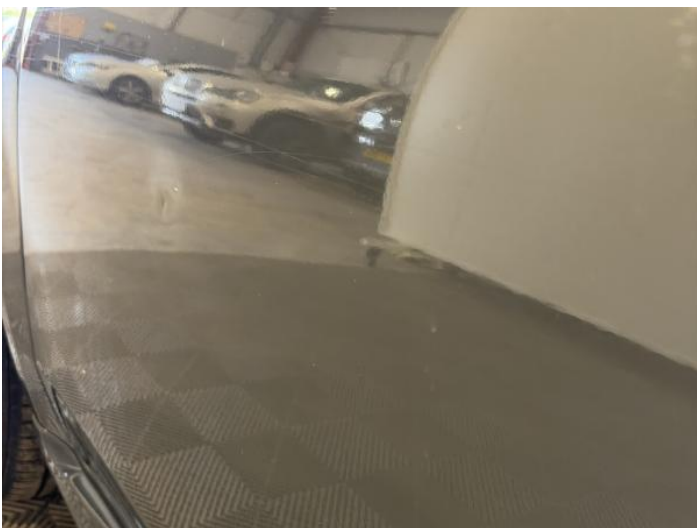
7: Door nsf  
Dented  
Over 30mm

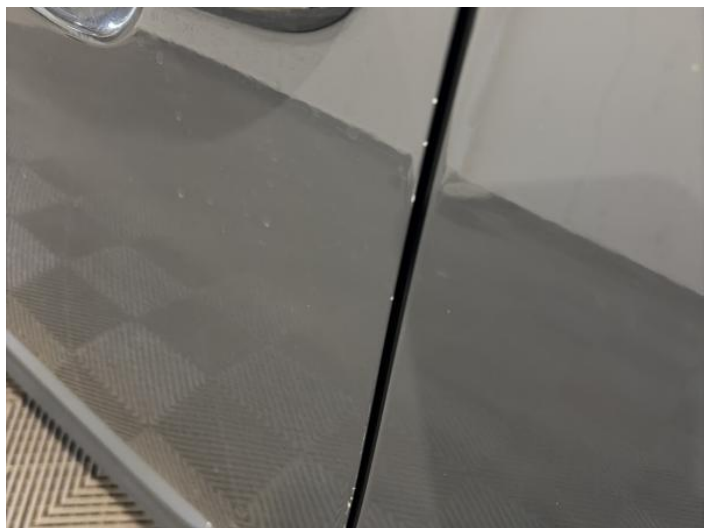
8: Door nsf  
Chipped  
Edge Chip

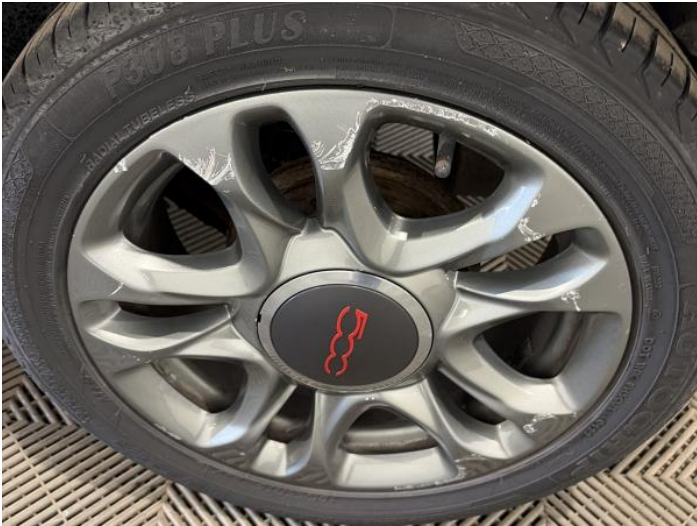
9: Wheel nsr  
Scratched  
Over 50mm

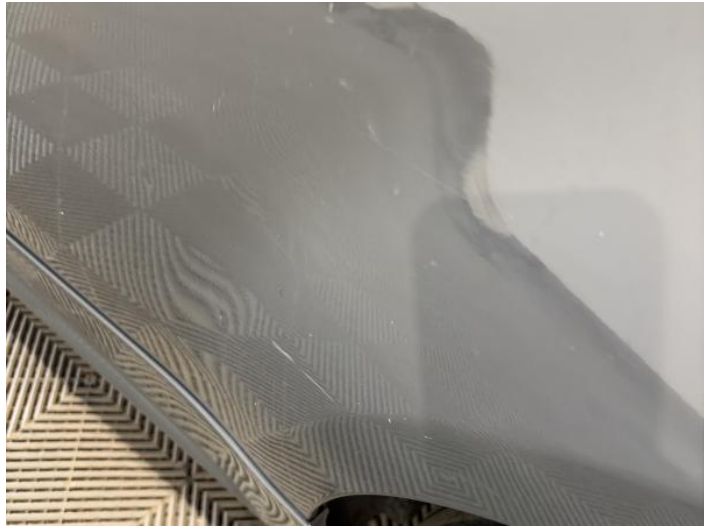
10: Qtr Panel nsr  
Scratched  
Over 25mm Thru Paint

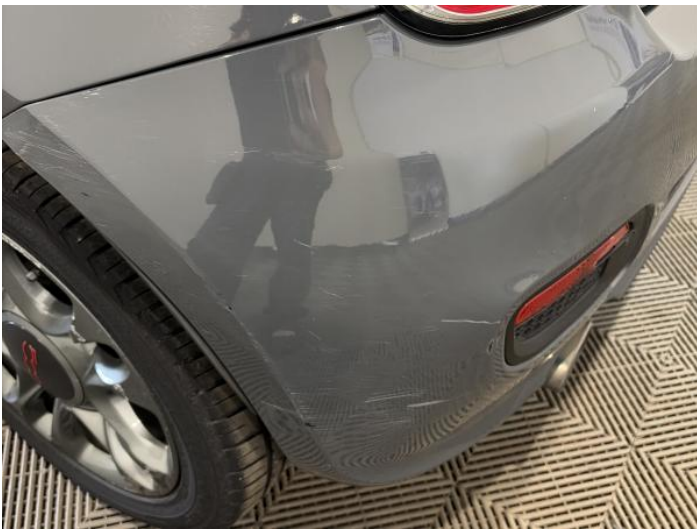
11: Bumper Rear  
Scratched  
Over 100mm Thru Paint

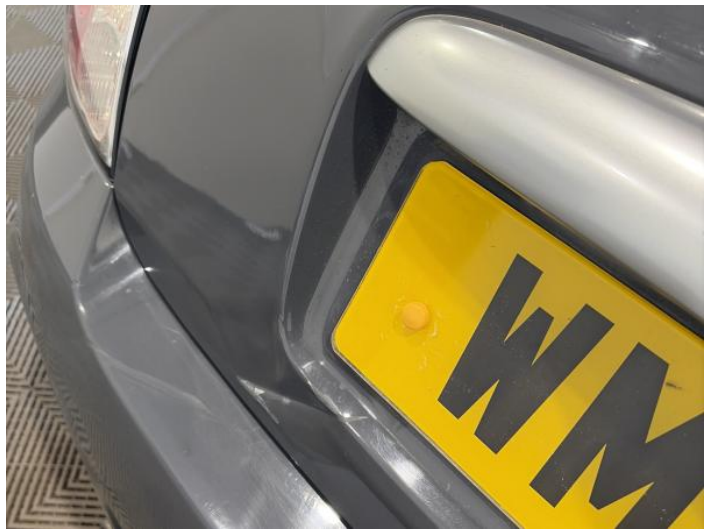
12: Tailgate  
Dented  
With Paint Damage

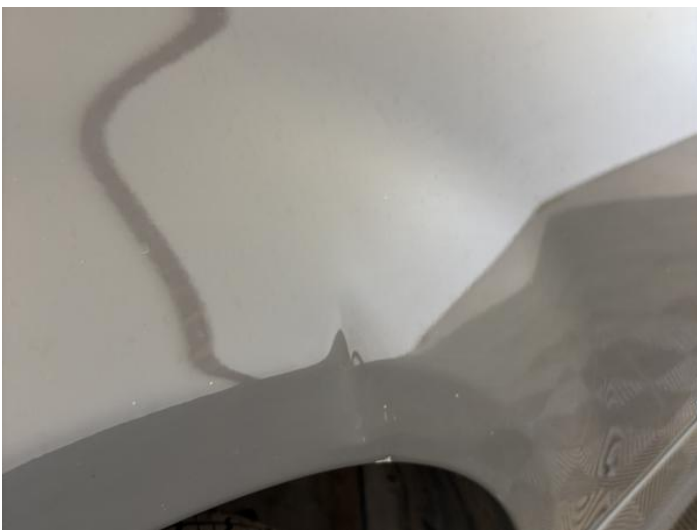
13: Qtr Panel osr  
Dented  
With Paint Damage

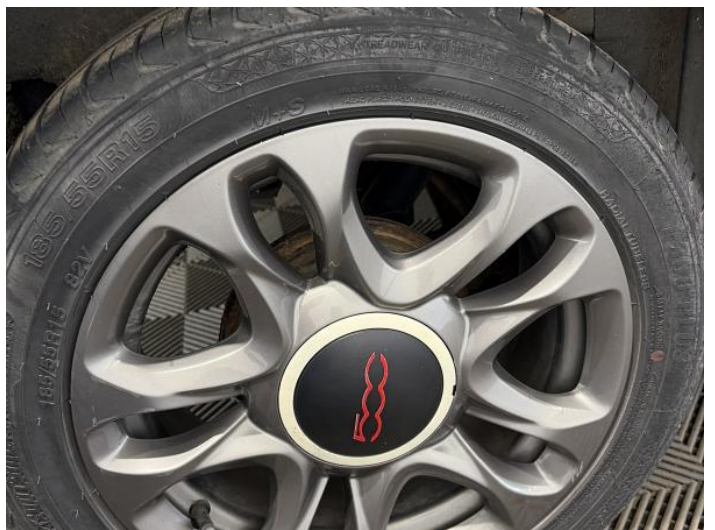
14: Wheel osr  
Scratched  
Over 50mm

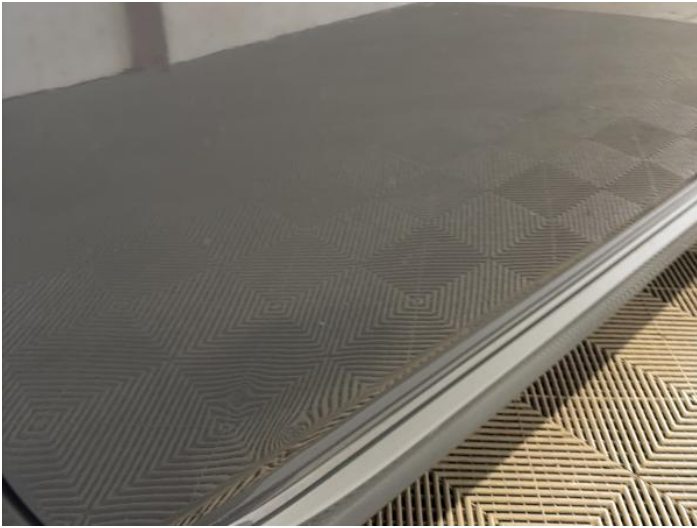
15: Door osf  
Dented  
Over 30mm

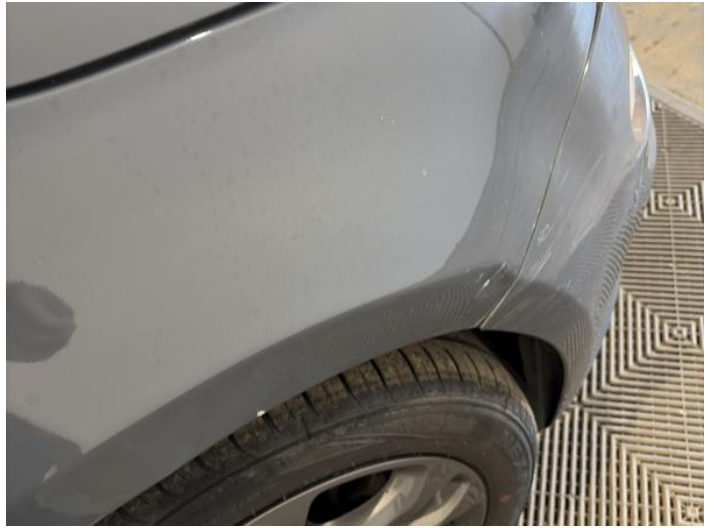
16: Wing osf  
Dented  
With Paint Damage

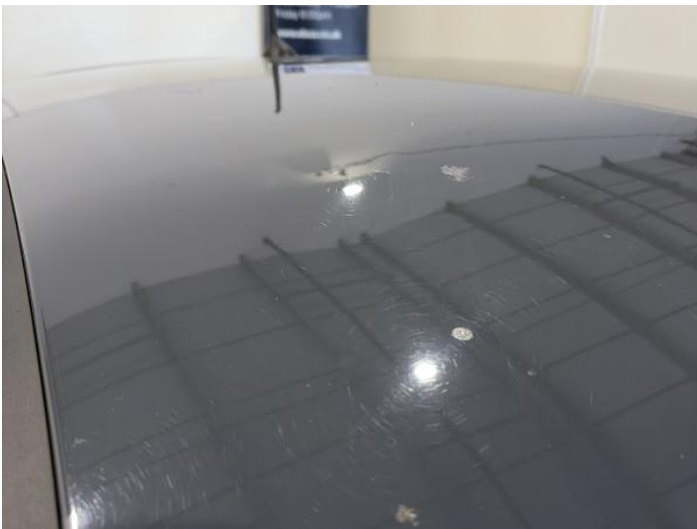
17: Roof  
Dented  
Over 30mm

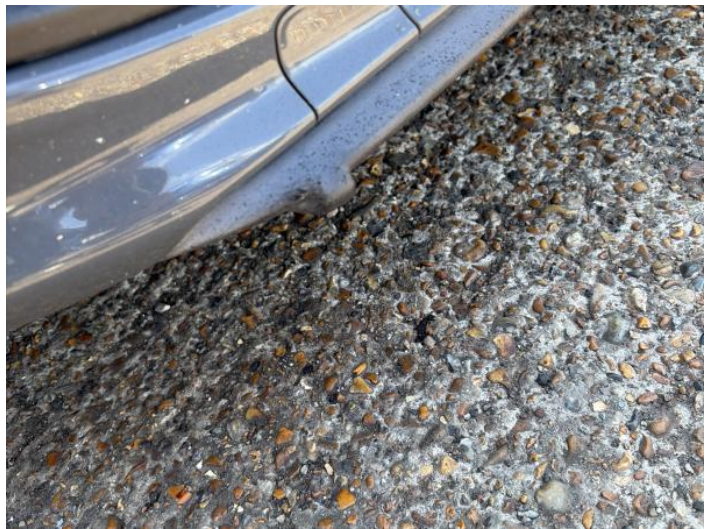
18: Bumper Front Moulding  
Broken  
Replace

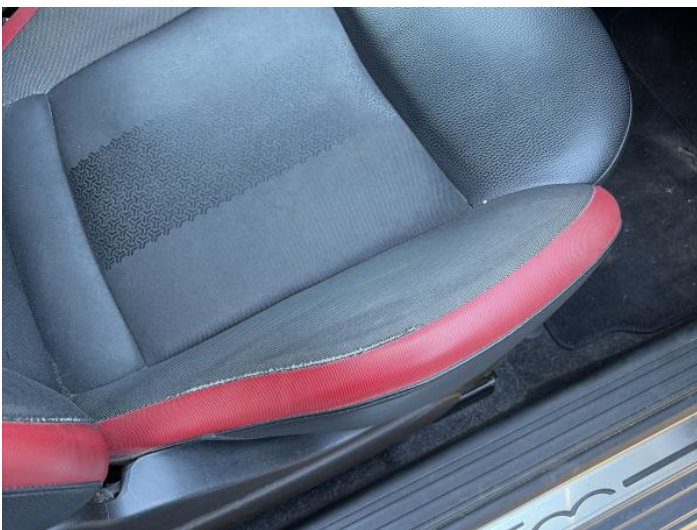
19: Seat Base Cover osf  
Scuffed  
Over 25mm
