VEHICLE INSPECTION REPORT

LW19ACV

Nissan X-Trail 1.3 DiG-T N-Connecta 5dr DCT

nama
GRADE
5

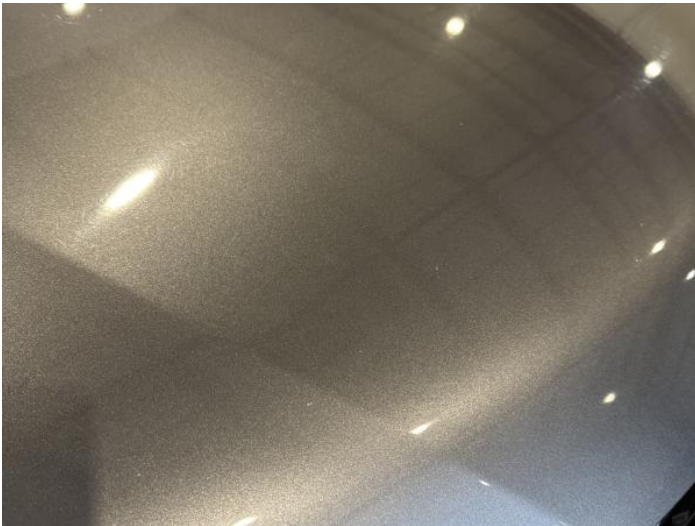
1: Bonnet
Chipped
Multiple Chips

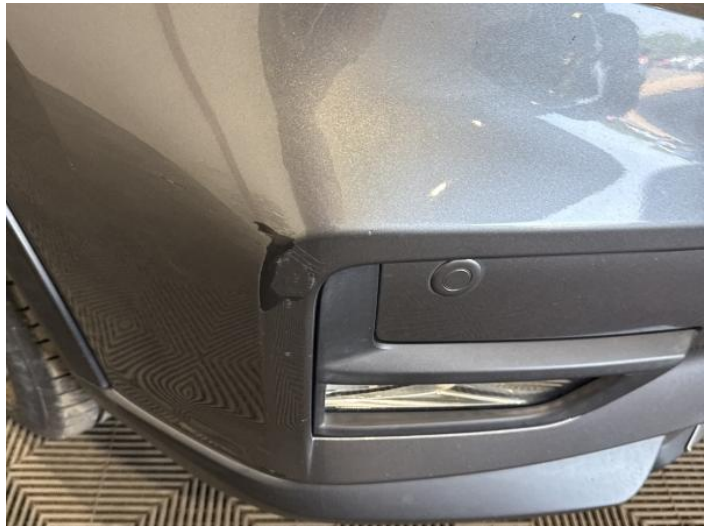
2: Bumper Front
Scratched
Over 100mm Thru Paint

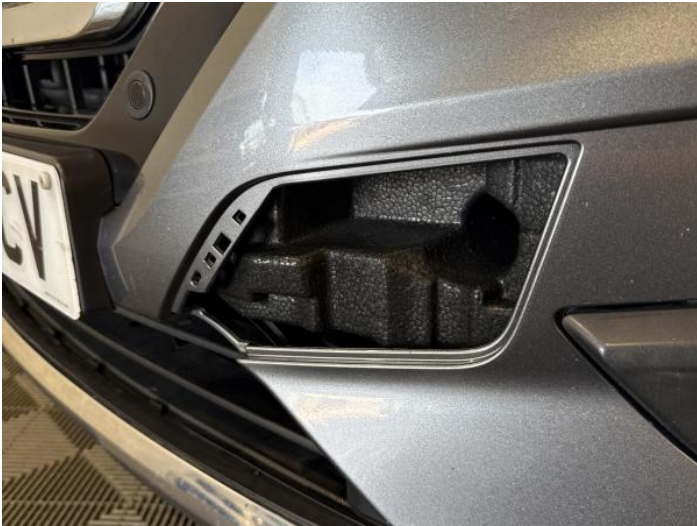
3: Front TowEye Cvr
Missing
Replace

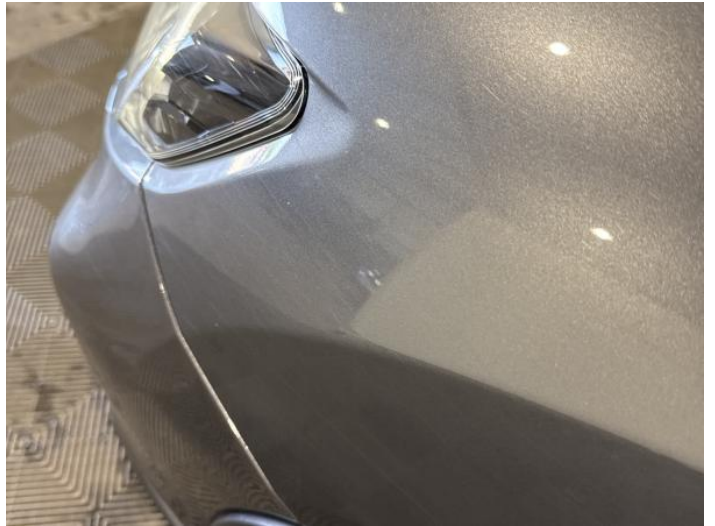
4: Wing nsf
Chipped
1 To 5

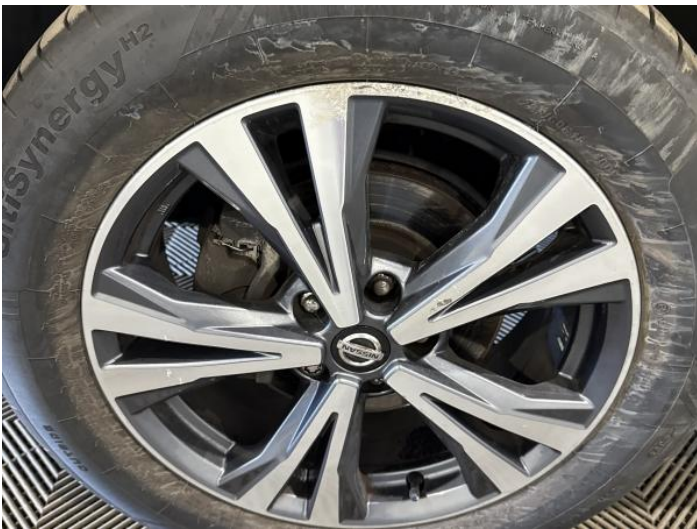
5: Wheel nsf
Scratched
Over 50mm

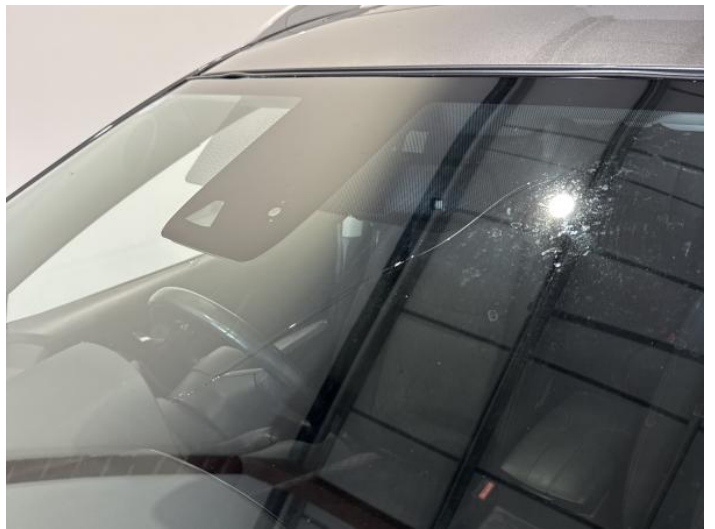
6: Screen Front
Cracked
Replace

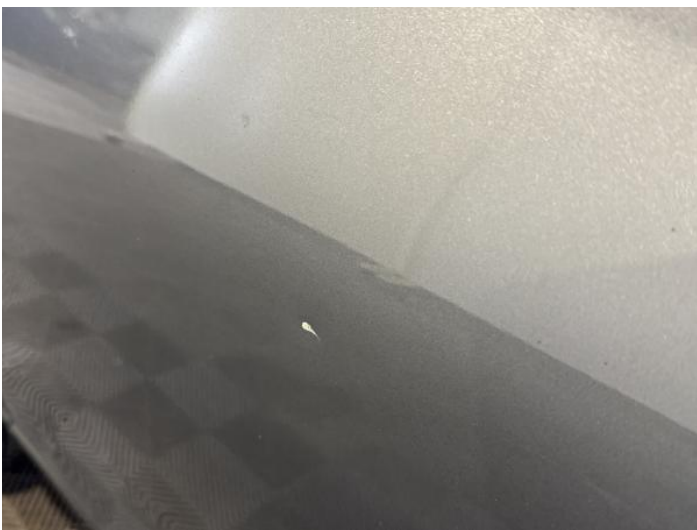
7: Door nsf
Scratched
UpTo 25mm Thru Paint

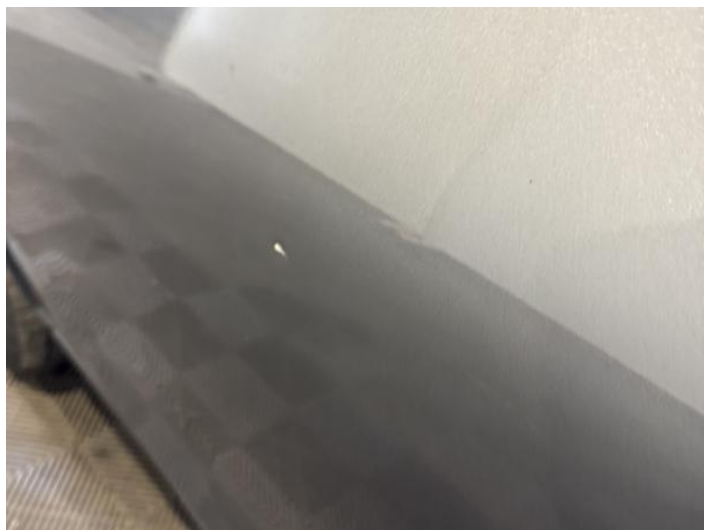
8: Door nsf
Dented
Between 10mm + 30mm

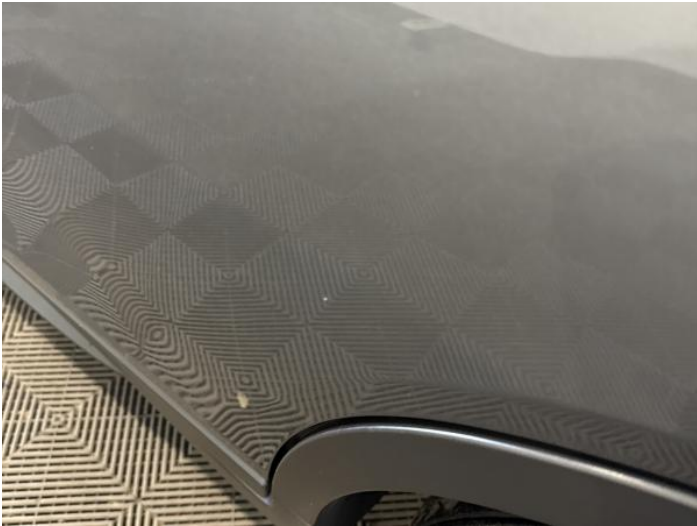
9: Door nsr
Chipped
1 To 5

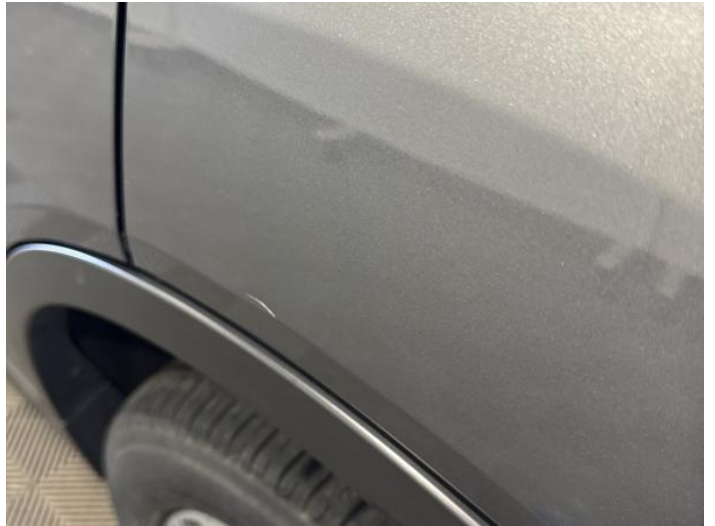
10: Qtr Panel nsr
Scratched
UpTo 25mm Thru Paint

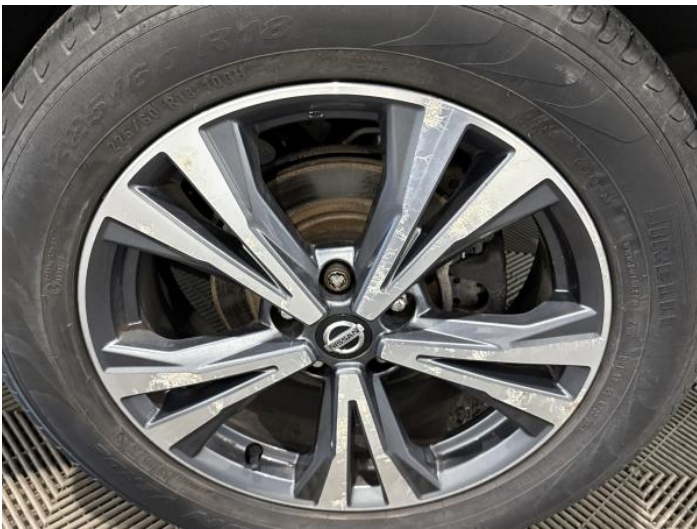
11: Wheel nsr
Scratched
Over 50mm

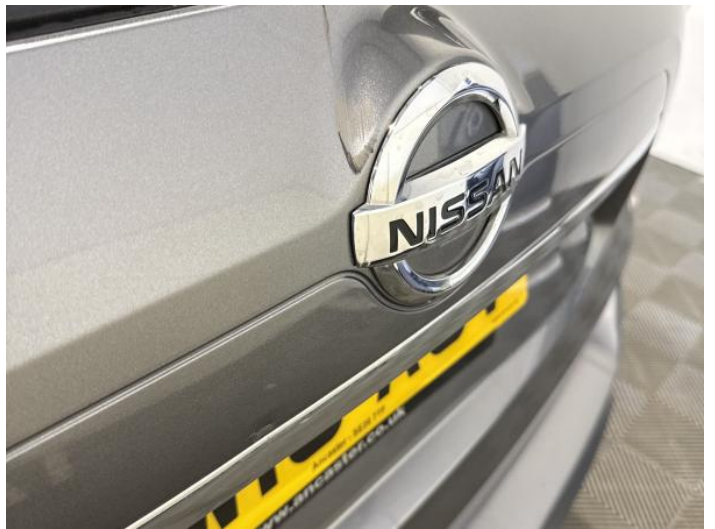
12: Tailgate
Scratched
Over 25mm Thru Paint

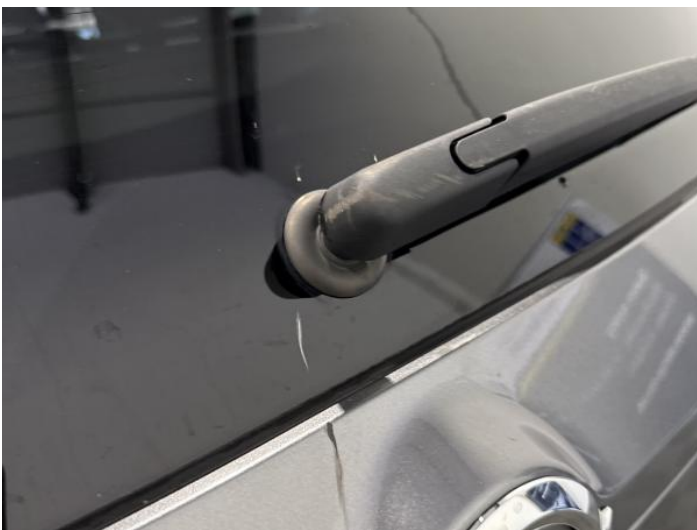
13: Screen Rear
Scratched
UpTo 30mm

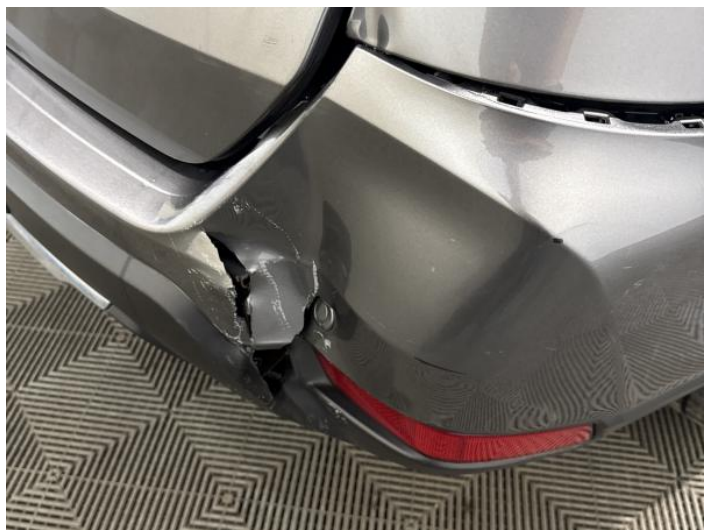
14: Bumper Rear
Cracked
Over 25mm

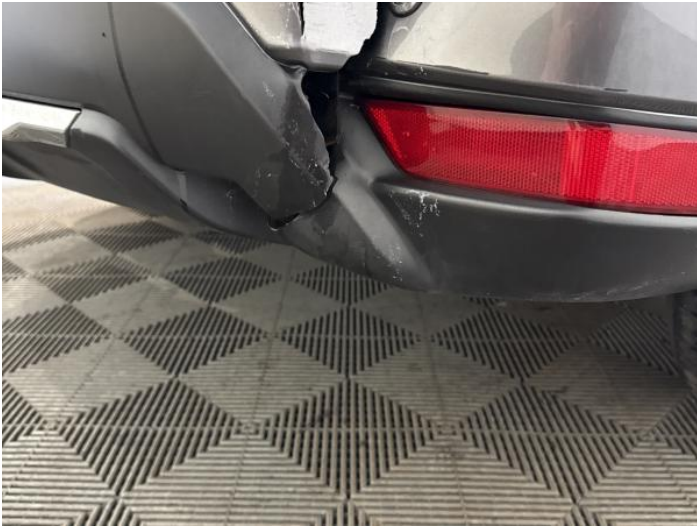
15: Bumper Rear Moulding
Broken
Replace

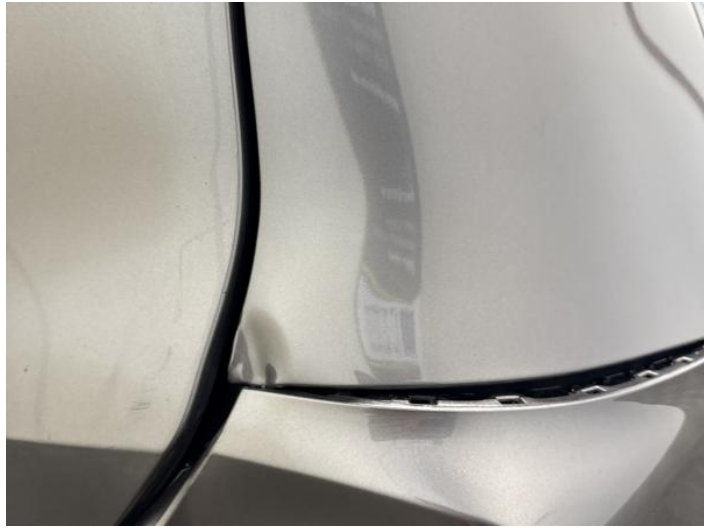
16: Qtr Panel osr
Dented
With Paint Damage

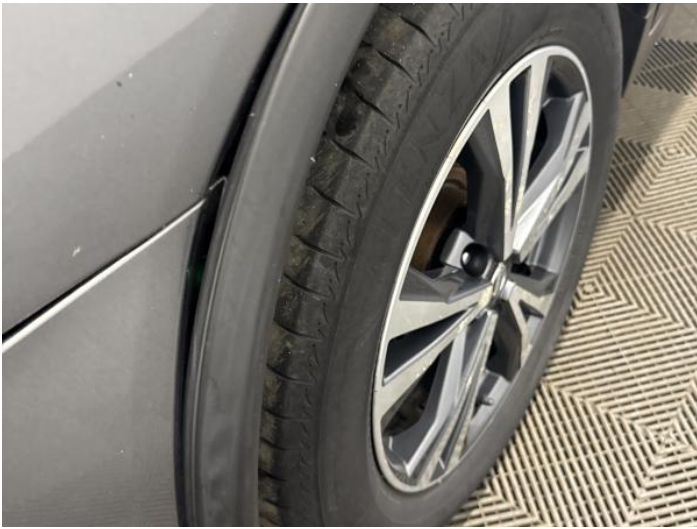
17: Qtr Panel Arch Extension os
Scuffed (Unpainted)
Over 100mm

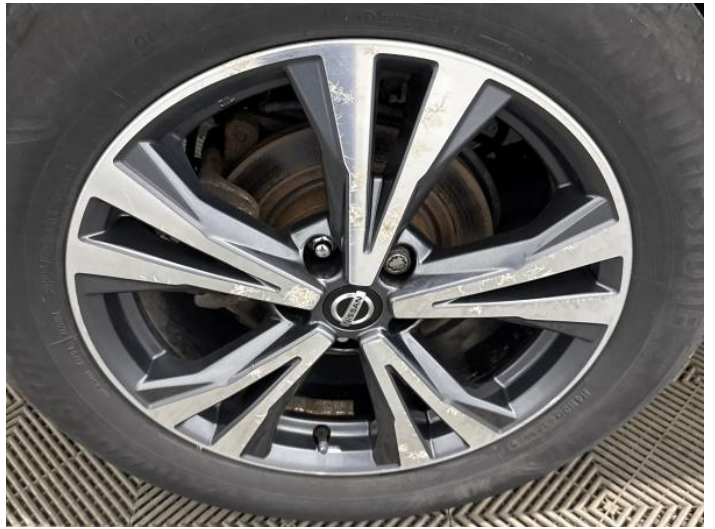
18: Wheel osr
Scratched
Over 50mm

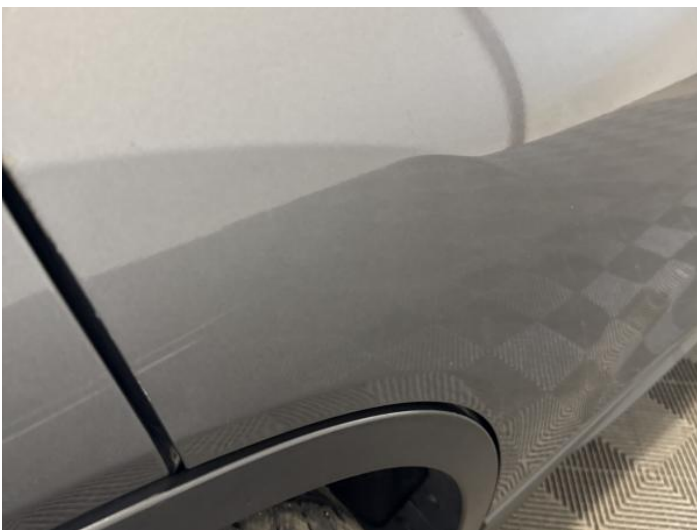
19: Door osr
Scratched
Over 25mm Thru Paint

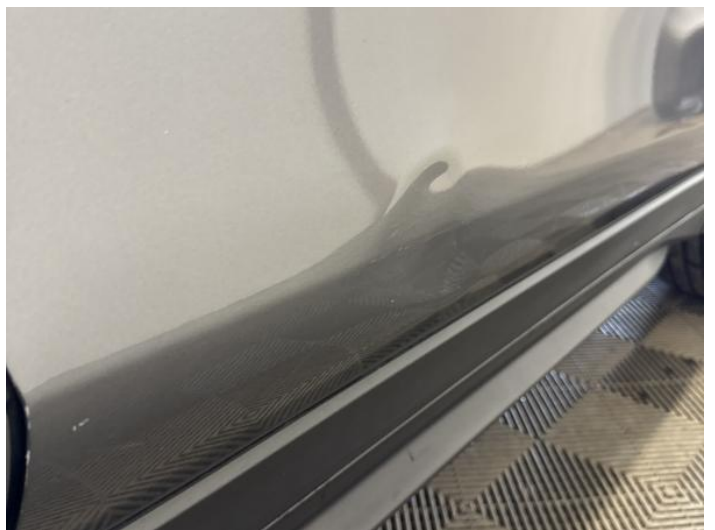
20: Door osf
Dented
Over 30mm

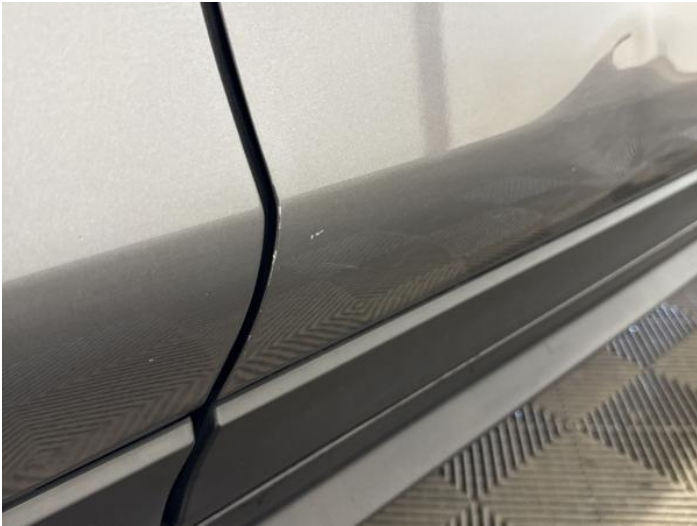
21: Door osf
Chipped
1 To 5

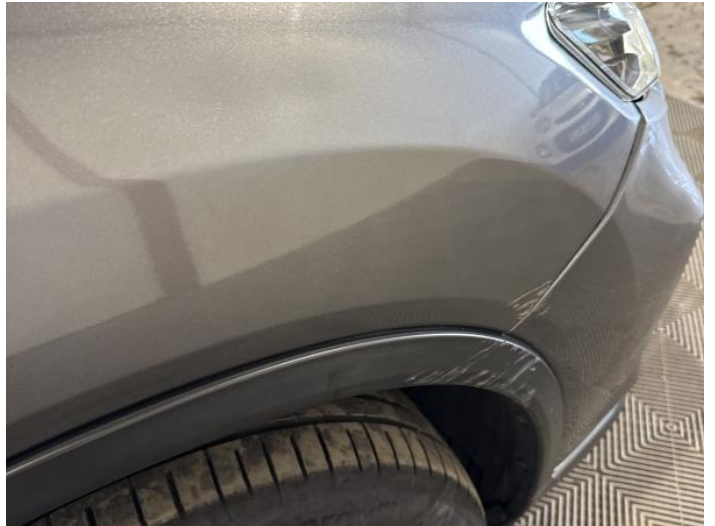
22: Wing osf
Dented
With Paint Damage

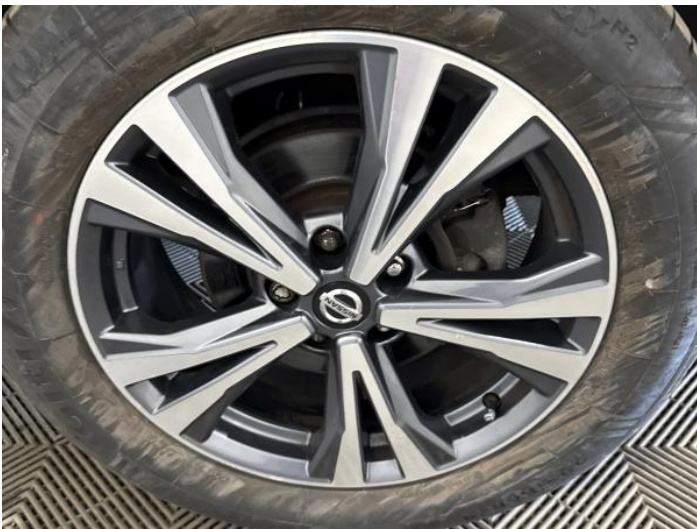
23: Wheel osf
Scratched
Up To 50mm

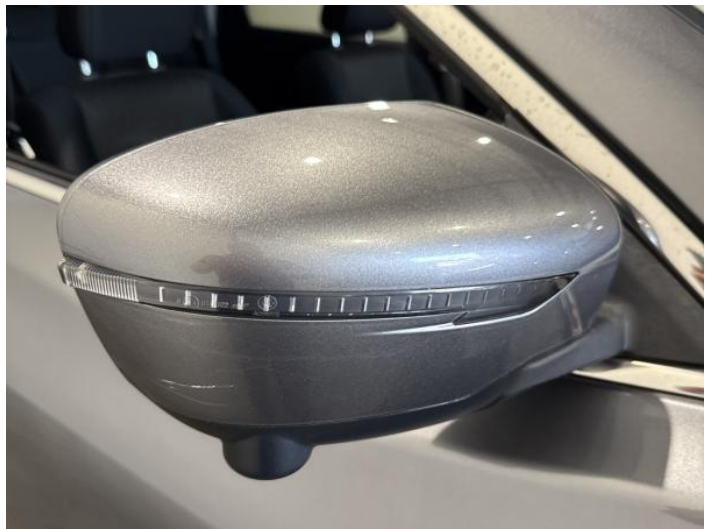
24: Door Mirror Assy osf
Scratched (Painted)
UpTo 25mm Thru Paint

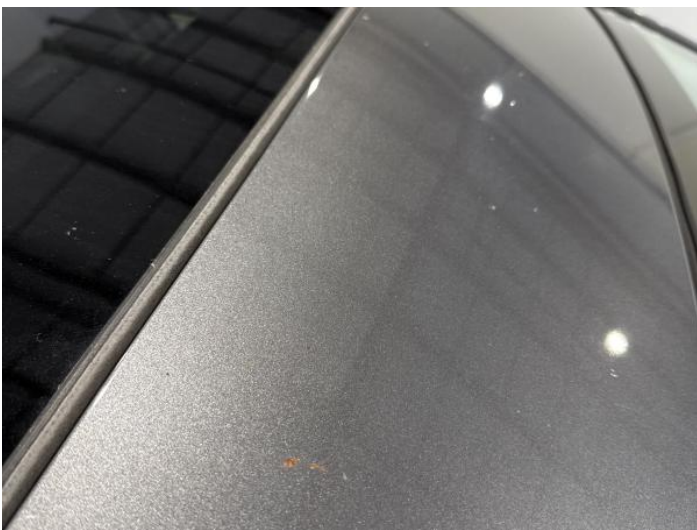
25: Roof
Chipped
1 To 5
