VEHICLE INSPECTION REPORT

GL11MXV

Skoda Yeti 1.2 TSI SE Plus 5dr

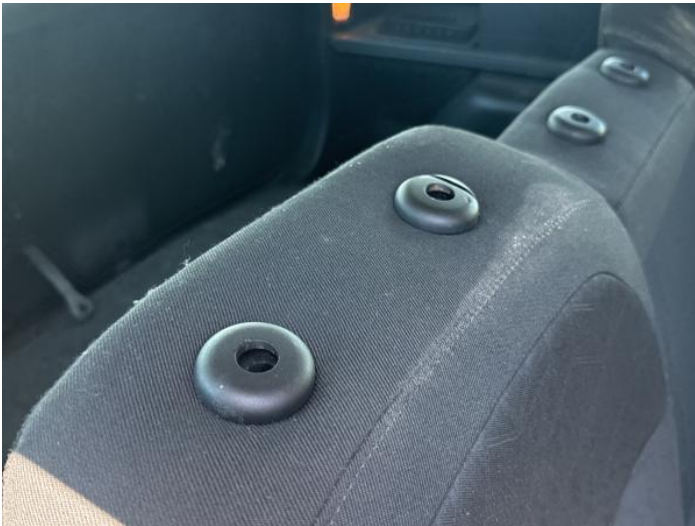
1: Headrest Assy Rear Seat os
Missing
Replace

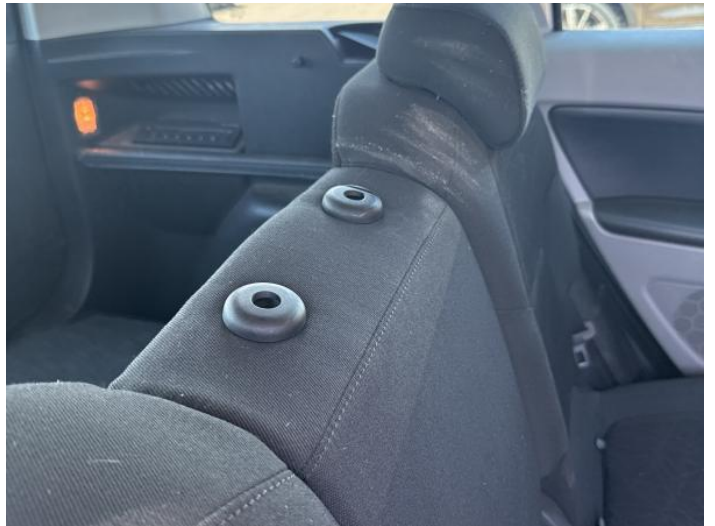
2: Headrest Assy Rear Seat Centr
Missing
Replace

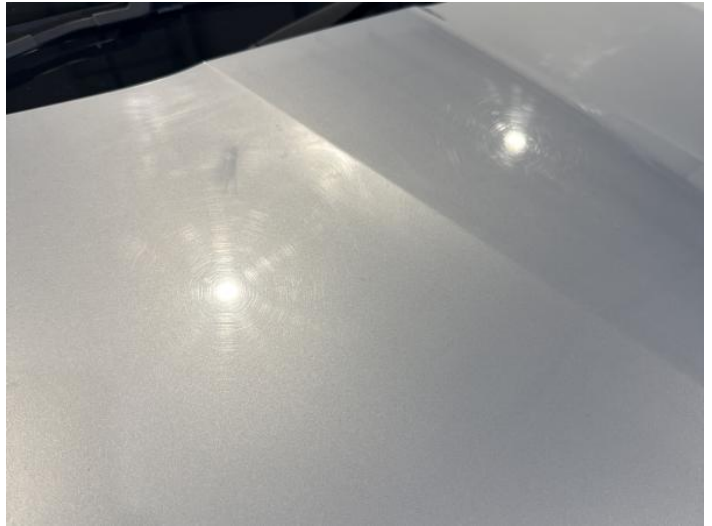
4: Bonnet
Scratched
Over 25mm Thru Paint

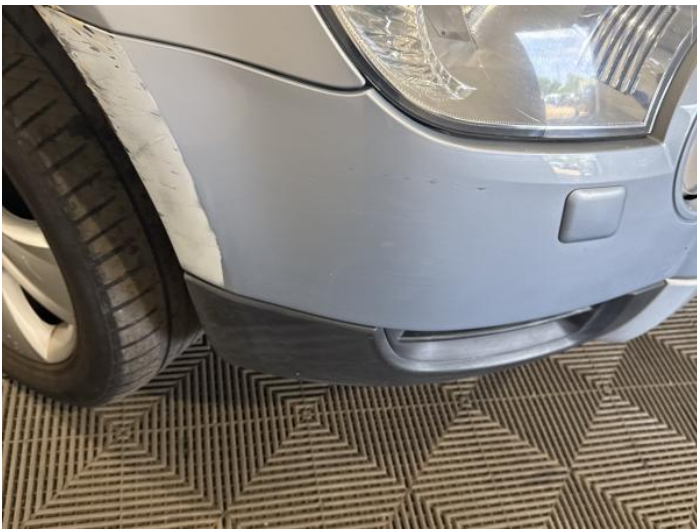
5: Bumper Front
Dented
With Paint Damage

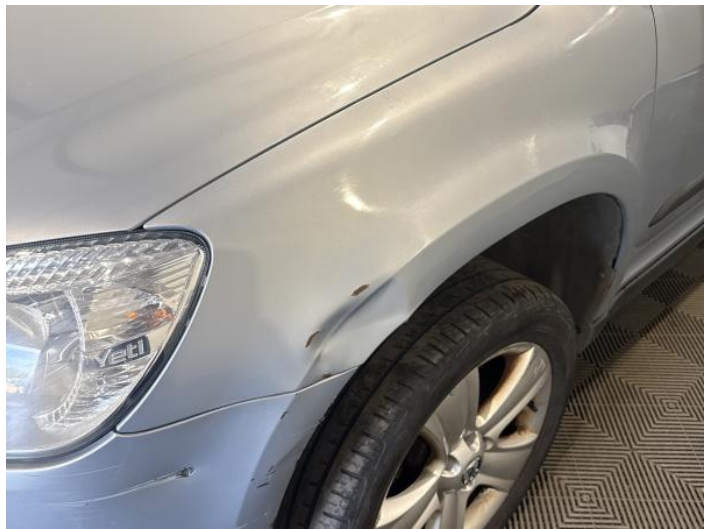
6: Wing nsf
Dented
With Paint Damage

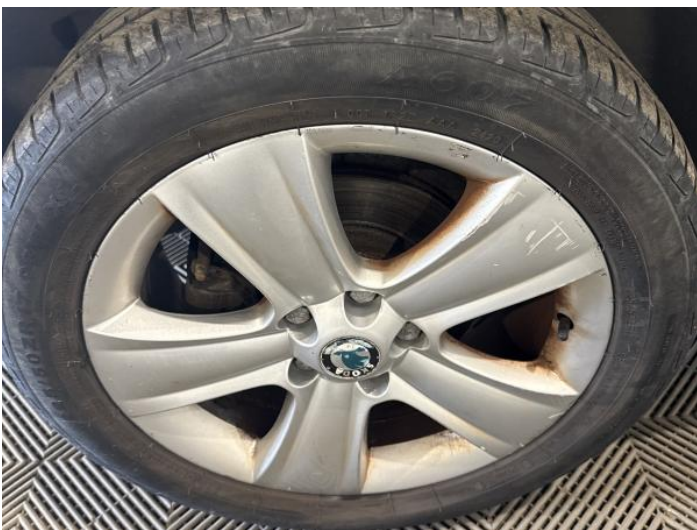
7: Wheel nsf
Scratched
Over 50mm

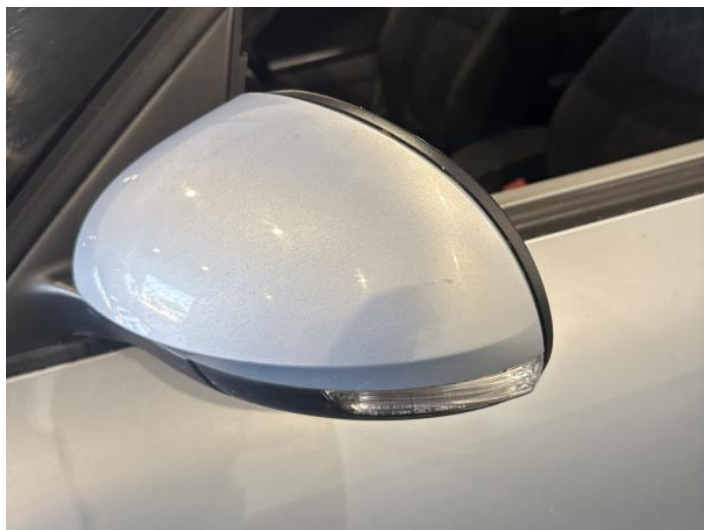
8: Door Mirror Assy nsf
Scratched (Painted)
UpTo 25mm Thru Paint

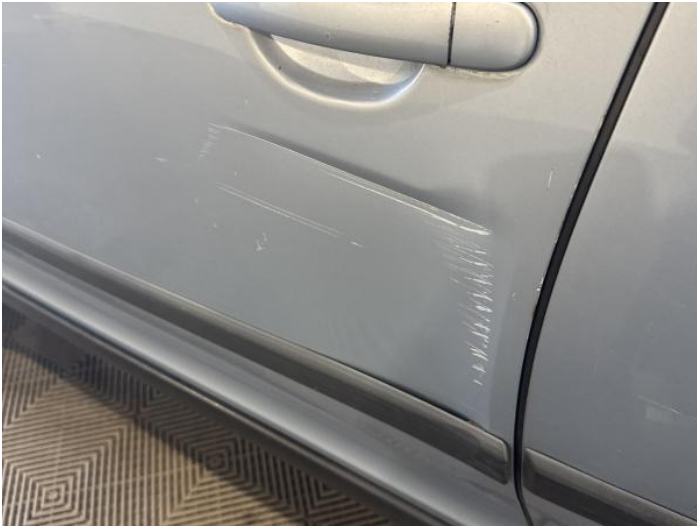
9: Door nsf
Dented
With Paint Damage

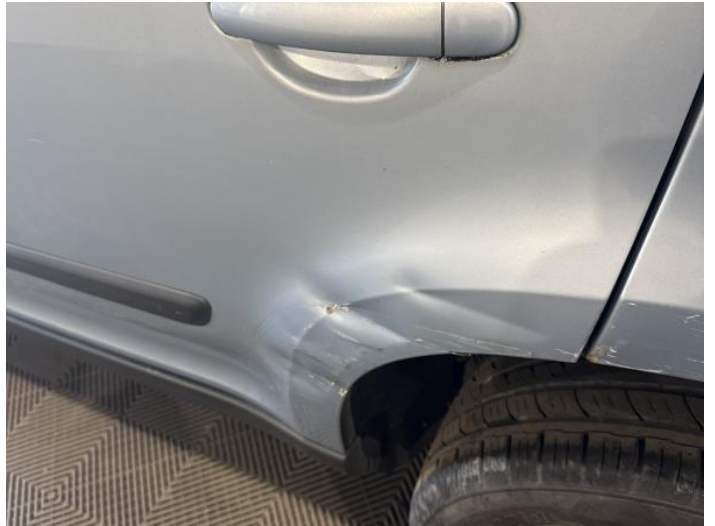
10: Door nsr
Dented
With Paint Damage

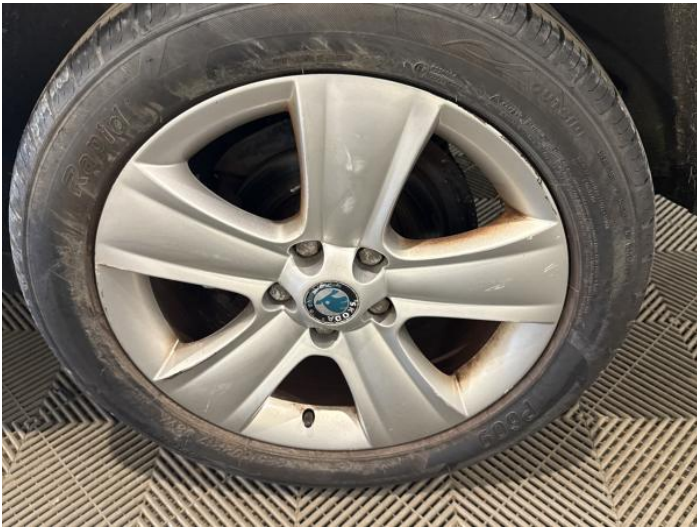
11: Wheel nsr
Scratched
Over 50mm

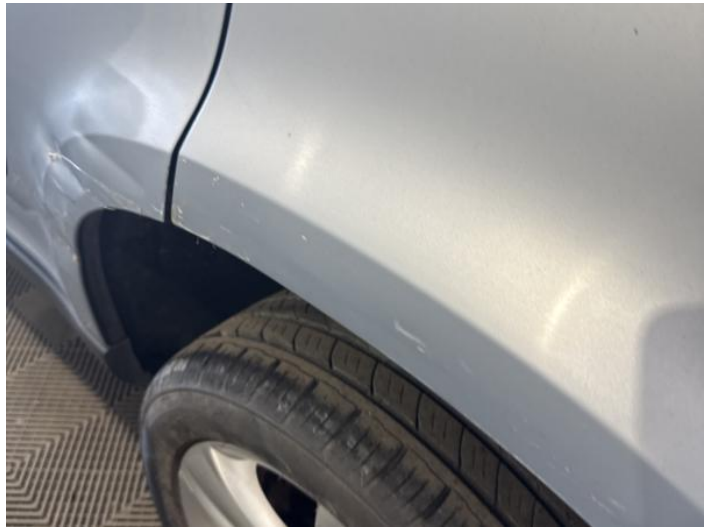
12: Qtr Panel nsr
Scratched
Rusted

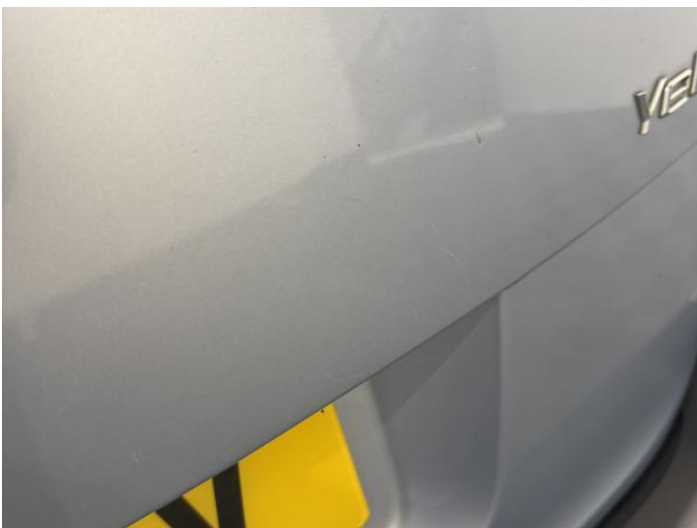
13: Tailgate
Scratched
Up To 25mm Thru Paint

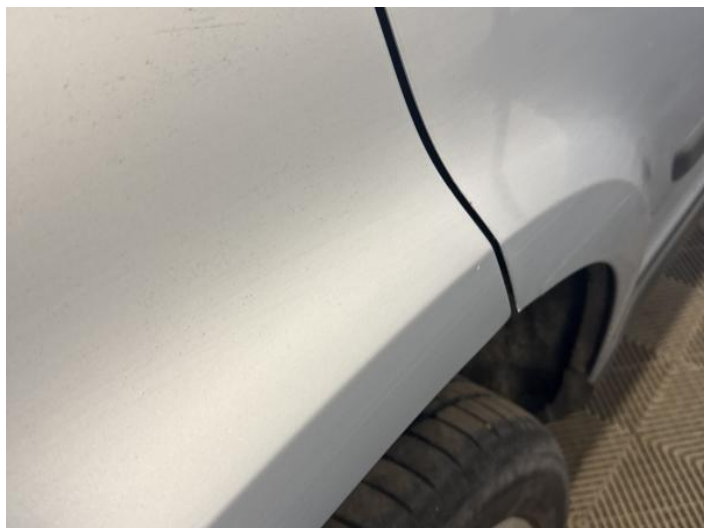
14: Qtr Panel osr
Chipped
1 To 5

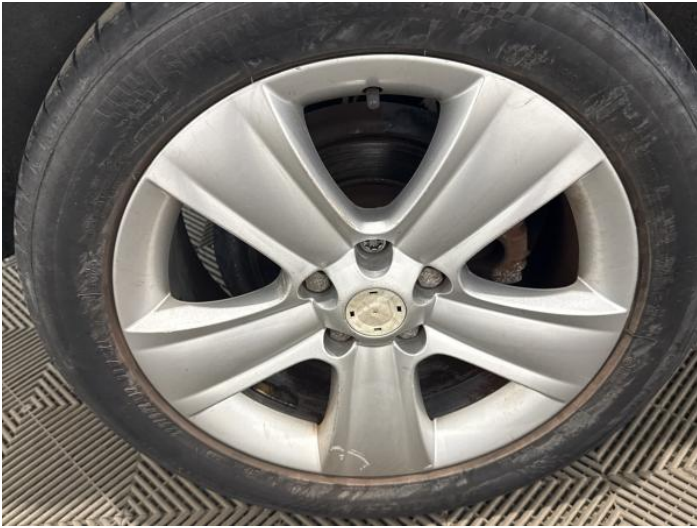
15: Wheel osr
Scratched
Over 50mm

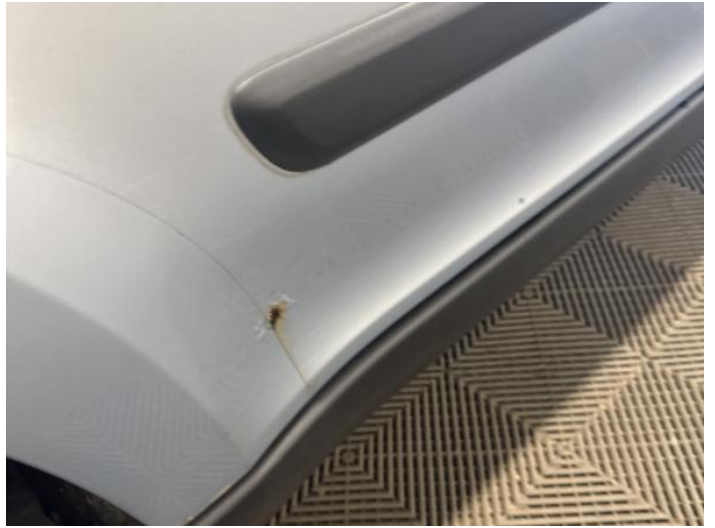
16: Door osr
Rusted
Over 5mm

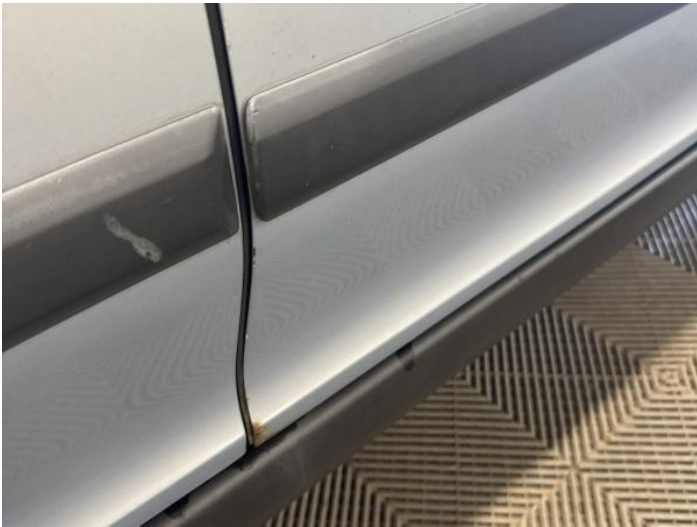
17: Door osf
Rusted
Over 5mm

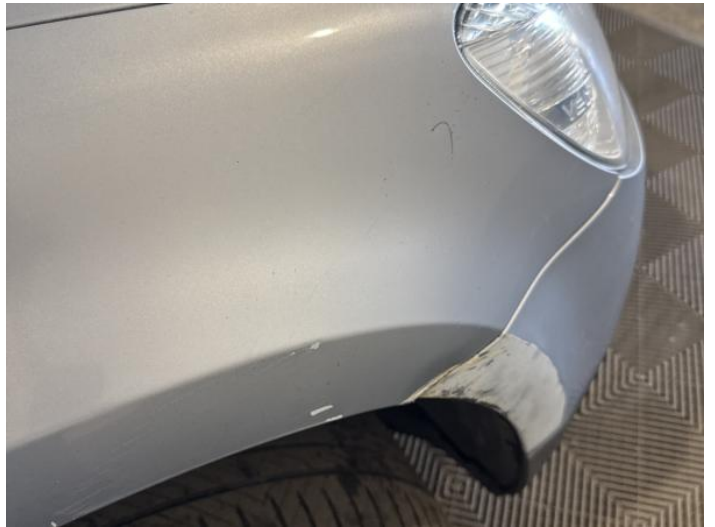
18: Wing osf
Dented
With Paint Damage

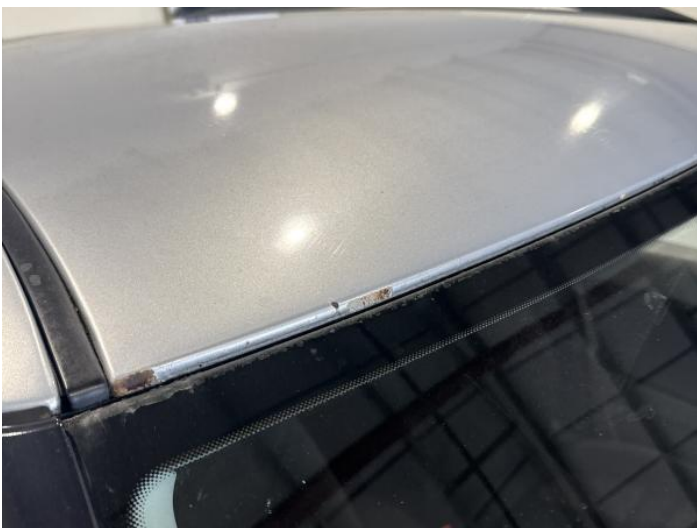
19: Roof
Rusted
Over 5mm

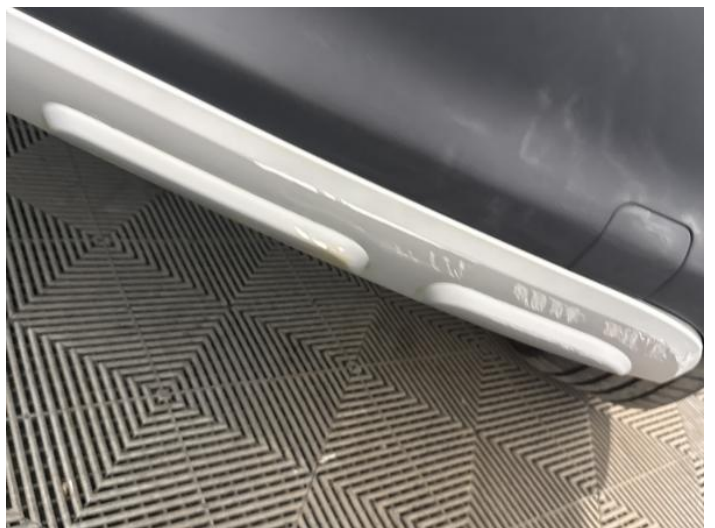
20: Bumper Rear Moulding
Scratched (Painted)
Over 25mm Thru Paint

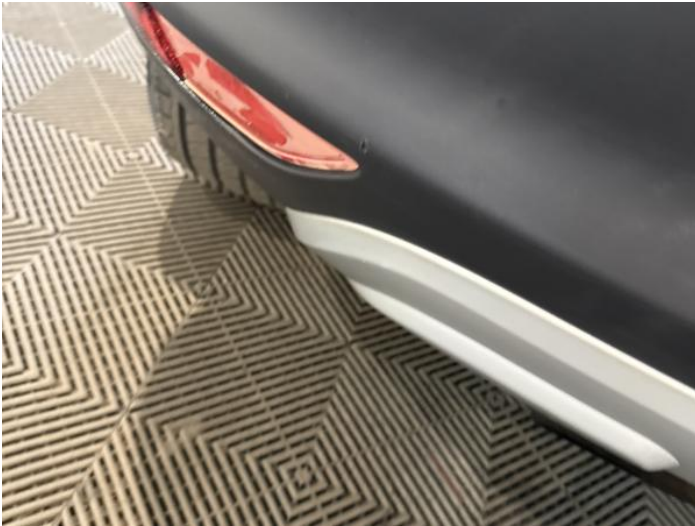
21: Bumper Reflector nsr
Broken
Replace

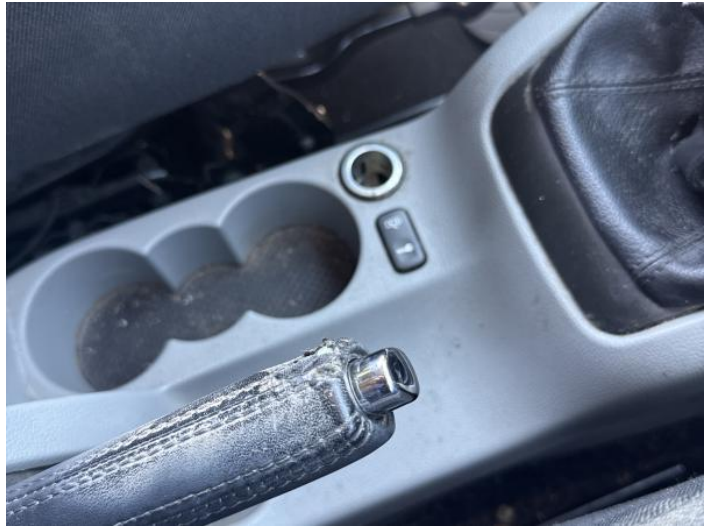
22: Switches And Controls
Broken
Replace
