VEHICLE INSPECTION REPORT

GV14LYO

Kia Rio 1.25 VR7 5dr

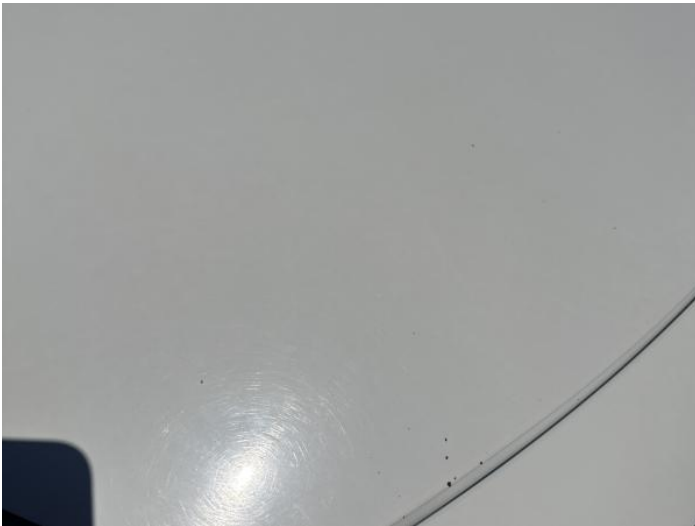
1: Bonnet
Scratched
Over 25mm Thru Paint

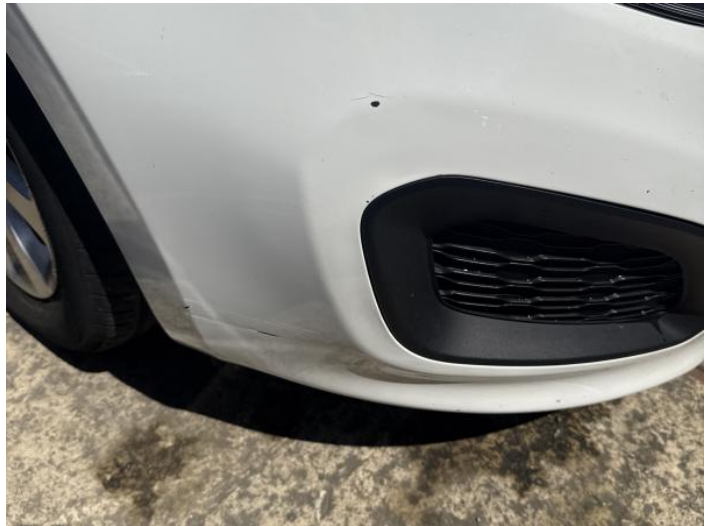
2: Bumper Front
Dented
With Paint Damage

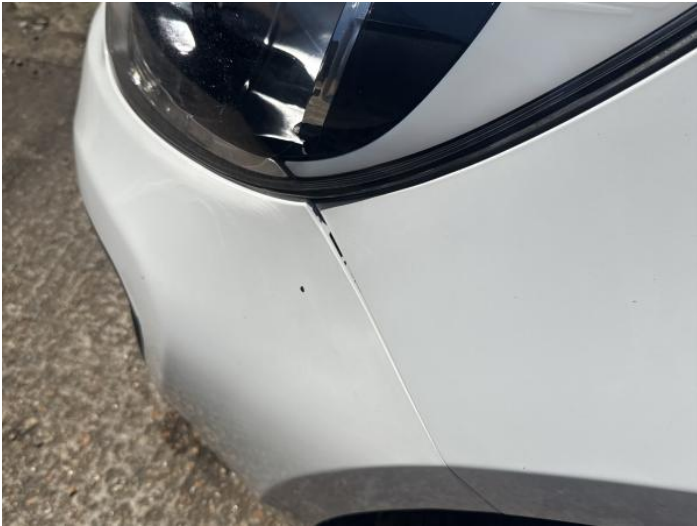
3: Bumper Front
Insecure
Action Required

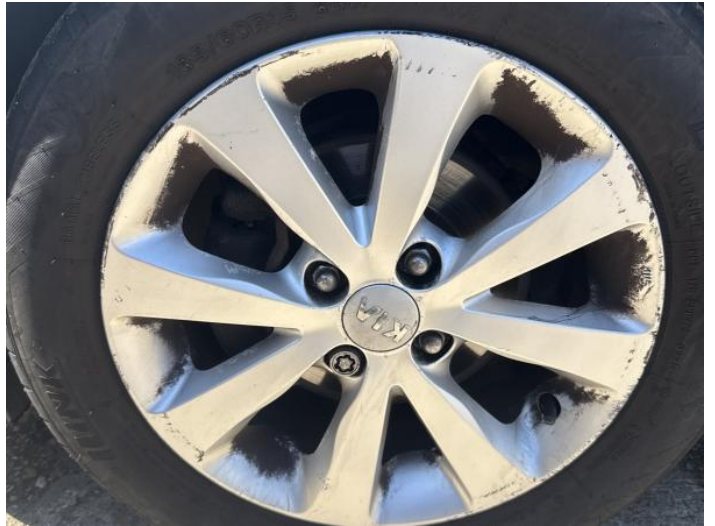
4: Wheel nsf
Scratched
Over 50mm

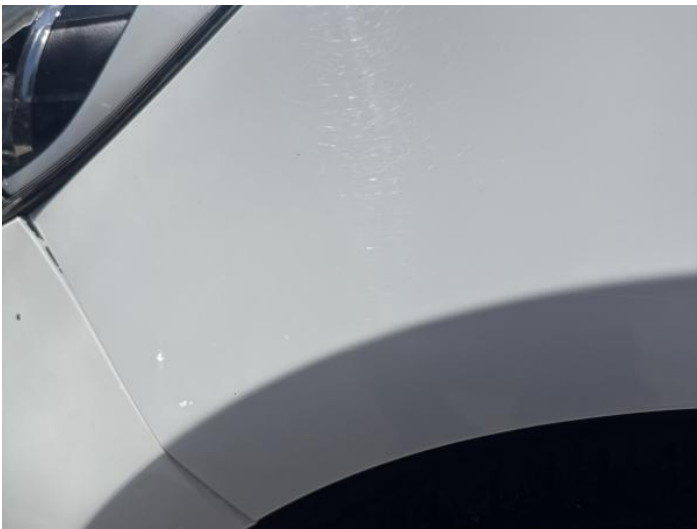
5: Wing nsf
Chipped
1 To 5

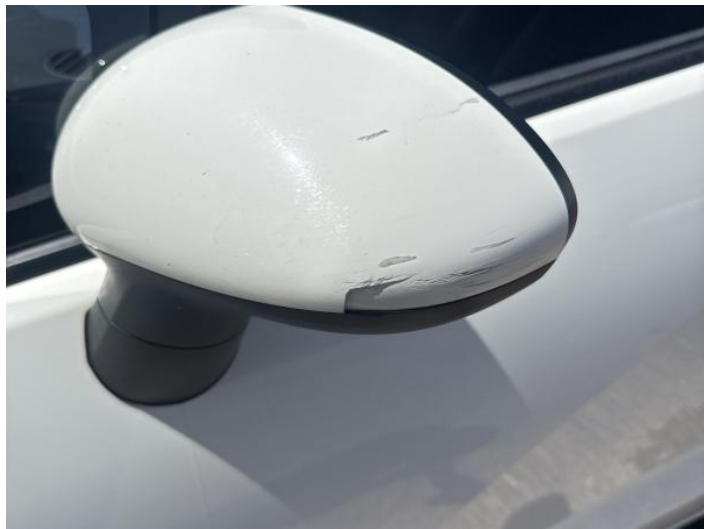
6: Door Mirror Assy nsf
Broken
Replace

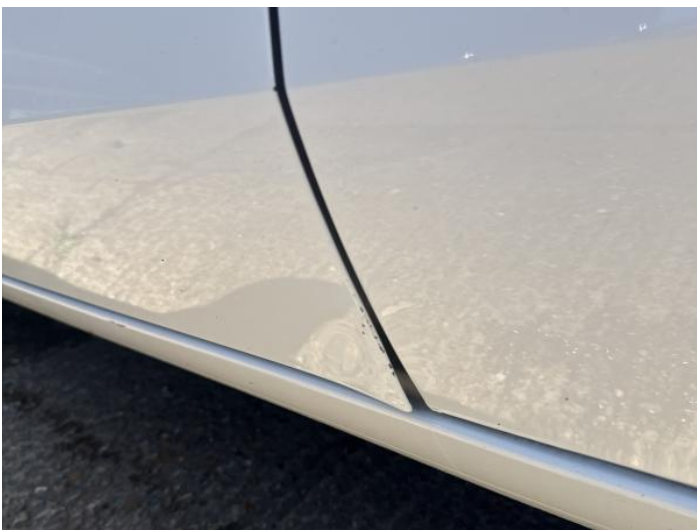
7: Door nsf
Dented
With Paint Damage

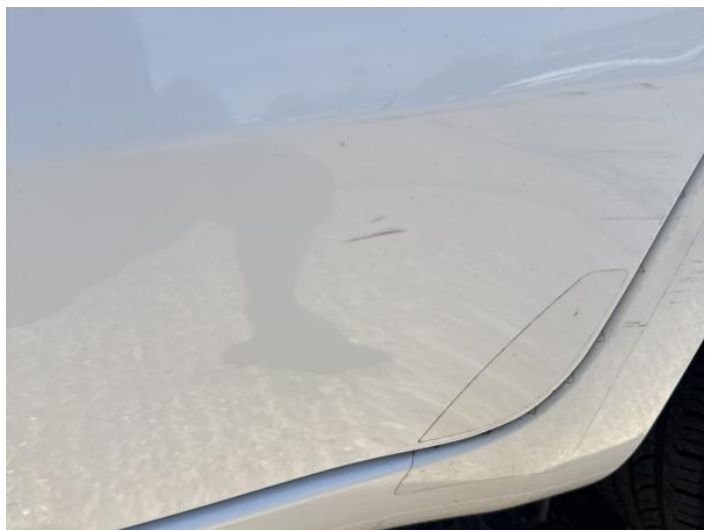
8: Door nsr
Scratched
Over 25mm Thru Paint

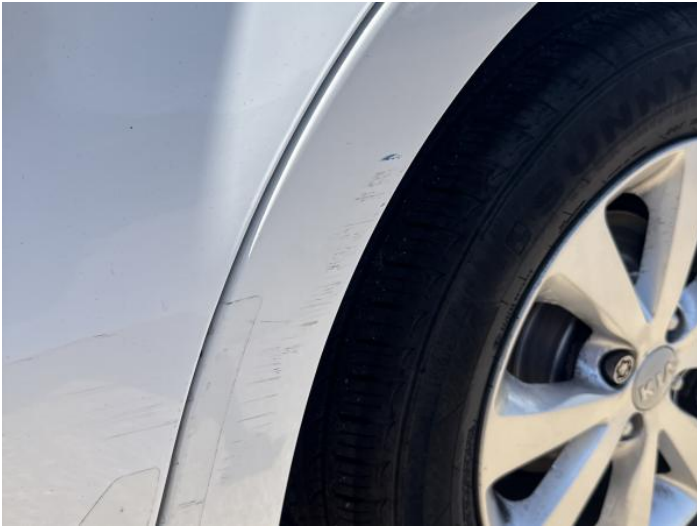
9: Qtr Panel nsr
Scratched
Over 25mm Thru Paint

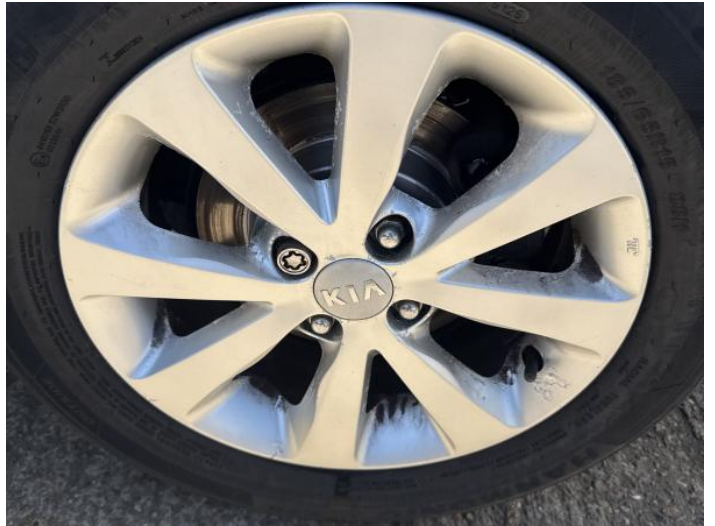
10: Wheel nsr
Scratched
Over 50mm

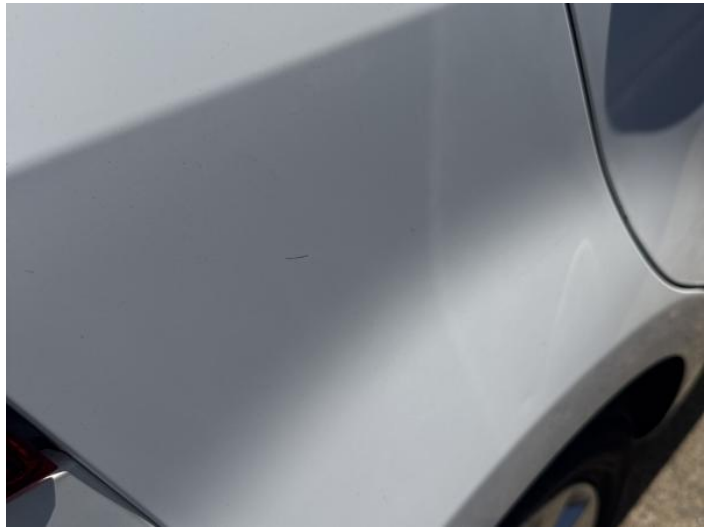
12: Qtr Panel osr
Scratched
UpTo 25mm Thru Paint

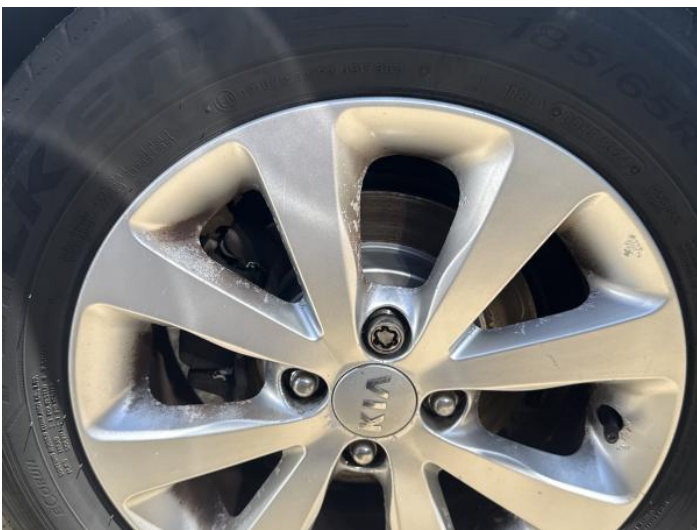
13: Wheel osr
Corroded
Light

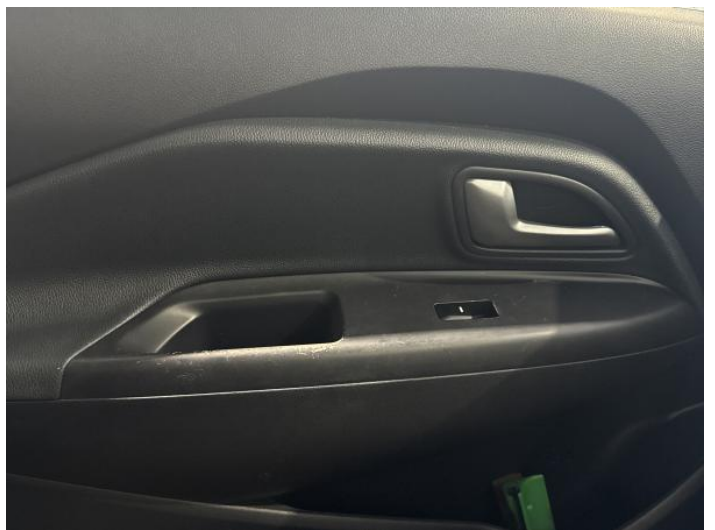
14: Door Pad nsf
Scuffed
Over 25mm

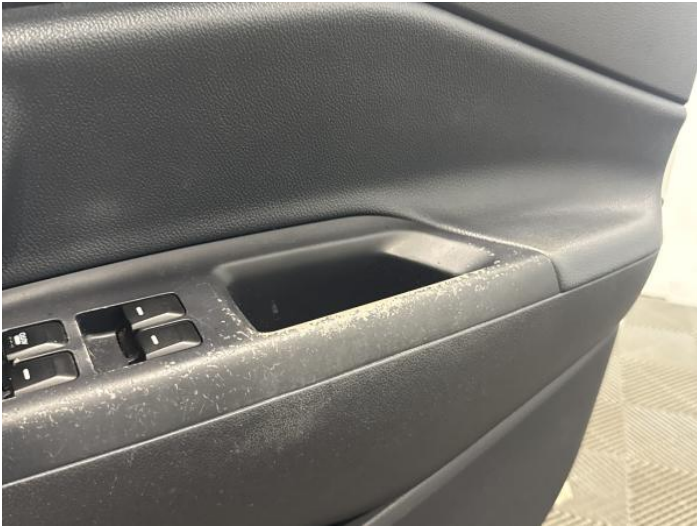
15: Door Pad osf
Scuffed
Over 25mm

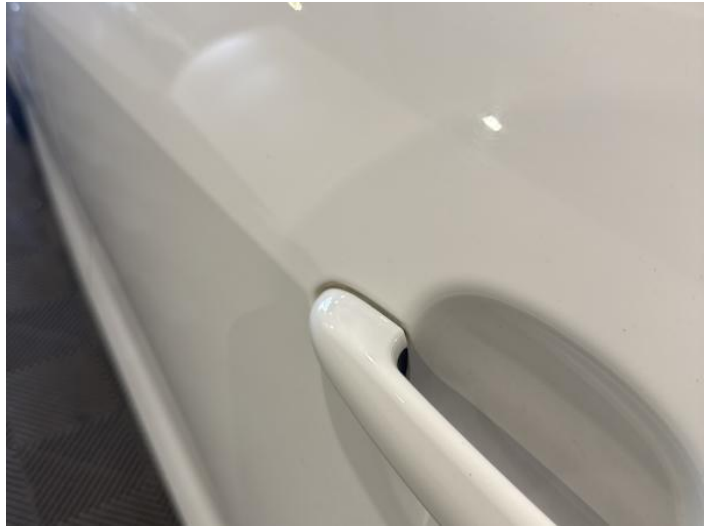
16: Door nsr
Dented
Between 10mm + 30mm

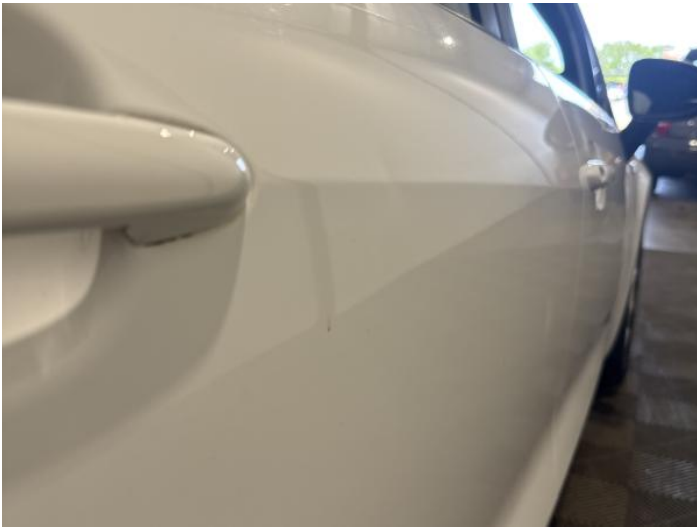
17: Door osf
Dented
Over 30mm

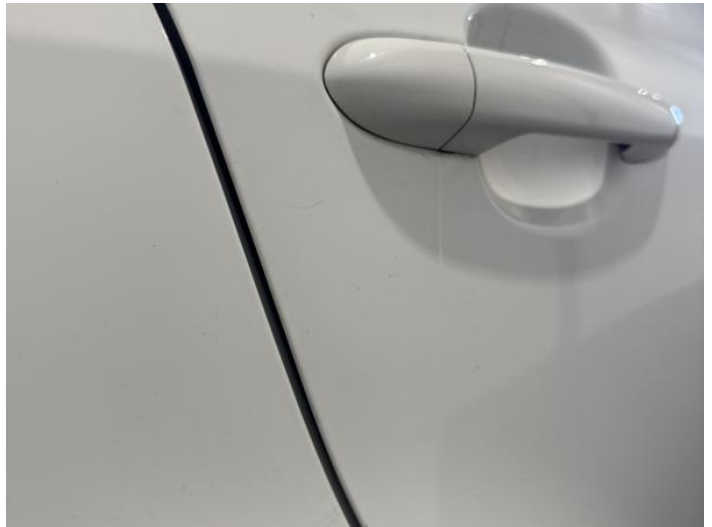
18: Door osr
Chipped
Edge Chip

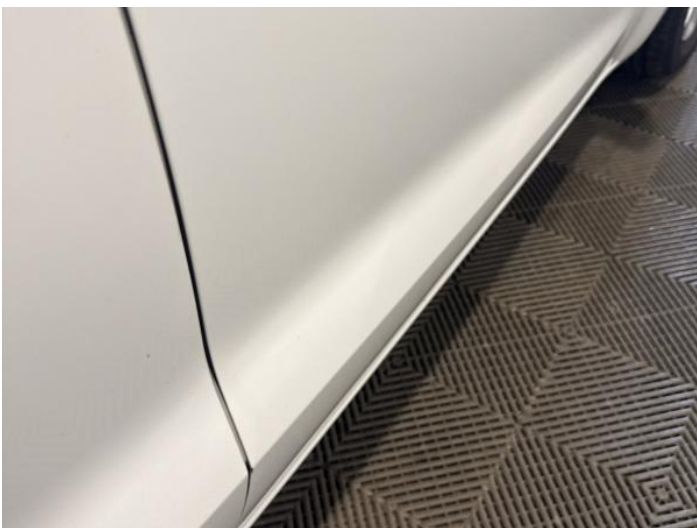
19: Door osf
Chipped
Edge Chip

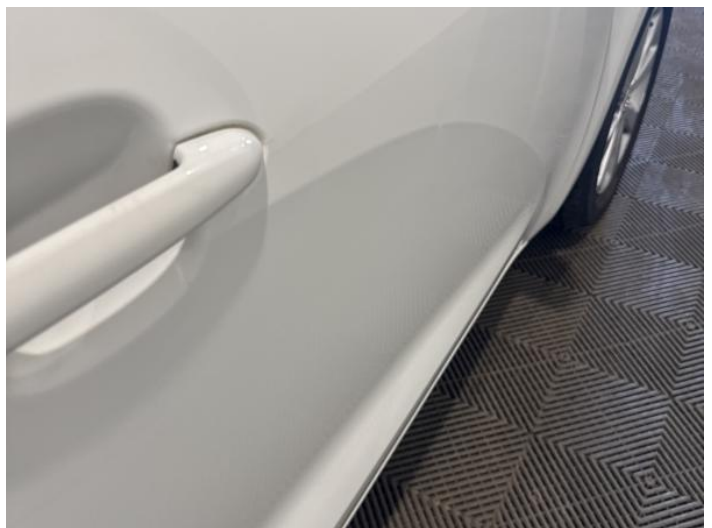
20: Door osf
Dented
Between 10mm + 30mm

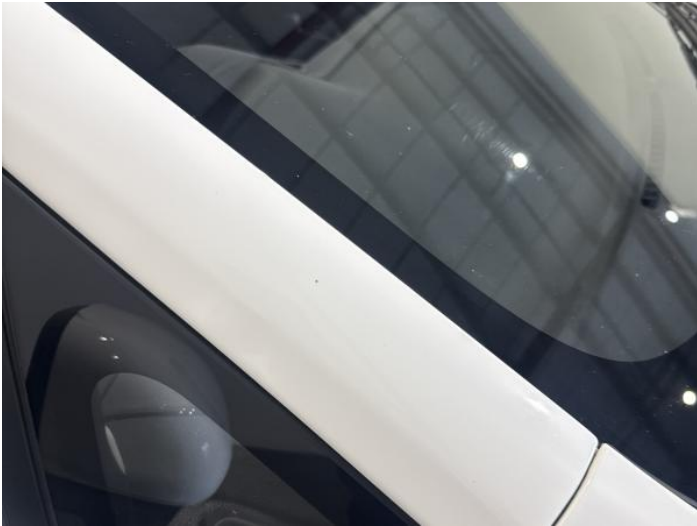
21: A Post osf
Chipped
1 To 5

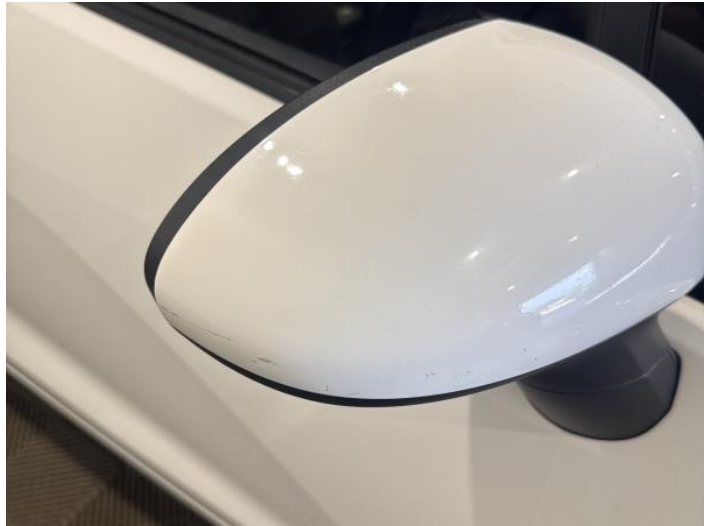
22: Door Mirror Assy osf
Scratched (Painted)
Over 25mm Thru Paint

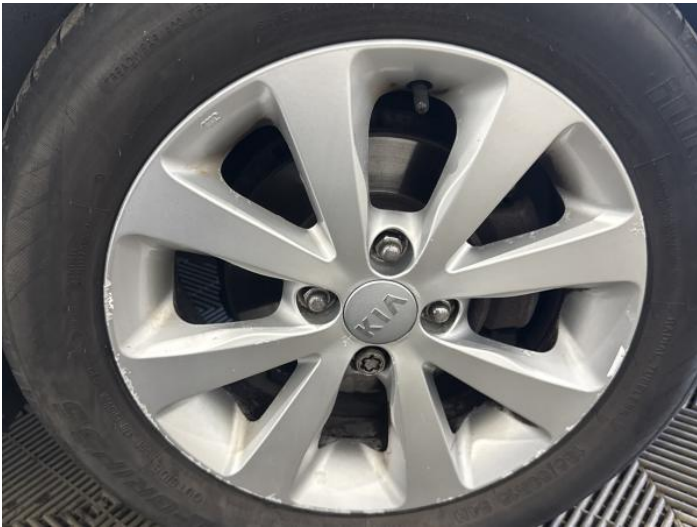
23: Wheel osf
Scratched
Over 50mm

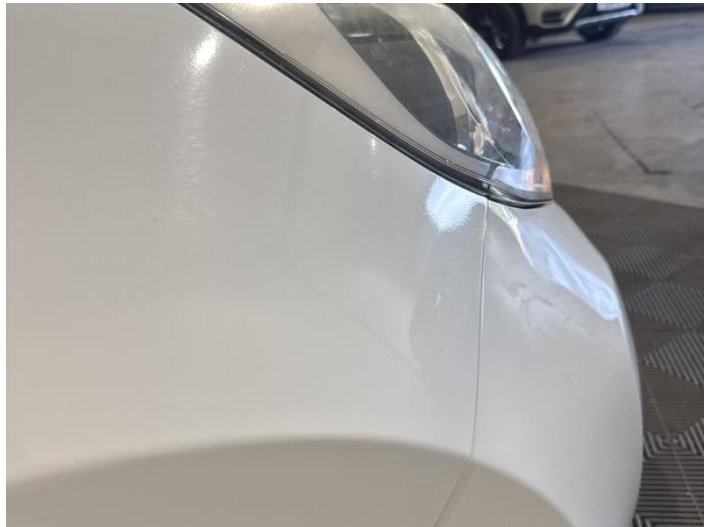
24: Wing osf
Chipped
Multiple Chips

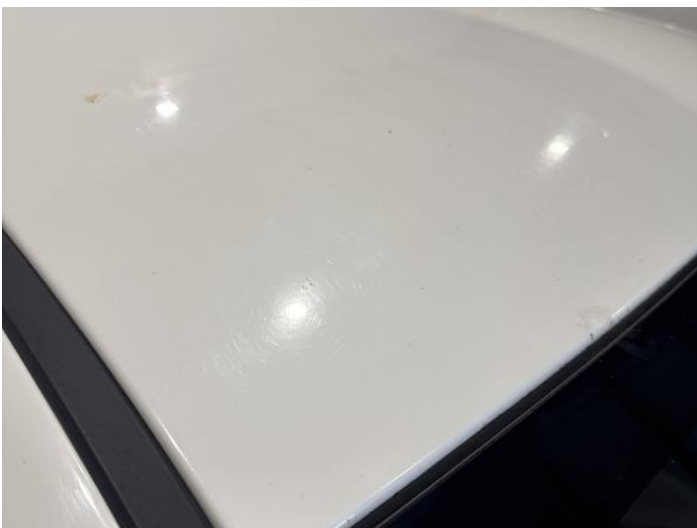
25: Roof
Rusted
Over 5mm

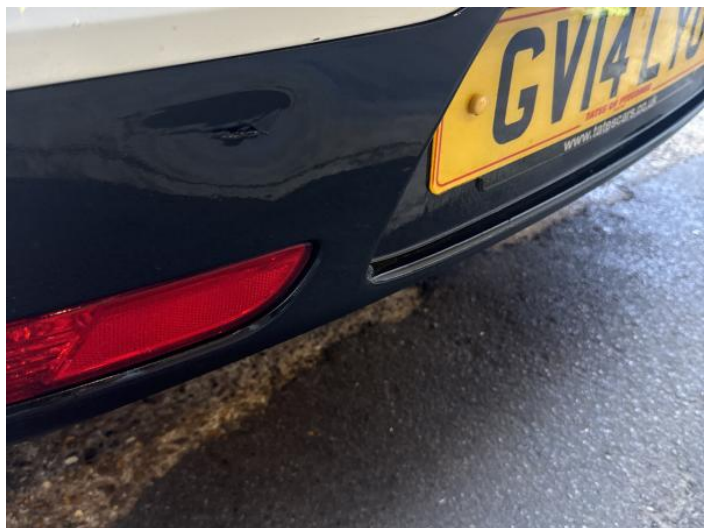
26: Bumper Rear Moulding
Scuffed (Unpainted)
Over 100mm
