# VEHICLE INSPECTION REPORT

GL17TWV

## Citroen C4 Picasso 1.2 PureTech Feel 5dr

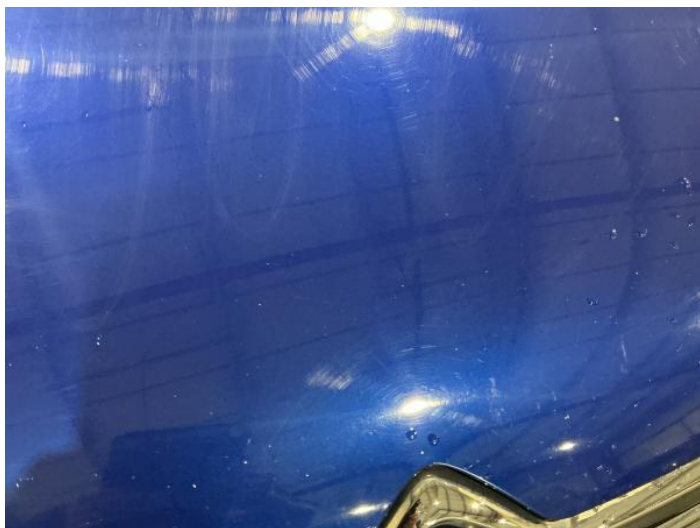
1: Bonnet  
Chipped  
Multiple Chips

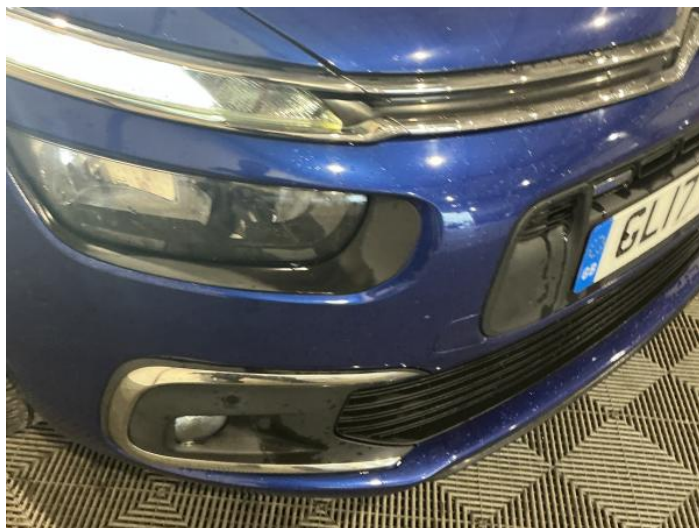
2: Bumper Front  
Chipped  
Multiple Chips

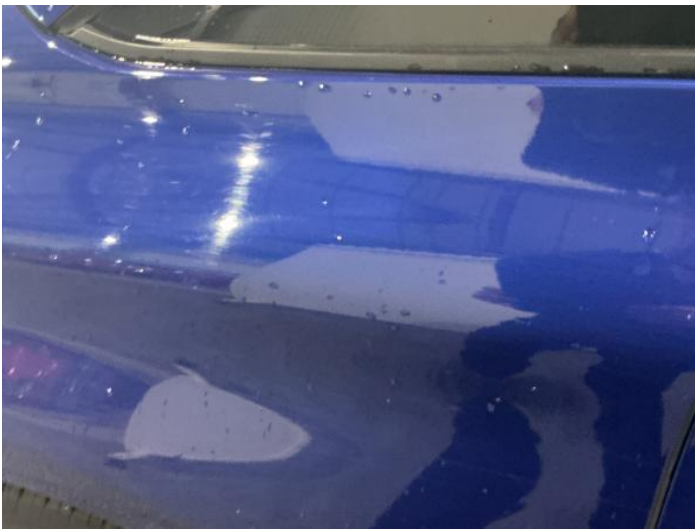
5: Wing nsf  
Chipped  
1 To 5

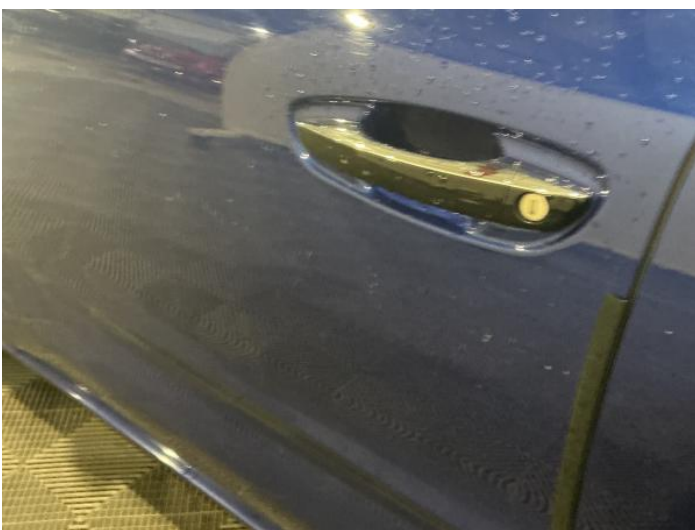
7: Door nsf  
Chipped  
1 To 5

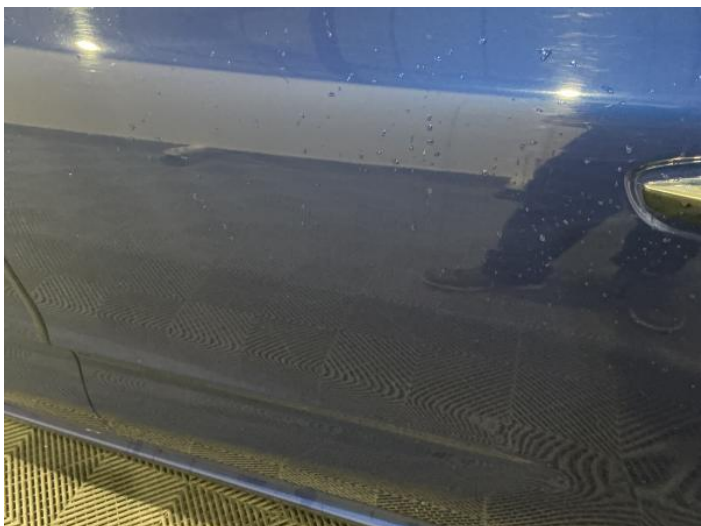
9: Door nsr  
Chipped  
1 To 5

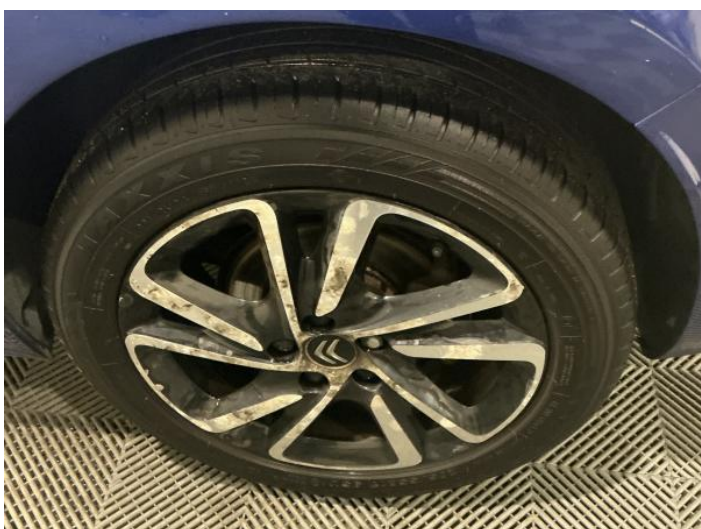
11: Wheel nsr  
Scratched  
Over 50mm

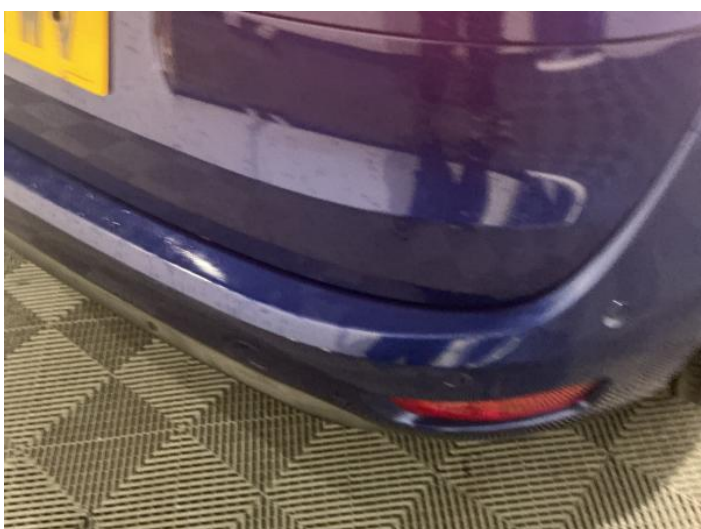
13: Bumper Rear  
Scratched  
Over 100mm Thru Paint

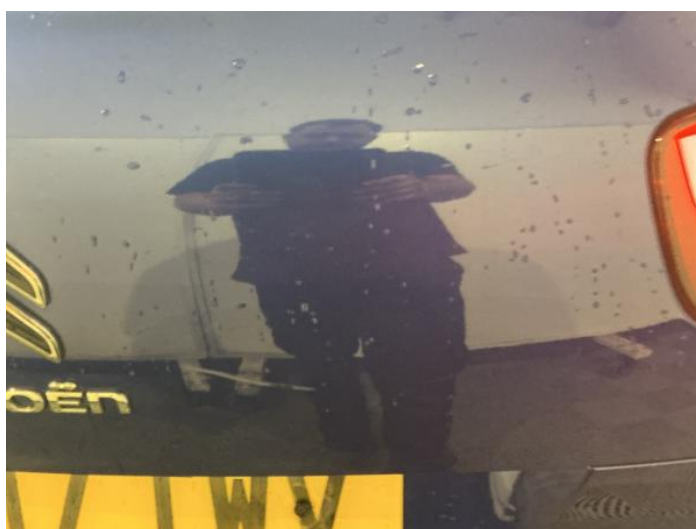
14: Boot Lid  
Scratched  
Over 25mm Thru Paint

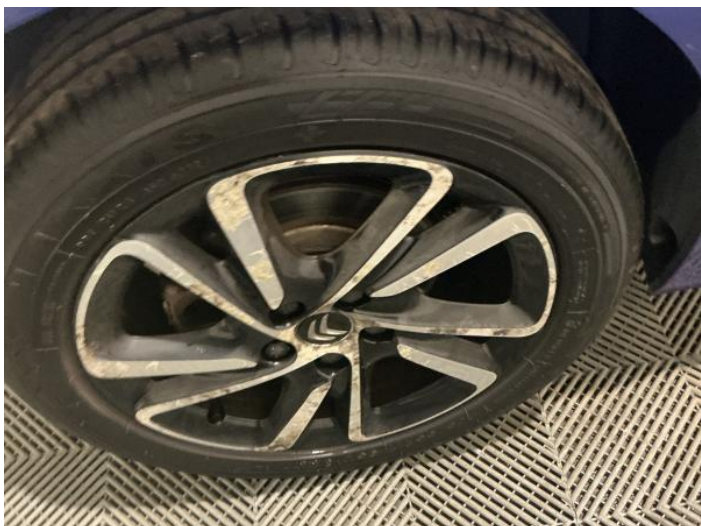
15: Wheel osr  
Scratched  
Over 50mm

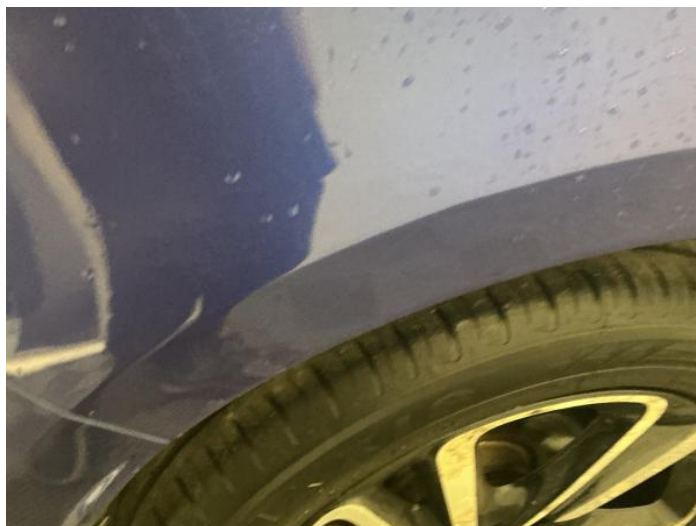
16: Qtr Panel osr  
Poor Previous Repair  
Paint Flake

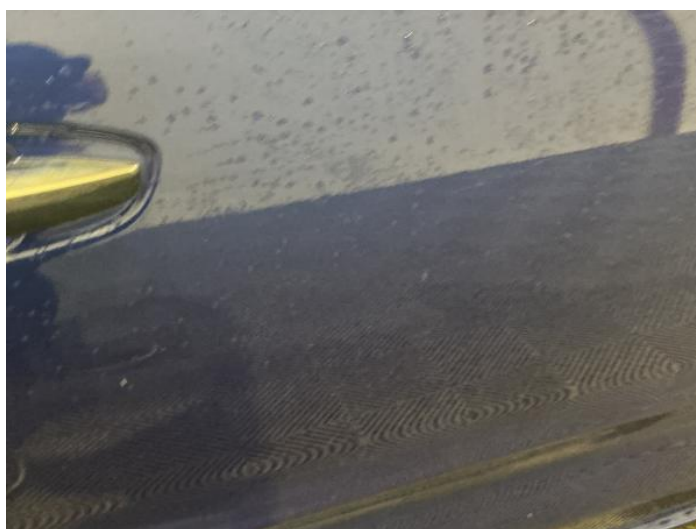
18: Door osf  
Chipped  
1 To 5

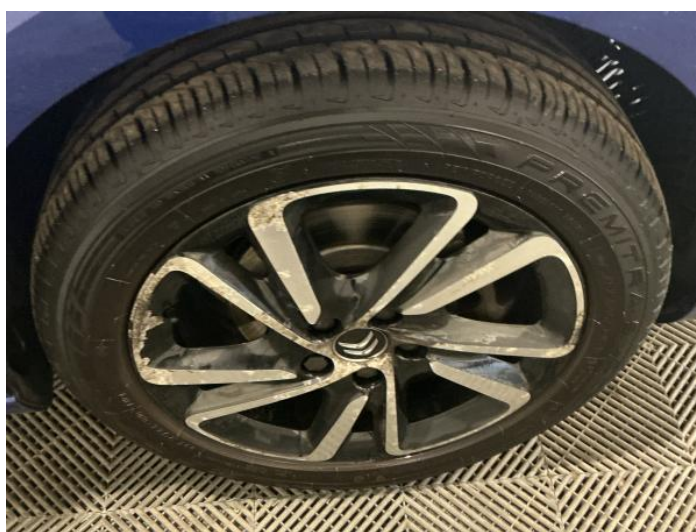
20: Wheel osf  
Scratched  
Over 50mm
