VEHICLE INSPECTION REPORT

AU60XPX

Audi A4 1.8T FSI 160 SE 5dr

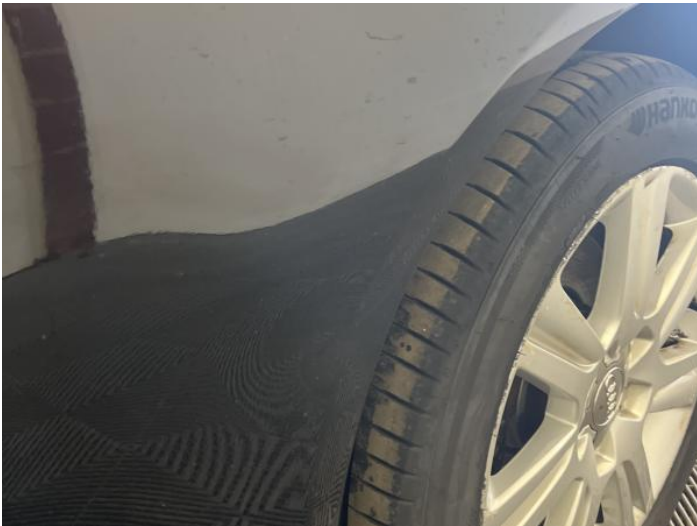
1: Wing of
Dented
Over 30mm

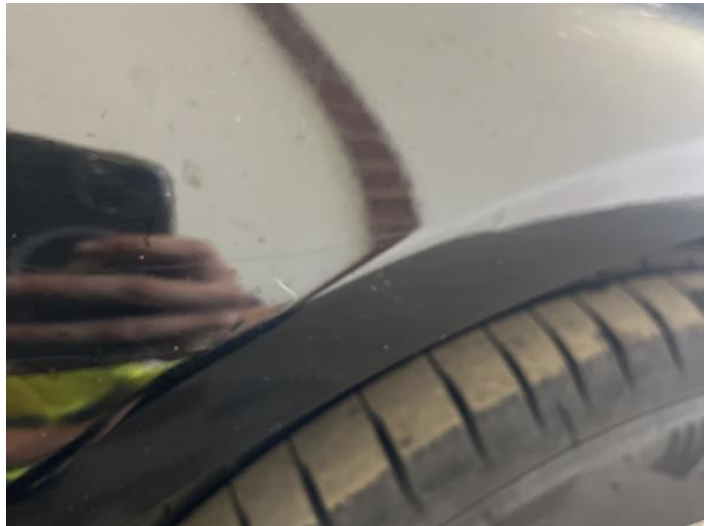
2: Wing of
Scratched
Over 25mm Thru Paint

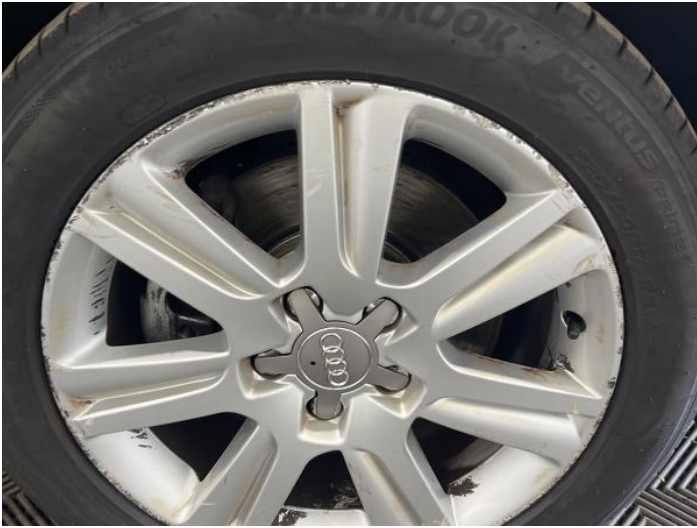
3: Wheel osf
Scratched
Over 50mm

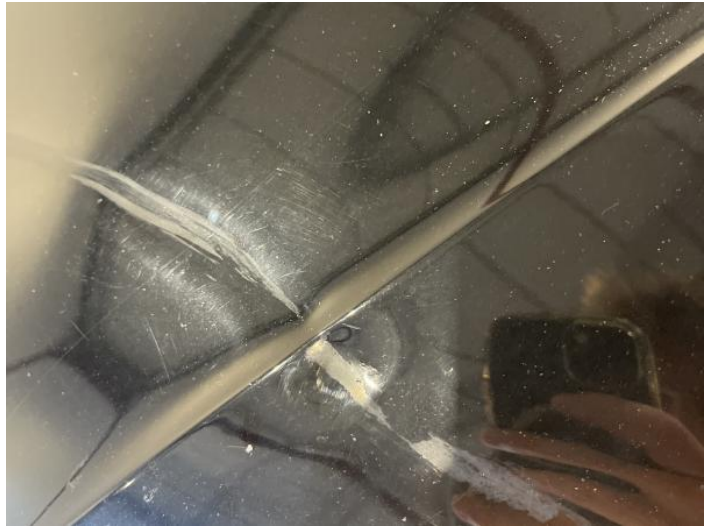
4: Bonnet
Dented
With Paint Damage

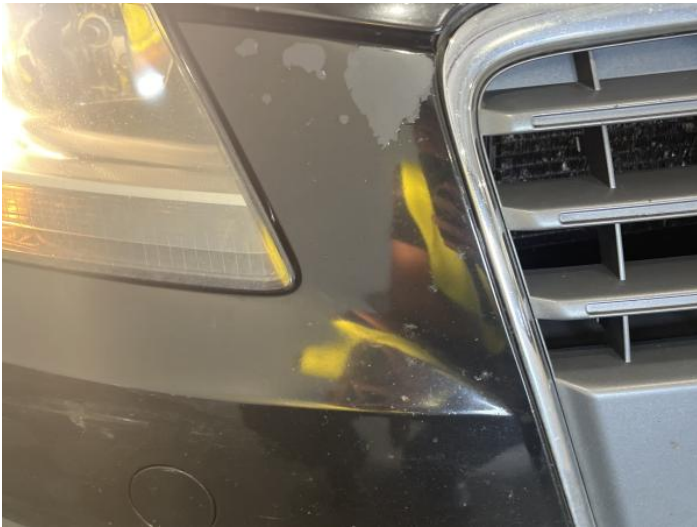
5: Bumper Front
Poor Previous Repair
Paint Flake

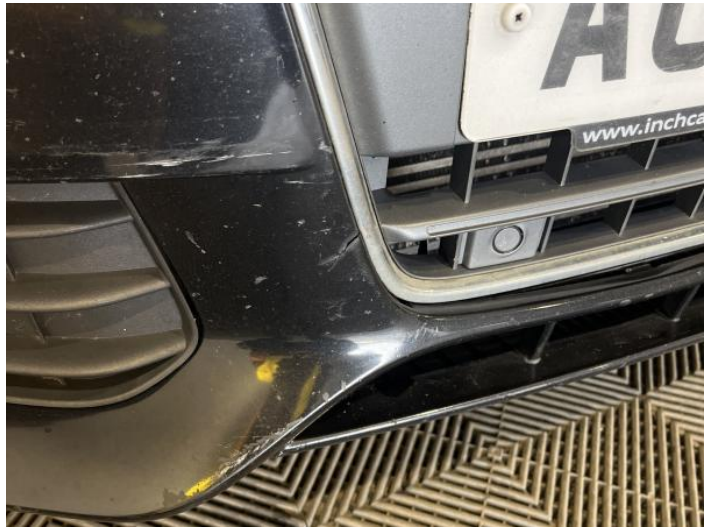
6: Bumper Front
Cracked
UpTo 25mm

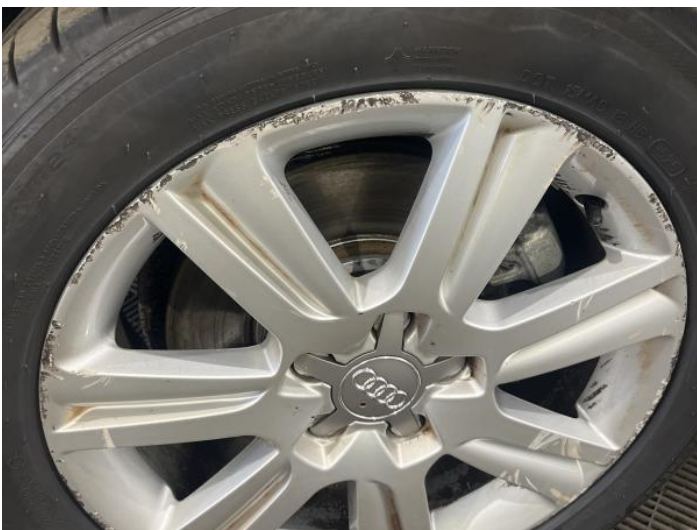
7: Wheel nsf
Scratched
Over 50mm

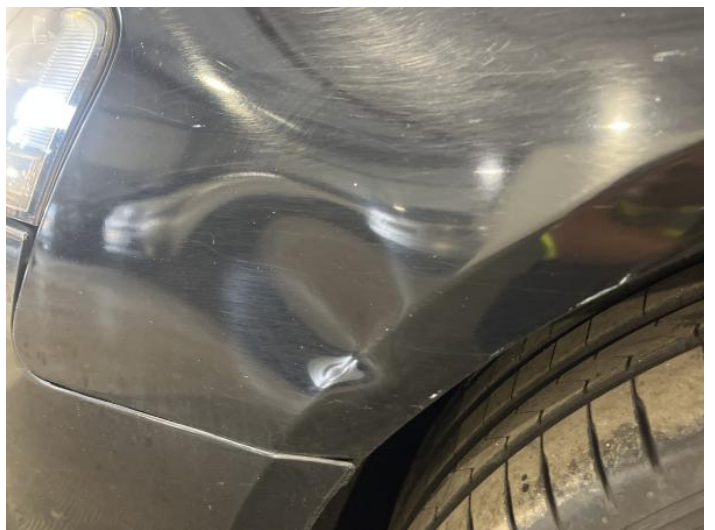
8: Wing nsf
Dented
Over 30mm

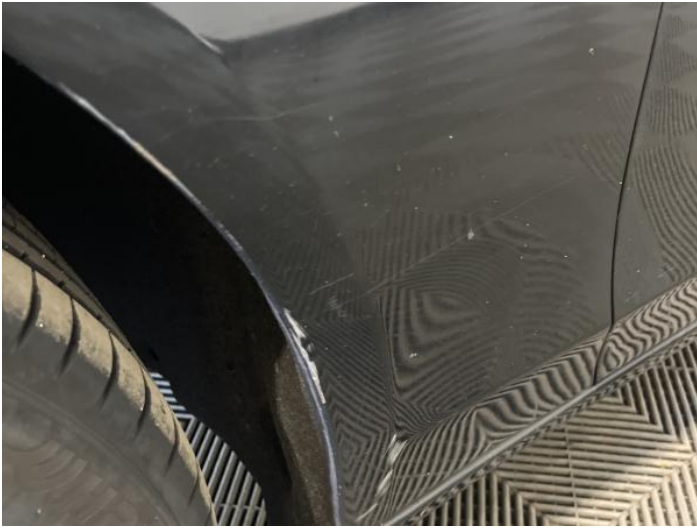
9: Wing nsf
Scratched
Over 25mm Thru Paint

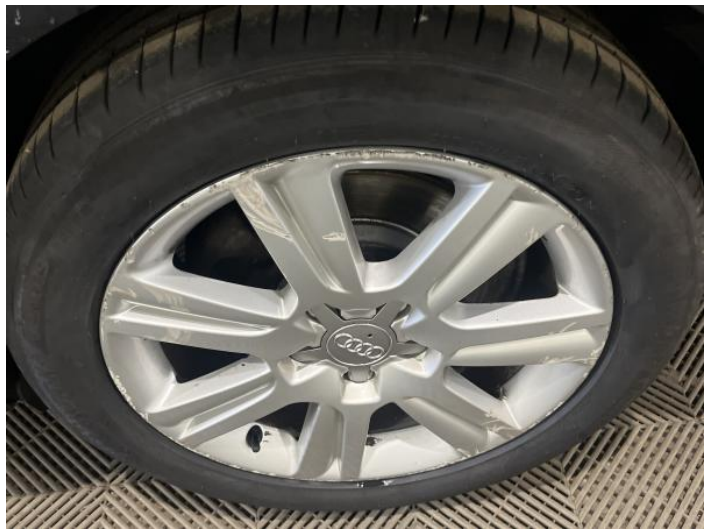
12: Wheel nsr
Scratched
Over 50mm

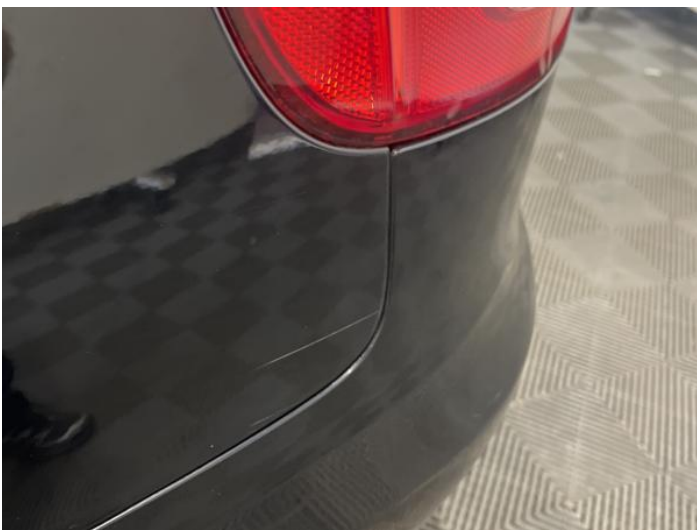
13: Qtr Panel nsr
Scratched
Over 25mm Thru Paint

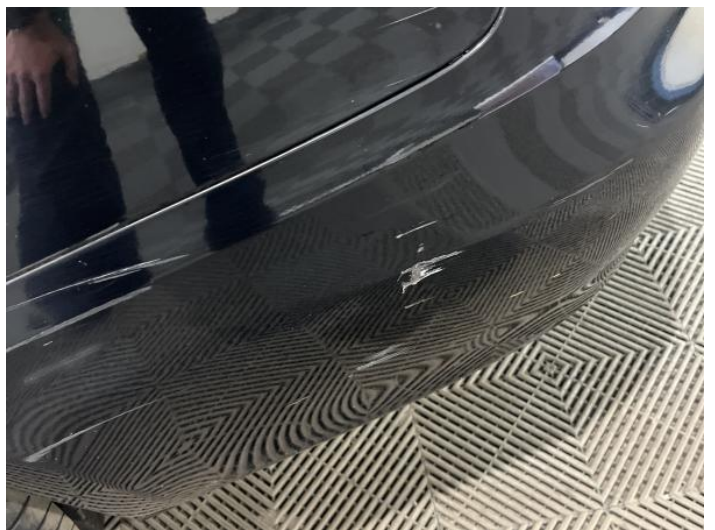
14: Bumper Rear
Scratched
Over 100mm Thru Paint

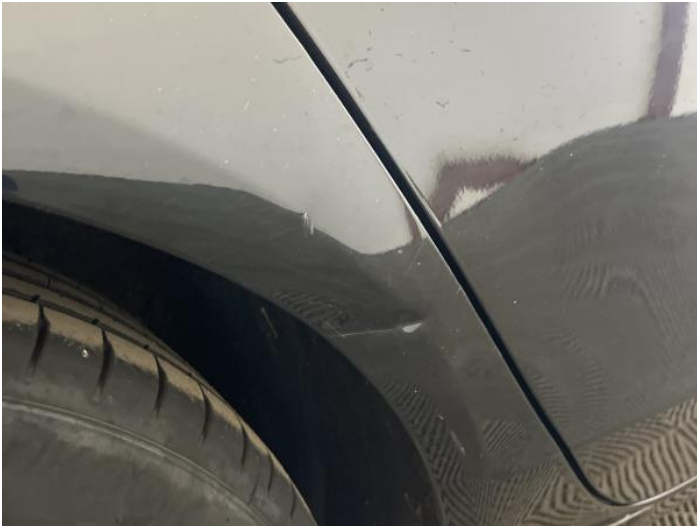
15: Qtr Panel osr
Dented
With Paint Damage

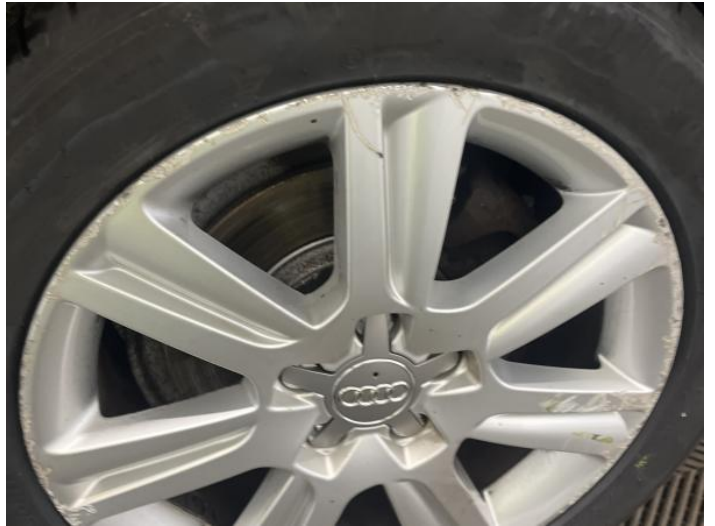
16: Wheel osr
Scratched
Over 50mm

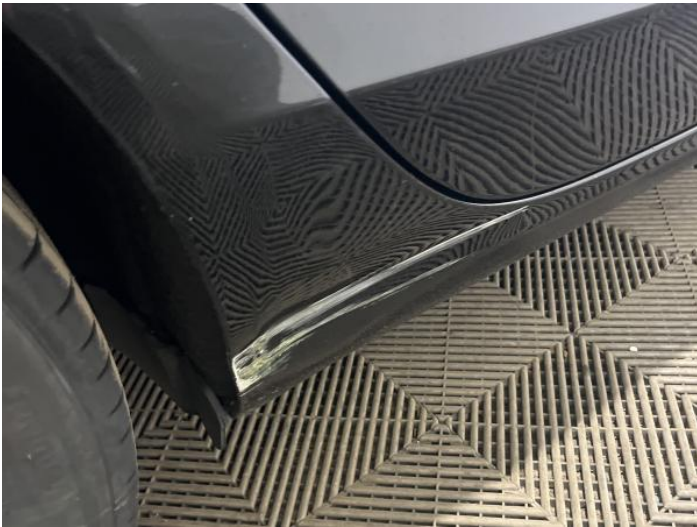
17: Sill os
Dented
With Paint Damage

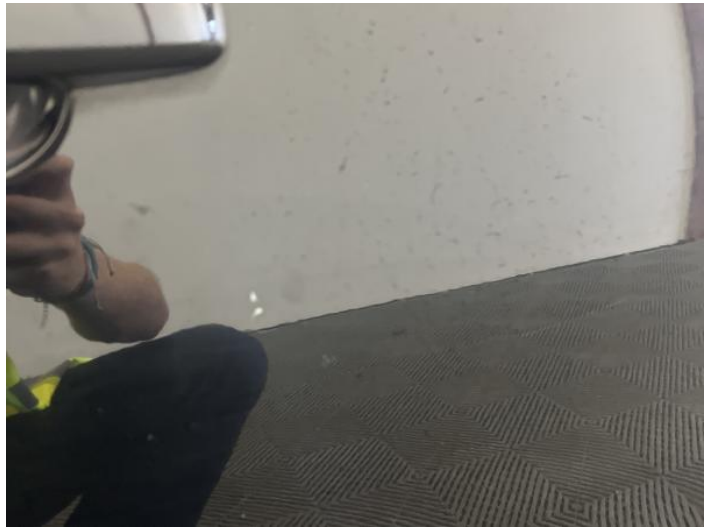
18: Door osr
Scratched
Over 25mm Thru Paint

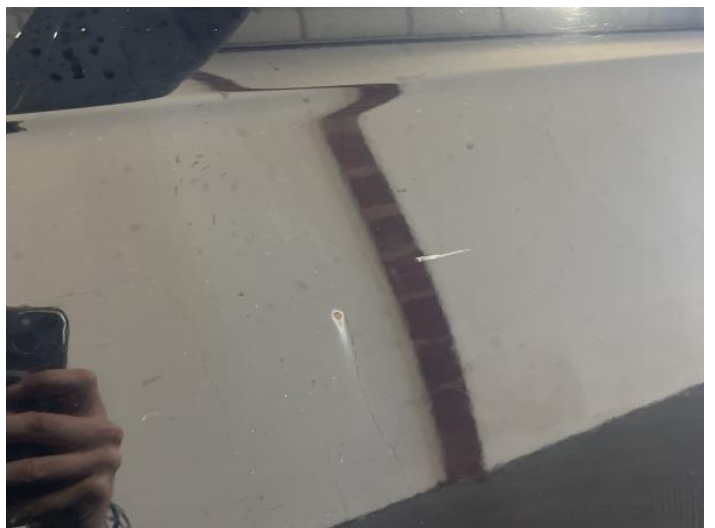
20: Door osf
Rusted
UpTo 5mm

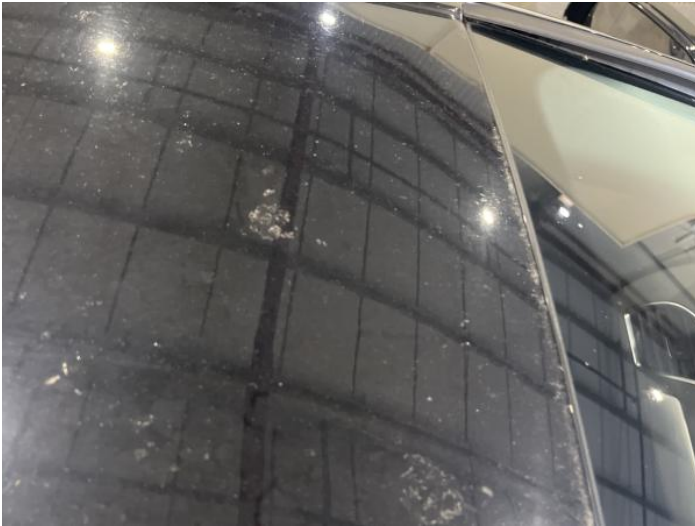
21: Roof
 Scratched
 Over 25mm Thru Paint
