VEHICLE INSPECTION REPORT

GX60CTK

Nissan Note 1.6 Tekna 5dr

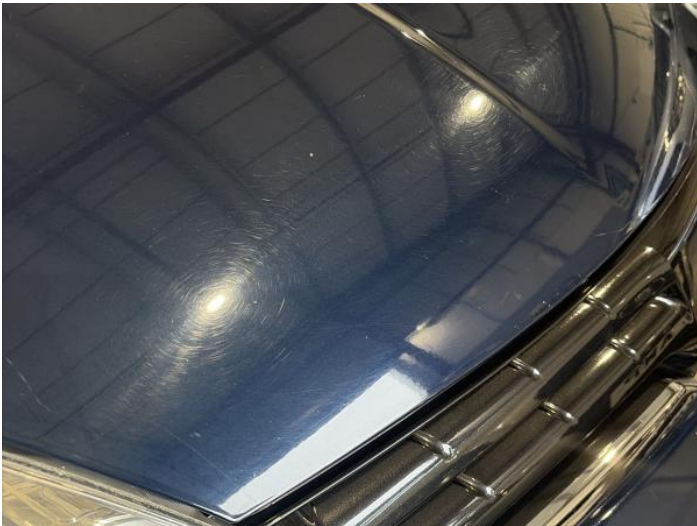
1: Bonnet
Scratched
Over 25mm Thru Paint

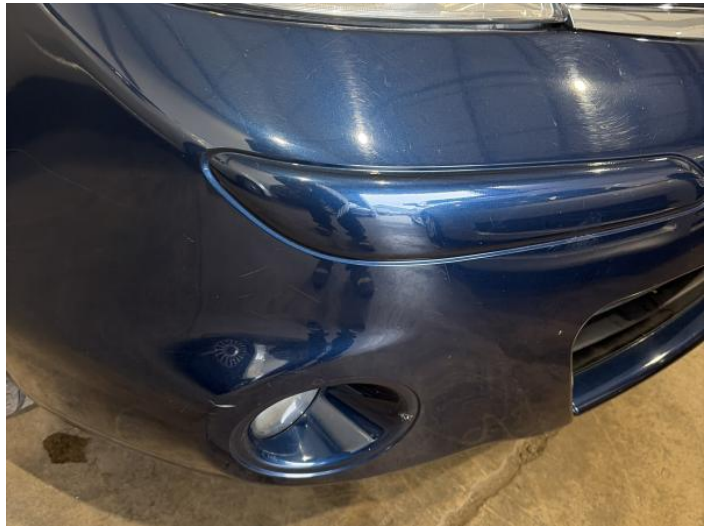
2: Bumper Front
Scratched
25 to 100mm Thru Paint

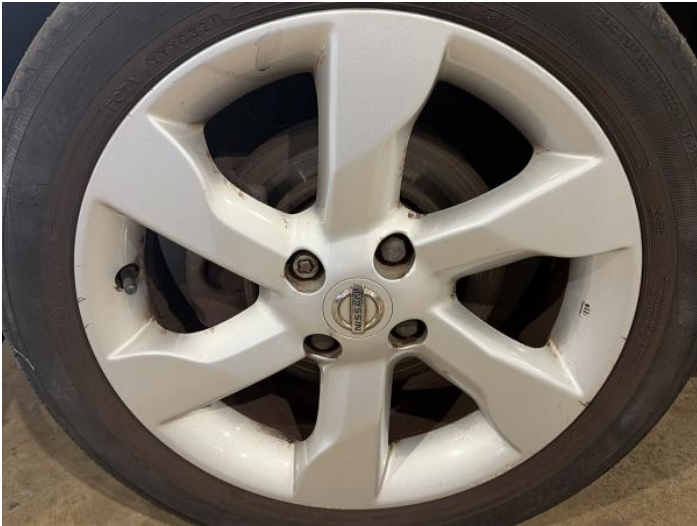
3: Wheel nsf
Scratched
Over 50mm

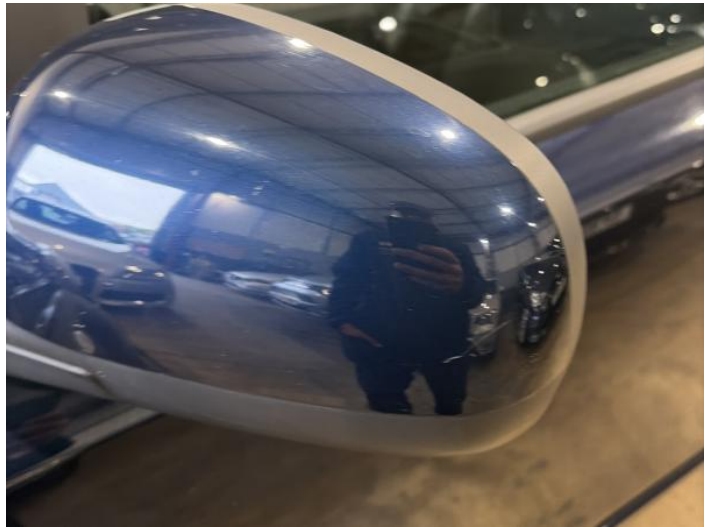
6: Door Mirror Assy nsf
Scratched (Painted)
UpTo 25mm Thru Paint

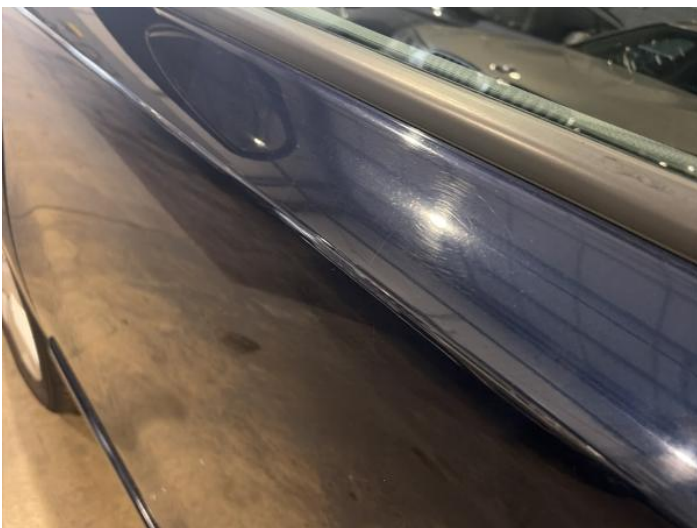
7: Door nsf
Dented
Between 10mm + 30mm

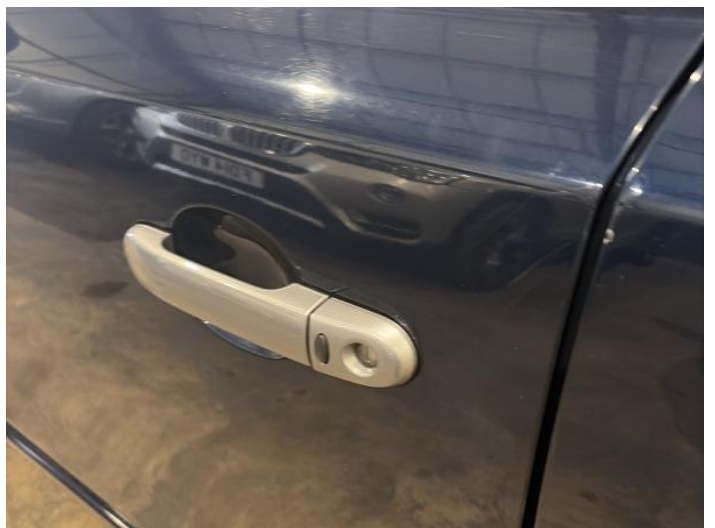
8: Door nsf
Scratched
Over 25mm Thru Paint

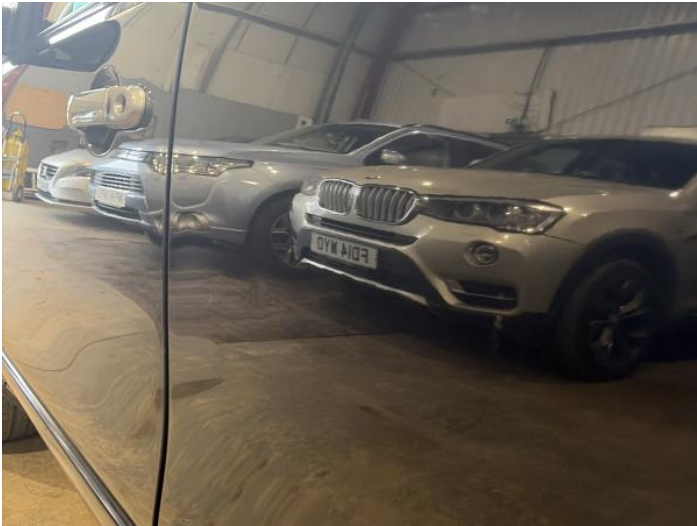
9: Door nsr
Dented
Over 30mm

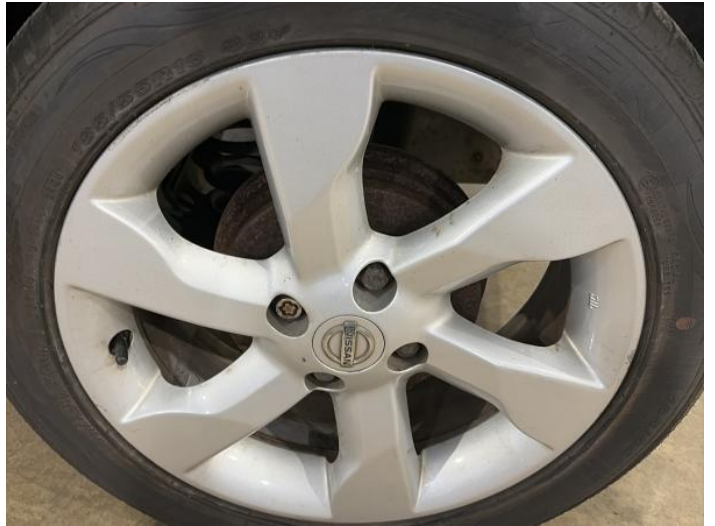
10: Wheel nsr
Scratched
Over 50mm

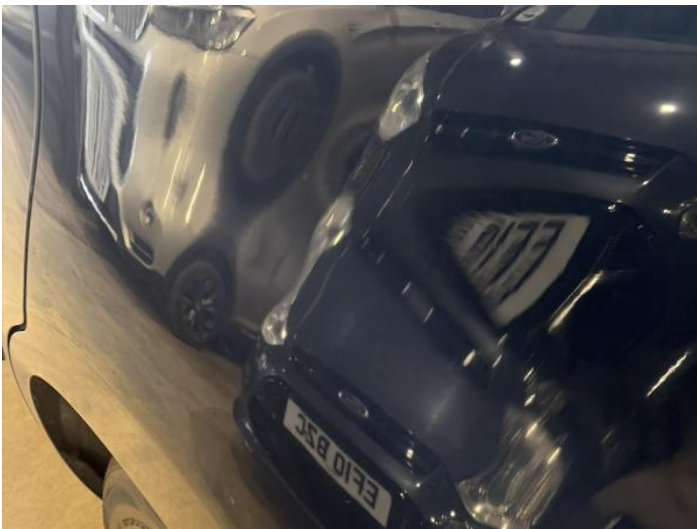
11: Qtr Panel nsr
Scratched
UpTo 25mm Thru Paint

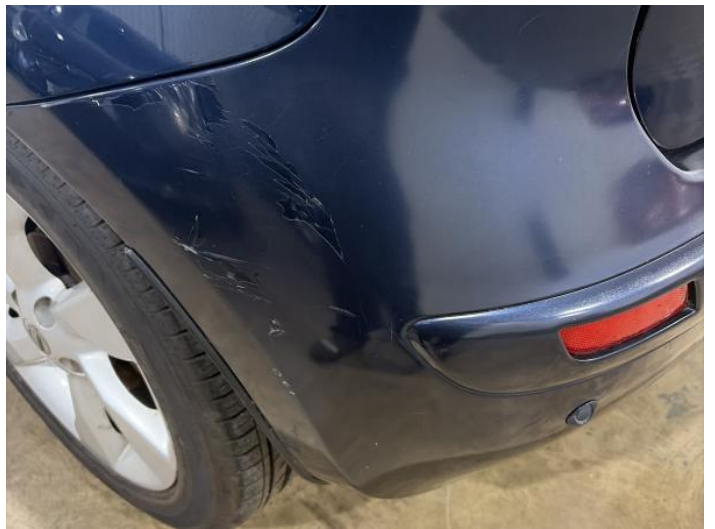
12: Bumper Rear
Poor Previous Repair
Poor Paint

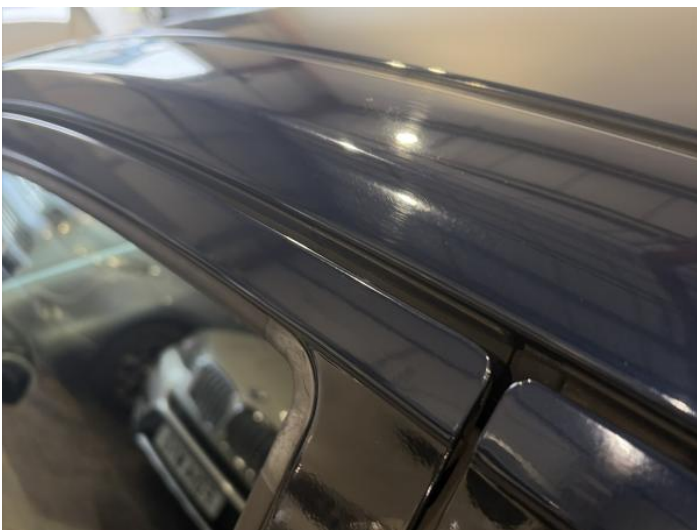
13: A Post ns
Dented
Between 10mm + 30mm

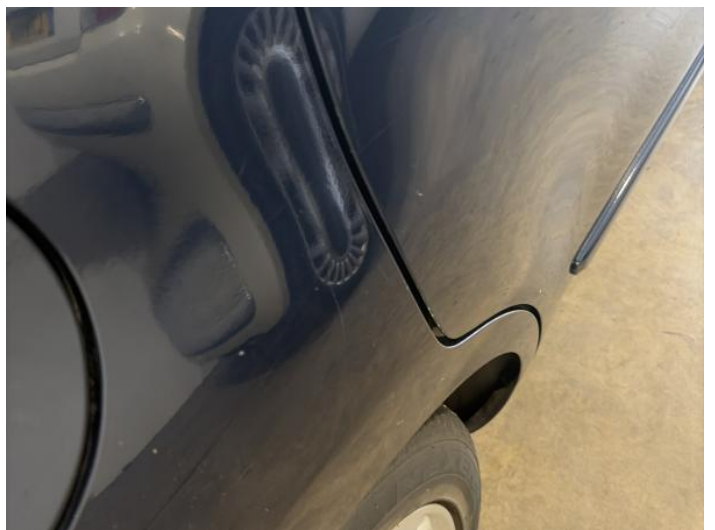
14: Qtr Panel osr
Scratched
Over 25mm Thru Paint

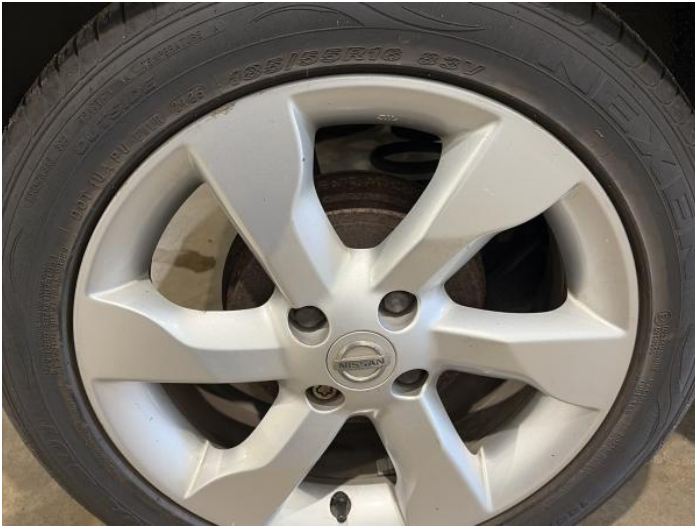
15: Wheel osr
Scratched
Over 50mm

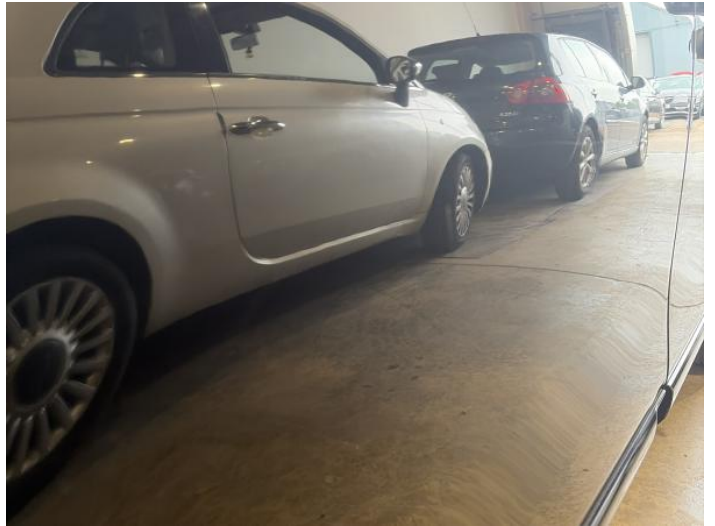
16: Door osr
Dented
Over 30mm

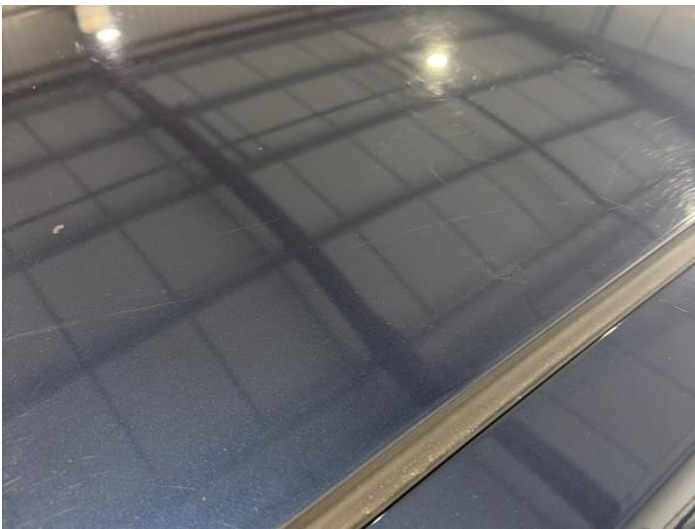
17: Roof
Scratched
Over 25mm Thru Paint

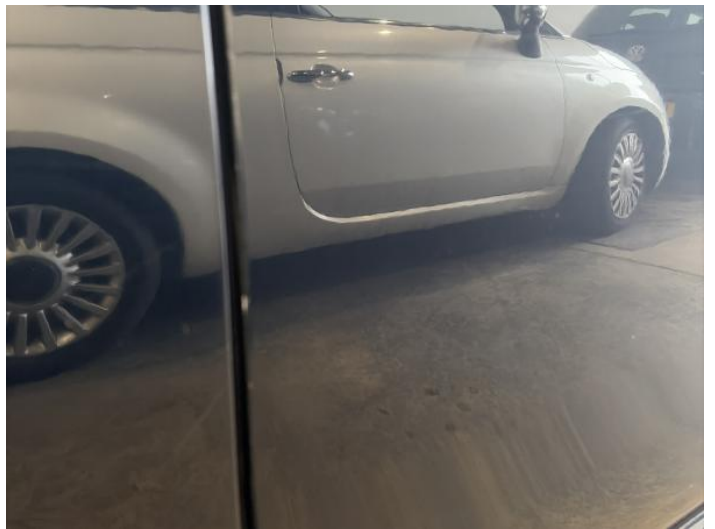
18: Door osf
Chipped
Edge Chip

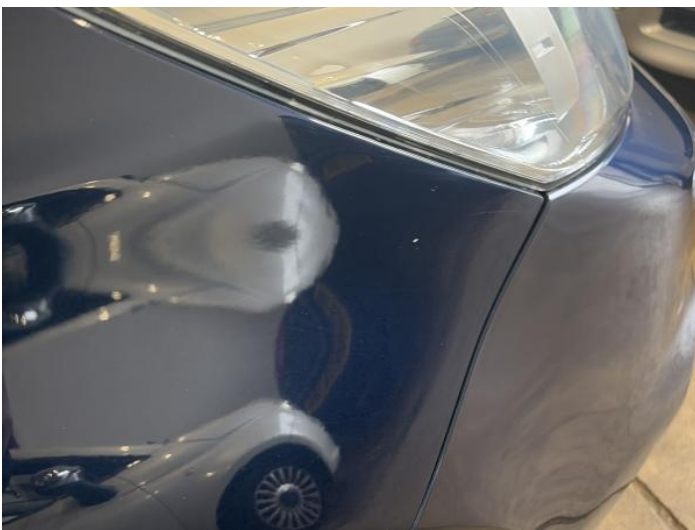
19: Wing osf
Chipped
1 To 5

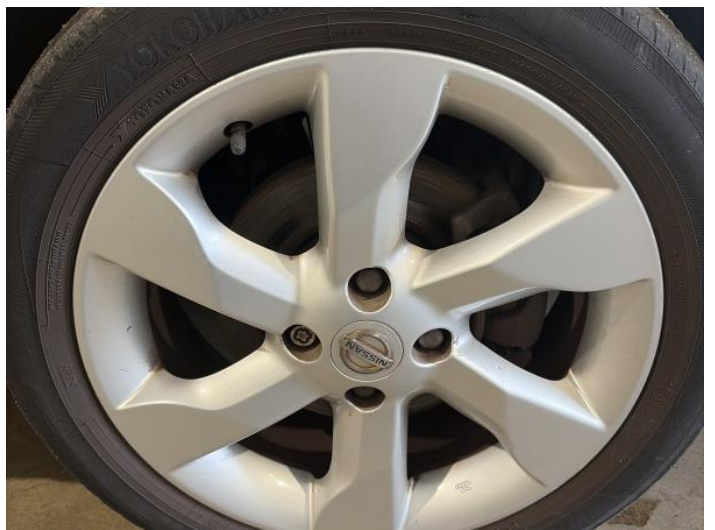
20: Wheel osf
Scratched
Over 50mm
