VEHICLE INSPECTION REPORT

EF10BZC

Ford S-Max 2.0 TDCi 163 Titanium X Sport 5dr Powershift

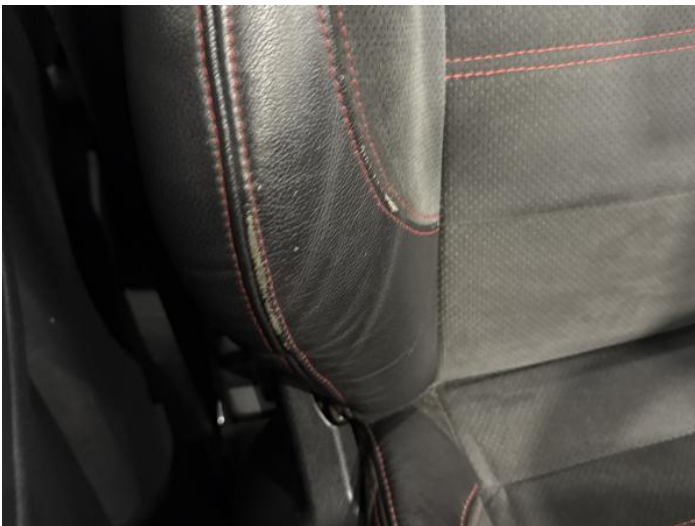
1: Seat Back Cover osf
Scuffed
Over 25mm

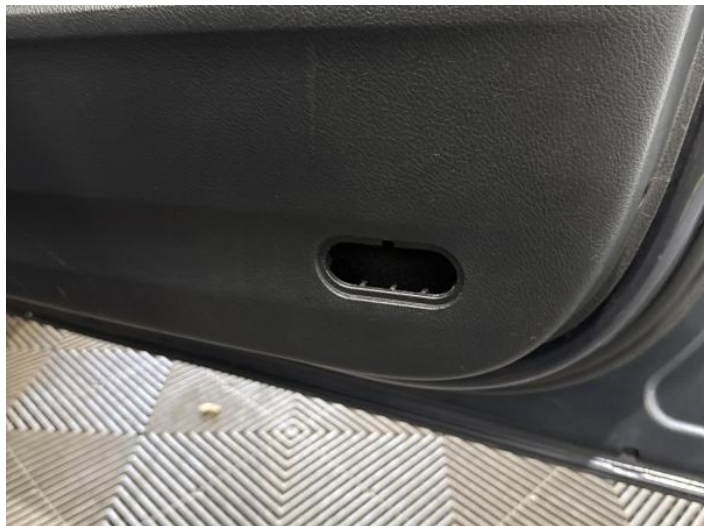
2: Fascia Trim
Missing
Replace

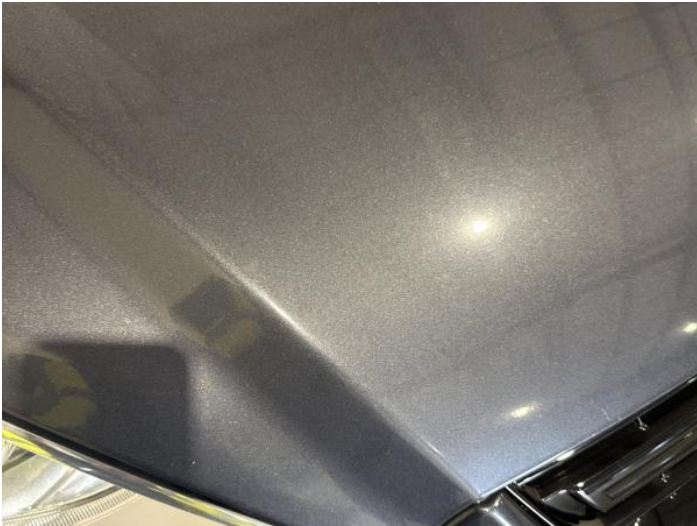
3: Bonnet
Chipped
1 To 5

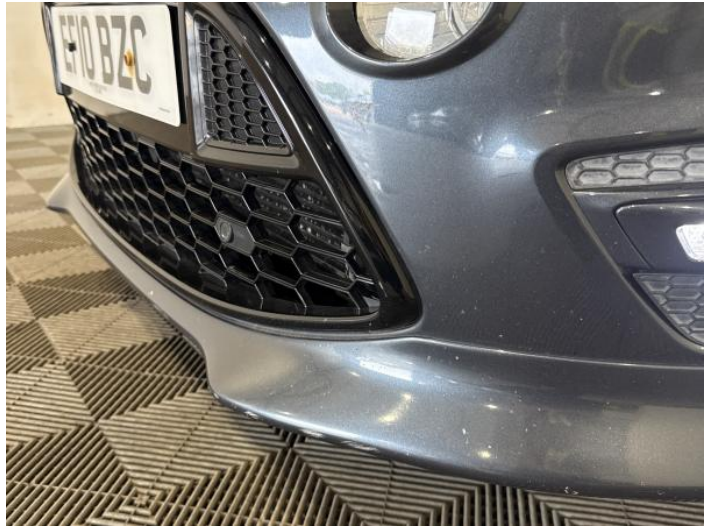
4: Bumper Front
Poor Previous Repair
Poor Paint

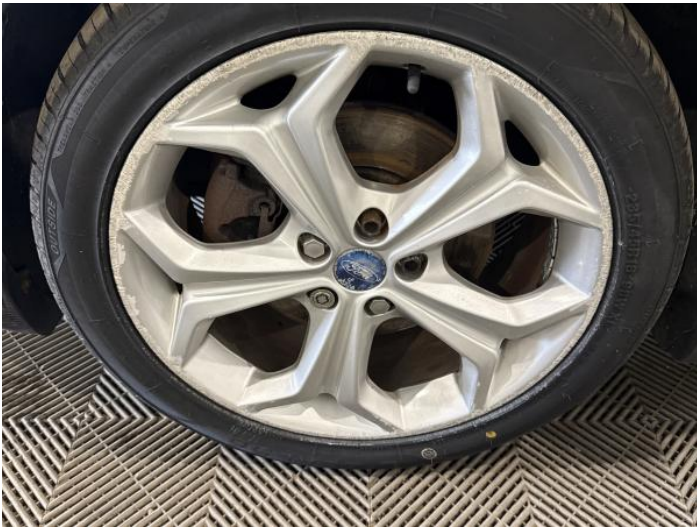
5: Wheel nsf
Scratched
Over 50mm

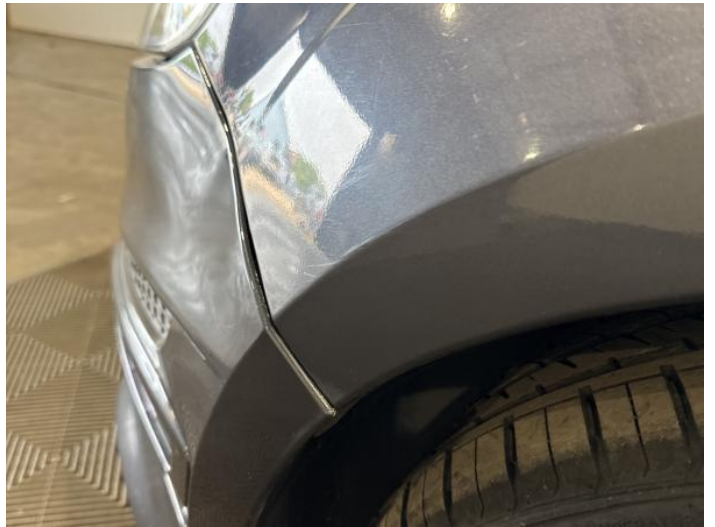
6: Wing nsf
Scratched
UpTo 25mm Thru Paint

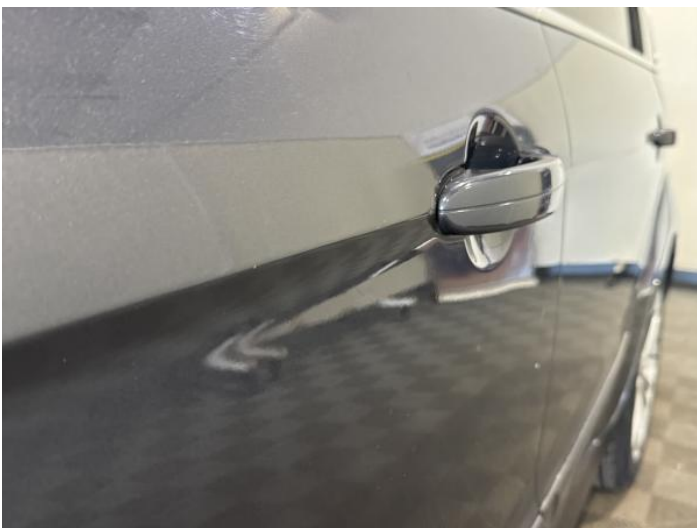
7: Door nsf
Dented
Between 10mm + 30mm

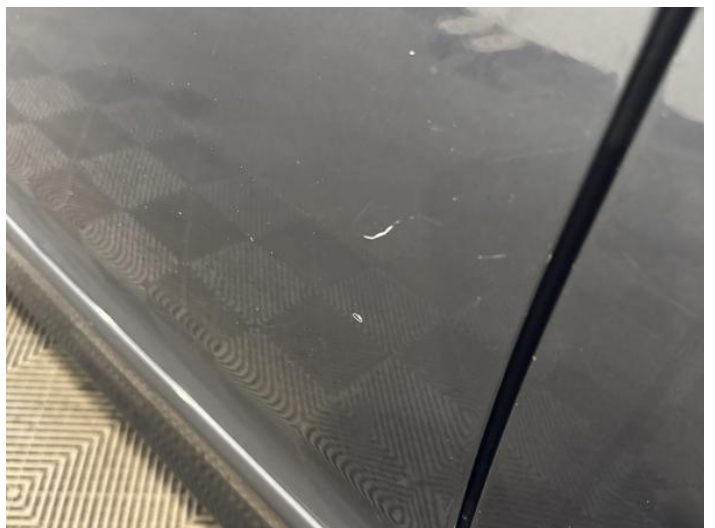
8: Door nsf
Scratched
UpTo 25mm Thru Paint

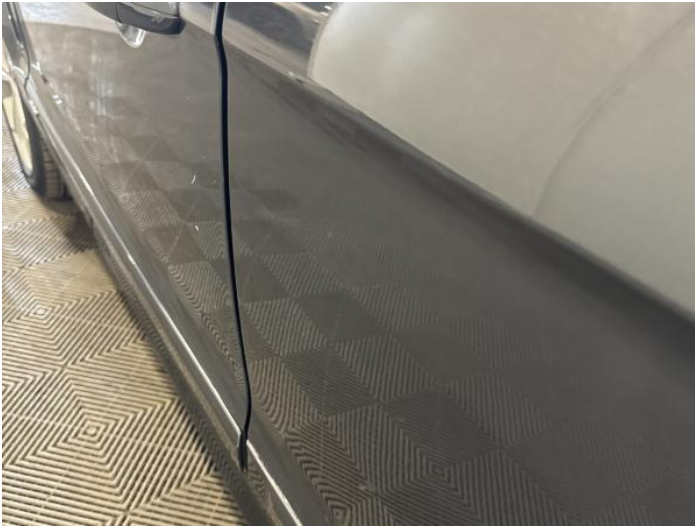
9: Door nsr
Dented
Between 10mm + 30mm

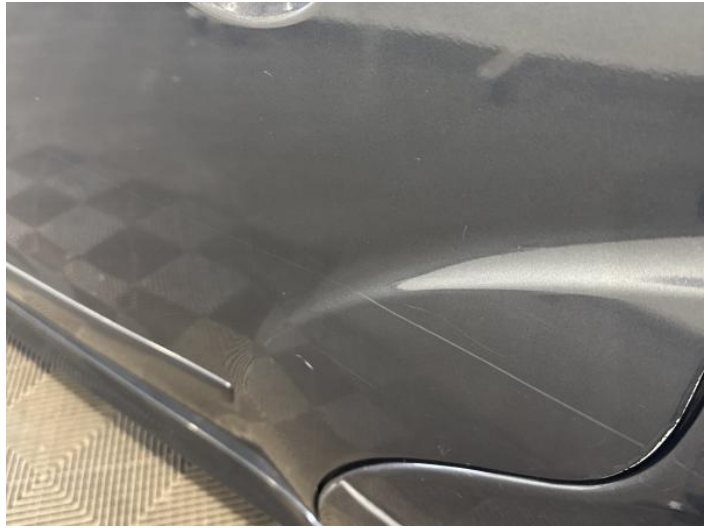
10: Door nsr
Scratched
Over 25mm Thru Paint

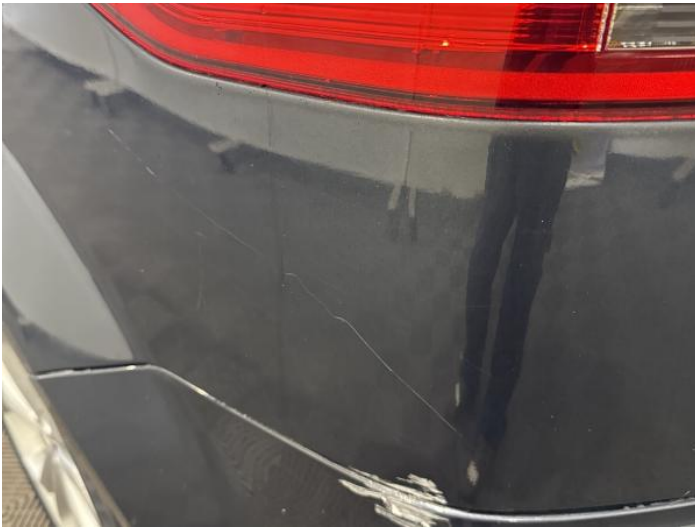
11: Qtr Panel nsr
Dented
With Paint Damage

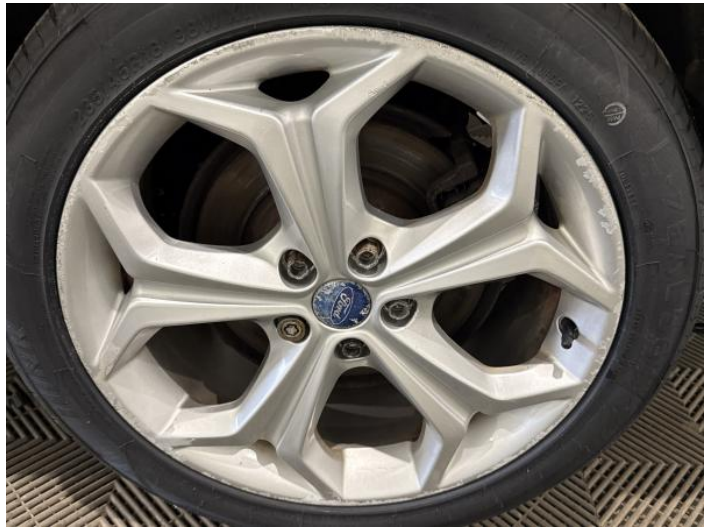
12: Wheel nsr
Scratched
Over 50mm

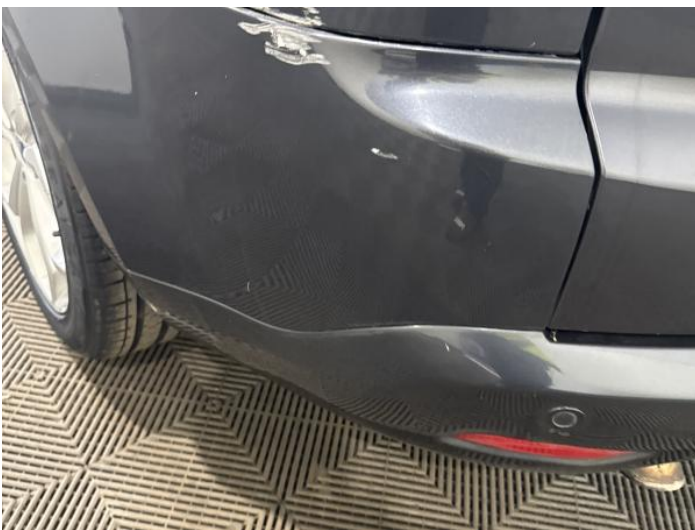
13: Bumper Rear
Scratched
Over 100mm Thru Paint

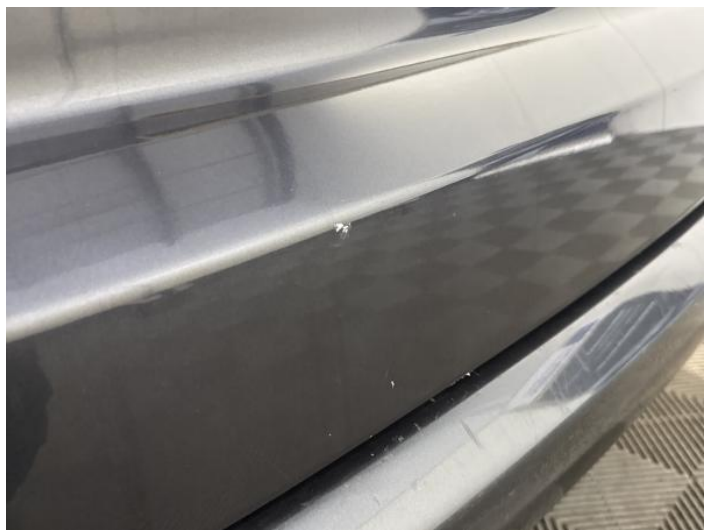
14: Tailgate
Scratched
UpTo 25mm Thru Paint

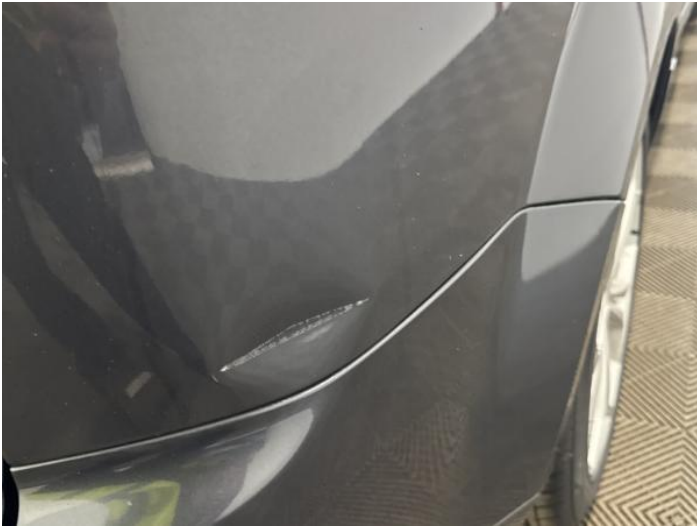
15: Qtr Panel osr
Dented
With Paint Damage

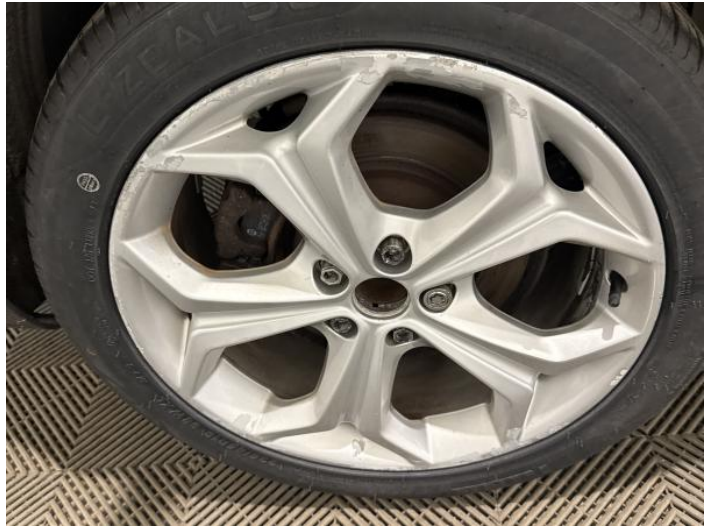
16: Wheel osr
Scratched
Over 50mm

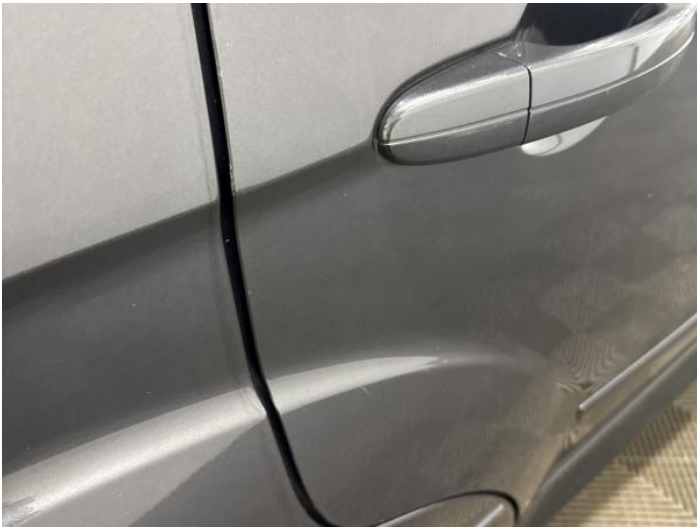
17: Door osr
Chipped
Edge Chip

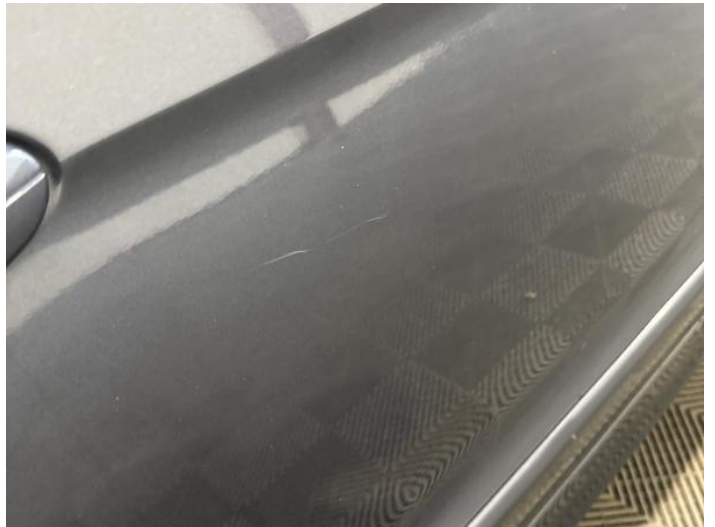
18: Door osf
Scratched
Over 25mm Thru Paint

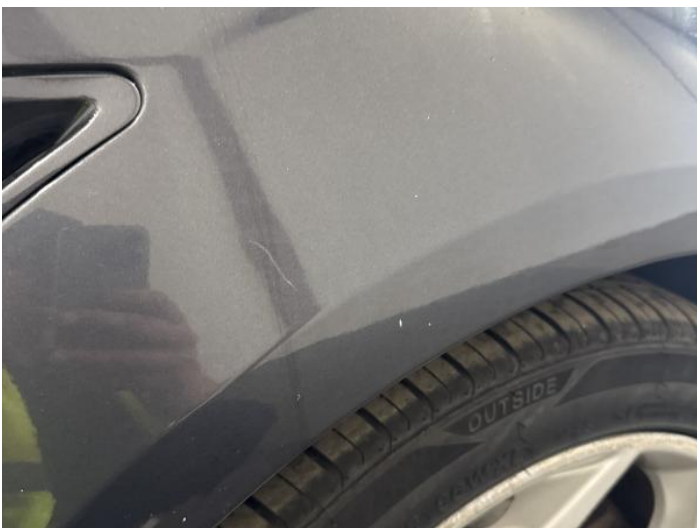
19: Wing osf
Scratched
Up To 25mm Thru Paint

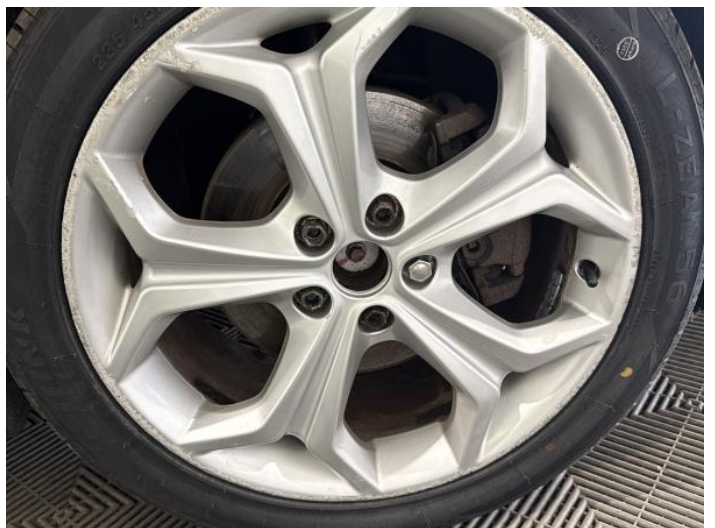
20: Wheel osf
Scratched
Over 50mm

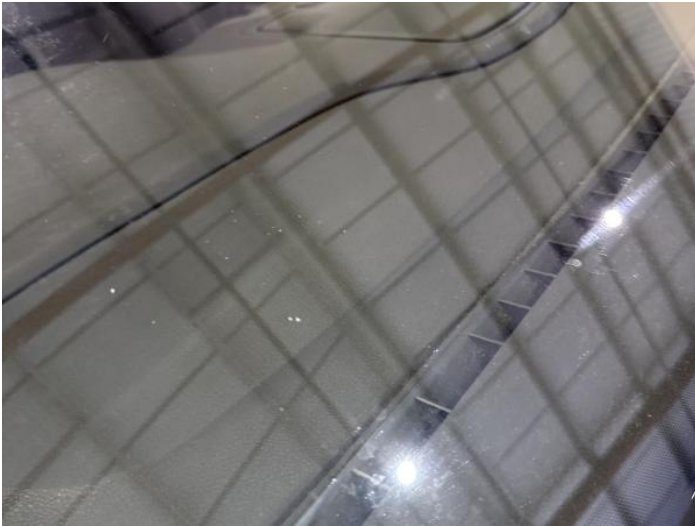
21: Screen Front
Chipped
UpTo 10mm

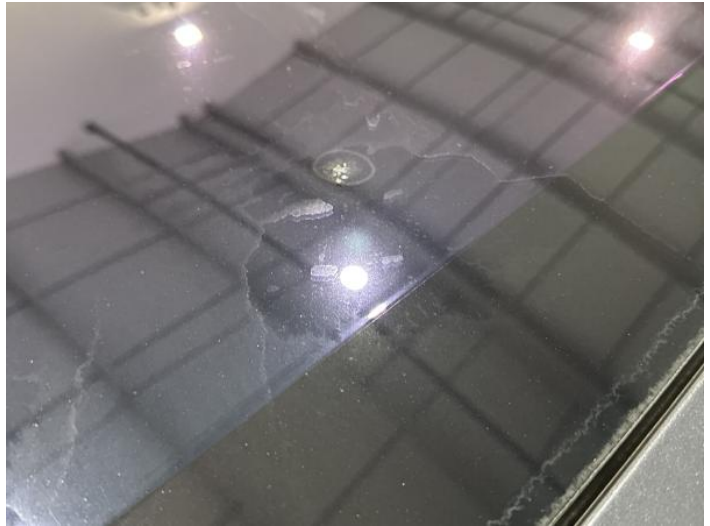
Cracked panoramic roof

22: Glass Roof
Cracked
Replace
