VEHICLE INSPECTION REPORT

GV12FVF

Volvo V40 D2 SE Nav 5dr

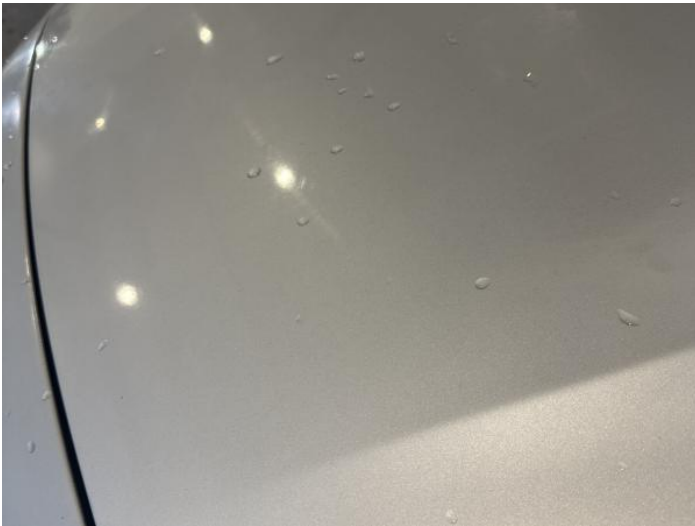
1: Bonnet
Poor Previous Repair
Poor Paint

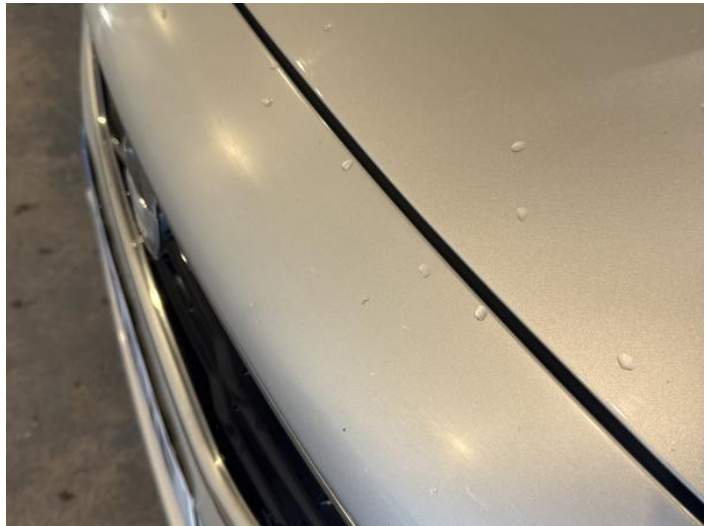
2: Bumper Front
Poor Previous Repair
Poor Paint

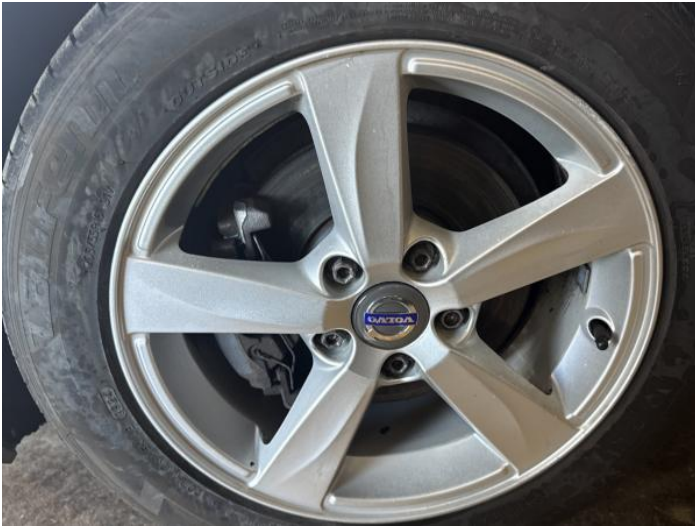
3: Wheel nsf
Scratched
Over 50mm

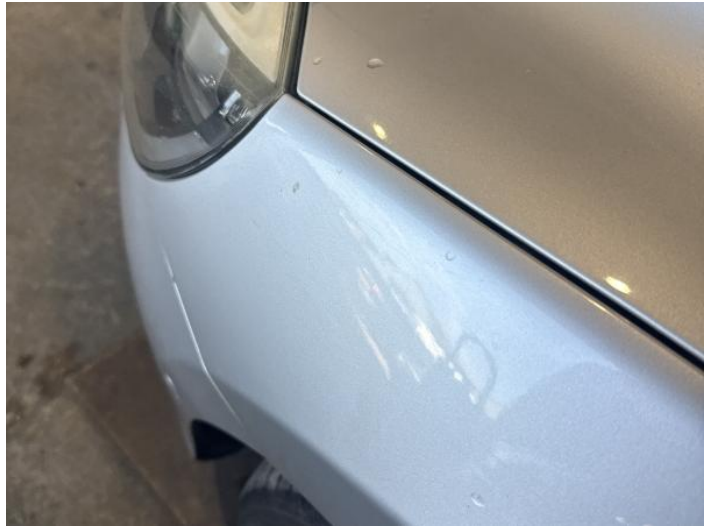
4: Wing nsf
Scratched
UpTo 25mm Thru Paint

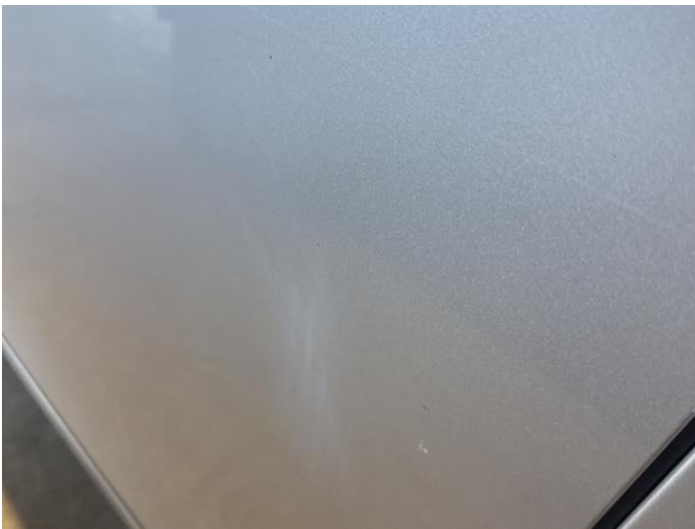
5: Door nsf
Scratched
Over 25mm Thru Paint

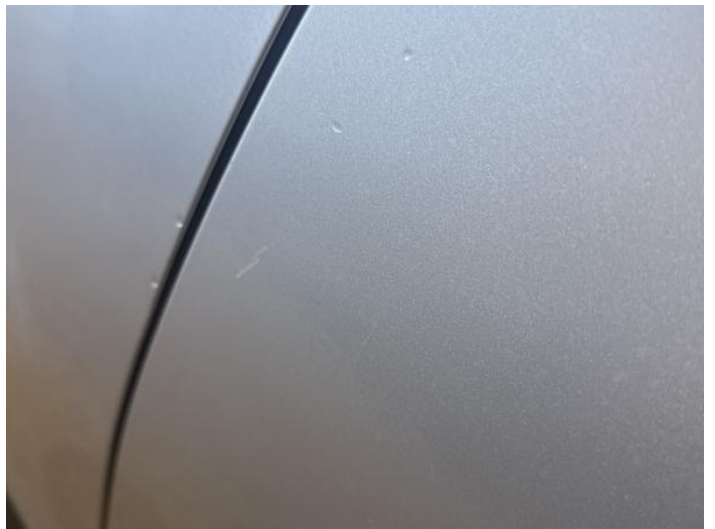
6: Door nsr
Scratched
UpTo 25mm Thru Paint

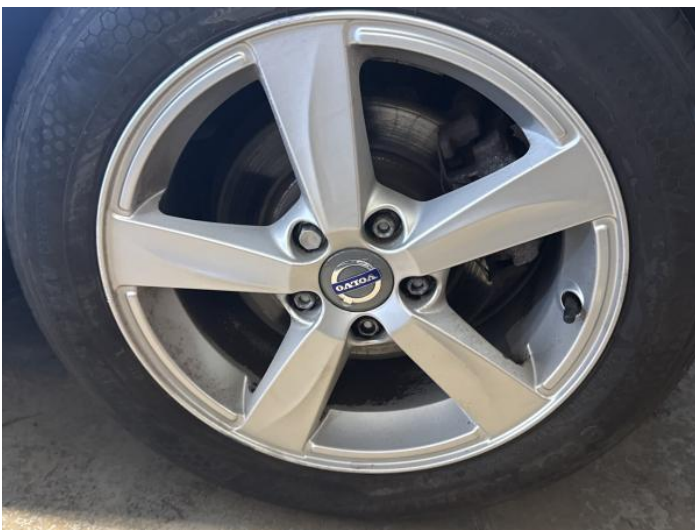
7: Wheel nsr
Scratched
Up To 50mm

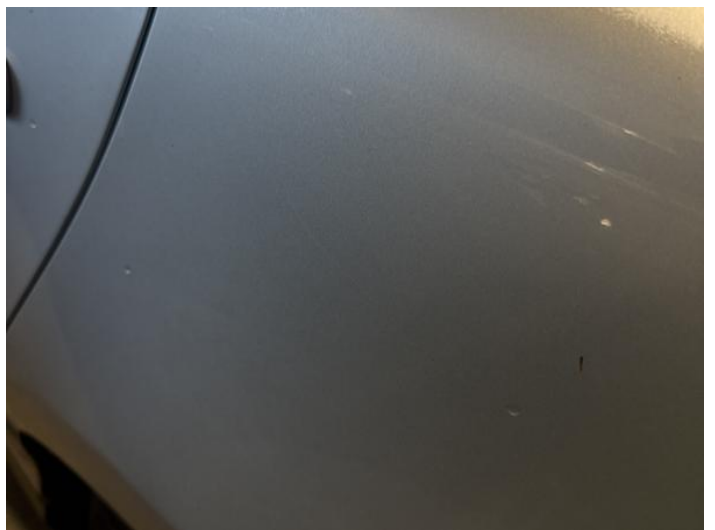
8: Qtr Panel nsr
Scratched
Over 25mm Thru Paint

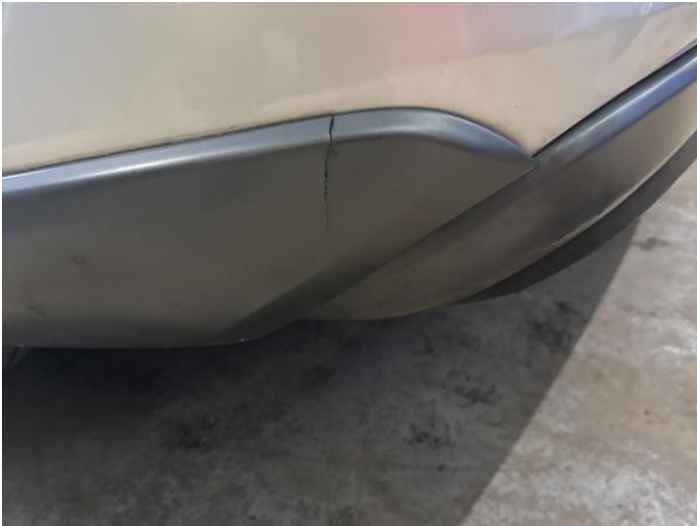
9: Bumper Rear Moulding
Broken
Replace

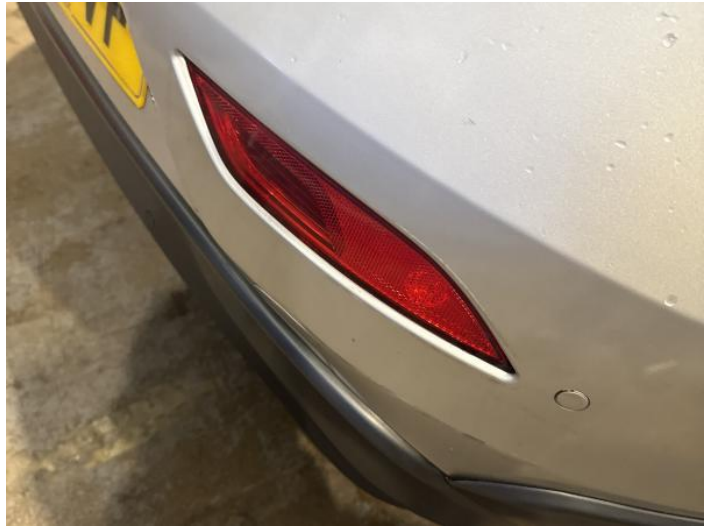
10: Bumper Rear
Poor Previous Repair
Poor Paint

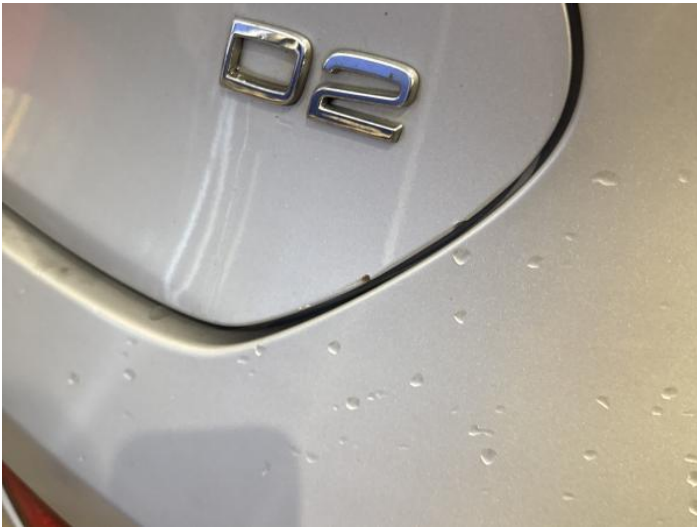
11: Tailgate
Scratched
Rusted

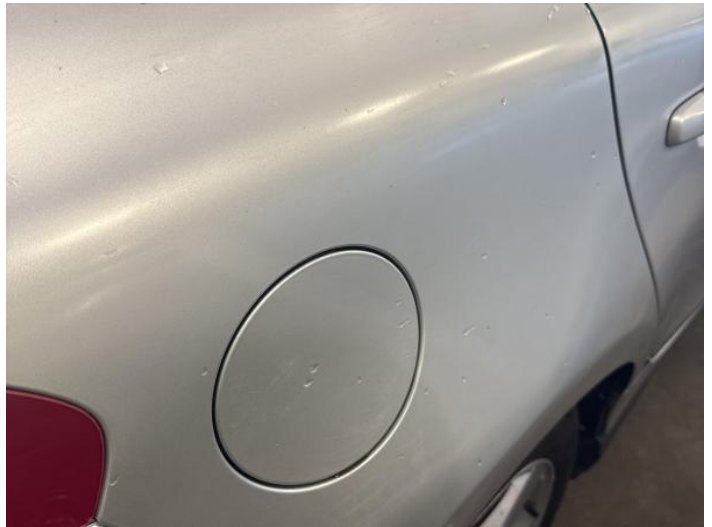
12: Qtr Panel osr
Scratched
Over 25mm Thru Paint

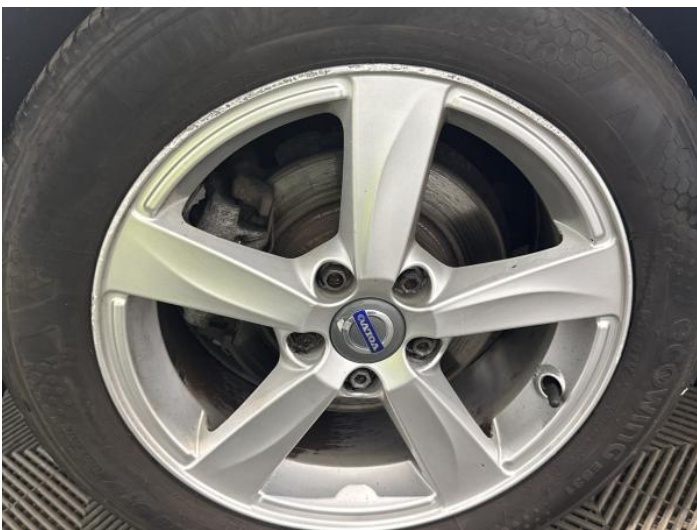
13: Wheel osr
Scratched
Over 50mm

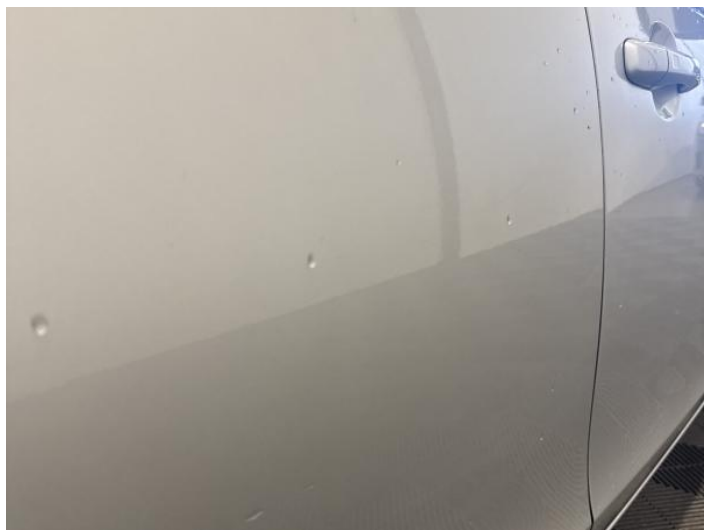
14: Door osr
Scratched
Over 25mm Thru Paint

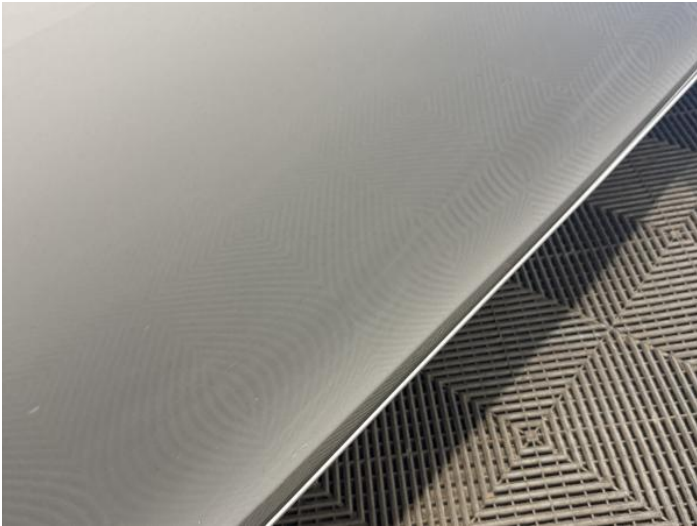
15: Door osf
 Scratched
 Over 25mm Thru Paint

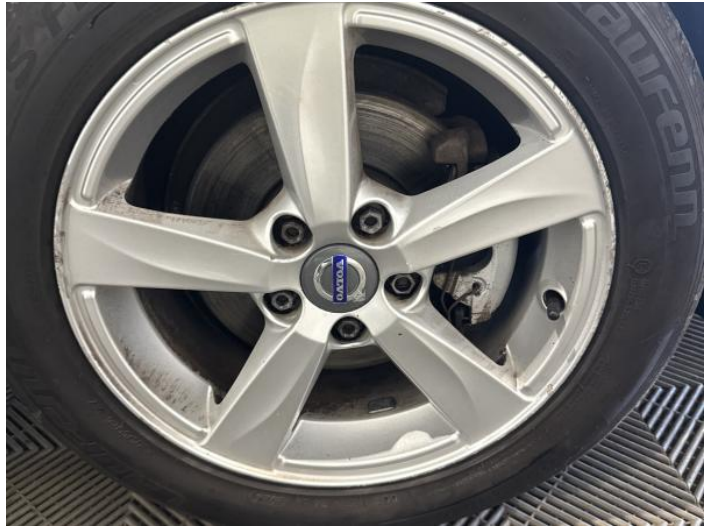
16: Wheel osf
 Scratched
 Over 50mm

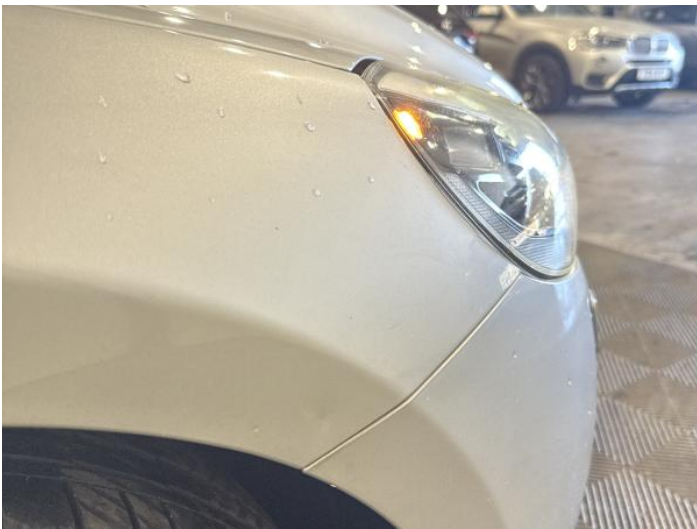
17: Wing osf
 Dented
 Between 10mm + 30mm

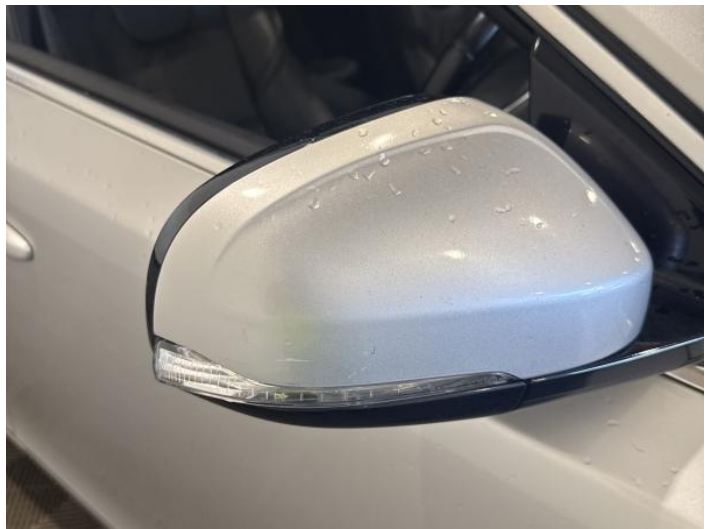
18: Door Mirror Assy osf
 Scratched (Painted)
 Over 25mm Thru Paint
