VEHICLE INSPECTION REPORT

CF14BJX

Citroen C4 Picasso 1.6 e-HDi 115 Airdream Exclusive 5dr

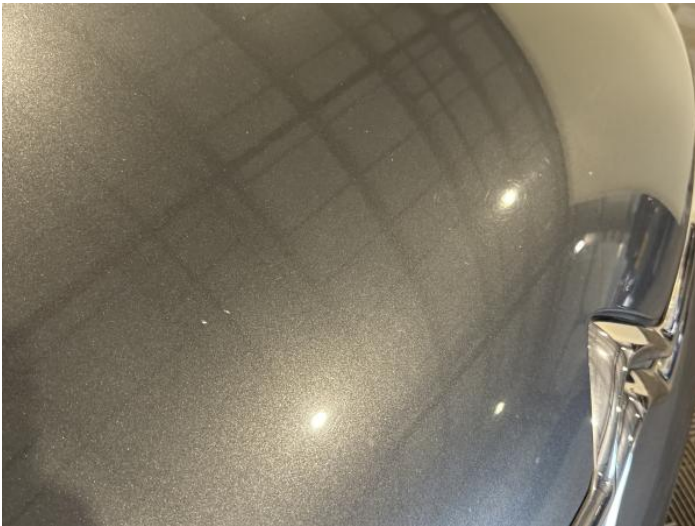
1: Bonnet
Chipped
1 To 5

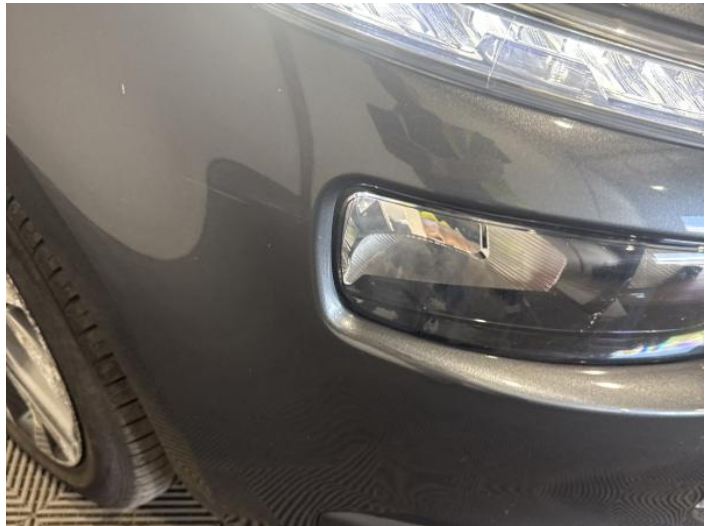
2: Bumper Front
Scratched
Over 100mm Thru Paint

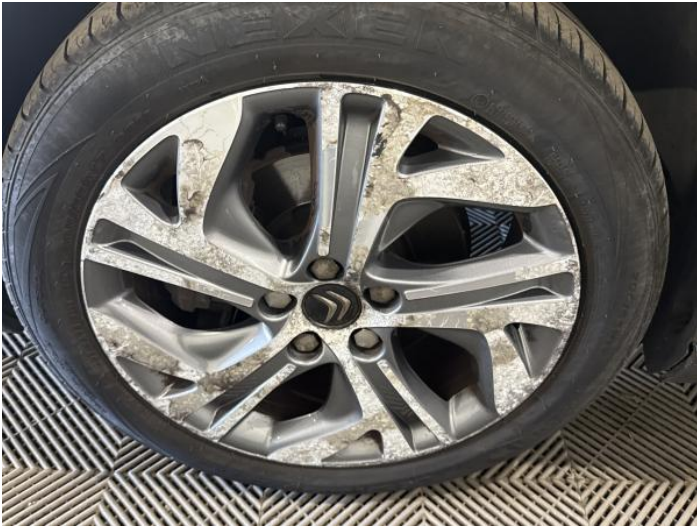
3: Wheel nsf
Scratched
Over 50mm

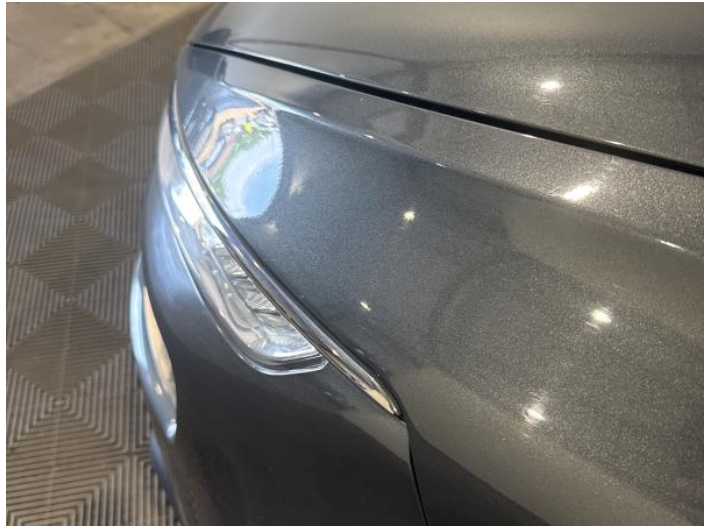
4: Wing nsf
Chipped
1 To 5

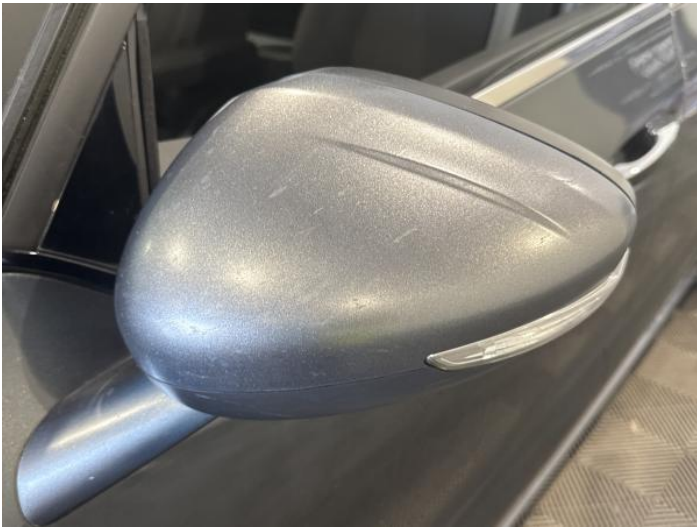
5: Door Mirror Assy nsf
Scratched (Painted)
Over 25mm Thru Paint

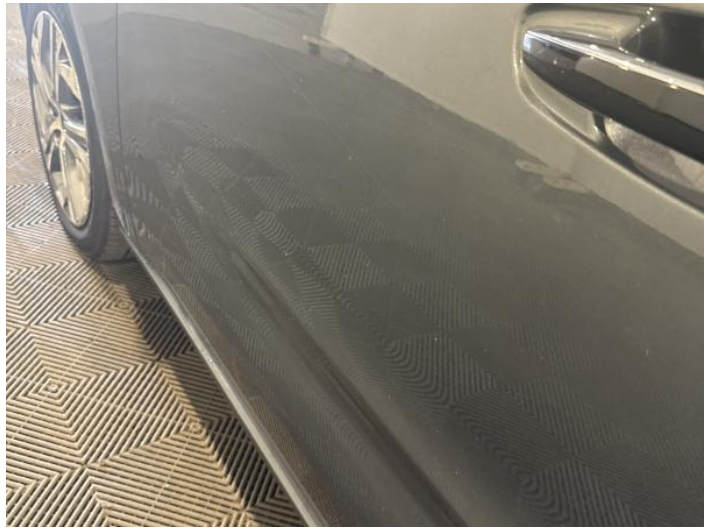
6: Door nsf
Chipped
Multiple Chips

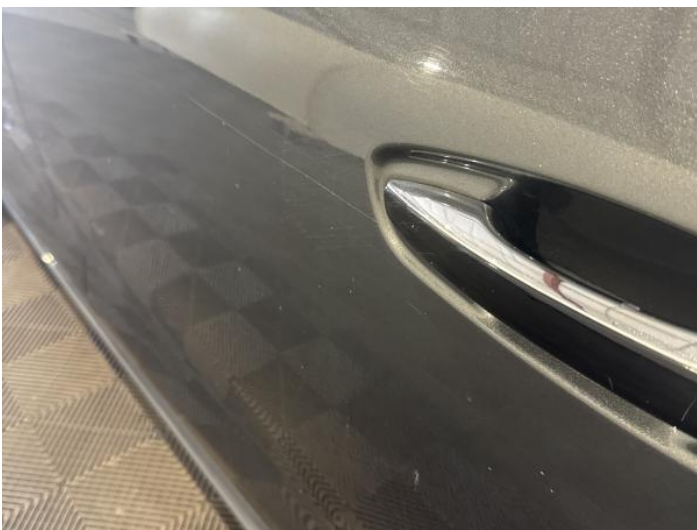
7: Door nsr
Scratched
Over 25mm Thru Paint

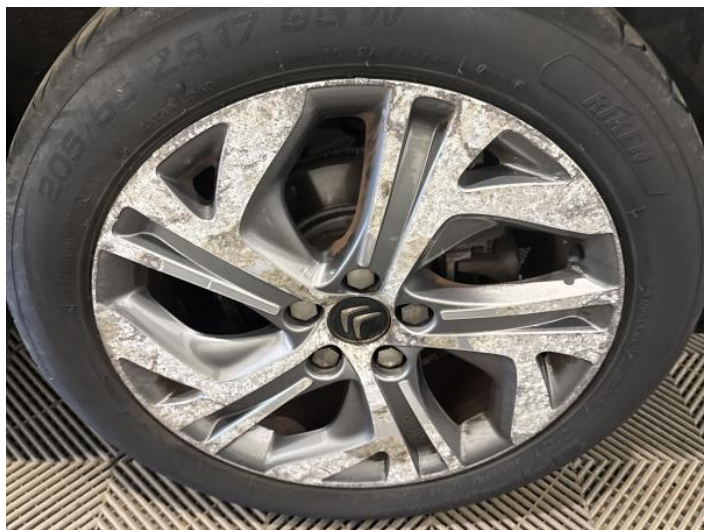
8: Wheel nsr
Scratched
Over 50mm

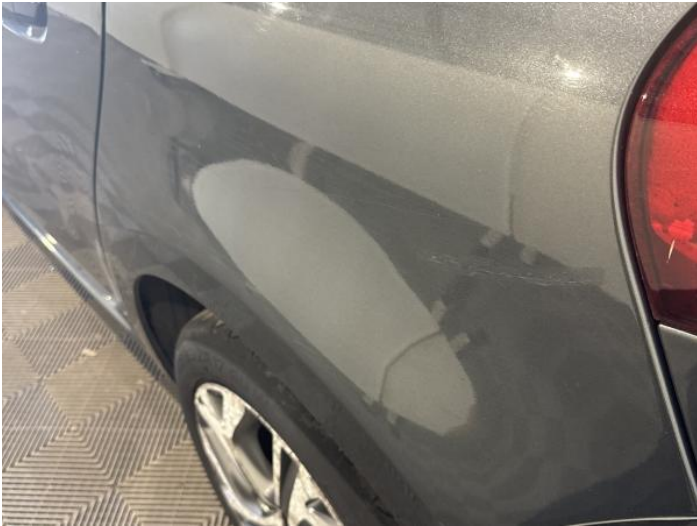
9: Qtr Panel nsr
Dented
With Paint Damage

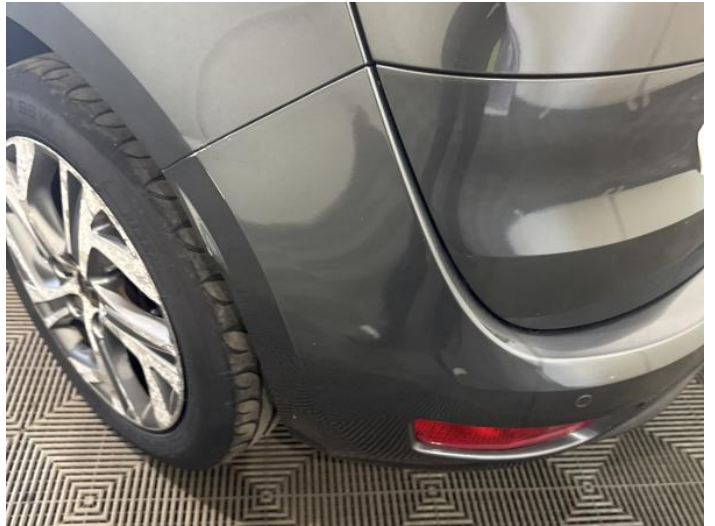
10: Bumper Rear
Scratched
25 to 100mm Thru Paint

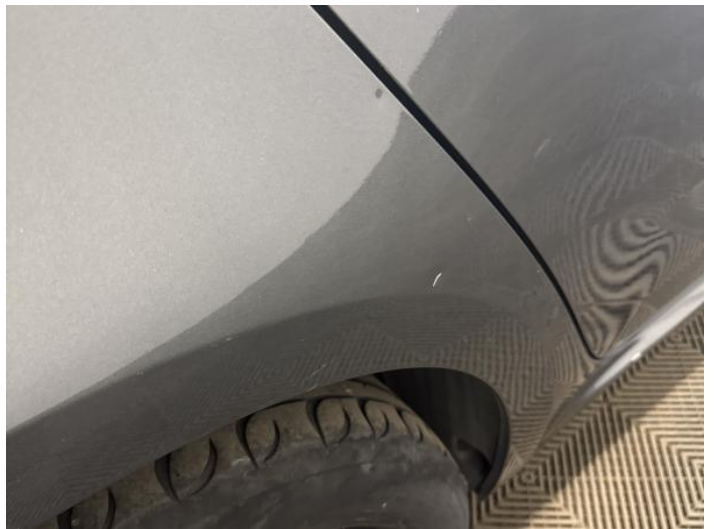
12: Qtr Panel osr
Dented
Between 10mm + 30mm

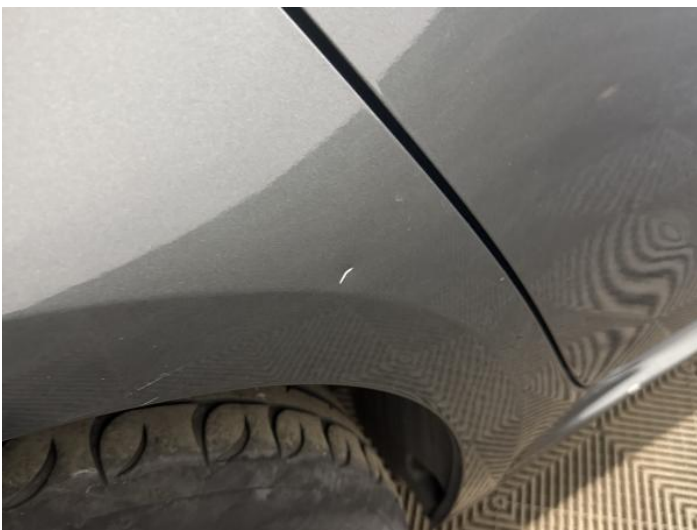
13: Qtr Panel osr
Scratched
Up To 25mm Thru Paint

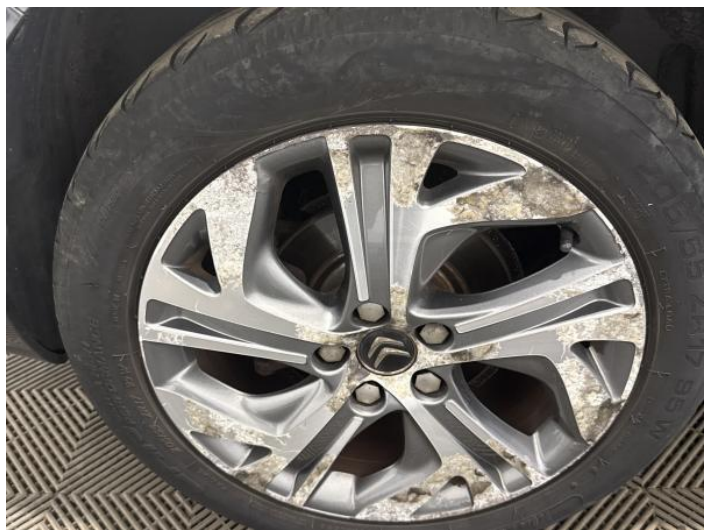
14: Wheel osr
Scratched
Over 50mm

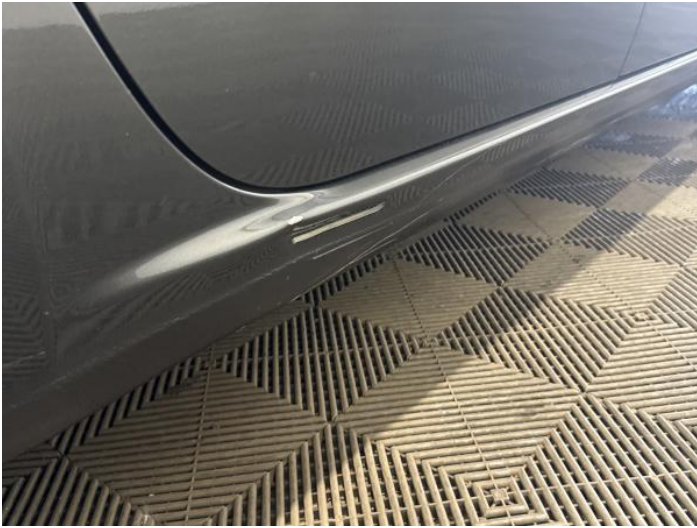
15: Sill os
Dented
With Paint Damage

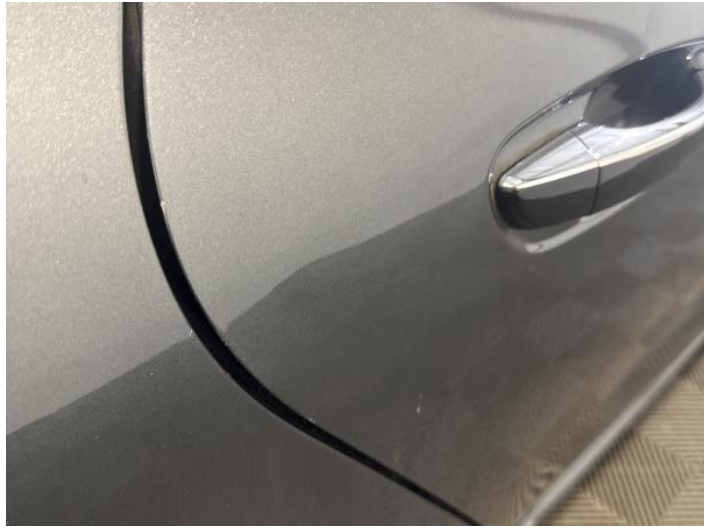
16: Door osr
Dented
Between 10mm + 30mm

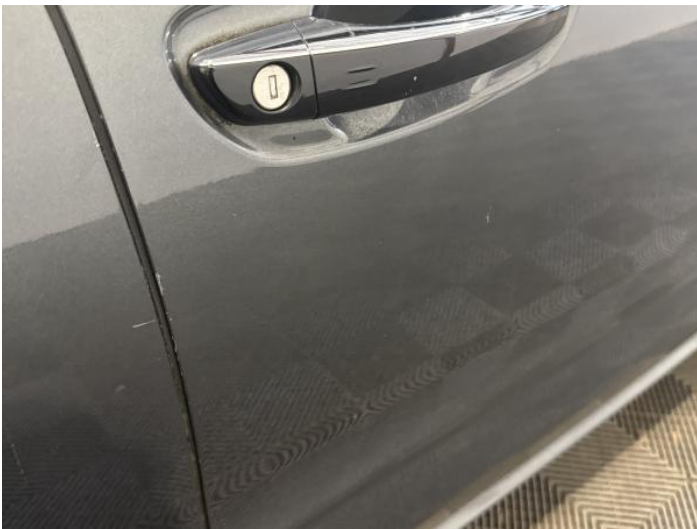
17: Door osf
Chipped
Edge Chip

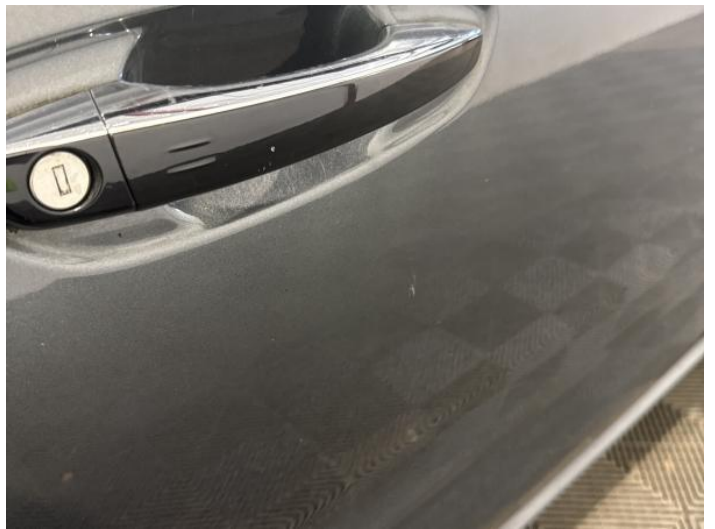
18: Door osf
Scratched
UpTo 25mm Thru Paint

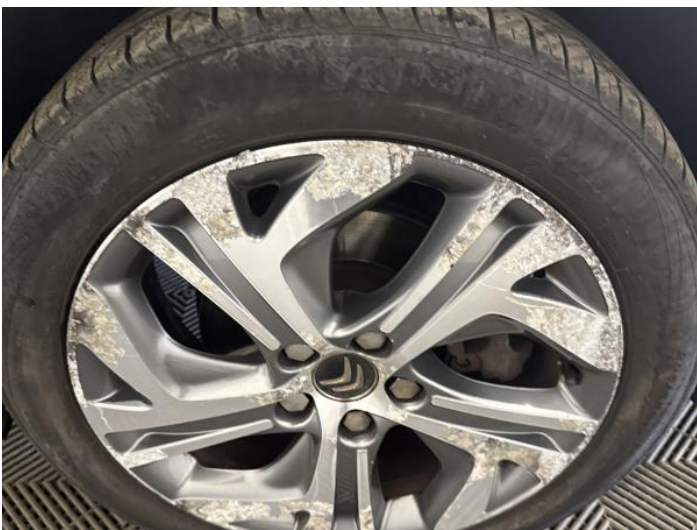
19: Wheel osf
Scratched
Over 50mm

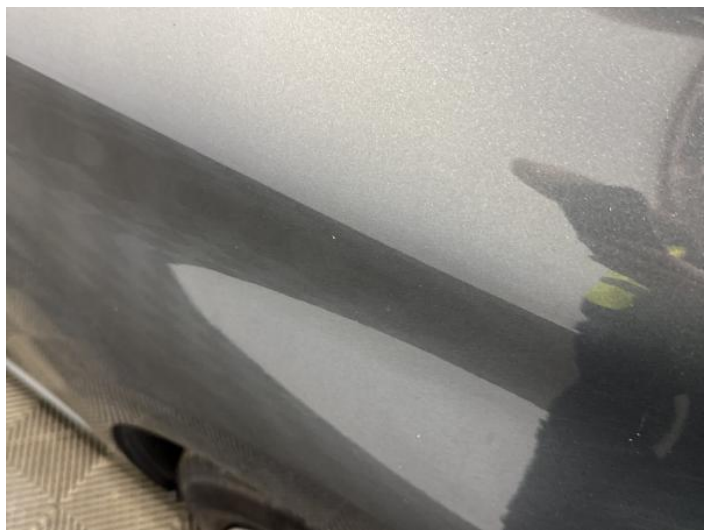
20: Wing osf
Chipped
1 To 5
