# VEHICLE INSPECTION REPORT

**LR09RVE**

## Mercedes-Benz M-Class ML 280 CDI SPORT

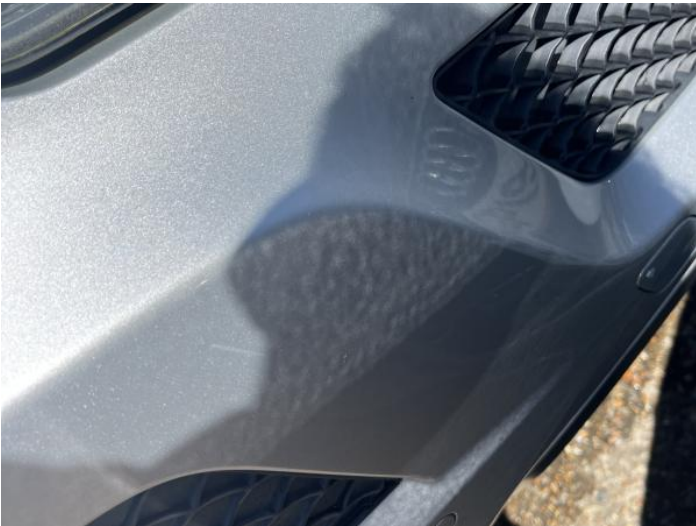
1: Bumper Front  
Scratched  
Over 100mm Thru Paint

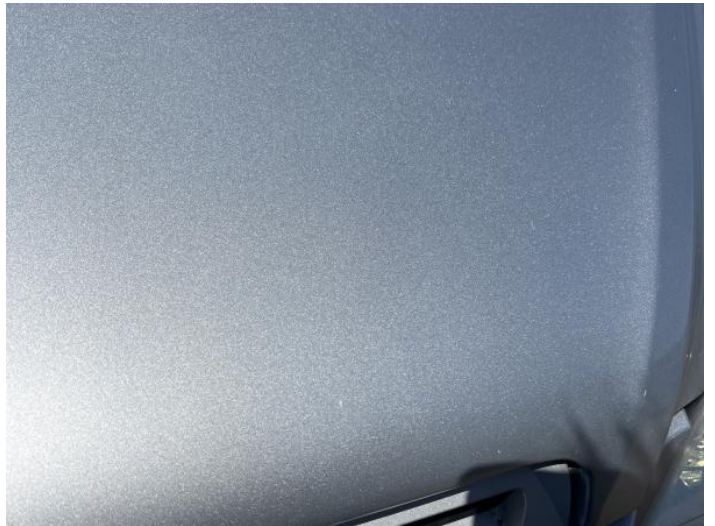
2: Bonnet  
Chipped  
Multiple Chips

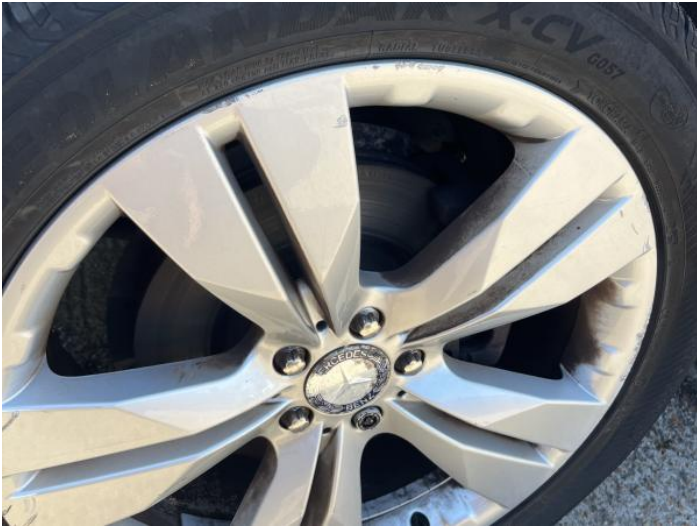
3: Wheel osf  
Scratched  
Over 50mm

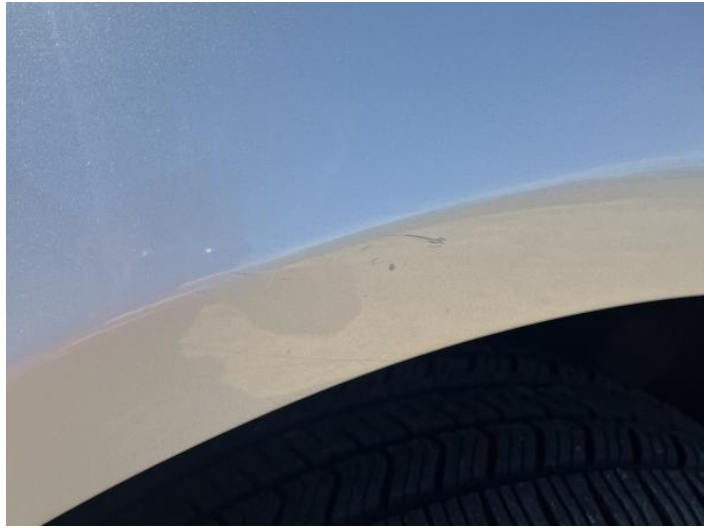
4: Wing nsf  
Scratched  
Over 25mm Thru Paint

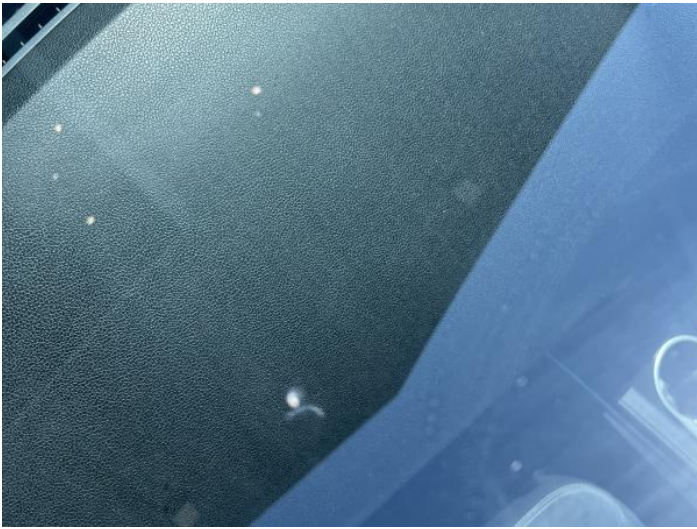
5: Screen Front  
Chipped  
UpTo 10mm

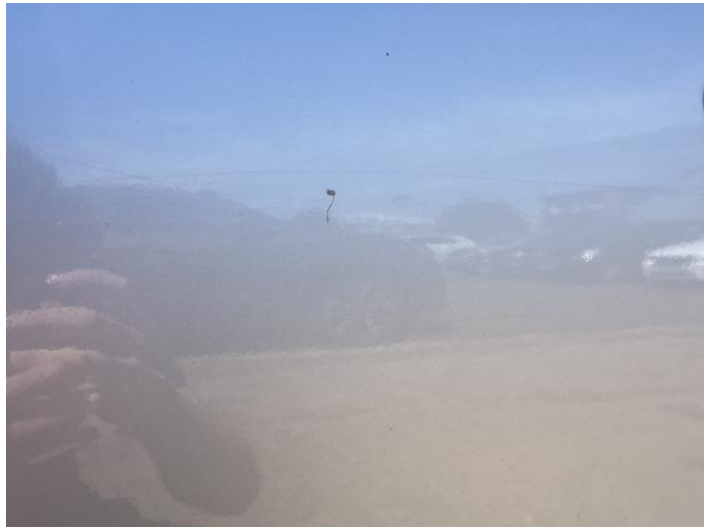
6: Door nsf  
Scratched  
Over 25mm Thru Paint

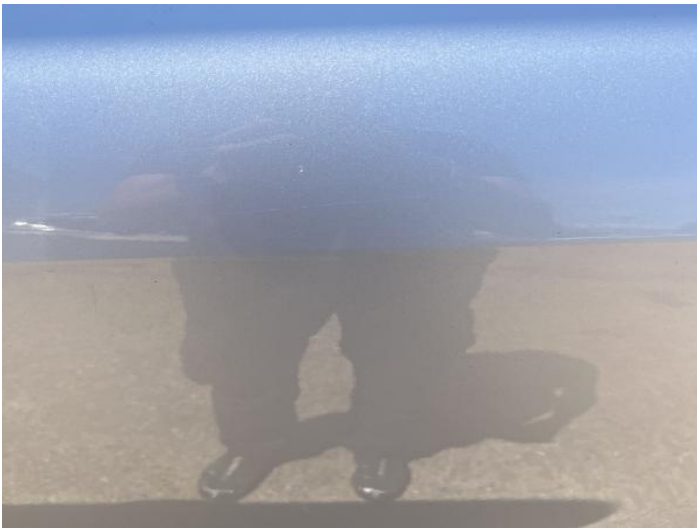
7: Door nsr  
Scratched  
Over 25mm Thru Paint

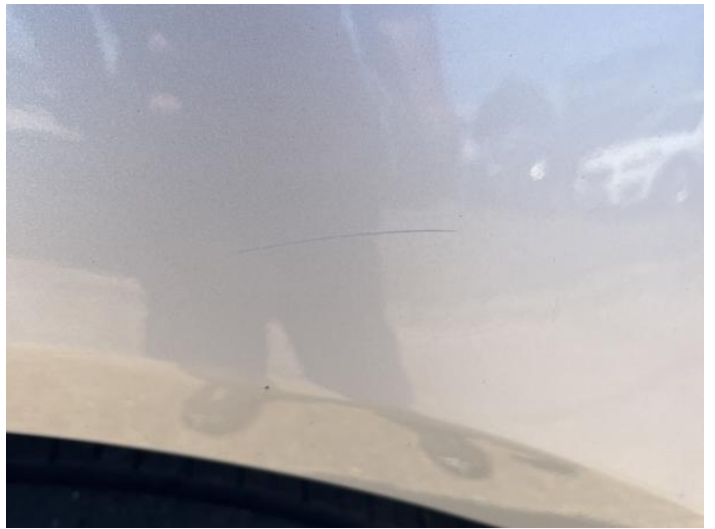
8: Qtr Panel nsr  
Scratched  
Over 25mm Thru Paint

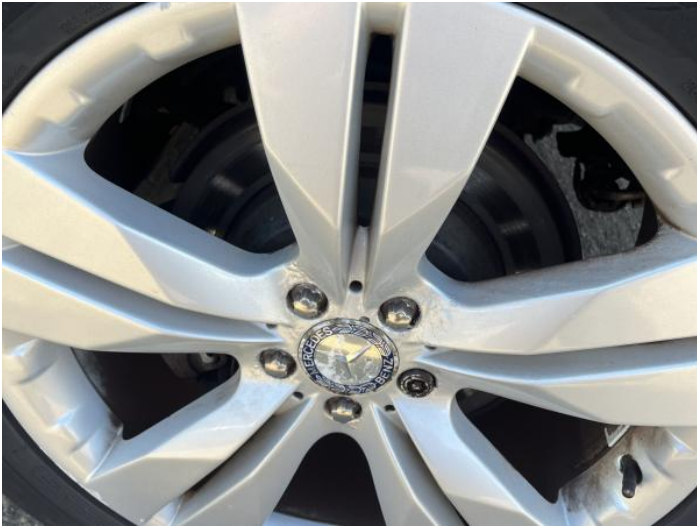
9: Wheel nsr  
Scratched  
Up To 50mm

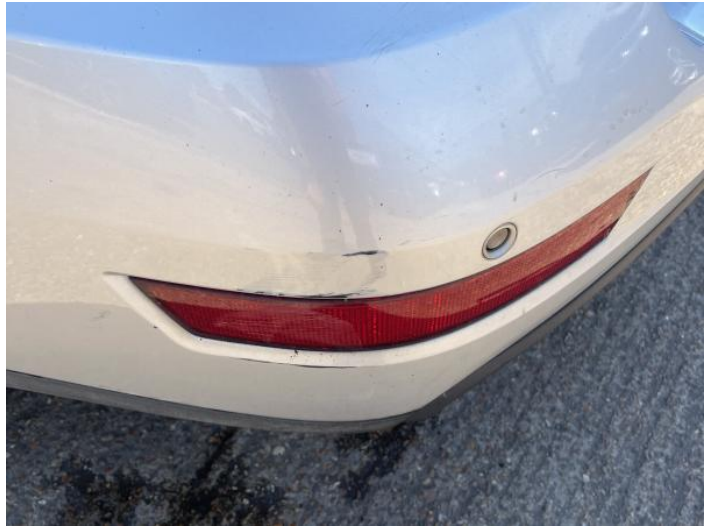
10: Bumper Rear  
Scratched  
Over 100mm Thru Paint

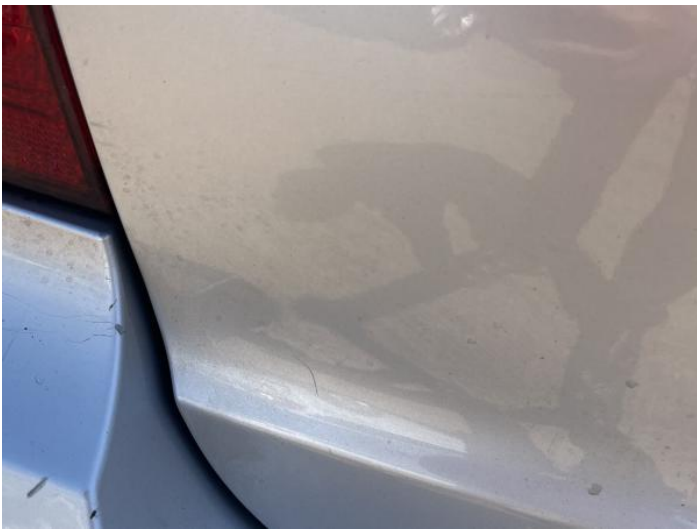
11: Tailgate  
Scratched  
Over 25mm Thru Paint

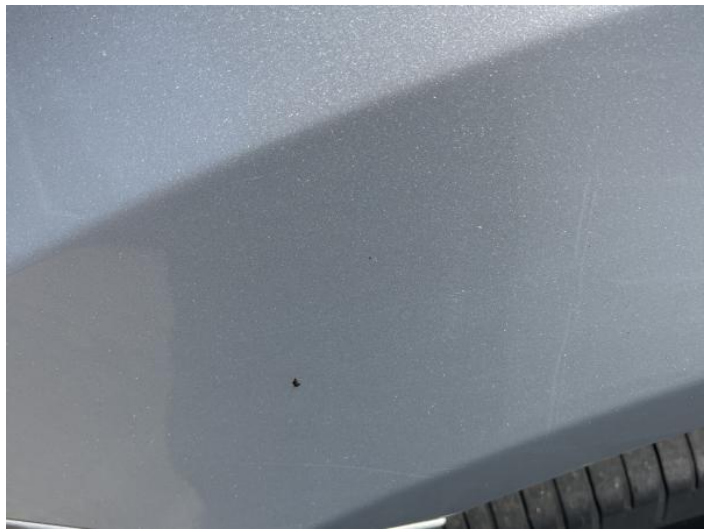
12: Qtr Panel osr  
Scratched  
Over 25mm Thru Paint

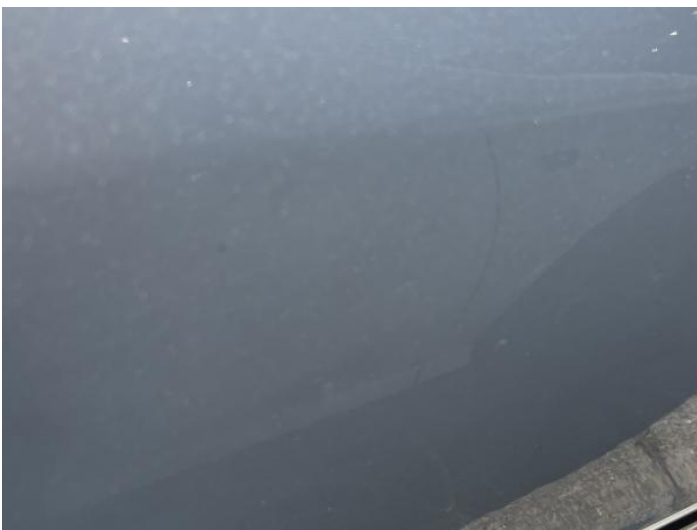
13: Door osf  
Scratched  
Up To 25mm Thru Paint

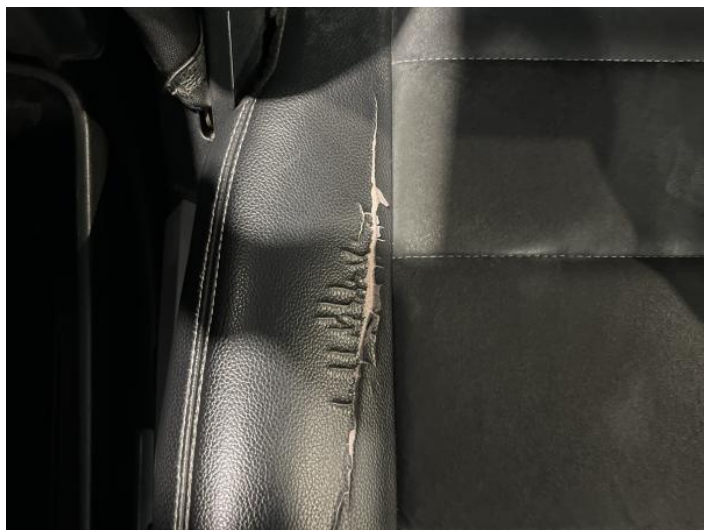
14: Seat Base Cover osf  
Torn  
Over 3mm
