VEHICLE INSPECTION REPORT

EU14WHH

Nissan Qashqai 1.2 DiG-T Acenta Premium 5dr

nama
GRADE
4

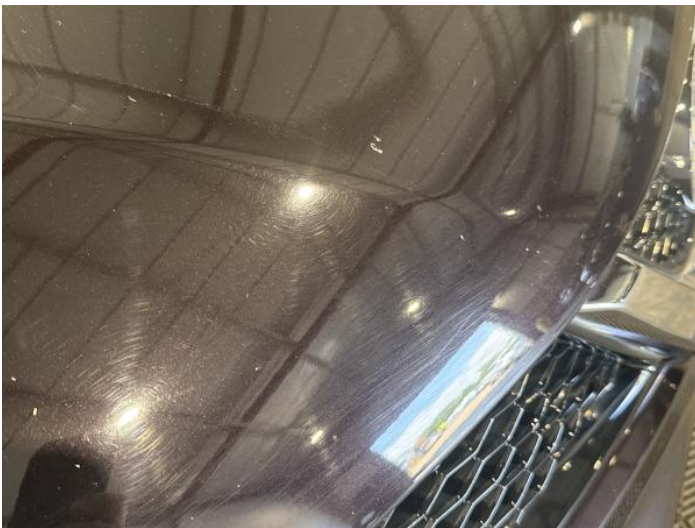
1: Bonnet
Scratched
Over 25mm Thru Paint

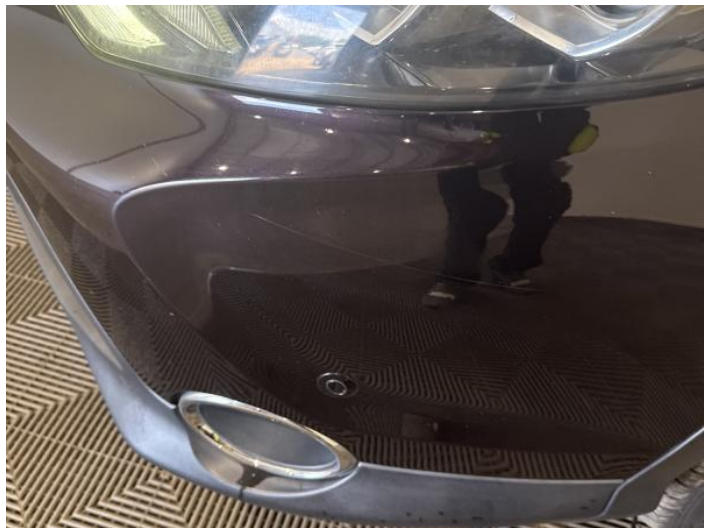
2: Bumper Front
Scratched
25 to 100mm Thru Paint

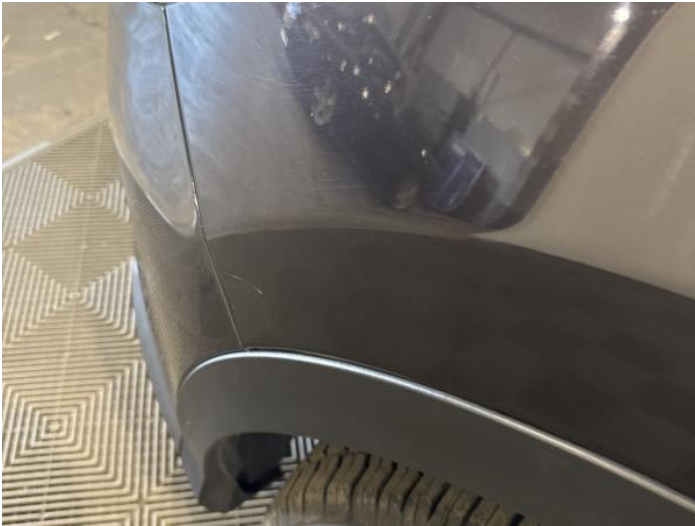
3: Wing nsf
Scratched
Over 25mm Thru Paint

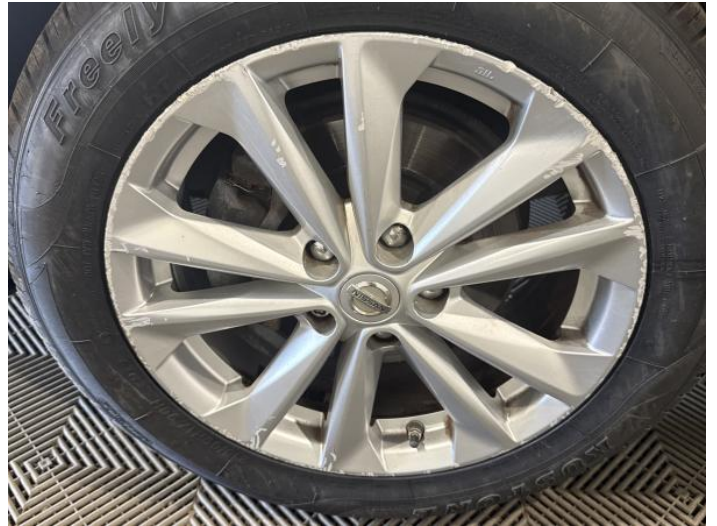
4: Wheel nsf
Scratched
Over 50mm

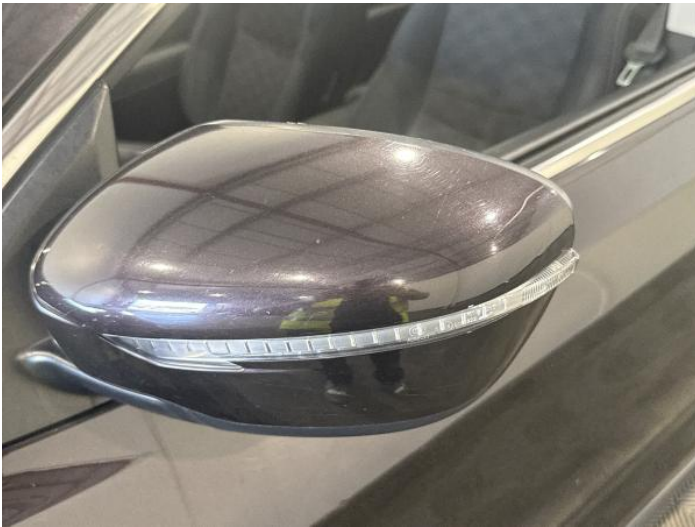
5: Door Mirror Assy nsf
Scratched (Painted)
UpTo 25mm Thru Paint

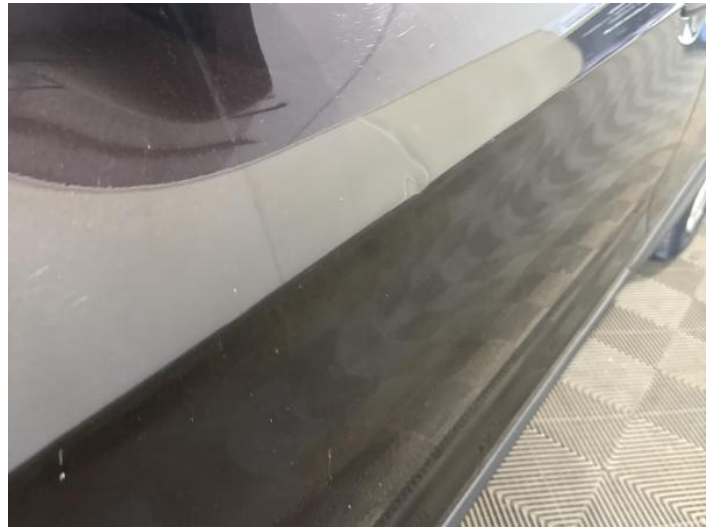
6: Door nsf
Dented
Between 10mm + 30mm

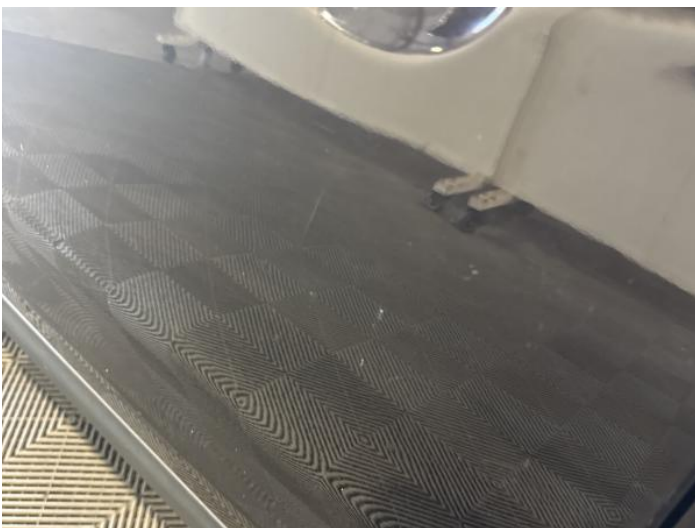
7: Door nsf
Scratched
Over 25mm Thru Paint

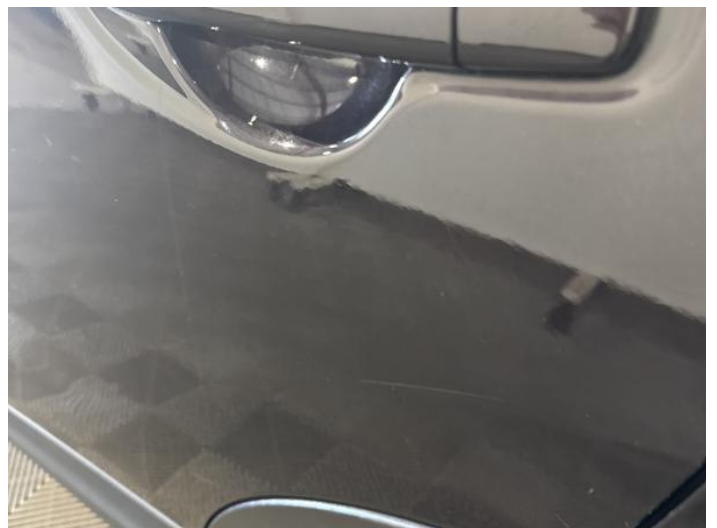
8: Door nsr
Scratched
Over 25mm Thru Paint

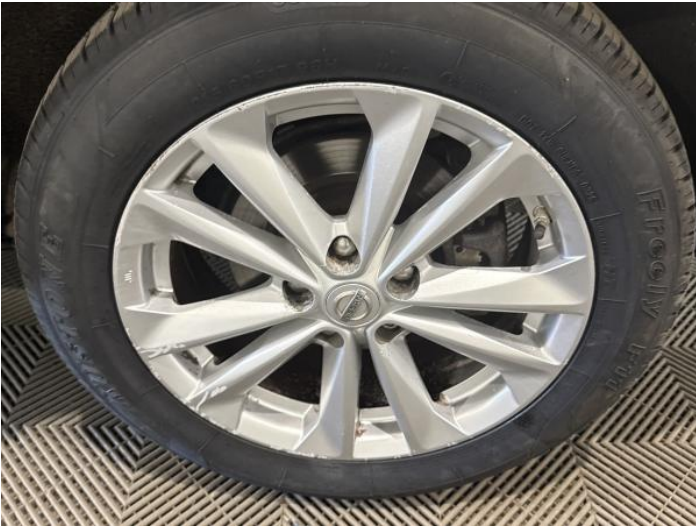
9: Wheel nsr
Scratched
Over 50mm

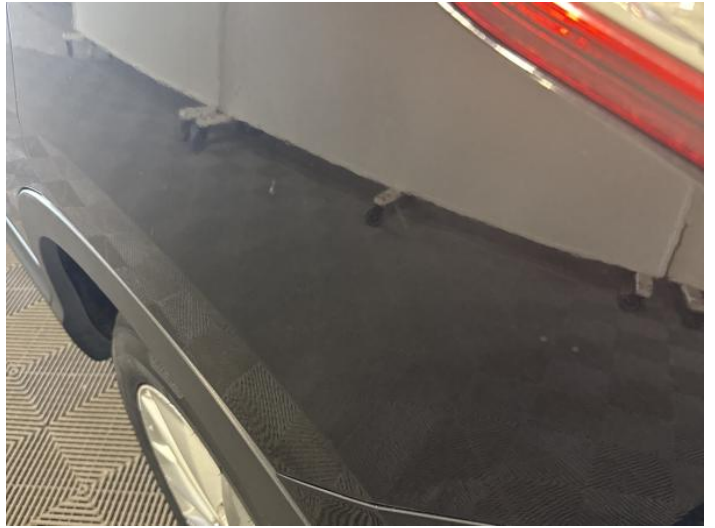
10: Qtr Panel nsr
Scratched
UpTo 25mm Thru Paint

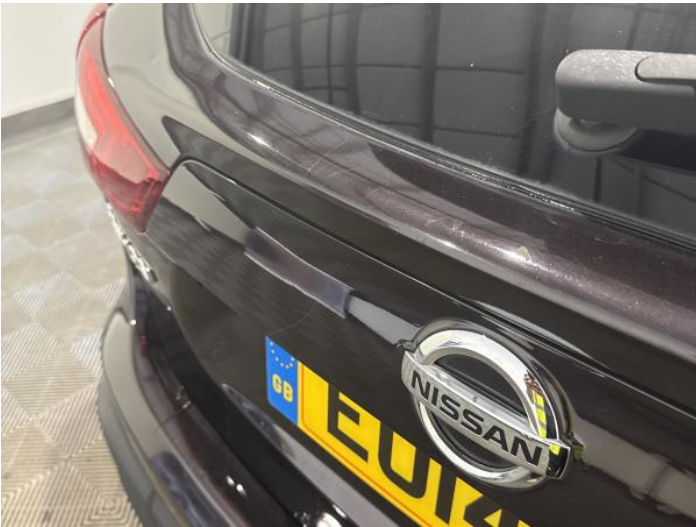
11: Tailgate
Scratched
Over 25mm Thru Paint

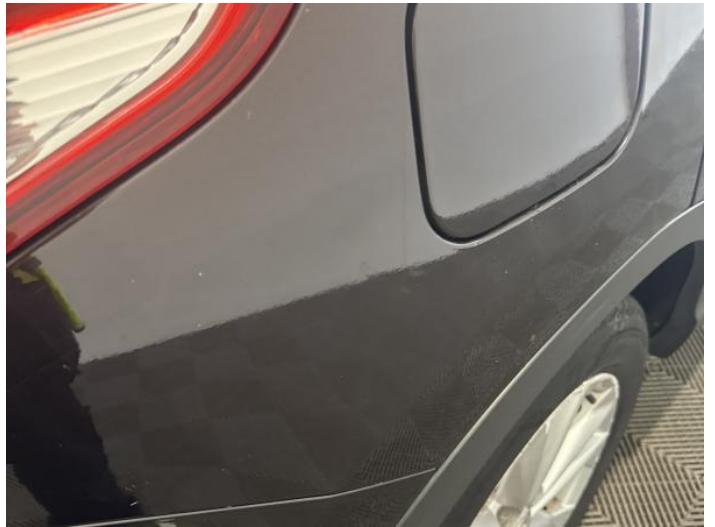
12: Qtr Panel osr
Chipped
1 To 5

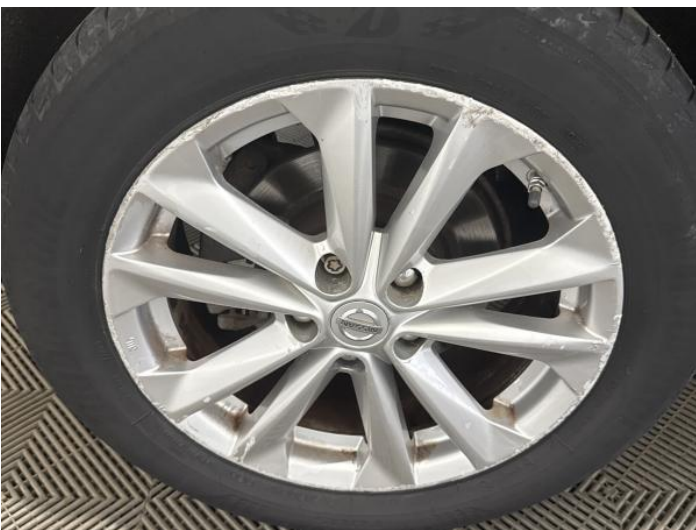
13: Wheel osr
Scratched
Over 50mm

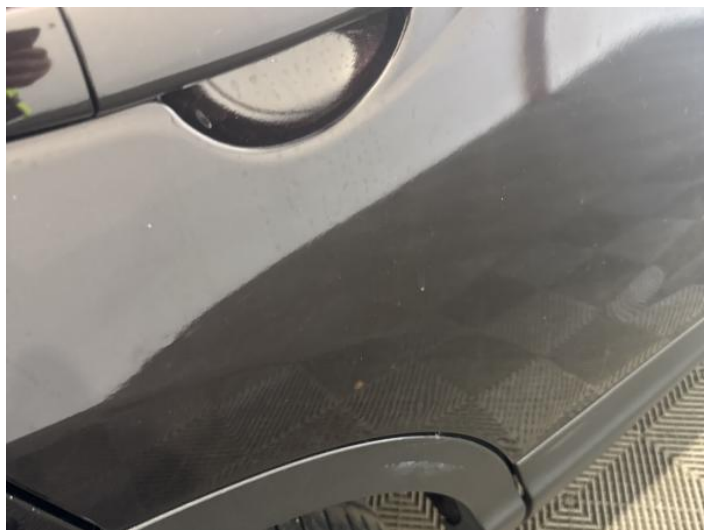
14: Door osr
Chipped
1 To 5

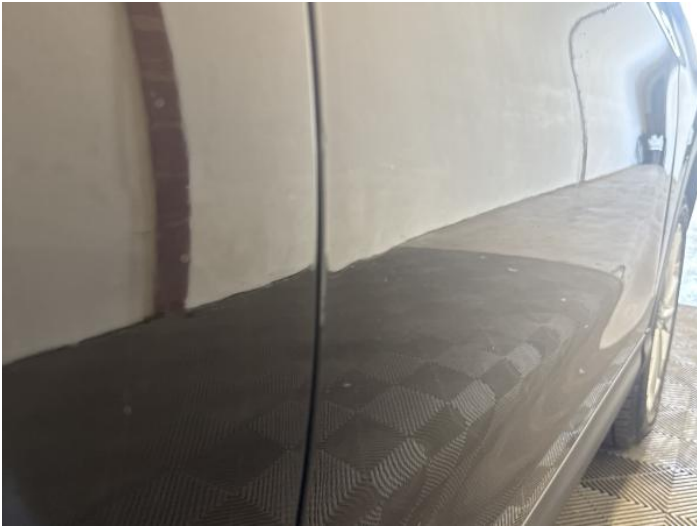
15: Door osf
Dented
Between 10mm + 30mm

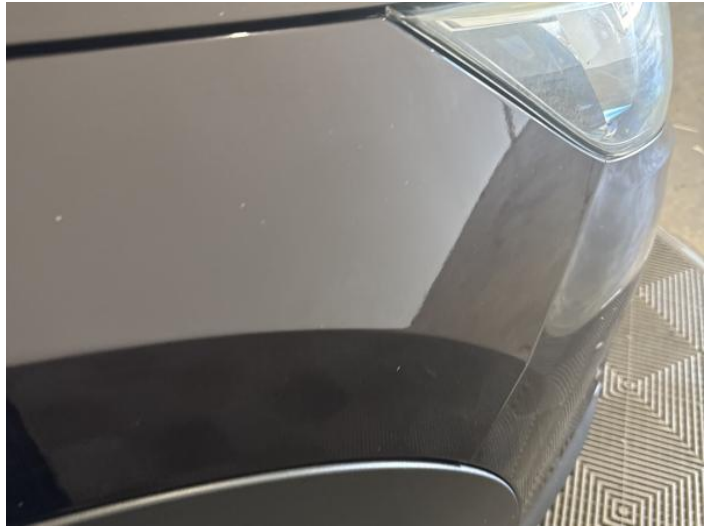
16: Wing osf
Chipped
1 To 5

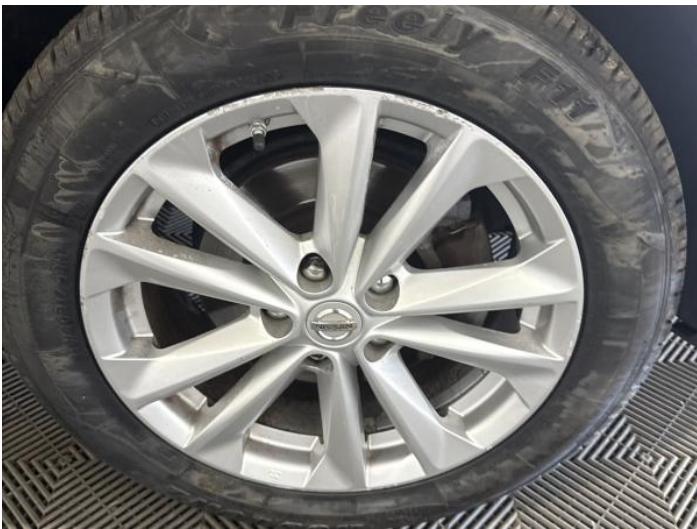
17: Wheel osf
Scratched
Over 50mm

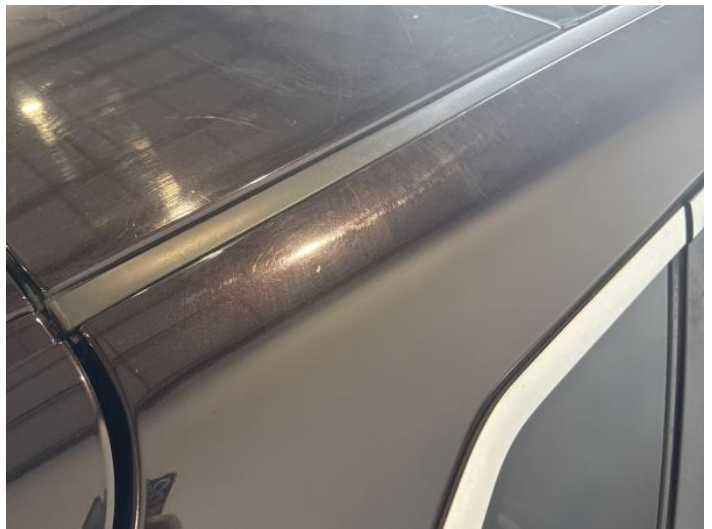
18: Roof
Scratched
Over 25mm Thru Paint
