VEHICLE INSPECTION REPORT

KN15HTE

Vauxhall Mokka 1.6i Tech Line 5dr

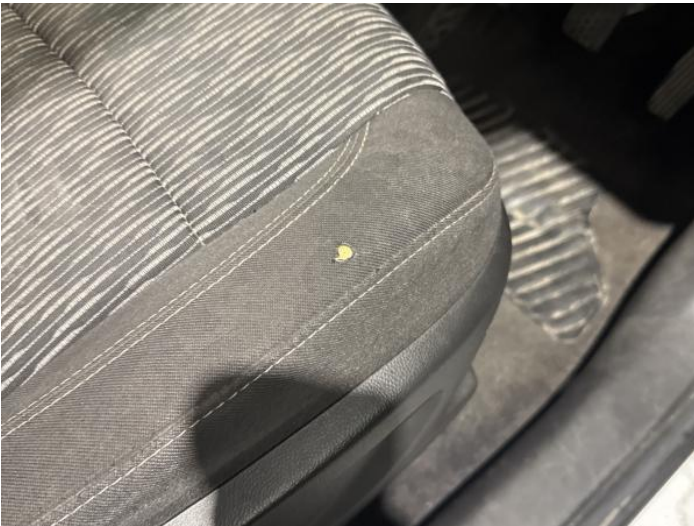
1: Seat Base Cover osf
Burn
Over 3mm

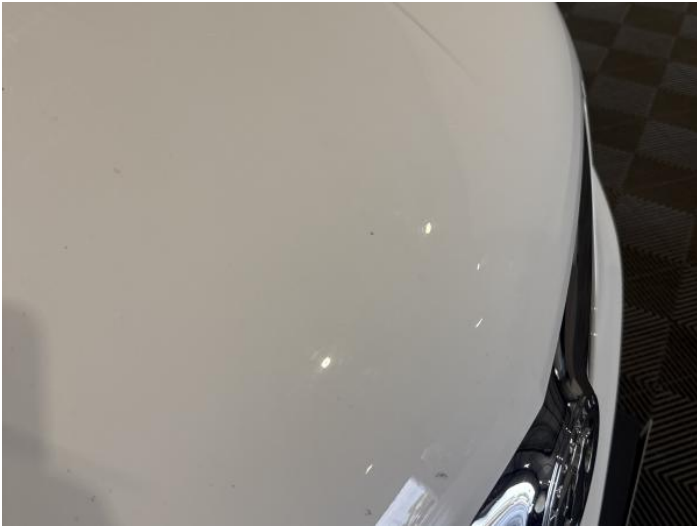
3: Bonnet
Chipped
Multiple Chips

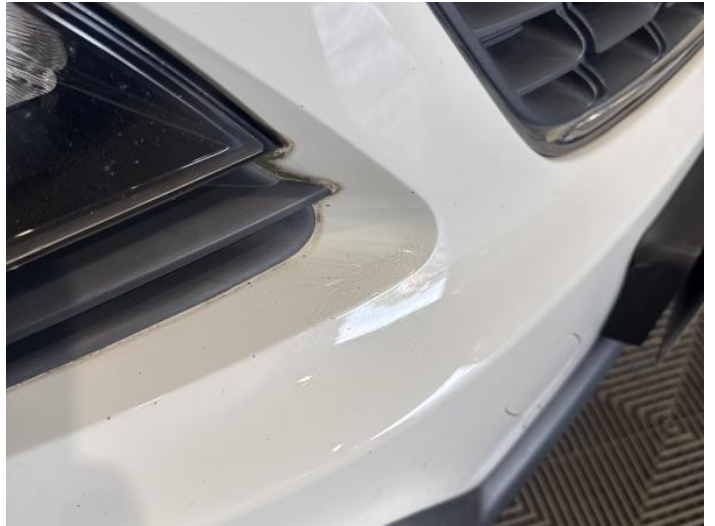
4: Bumper Front
Dented
With Paint Damage

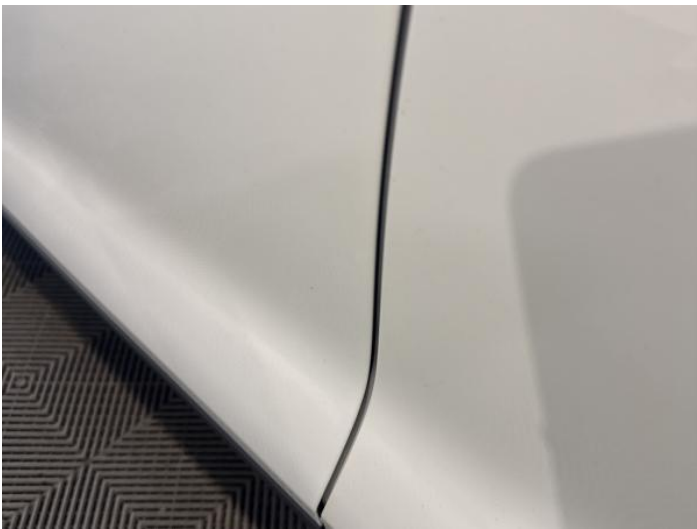
5: Door nsf
Chipped
Edge Chip

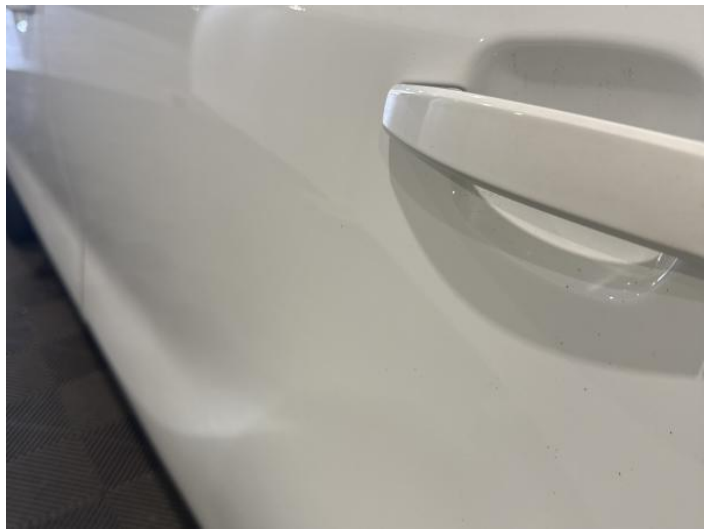
6: Door nsr
Poor Previous Repair
Rippled Up To 30%

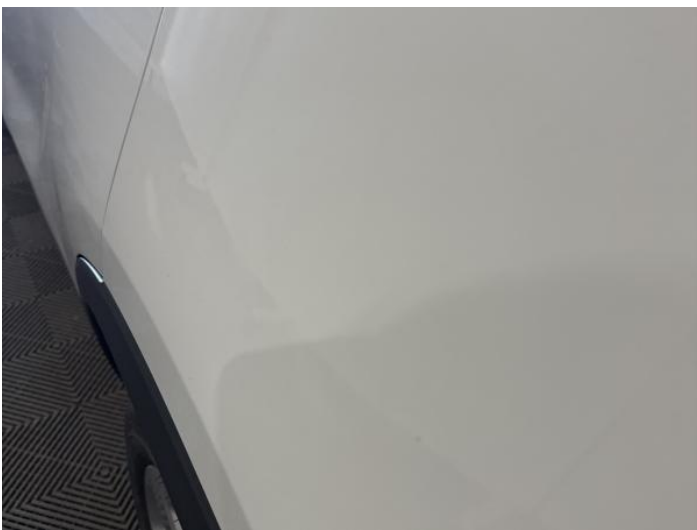
7: Qtr Panel nsr
Scratched
Over 25mm Thru Paint

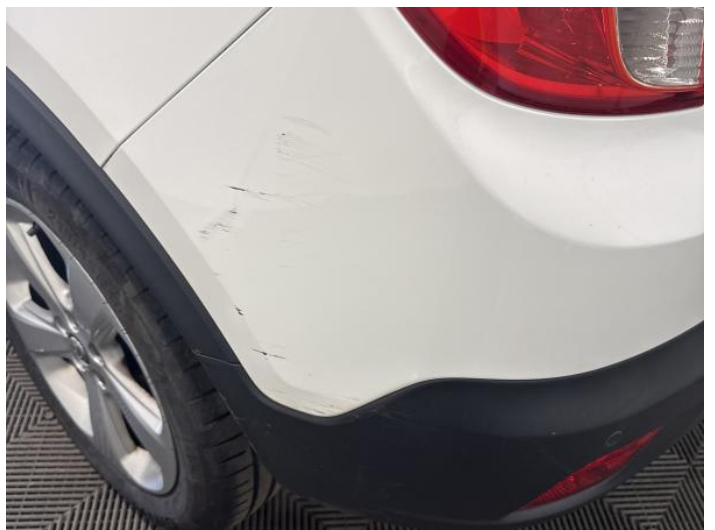
8: Bumper Rear
Scratched
25 to 100mm Thru Paint

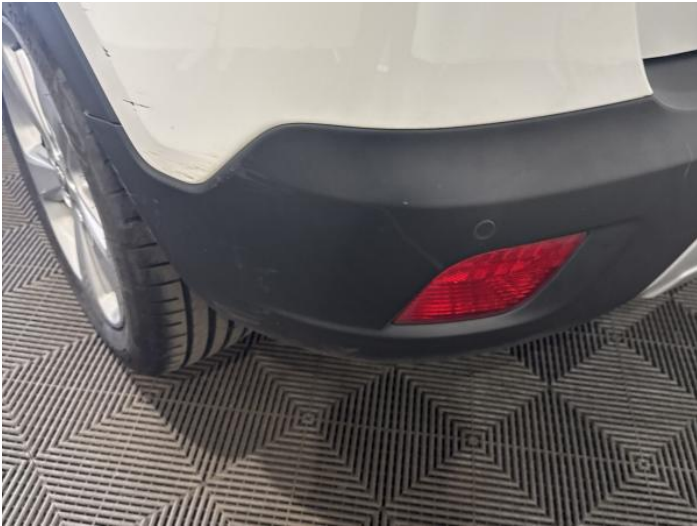
9: Bumper Rear Moulding
Scuffed (Unpainted)
Over 100mm

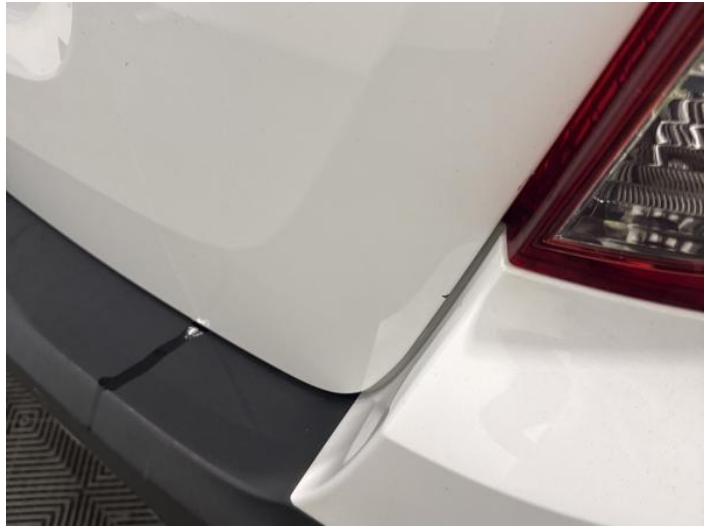
10: Tailgate
Chipped
1 To 5

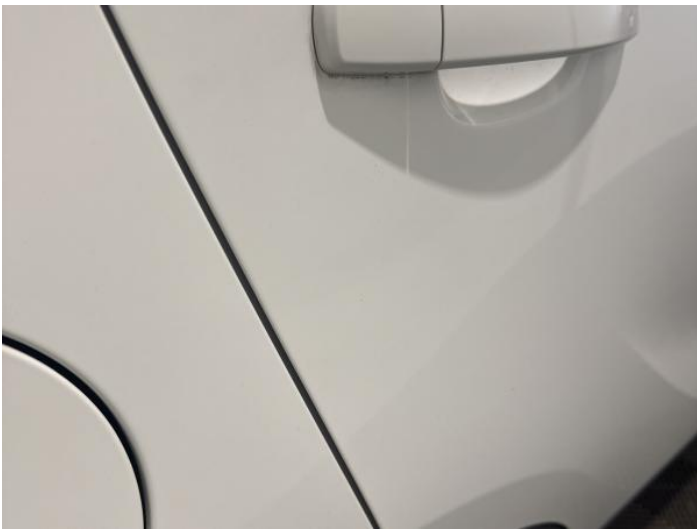
11: Door osr
Chipped
Edge Chip

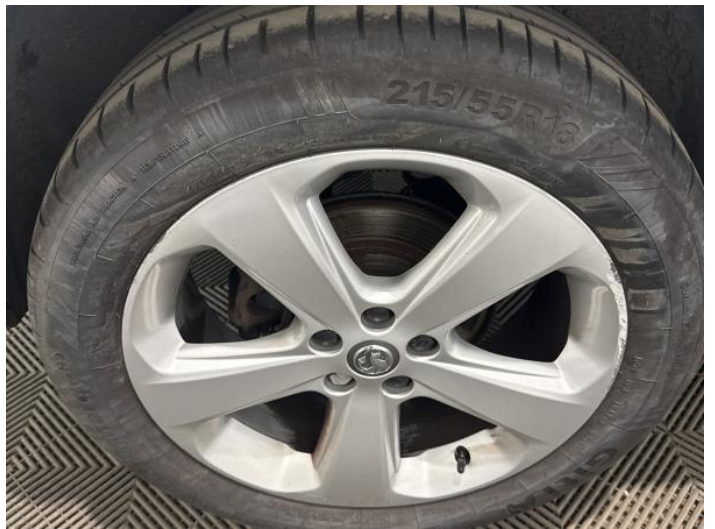
12: Wheel osr
Scratched
Over 50mm

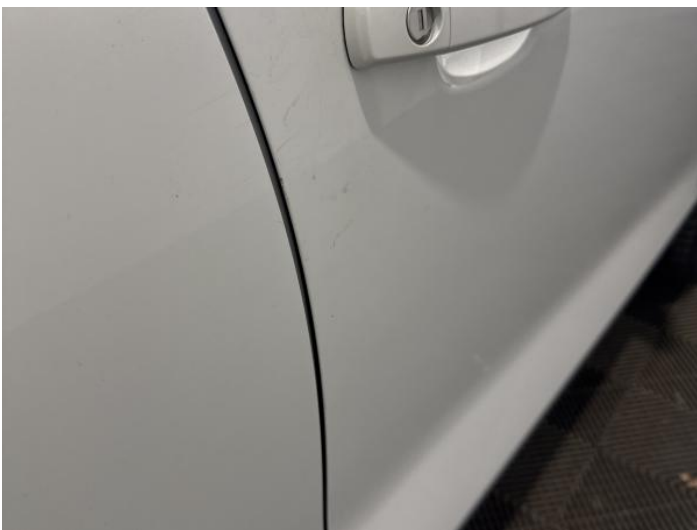
13: Door osf
Chipped
Edge Chip

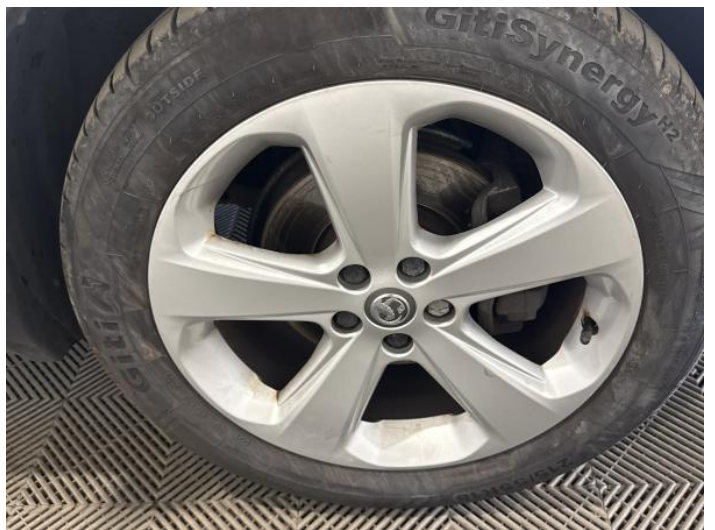
14: Wheel osf
Scratched
Over 50mm

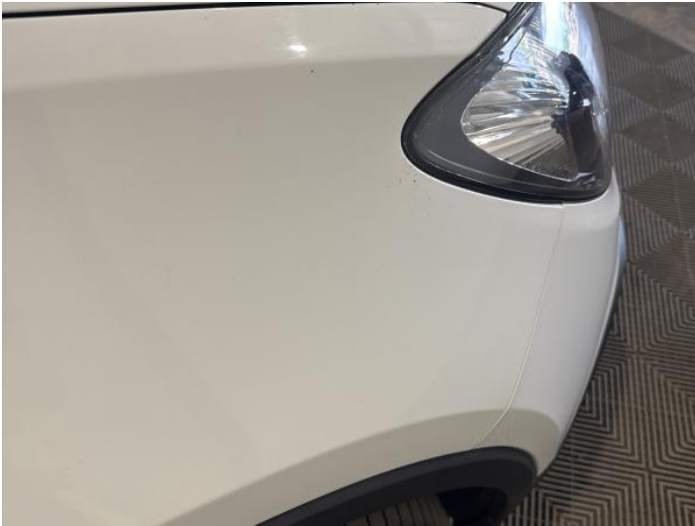
15: Wing osf
Chipped
1 To 5

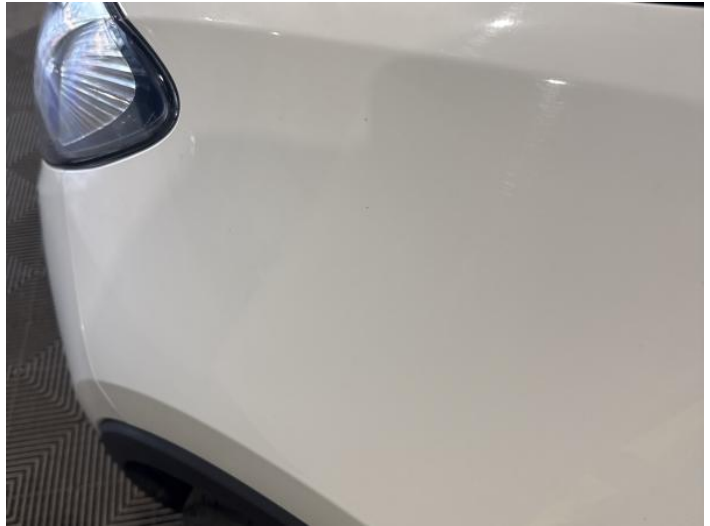
16: Wing nsf
Chipped
1 To 5

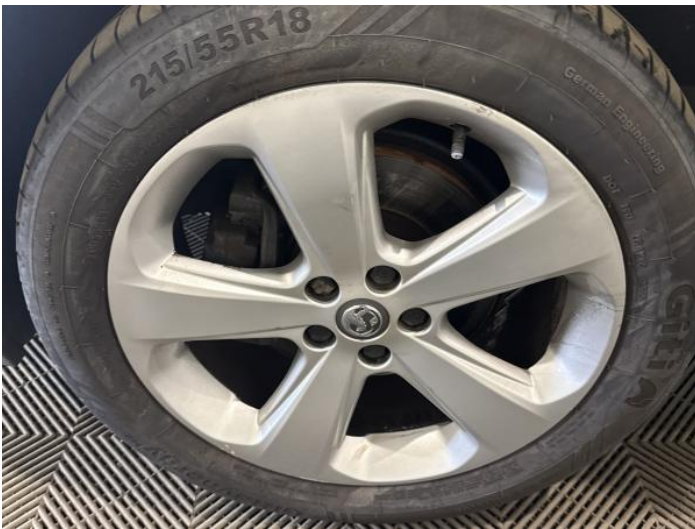
17: Wheel nsf
Scratched
Over 50mm
