# VEHICLE INSPECTION REPORT

**GJ60FGO**

## Jaguar XF 3.0d V6 Luxury 4dr Auto

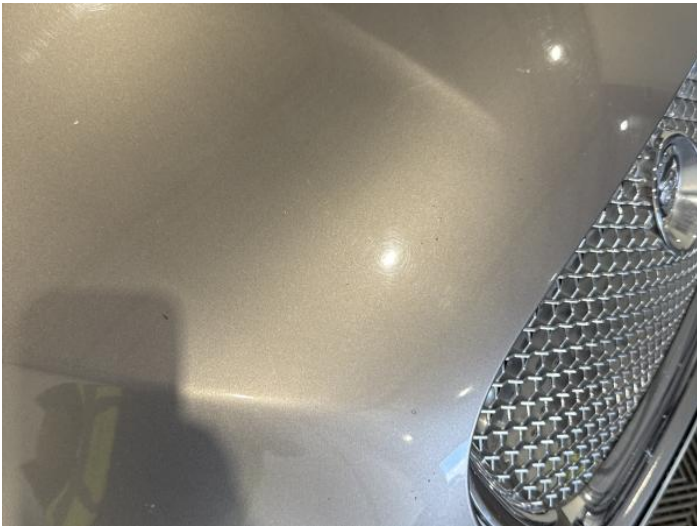
1: Bonnet  
Chipped  
Multiple Chips

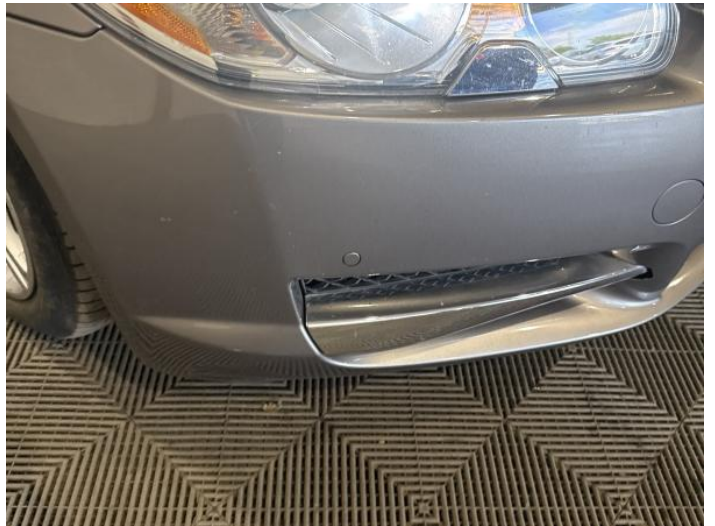
2: Bumper Front  
Chipped  
Multiple Chips

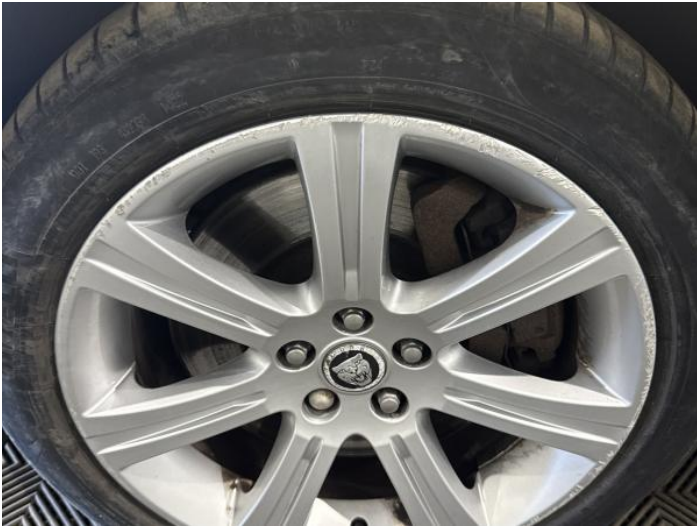
3: Wheel nsf  
Scratched  
Over 50mm

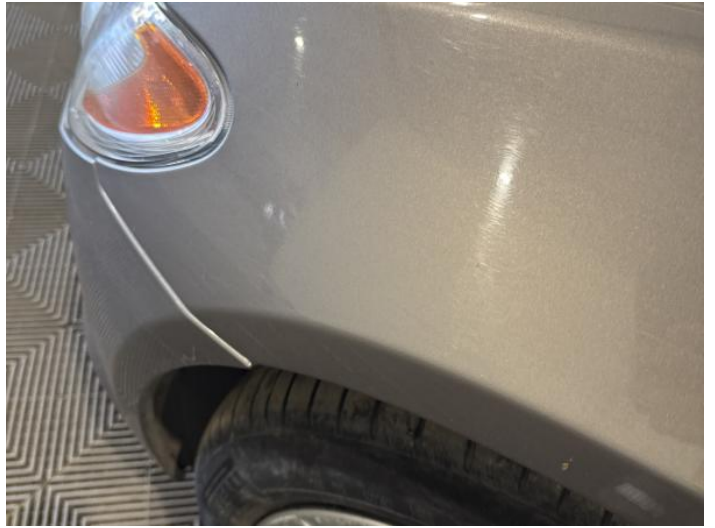
4: Wing nsf  
Scratched  
UpTo 25mm Thru Paint

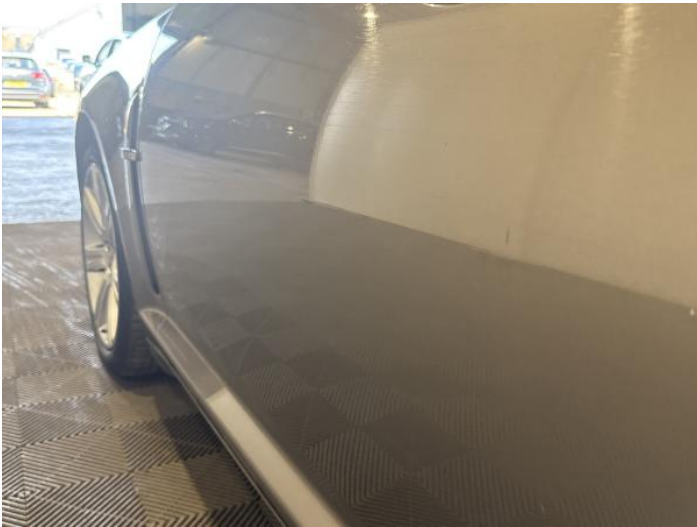
5: Door nsf  
Dented  
Between 10mm + 30mm

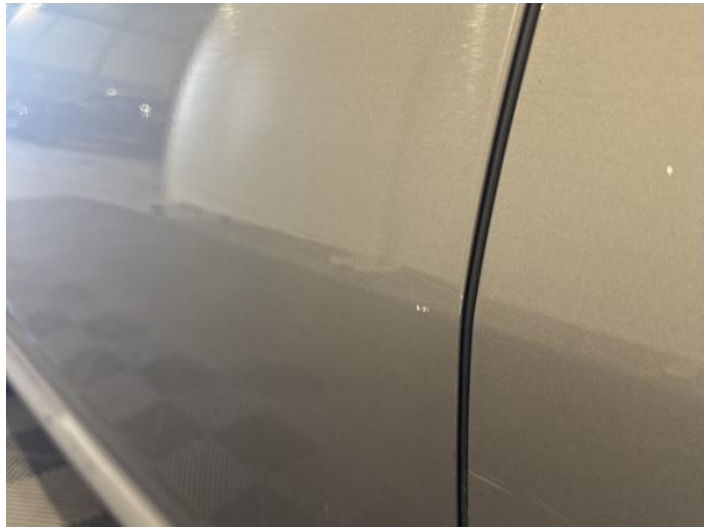
6: Door nsf  
Chipped  
1 To 5

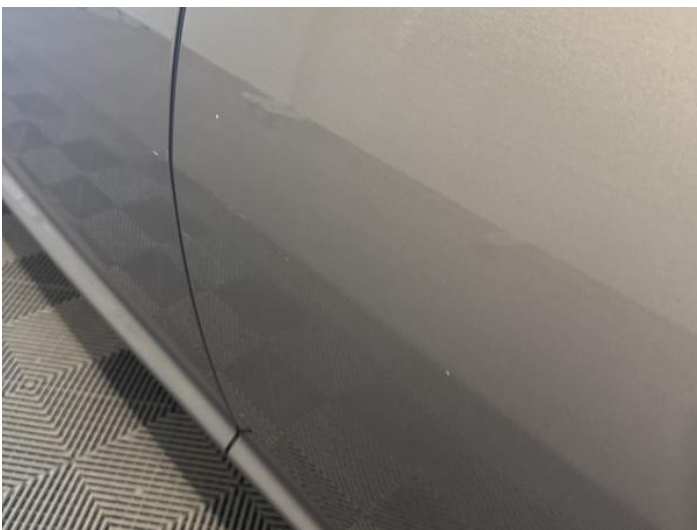
7: Door nsr  
Scratched  
Over 25mm Thru Paint

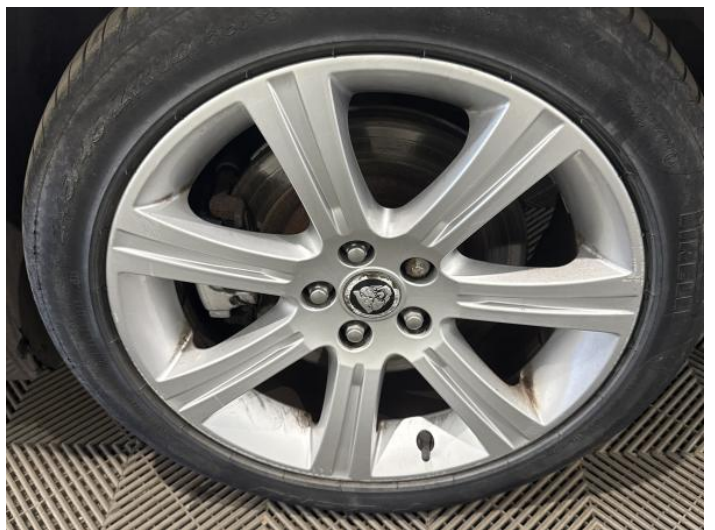
8: Wheel nsr  
Scratched  
Over 50mm

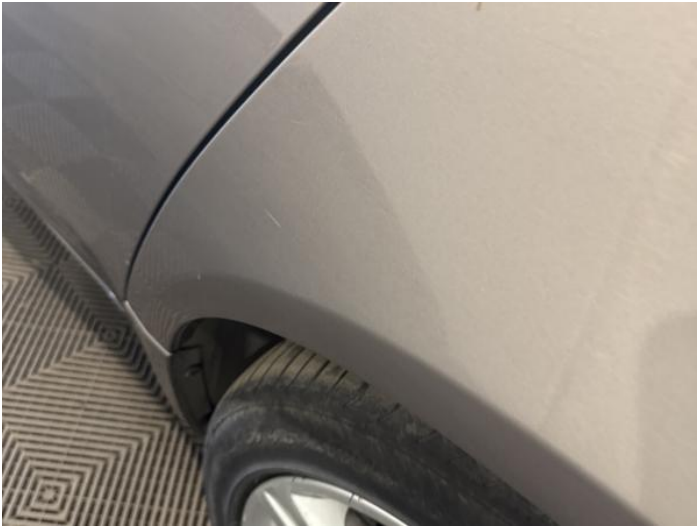
9: Qtr Panel nsr  
Scratched  
UpTo 25mm Thru Paint

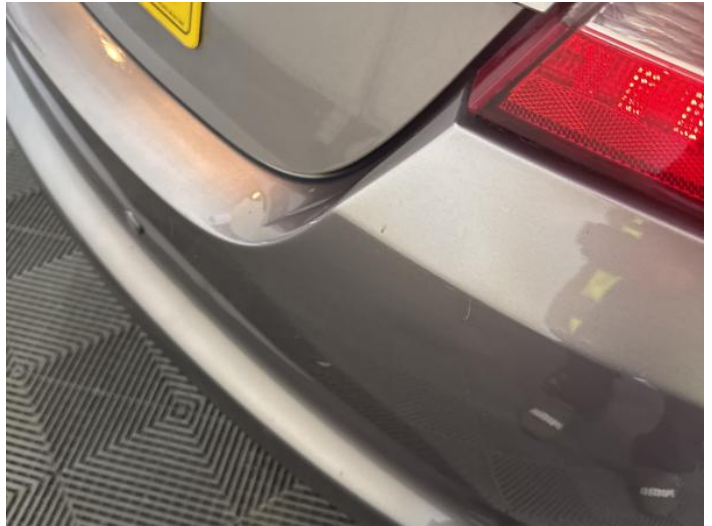
10: Bumper Rear  
Scratched  
Up To 25mm Thru Paint

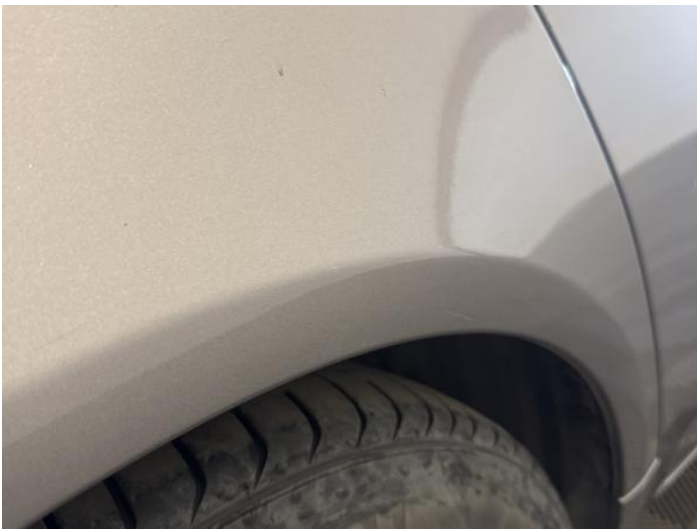
11: Qtr Panel osr  
Scratched  
UpTo 25mm Thru Paint

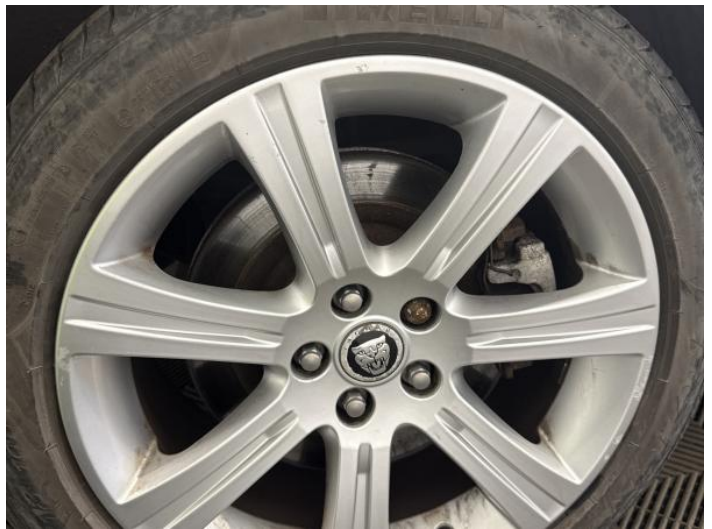
12: Wheel osr  
Scratched  
Up To 50mm

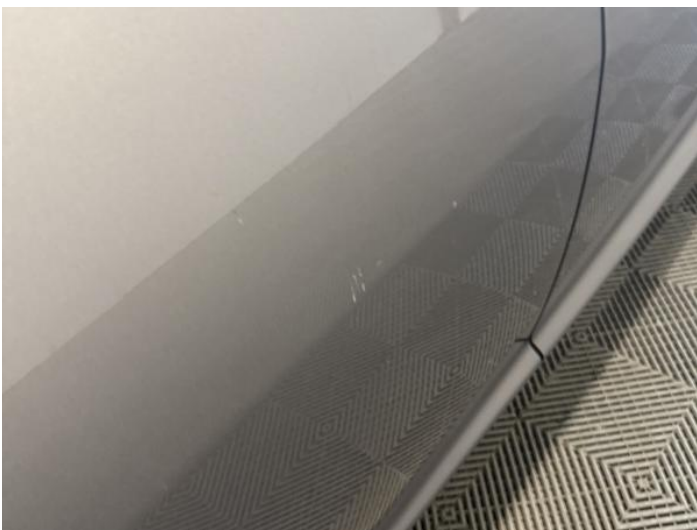
13: Door osr  
Scratched  
Over 25mm Thru Paint

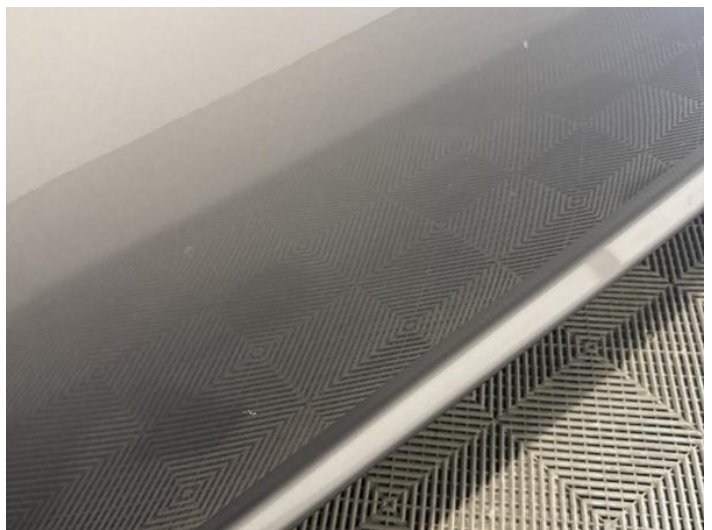
14: Door osf  
Scratched  
UpTo 25mm Thru Paint

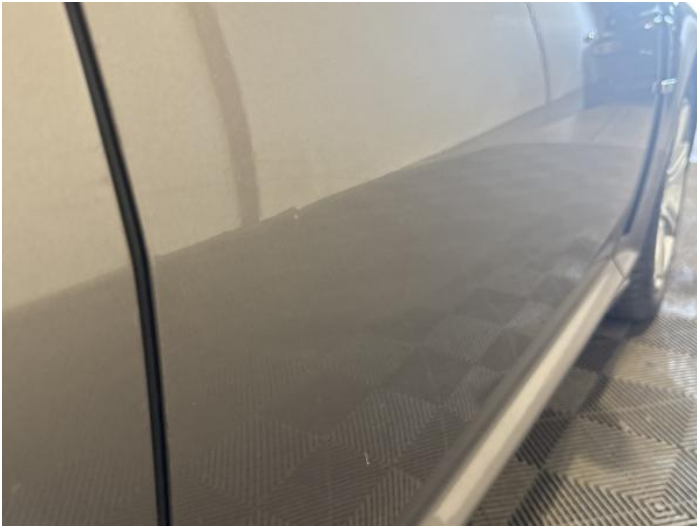
15: Door osf  
Dented  
Between 10mm + 30mm

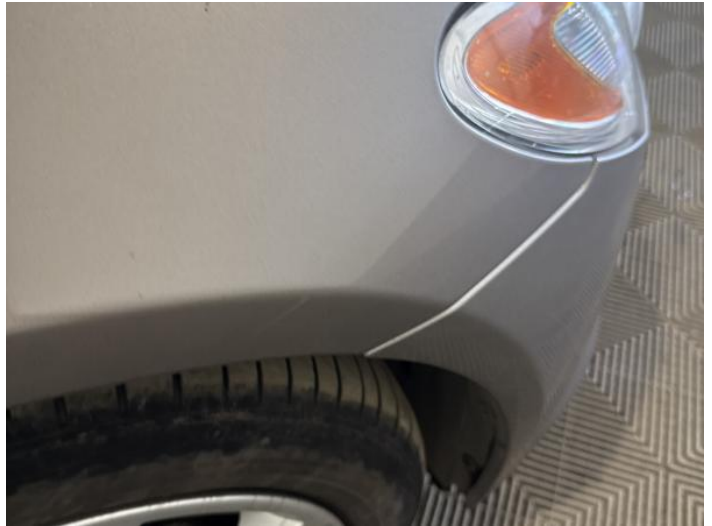
16: Wing osf  
Scratched  
UpTo 25mm Thru Paint

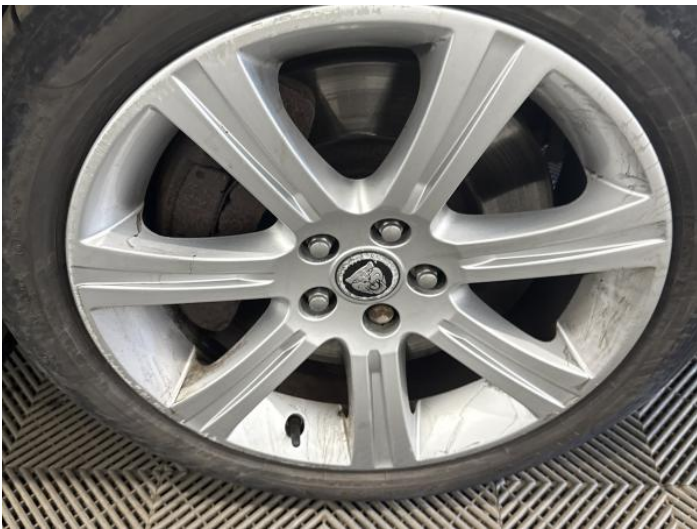
17: Wheel osf  
Scratched  
Over 50mm
