VEHICLE INSPECTION REPORT

RF16WLB

Ford Kuga 2.0 TDCi 180 Titanium 5dr Powershift

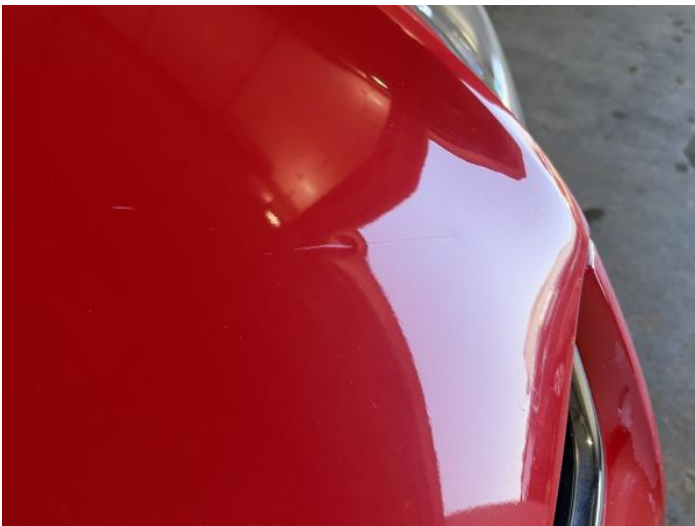
1: Bonnet
Dented
With Paint Damage

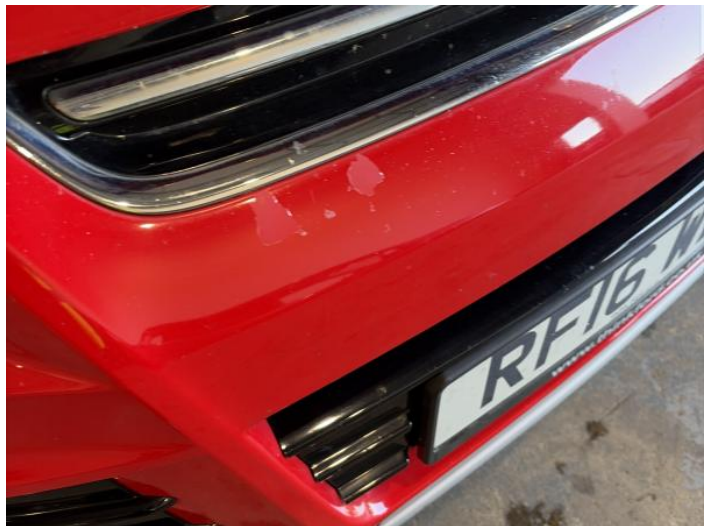
2: Bumper Front
Poor Previous Repair
Paint Flake

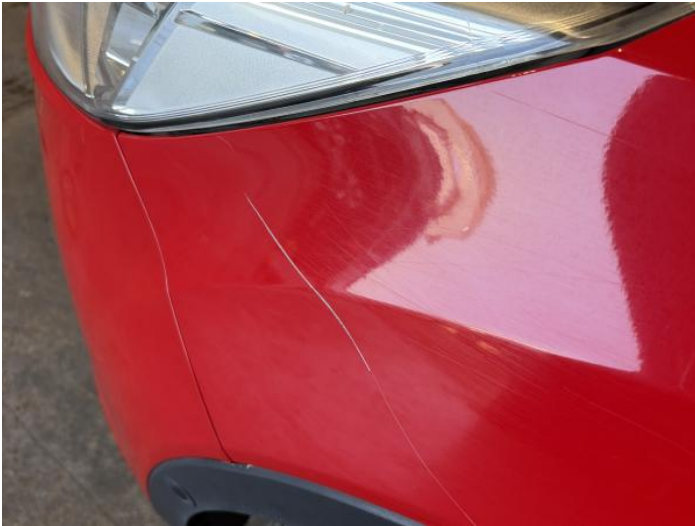
3: Wing nsf
Scratched
Over 25mm Thru Paint

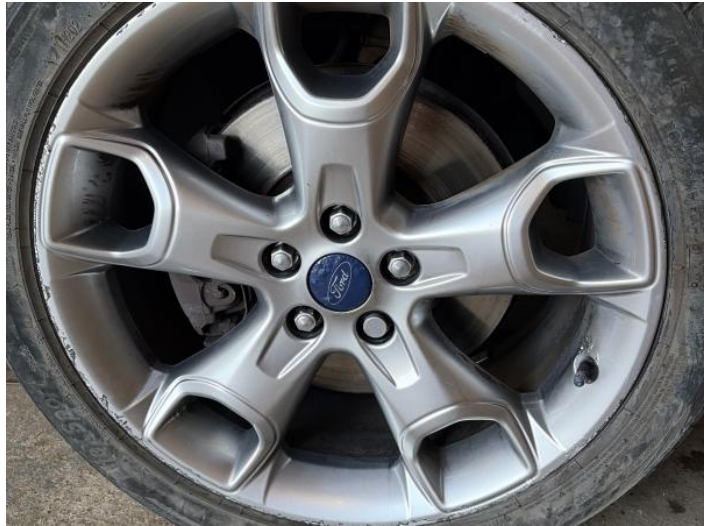
4: Wheel nsf
Scratched
Over 50mm

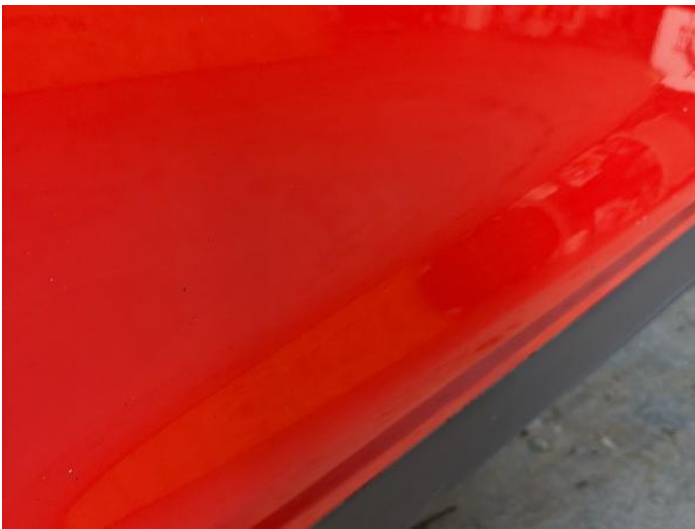
5: Door nsf
Dented
Between 10mm + 30mm

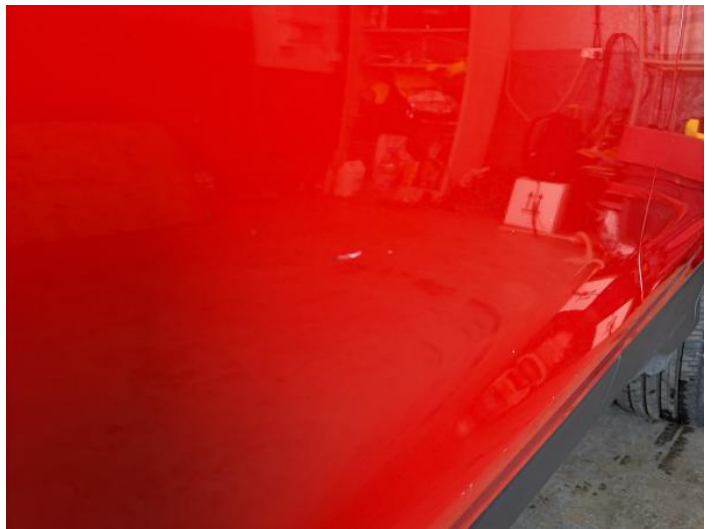
6: Door nsf
Scratched
Over 25mm Thru Paint

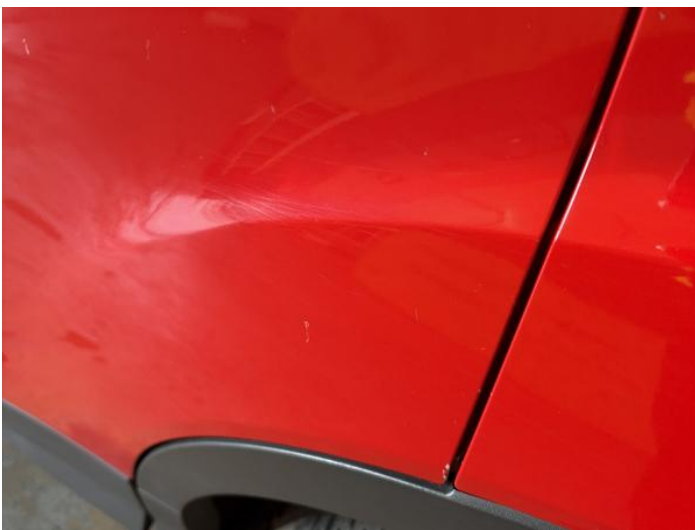
7: Door nsr
Chipped
Edge Chip

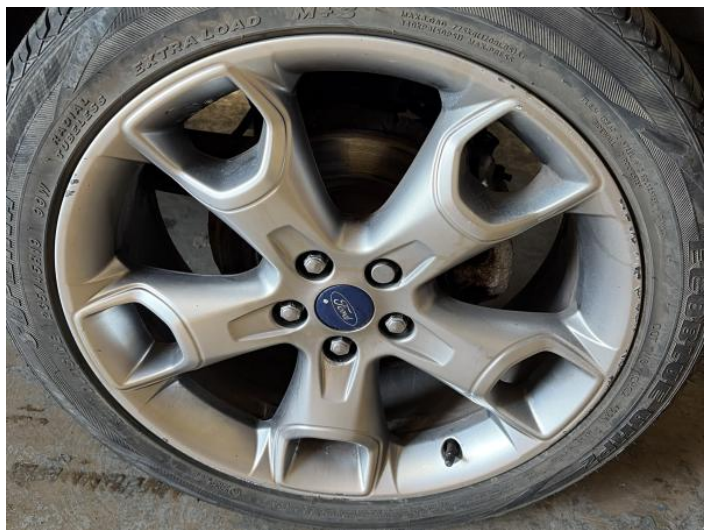
8: Wheel nsr
Scratched
Over 50mm

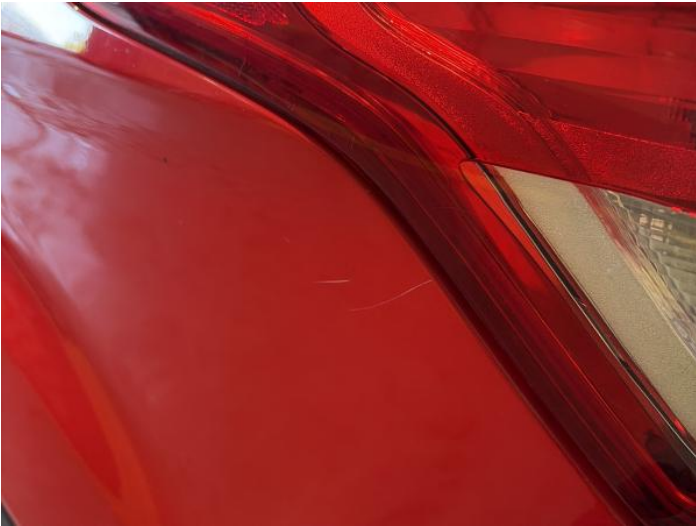
9: Qtr Panel nsr
Scratched
Over 25mm Thru Paint

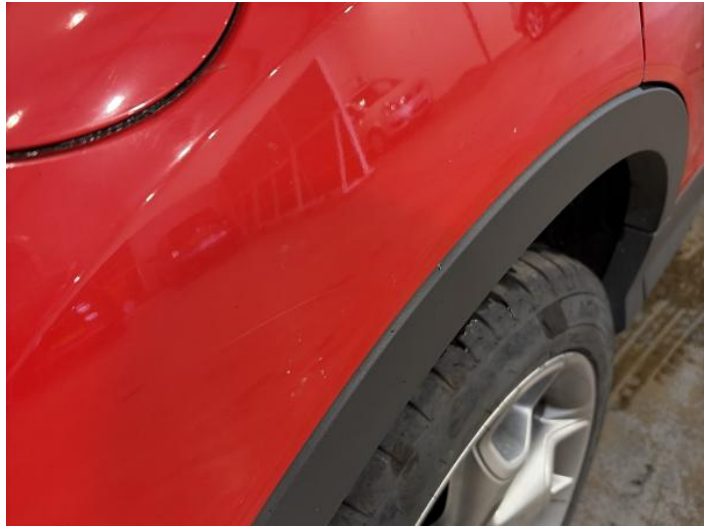
10: Qtr Panel osr
Scratched
Over 25mm Thru Paint

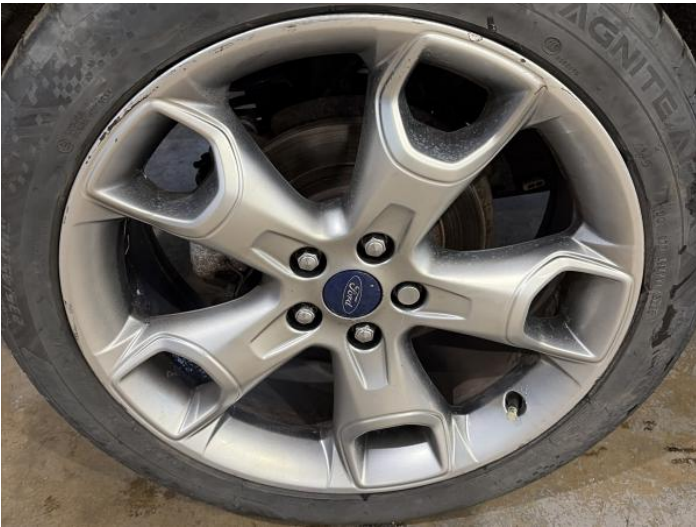
11: Wheel osr
Scratched
Over 50mm

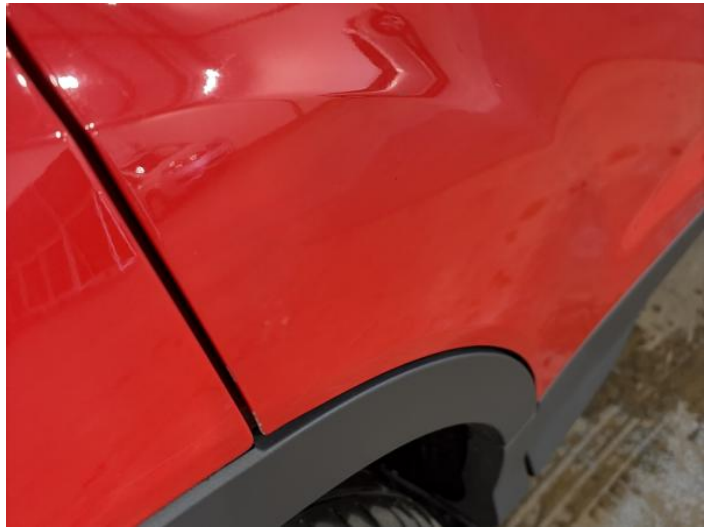
12: Door osr
Chipped
Edge Chip

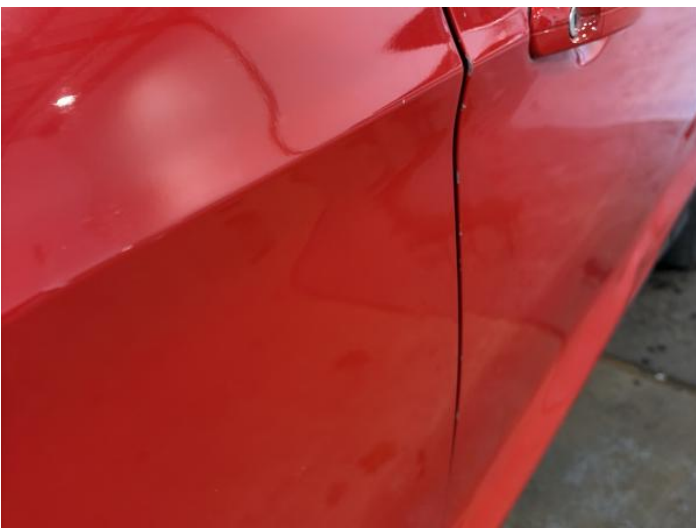
13: Door osr
Dented
Between 10mm + 30mm

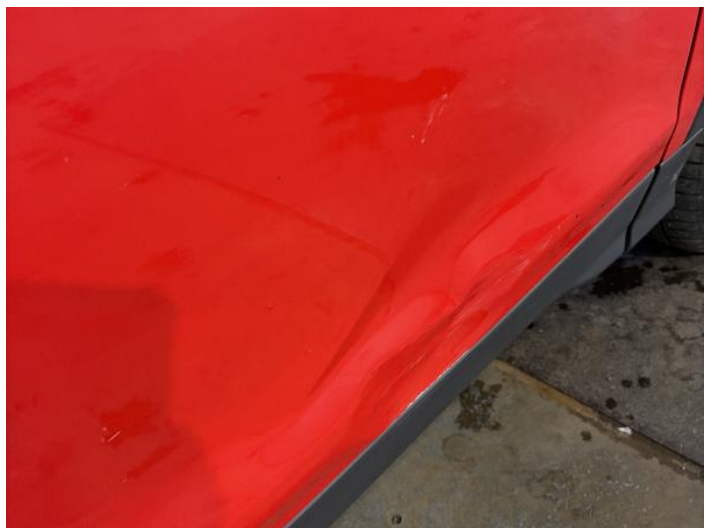
14: Door osf
Dented
With Paint Damage

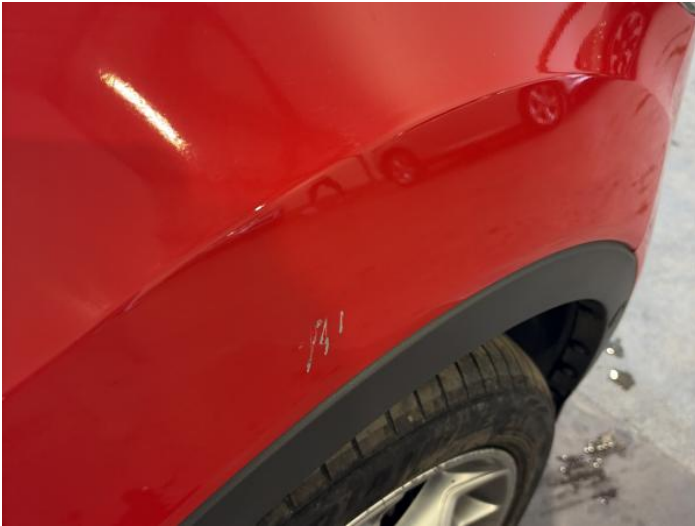
15: Wing osf
 Scratched
 Over 25mm Thru Paint

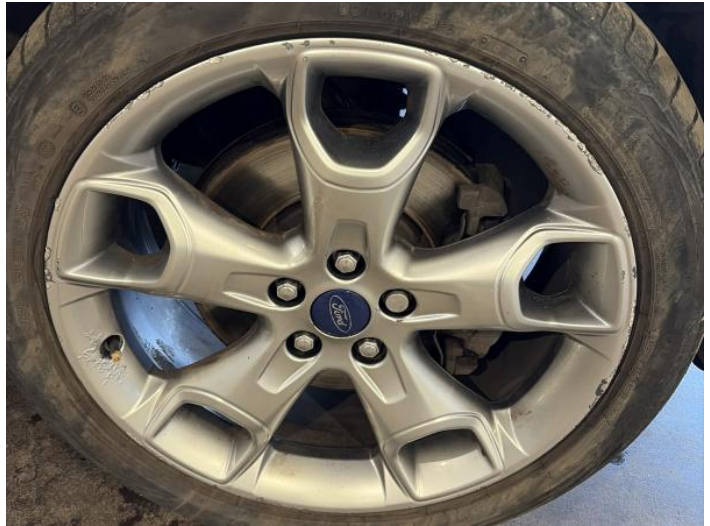
16: Wheel osf
 Scratched
 Over 50mm

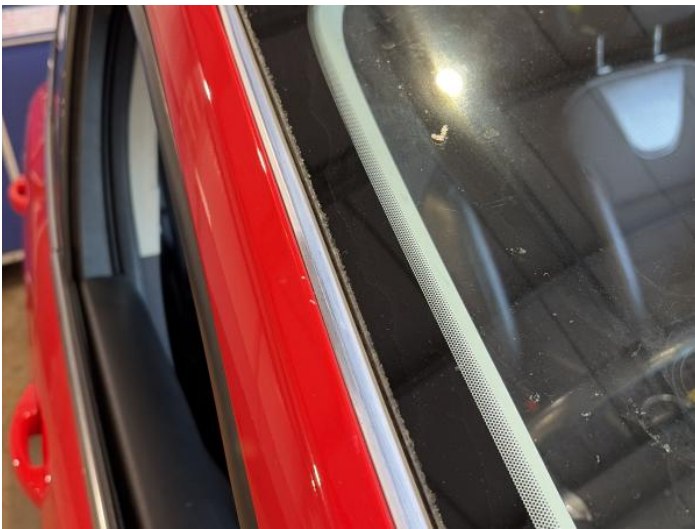
17: A Post os
 Chipped
 1 To 5

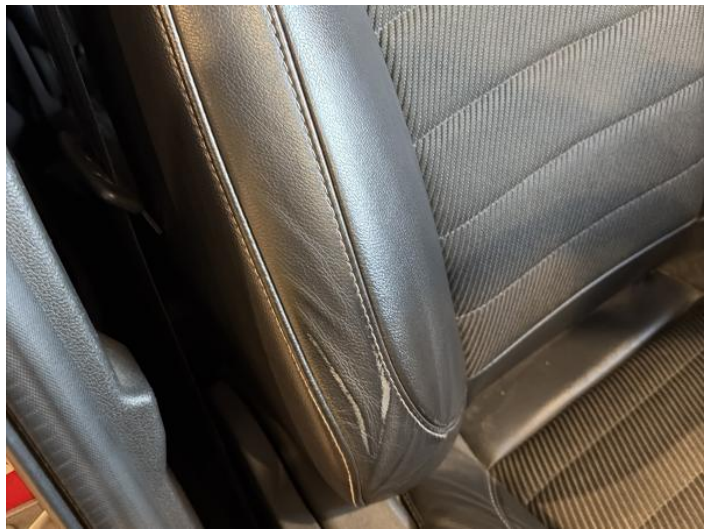
18: Seat Back Cover osf
 Scuffed
 Over 25mm
