## VEHICLE INSPECTION REPORT

**DP67GFJ**

### Nissan Qashqai 1.2 DiG-T N-Connecta 5dr

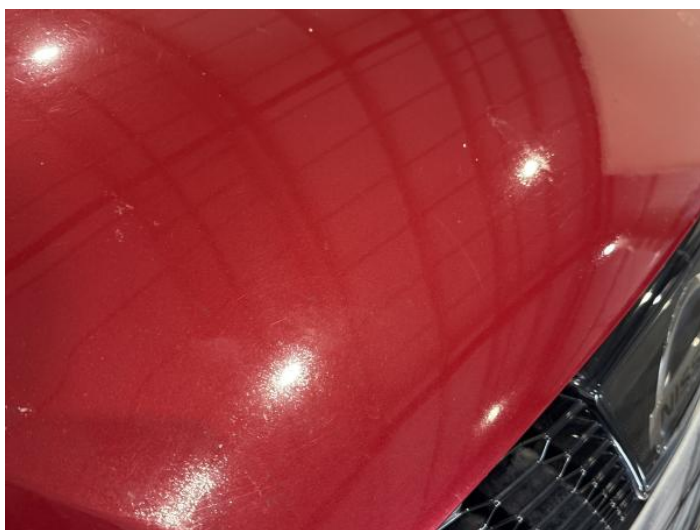
1: Bonnet  
Poor Previous Repair  
Poor Paint

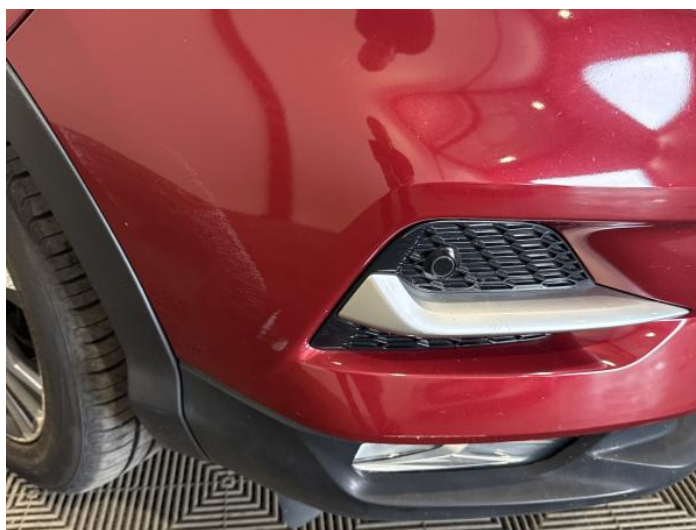
2: Bumper Front  
Scratched  
25 to 100mm Thru Paint

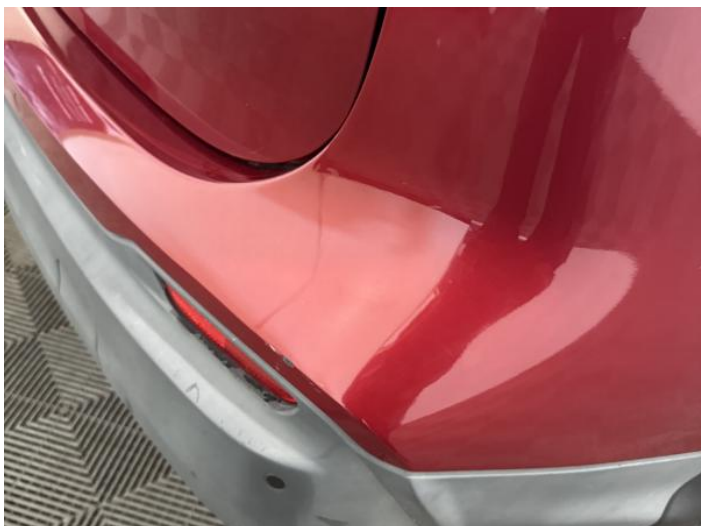
9: Bumper Rear  
Scratched  
25 to 100mm Thru Paint

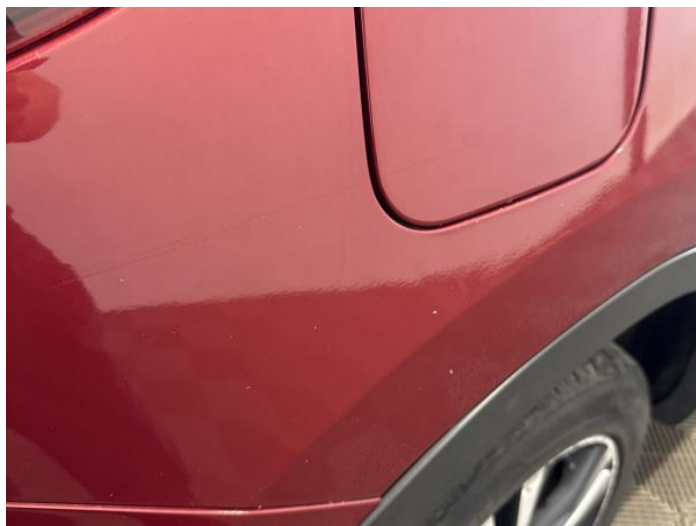
10: Qtr Panel osr  
Scratched  
Over 25mm Thru Paint

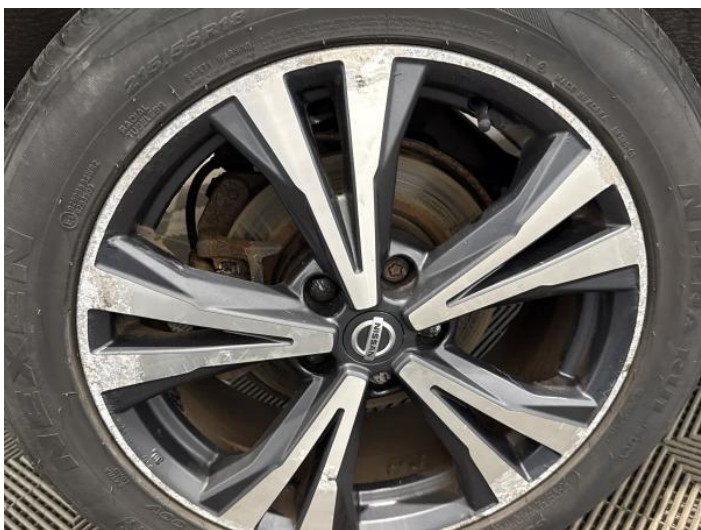
11: Wheel osr  
Scratched  
Over 50mm

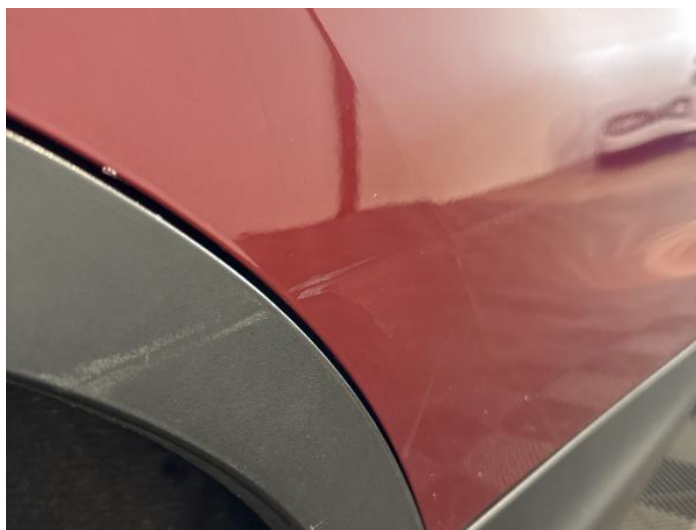
12: Door osr  
Dented  
With Paint Damage

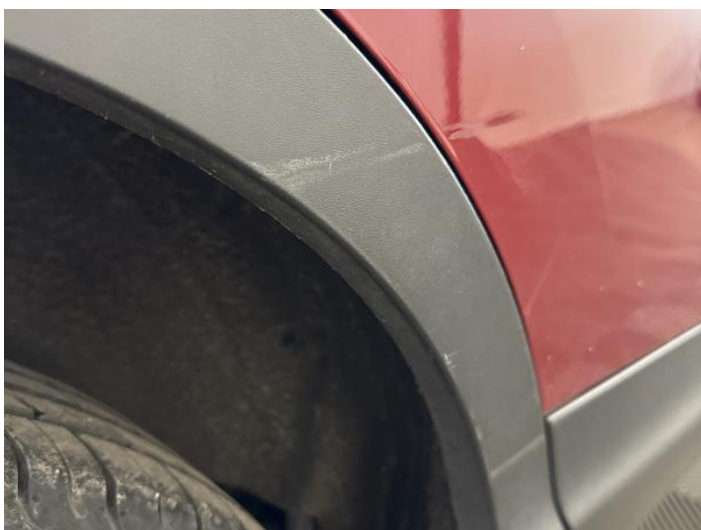
13: Qtr Panel Arch Extension os  
Scuffed (Unpainted)  
Over 100mm

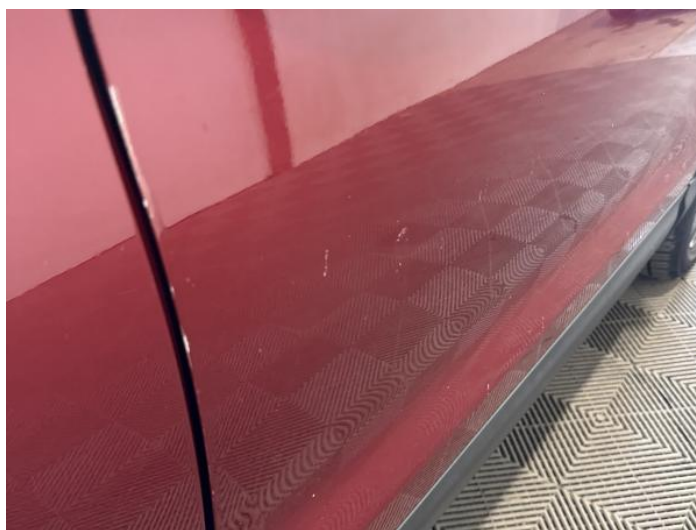
14: Door osf  
Scratched  
Over 25mm Thru Paint

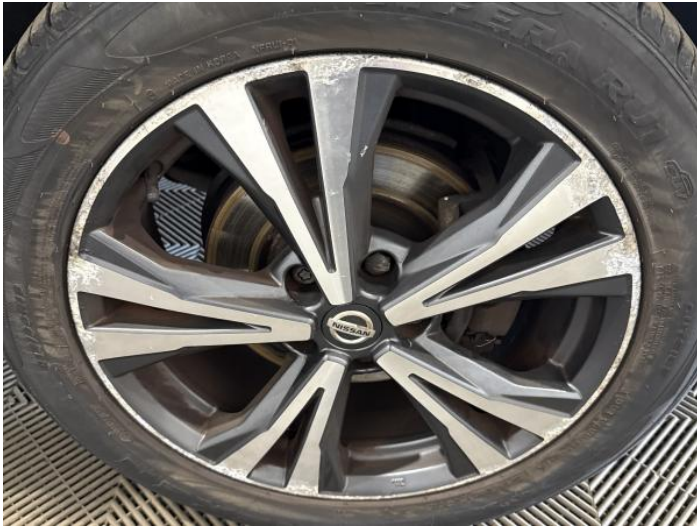
16: Wheel osf  
Scratched  
Over 50mm

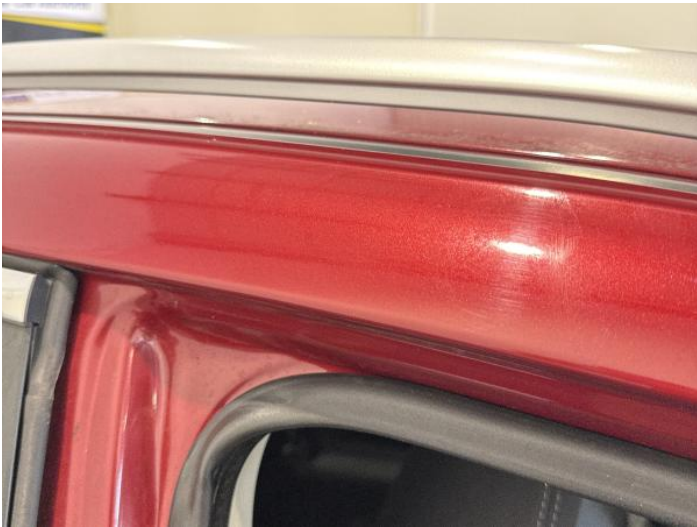
17: A Post os  
Poor Previous Repair  
Poor Paint
