VEHICLE INSPECTION REPORT

WF59KWG

Citroen C4 Picasso 1.6HDi 16V VTR Plus 5dr [5 Seat]

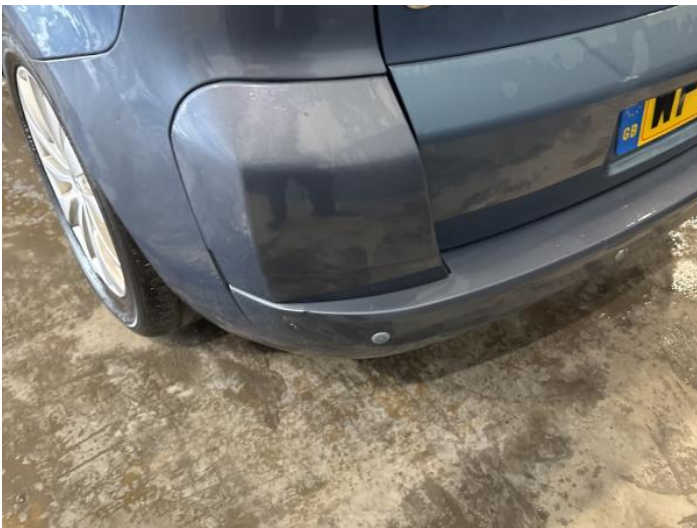
1: Bumper Rear
Dented
With Paint Damage

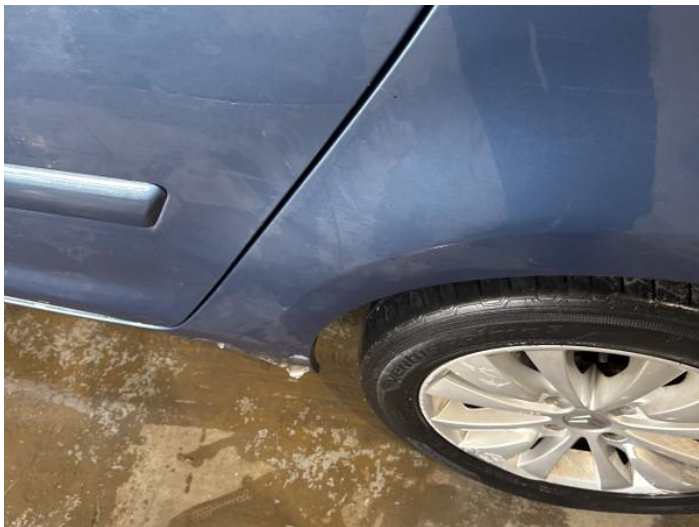
3: Qtr Panel nsr
Dented
With Paint Damage

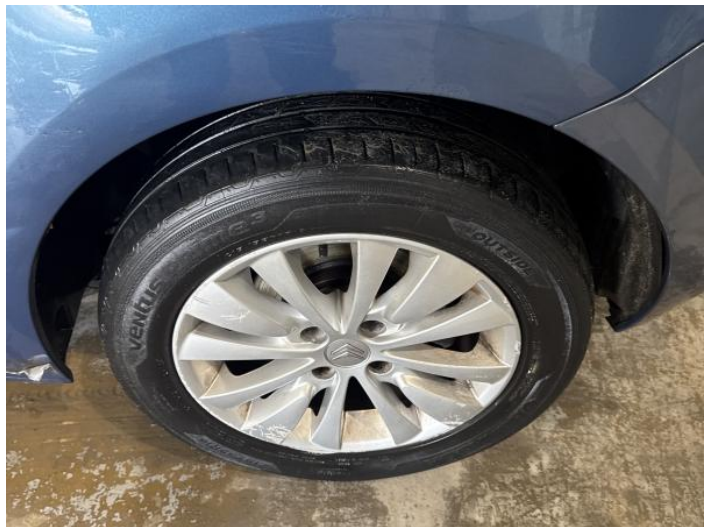
4: Wheel nsr
Scratched
Over 50mm

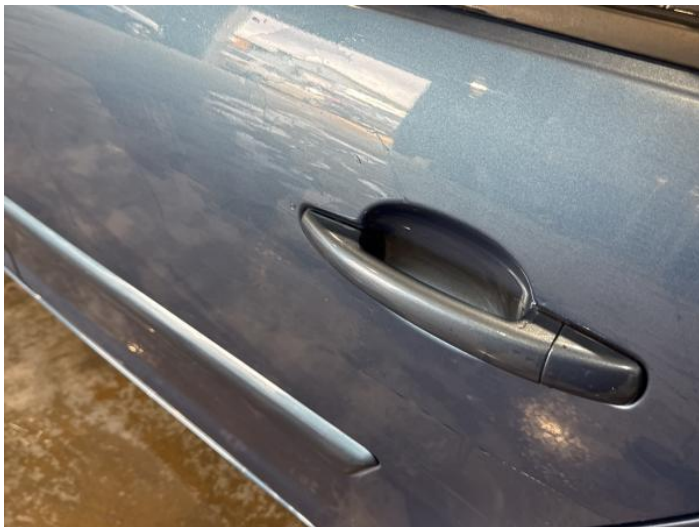
5: Door nsr
Chipped
1 To 5

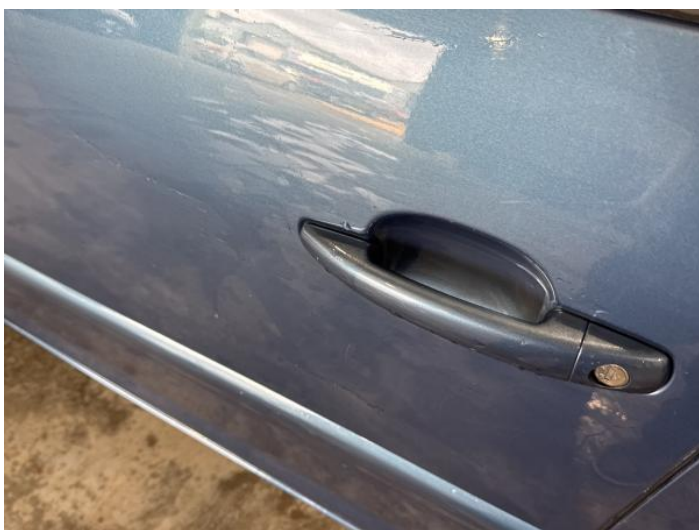
7: Door nsf
Chipped
1 To 5

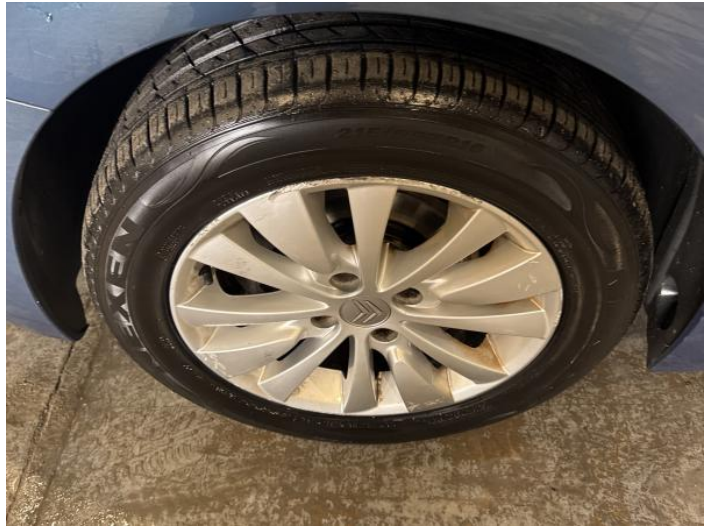
9: Wing nsf
Scratched
Over 25mm Not Thru Paint

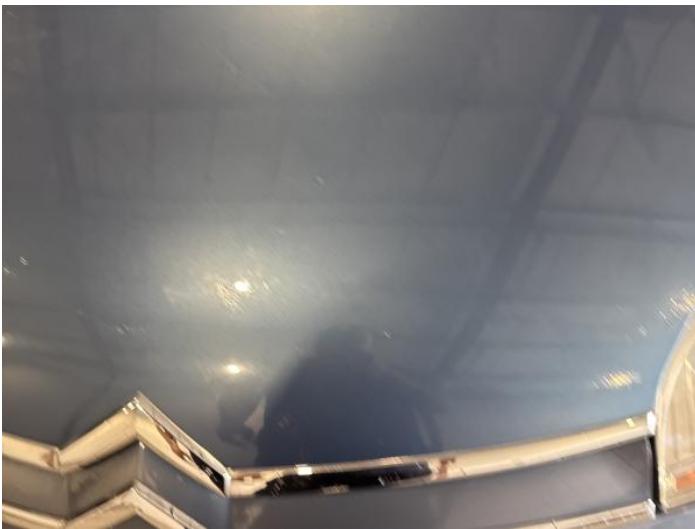
11: Bonnet
Chipped
1 To 5

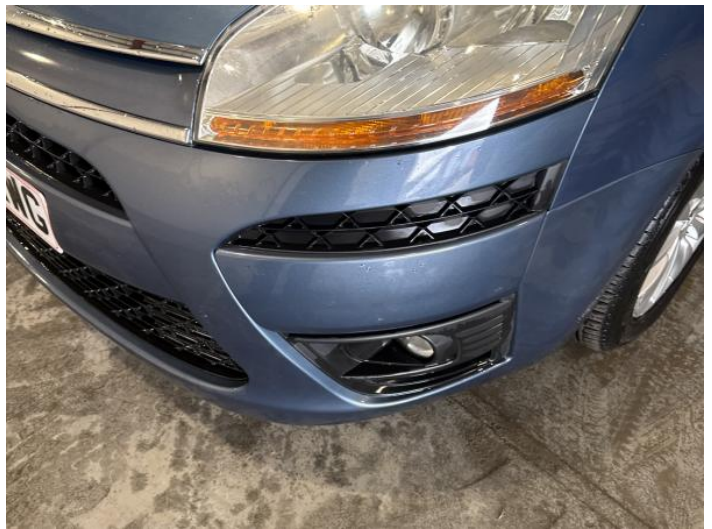
12: Bumper Front
Scratched
Over 100mm Thru Paint

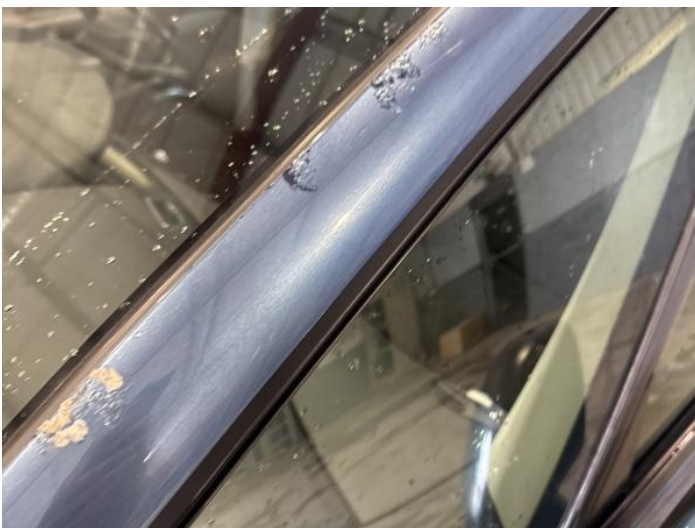
13: A Post ns
Poor Previous Repair
Paint Flake

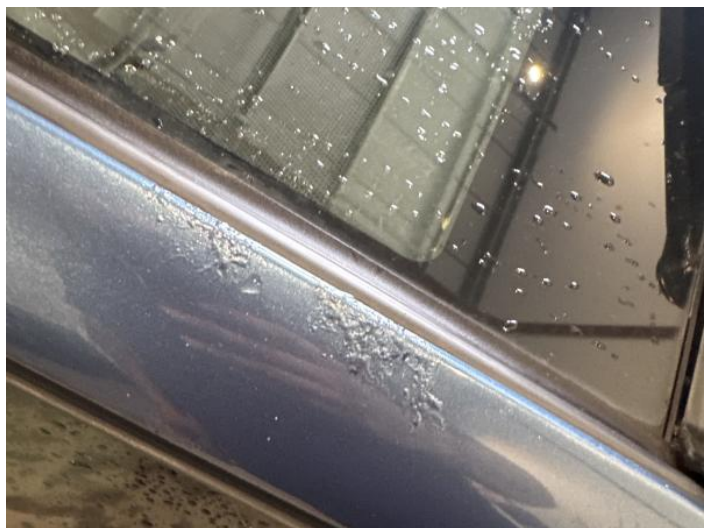
14: A Post os
Rusted
Over 5mm

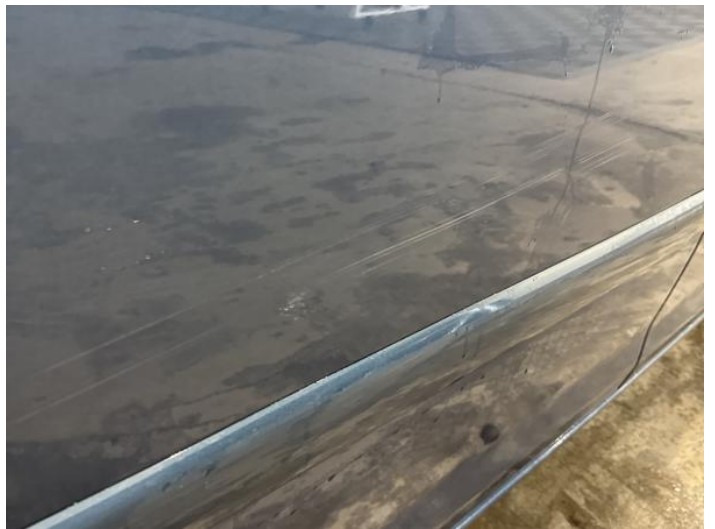
18: Door osr
Dented
With Paint Damage

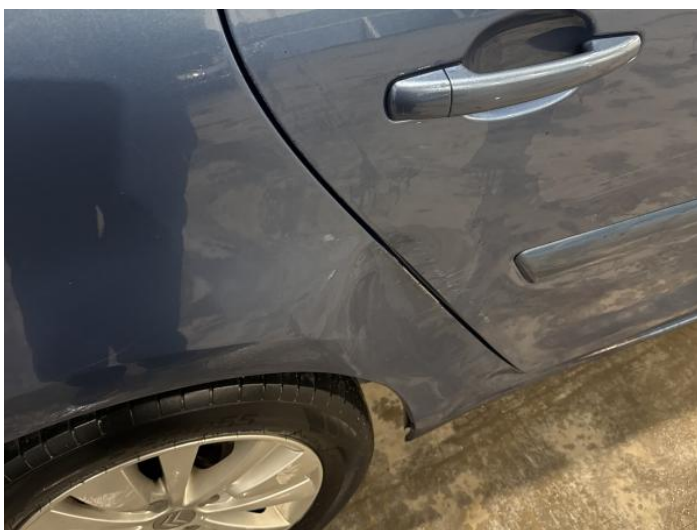
19: Qtr Panel osr
Dented
With Paint Damage

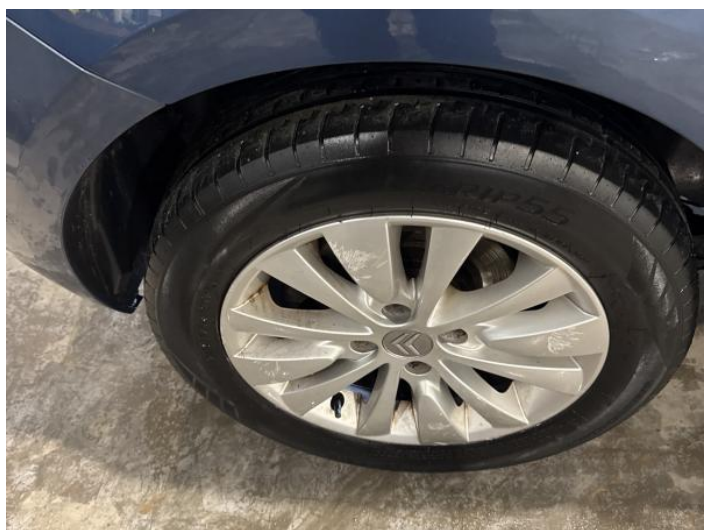
20: Wheel osr
Scratched
Over 50mm
