# VEHICLE INSPECTION REPORT

**HY62SWV**

## Skoda Octavia 2.0T FSI vRS 5dr

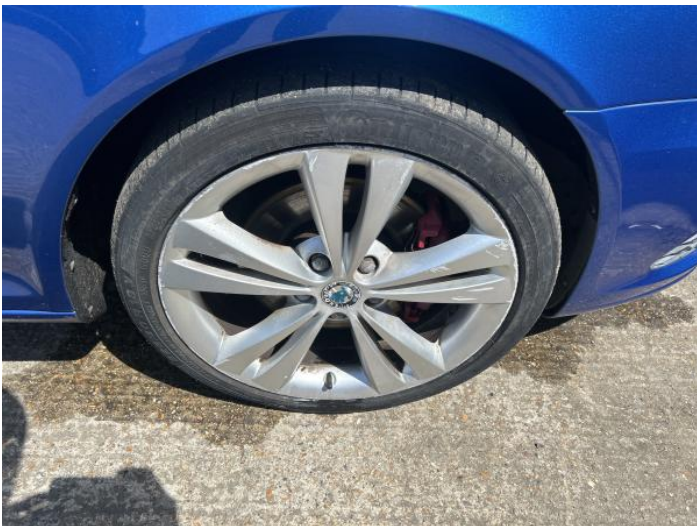
1: Wheel of  
Scratched  
Over 50mm

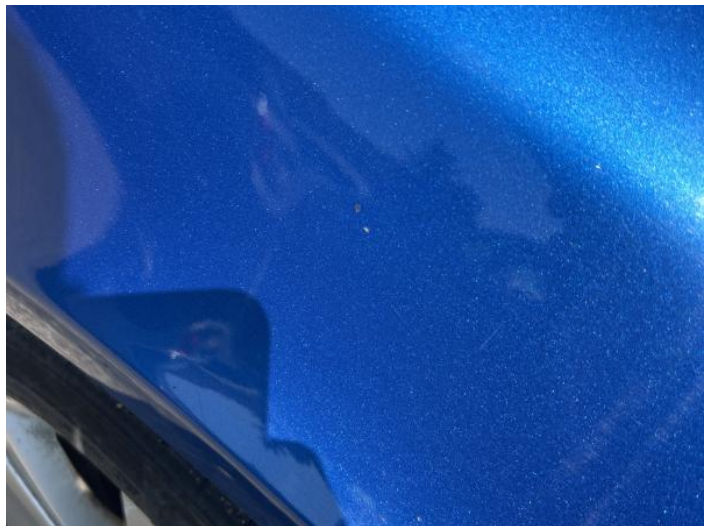
2: Wing of  
Chipped  
1 To 5

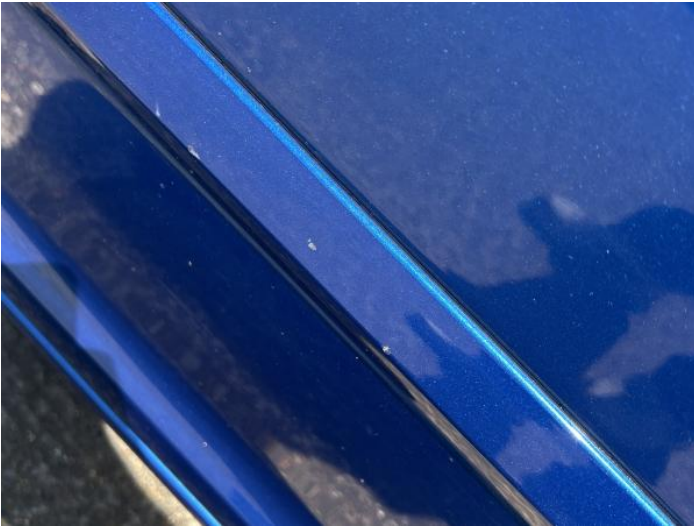
3: Door Moulding osf  
Scratched (Painted)  
UpTo 25mm Thru Paint

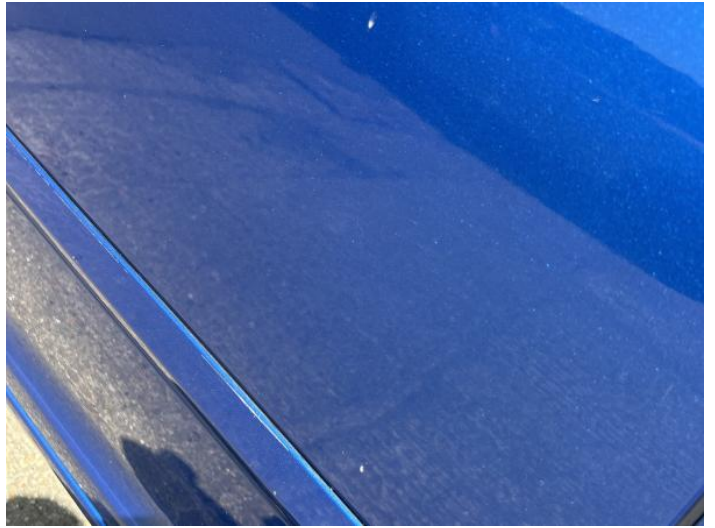
4: Door osr  
Chipped  
1 To 5

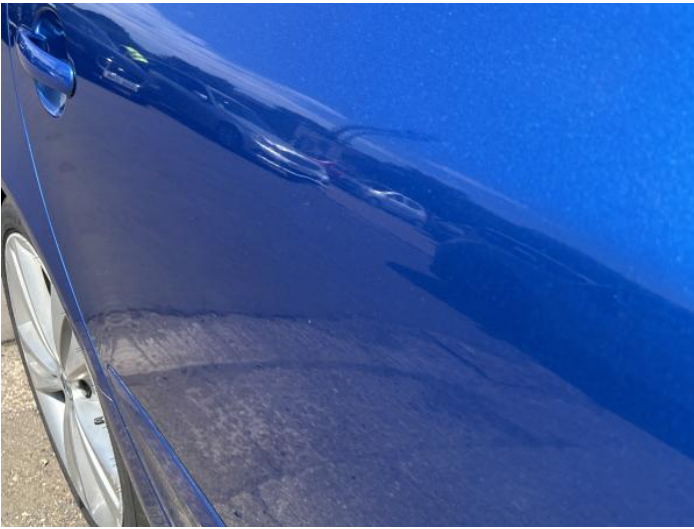
5: Door osr  
Dented  
2 Or Less UpTo 10mm

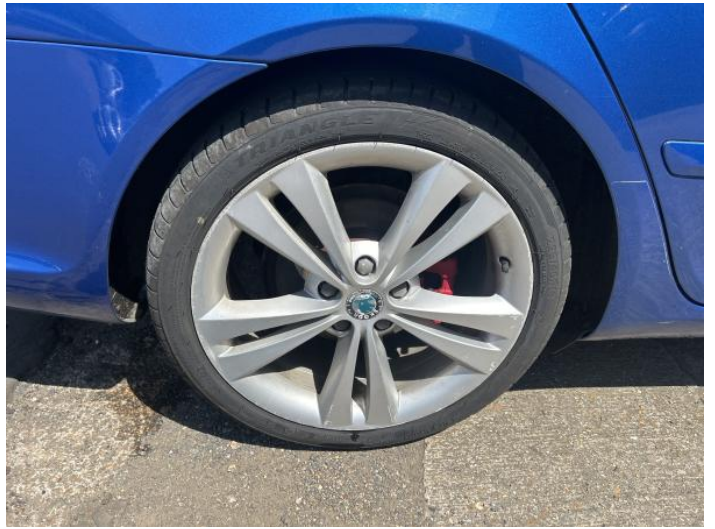
6: Wheel osr  
Scratched  
Over 50mm

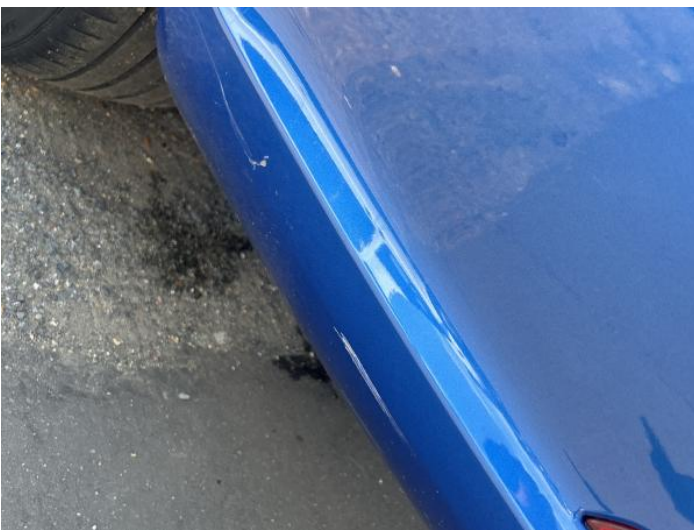
7: Bumper Rear  
Scratched  
Over 100mm Thru Paint

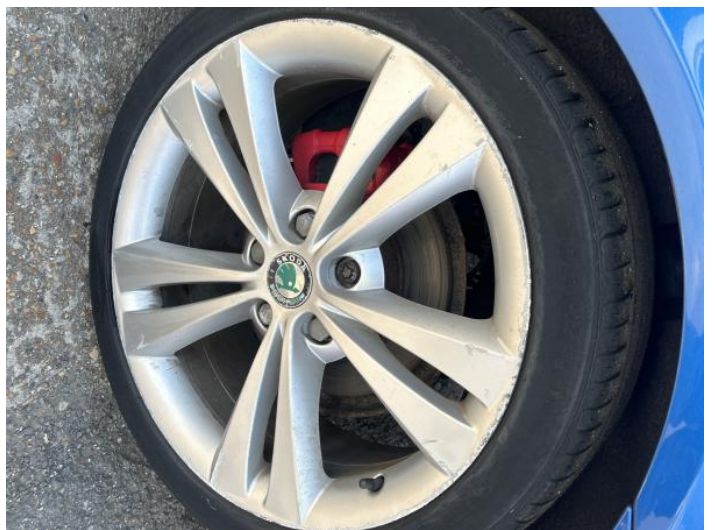
8: Wheel nsr  
Scratched  
Over 50mm

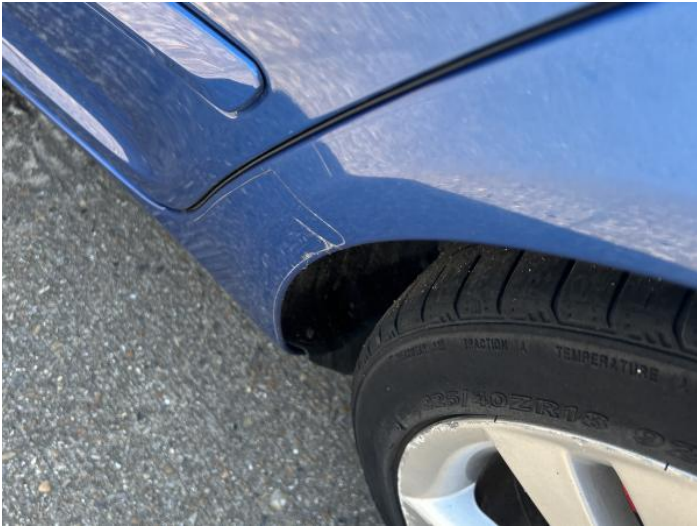
9: Qtr Panel nsr  
Dented  
2 Or Less UpTo 10mm

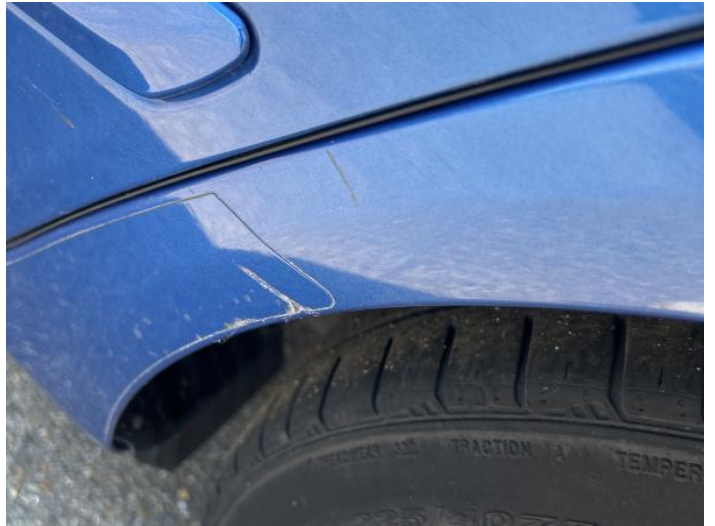
10: Qtr Panel nsr  
Scratched  
UpTo 25mm Thru Paint

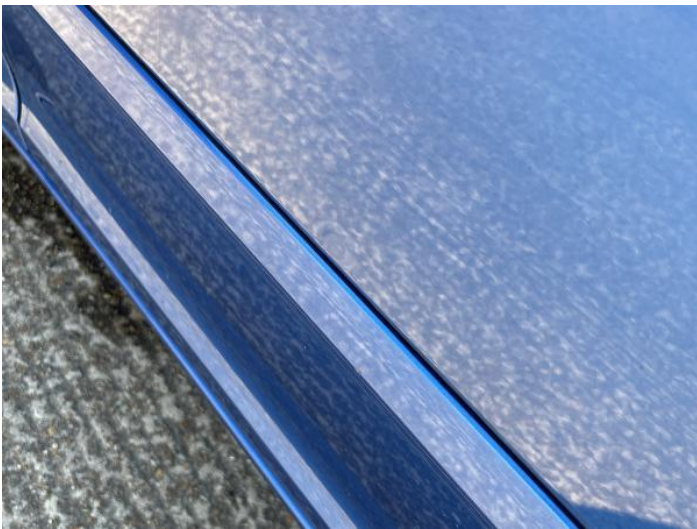
11: Door nsf  
Dented  
2 Or Less UpTo 10mm

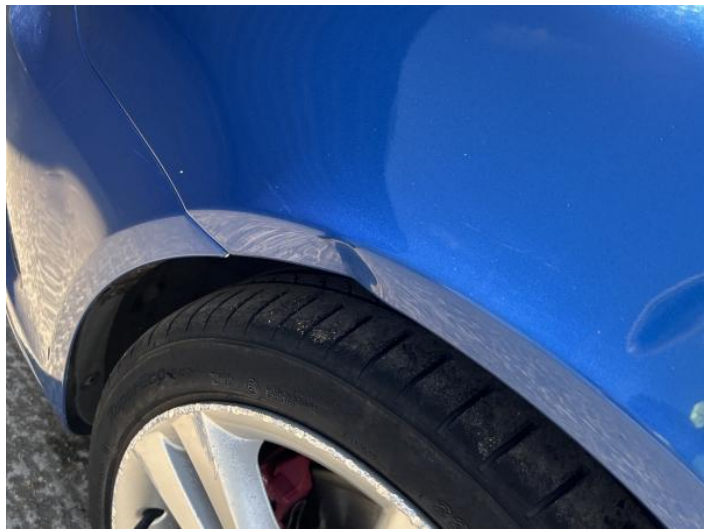
12: Wing nsf  
Dented  
With Paint Damage

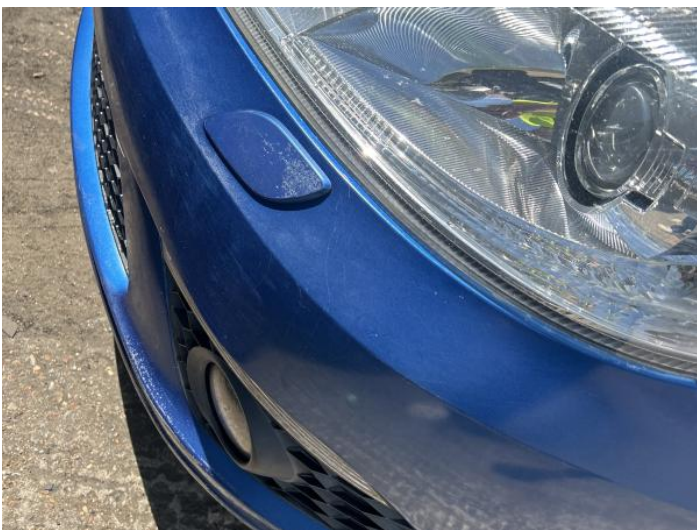
13: Bumper Front  
Poor Previous Repair  
Poor Paint

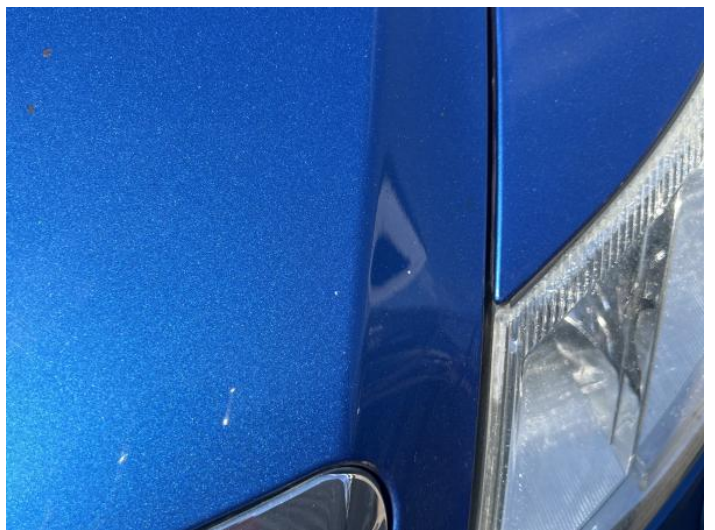
14: Bonnet  
Chipped  
1 To 5

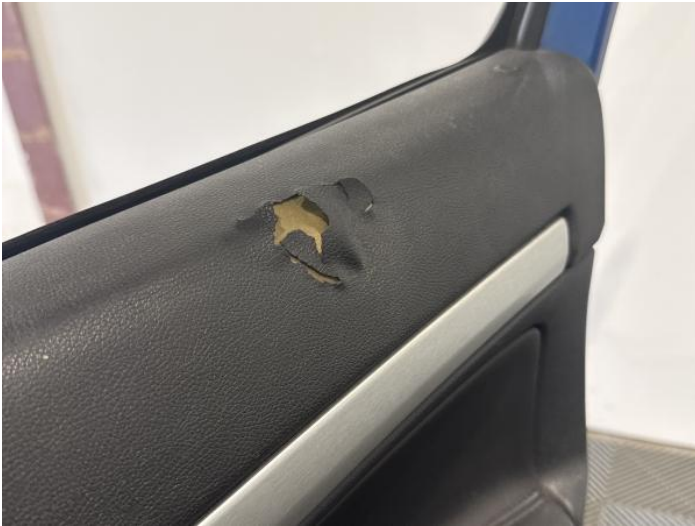
15: Door Pad osf  
Torn  
Over 10mm

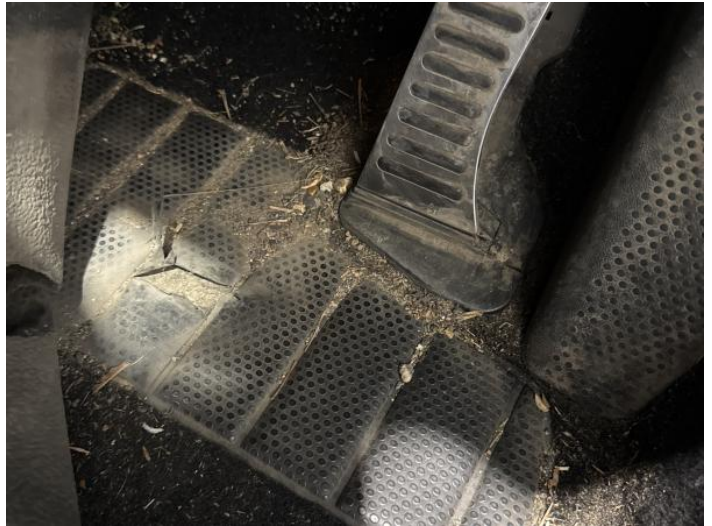
16: Carpets Front  
Torn  
Over 10mm
