VEHICLE INSPECTION REPORT

RJ61YOG

Hyundai I30 1.6 CRDi Premium 5dr

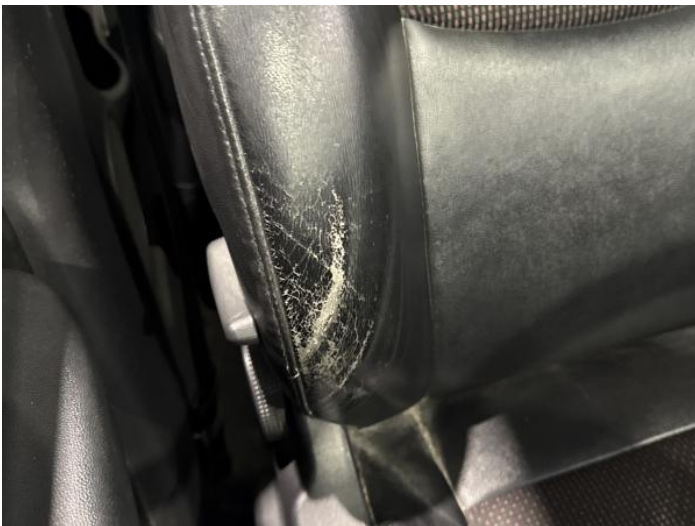
1: Seat Back Cover osf
Scuffed
Over 25mm

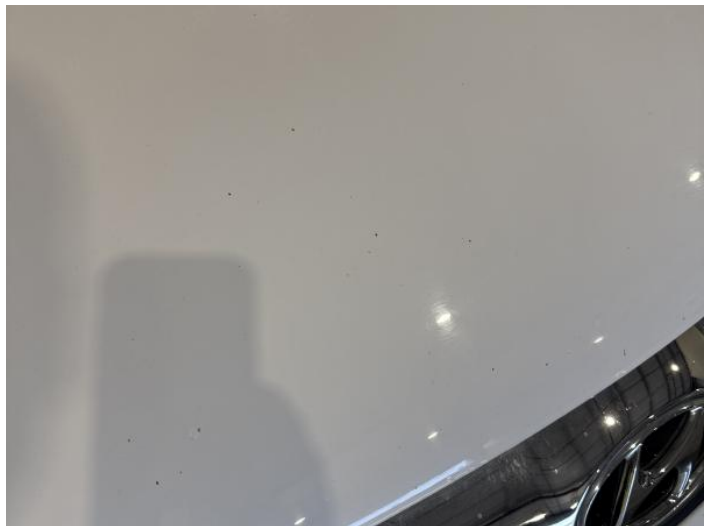
2: Bonnet
Chipped
Multiple Chips

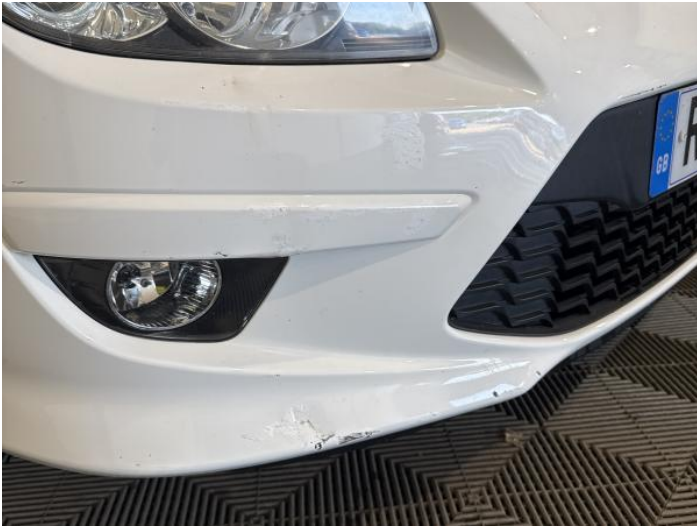
3: Bumper Front
Dented
With Paint Damage

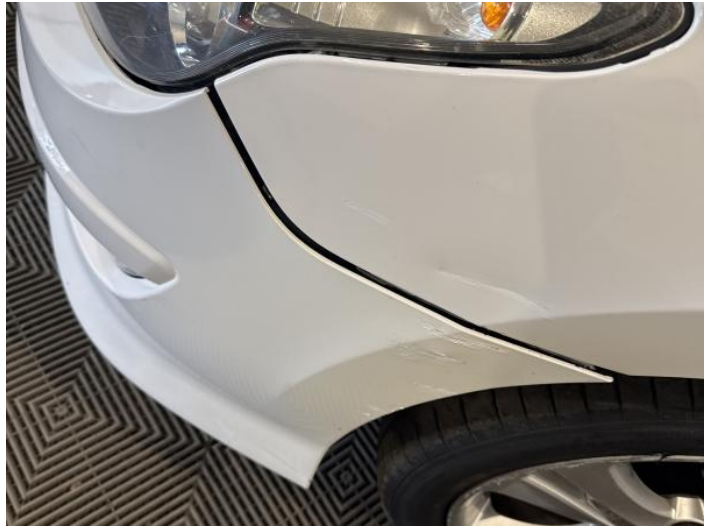
4: Bumper Front
Insecure
Action Required

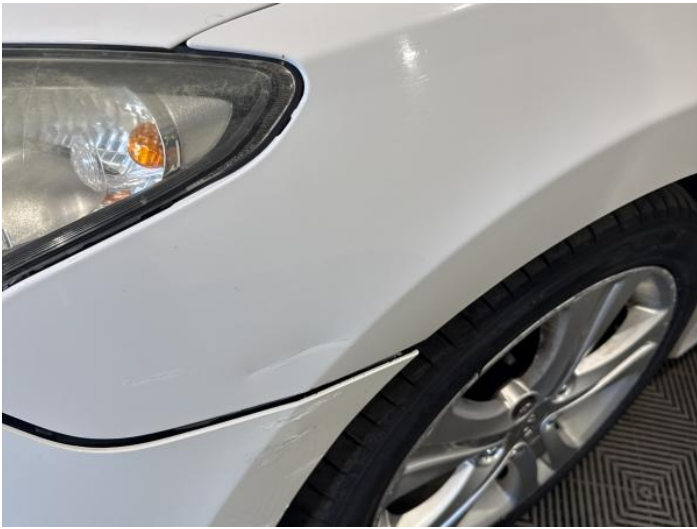
5: Wing nsf
Dented
With Paint Damage

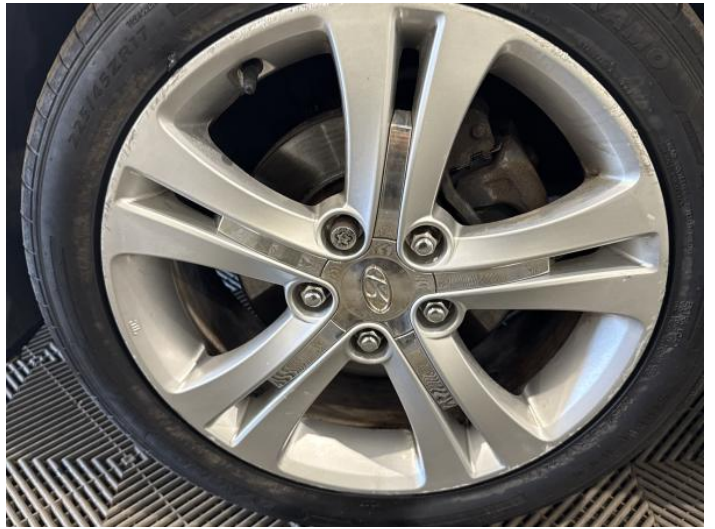
6: Wheel nsf
Scratched
Over 50mm

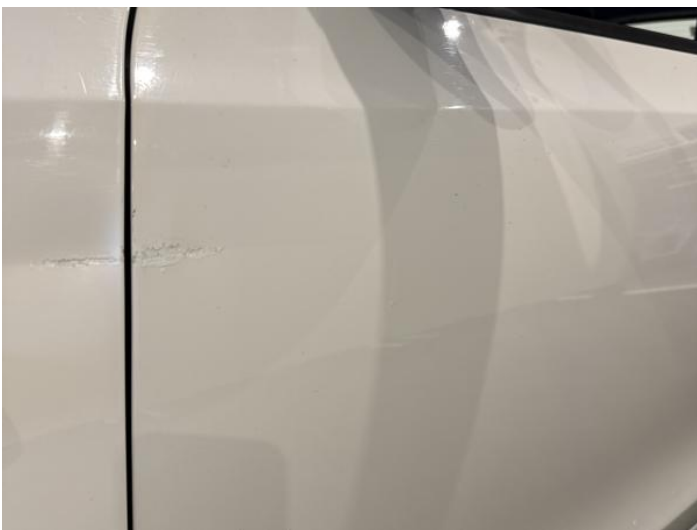
7: Door nsf
Dented
With Paint Damage

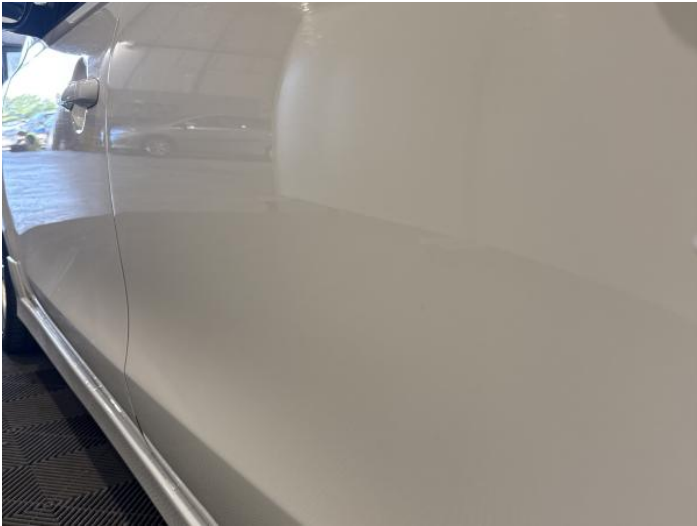
9: Door nsr
Dented
Between 10mm + 30mm

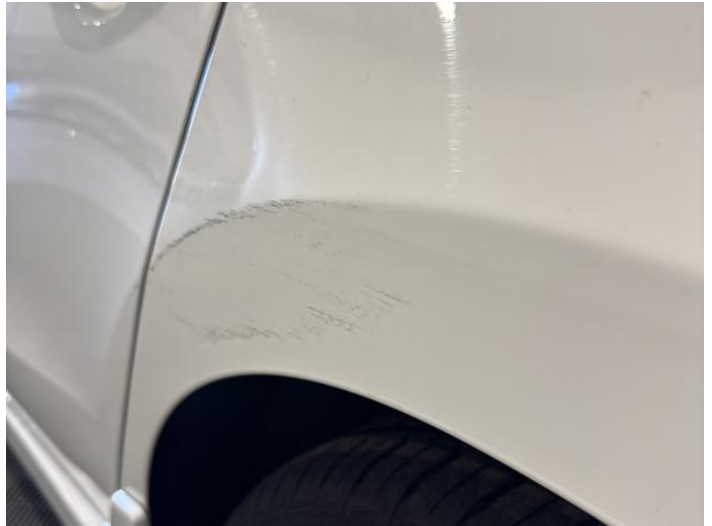
10: Qtr Panel nsr
Scratched
Over 25mm Thru Paint

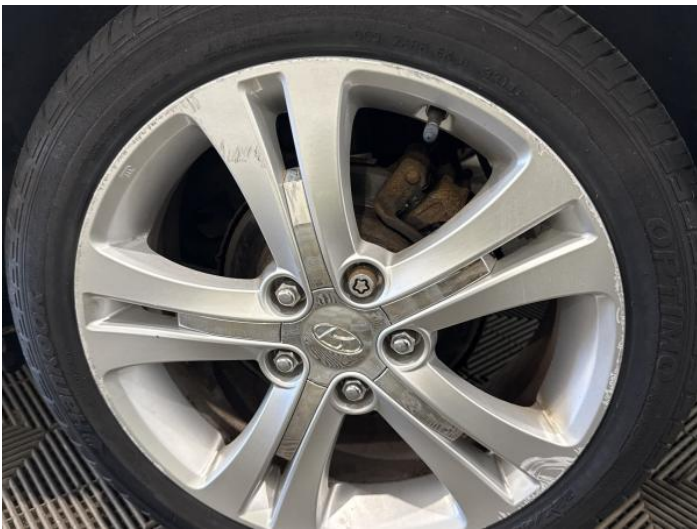
11: Wheel nsr
Scratched
Over 50mm

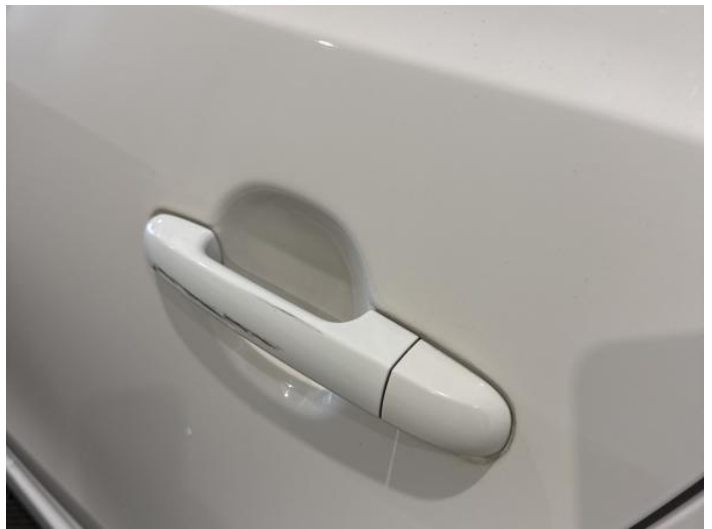
12: Handle Outer nsr
Scratched (Painted)
Over 25mm Thru Paint

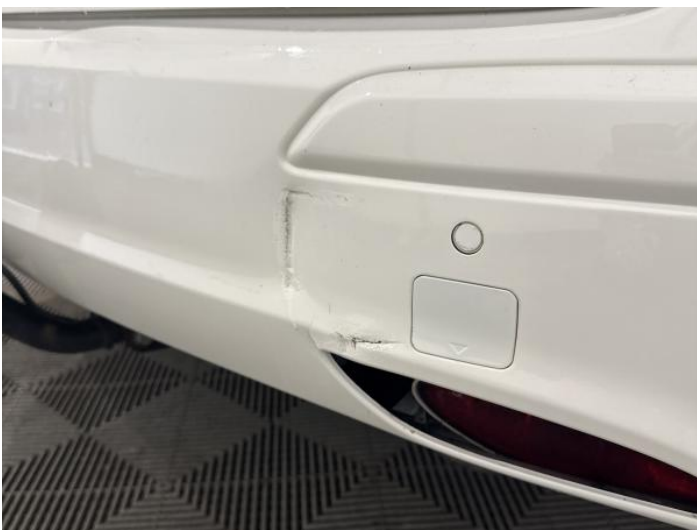
13: Bumper Rear
Cracked
Over 25mm

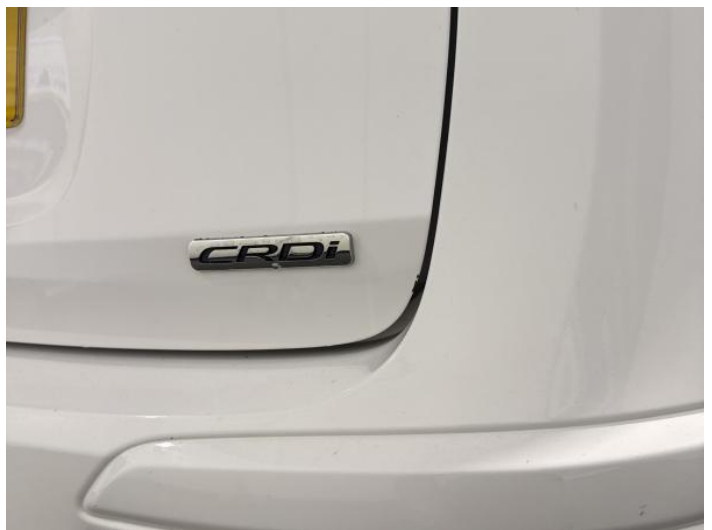
14: Tailgate
Scratched
UpTo 25mm Thru Paint

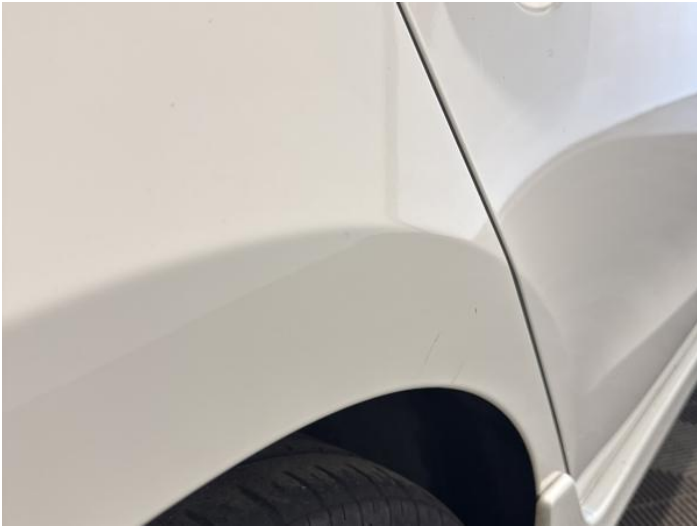
15: Qtr Panel osr
Dented
2 Or Less UpTo 10mm

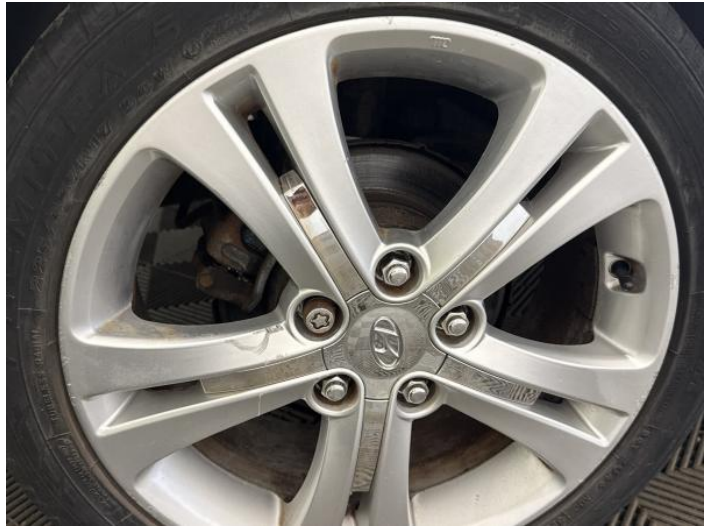
16: Wheel osr
Scratched
Over 50mm

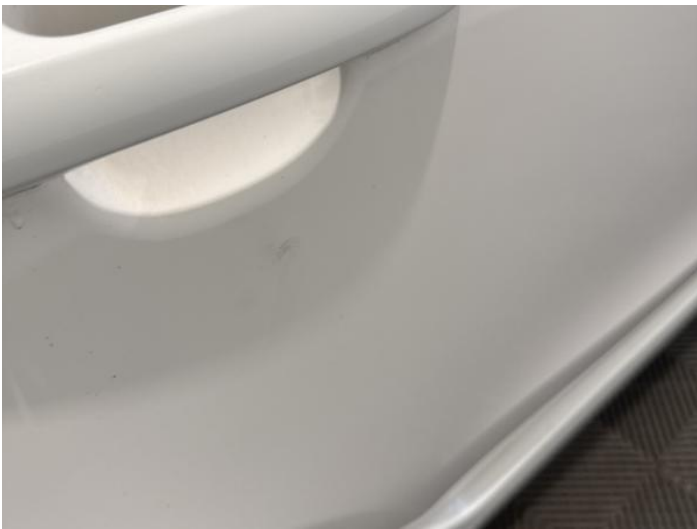
17: Door osr
Scratched
UpTo 25mm Thru Paint

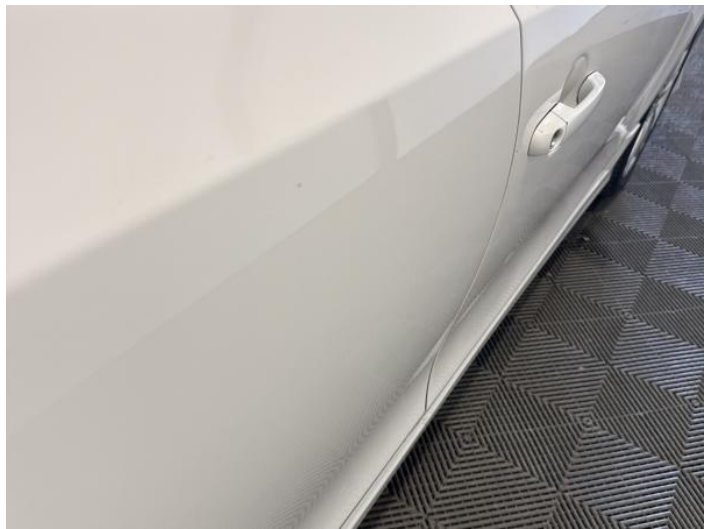
18: Door osr
Dented
Between 10mm + 30mm

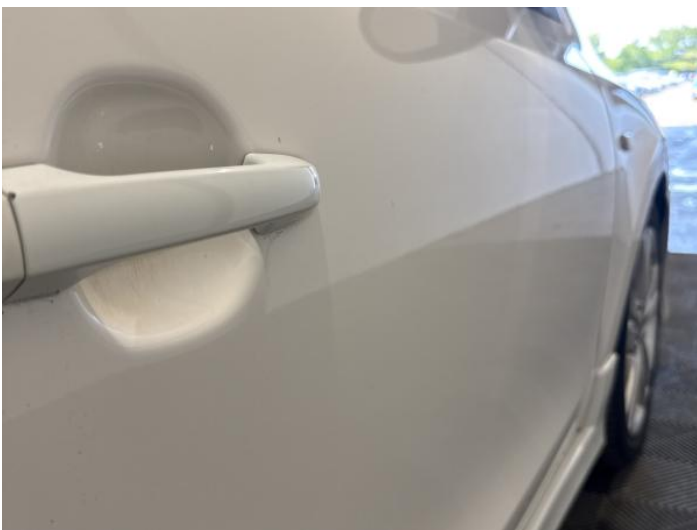
19: Door osf
Dented
Over 30mm

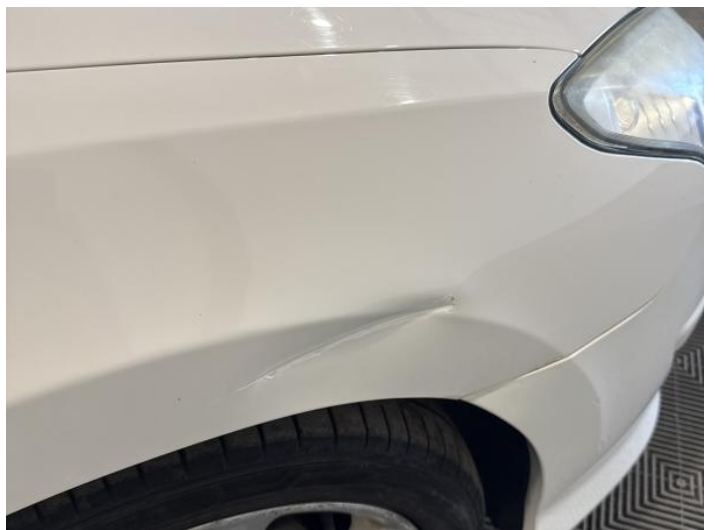
20: Wing osf
Dented
With Paint Damage

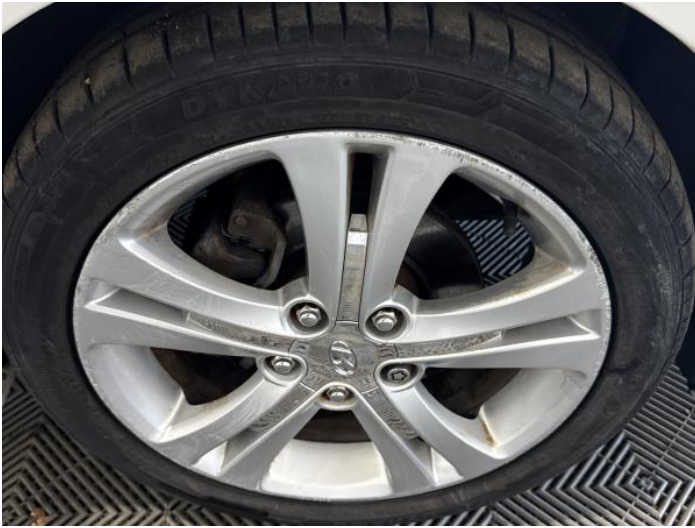
21: Wheel osf
 Scratched
 Over 50mm

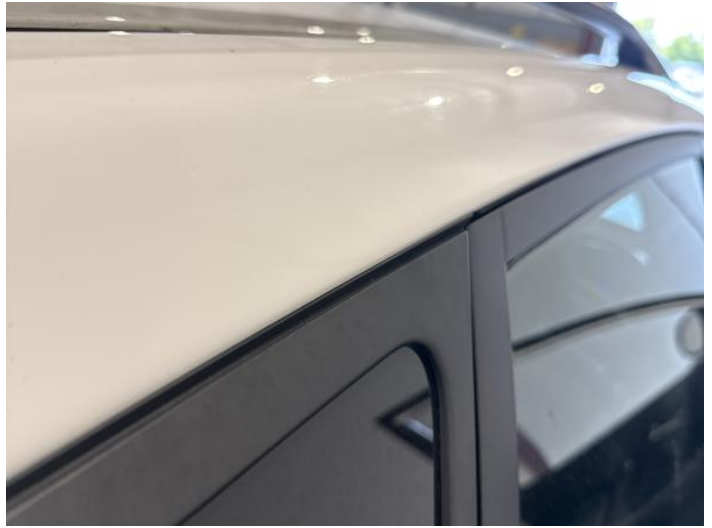
22: C Post os
 Dented
 Between 10mm + 30mm
