VEHICLE INSPECTION REPORT

F2FSA

Daimler Limousine Auto DF 420 CHASSIS

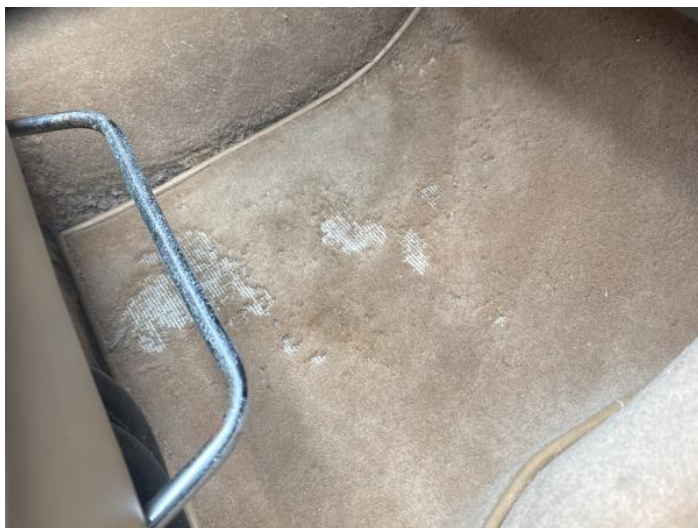
1: Carpets Front
Torn
Over 10mm

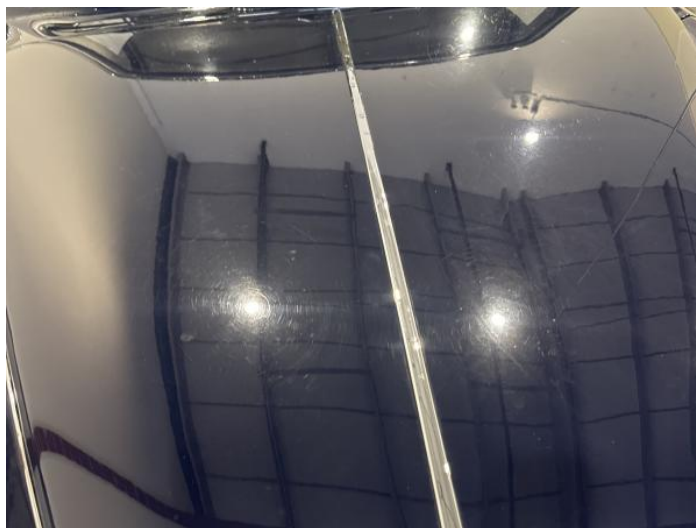
2: Bonnet
Chipped
1 To 5

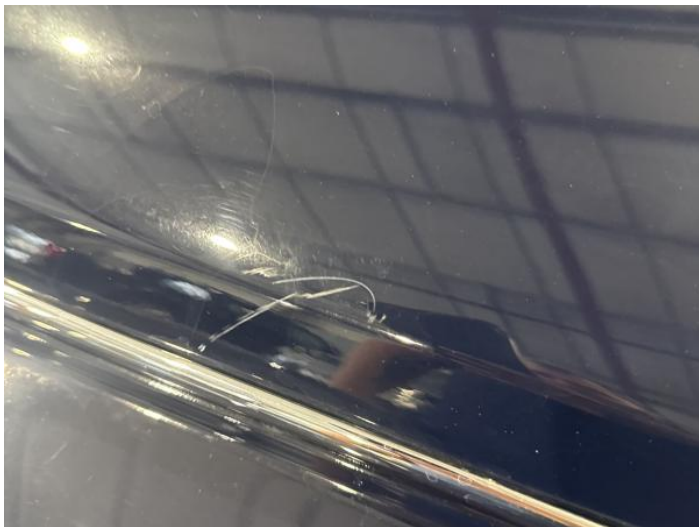
3: Boot Lid
Scratched
UpTo 25mm Thru Paint

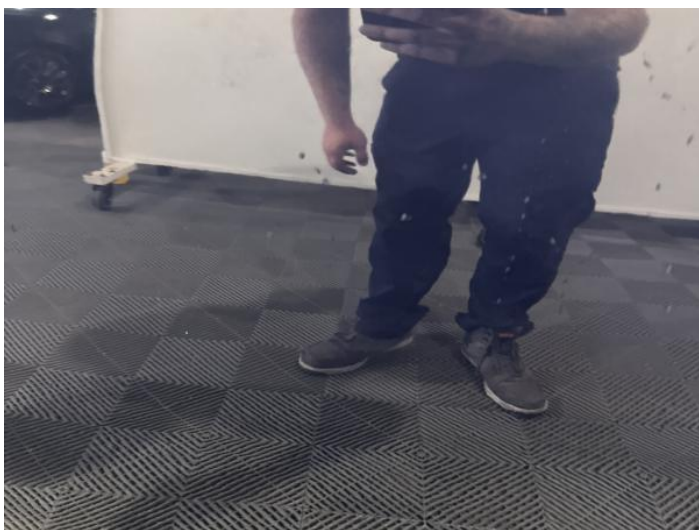
5: Door nsf
Dented
Over 30mm

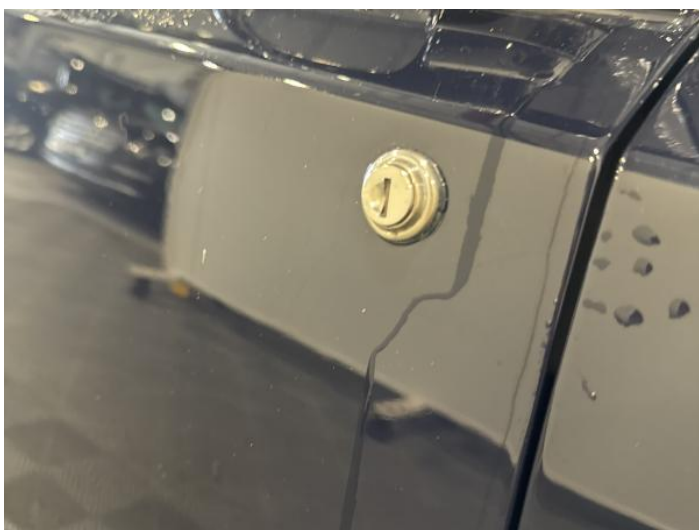
7: Door nsr
Rusted
UpTo 5mm

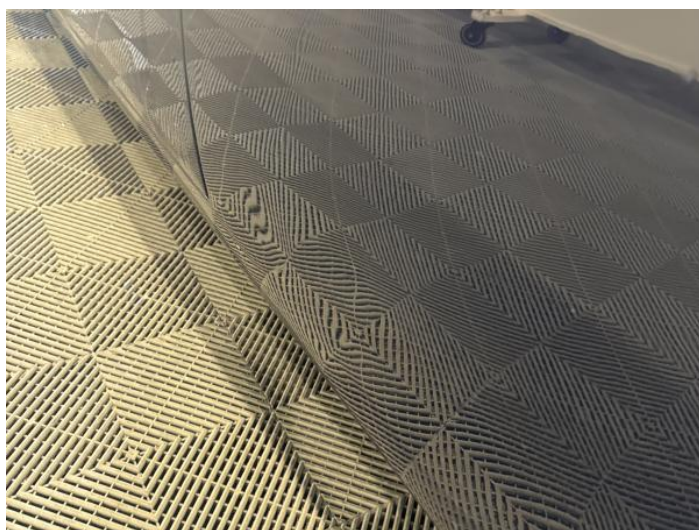
8: Qtr Panel nsr
Dented
Between 10mm + 30mm

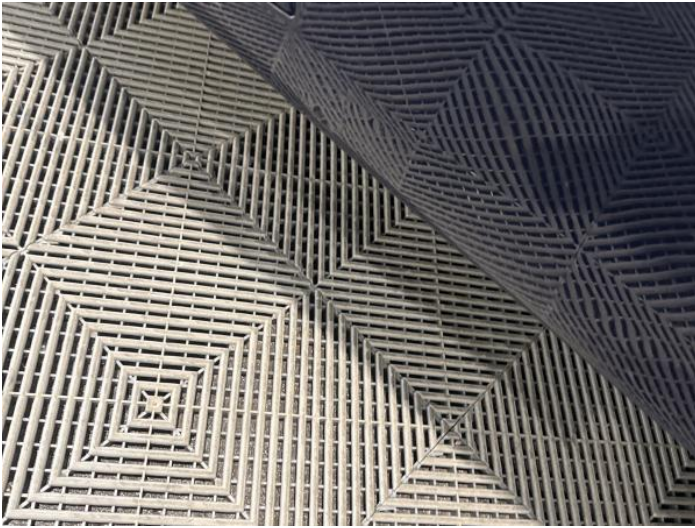
9: Sill ns
Dented
Between 10mm + 30mm

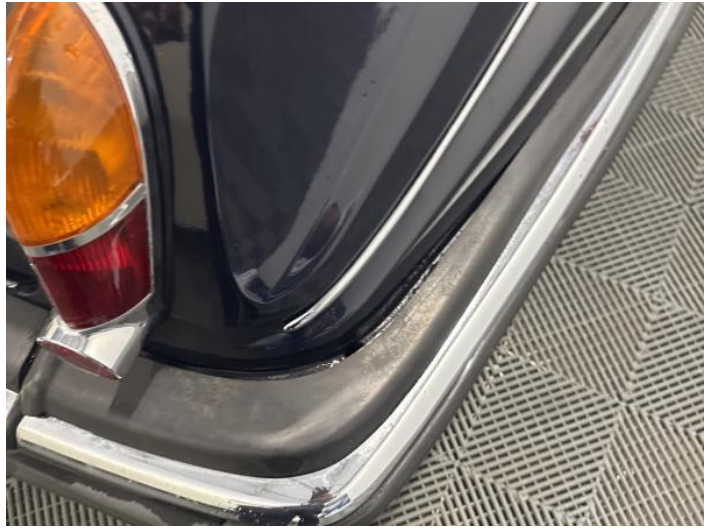
10: Bumper Rear Moulding
Broken
Replace

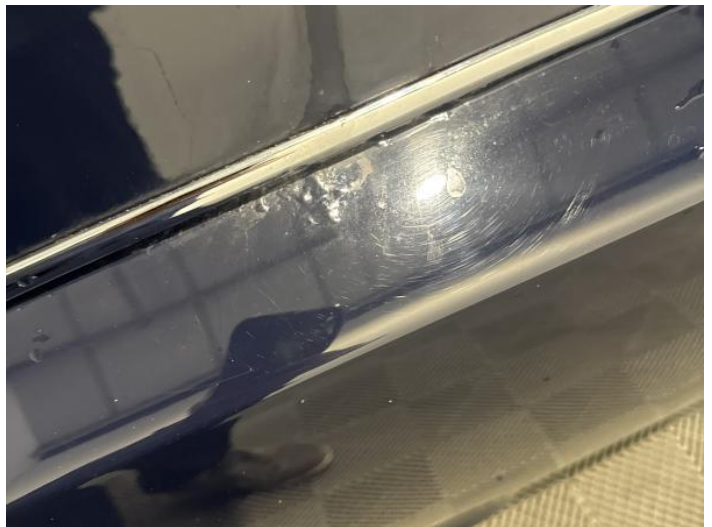
12: Qtr Panel osr
Rusted
UpTo 5mm

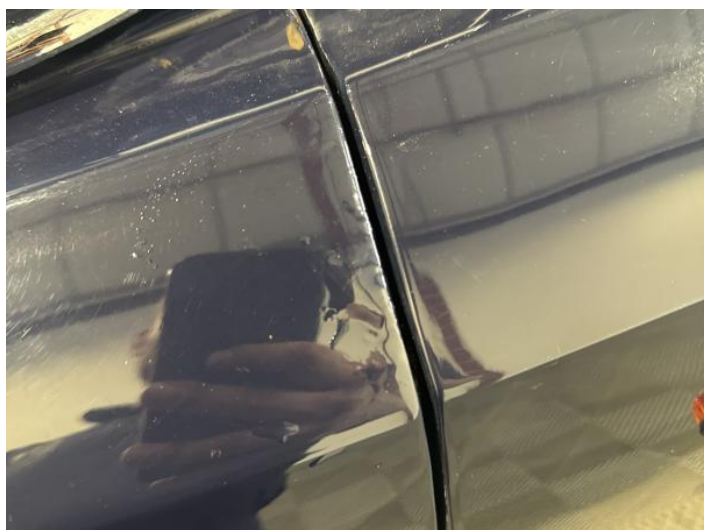
14: Door osf
Rusted
Over 5mm

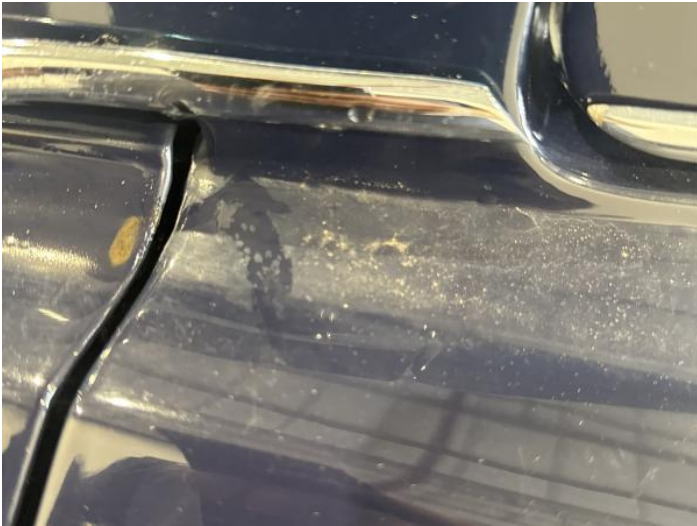
15: Wing osf
Rusted
Over 5mm

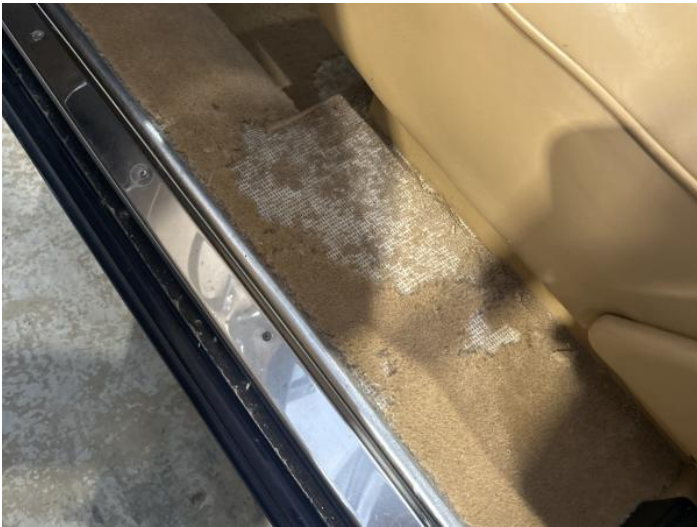
17: Carpets Front
Torn
Over 10mm
