# VEHICLE INSPECTION REPORT

**RE15BLJ**

## Ford Focus 1.6 125 Zetec 5dr Powershift

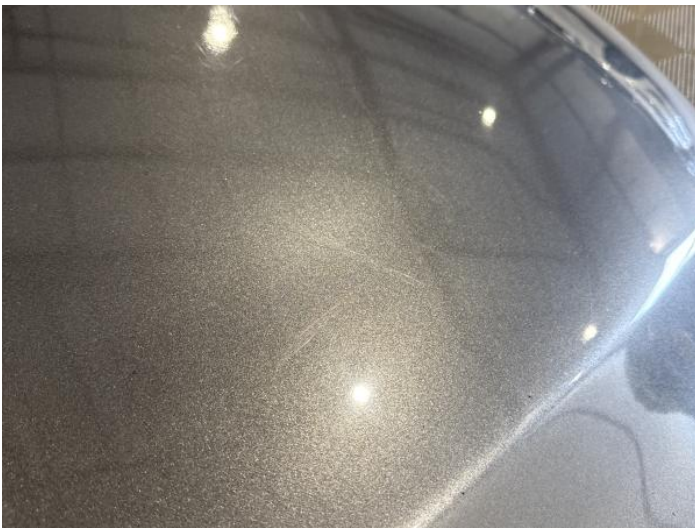
1: Bonnet  
Scratched  
Over 25mm Thru Paint

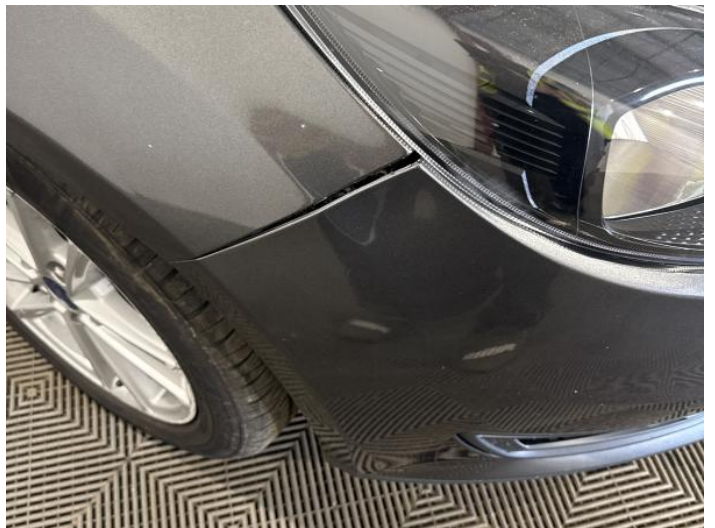
2: Bumper Front  
Insecure  
Action Required

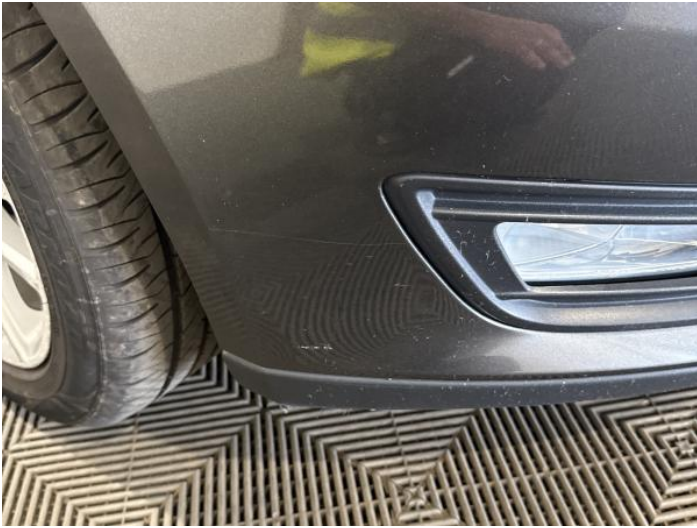
3: Bumper Front  
Scratched  
25 to 100mm Thru Paint

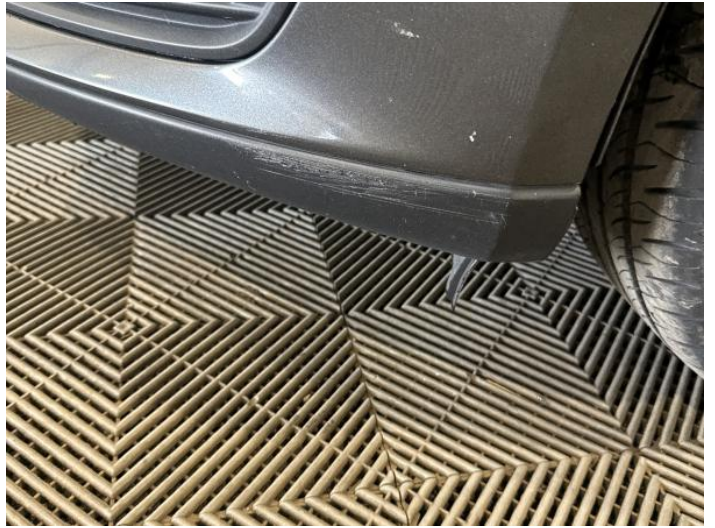
4: Bumper Front Moulding  
Scuffed (Unpainted)  
Over 100mm

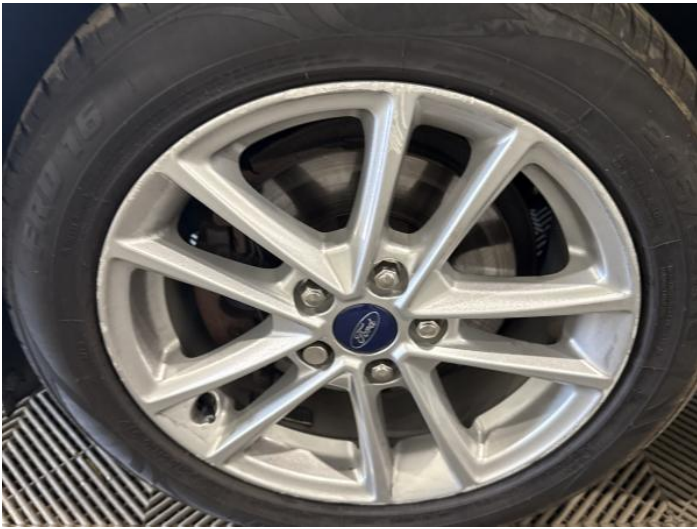
5: Wheel nsf  
Scratched  
Over 50mm

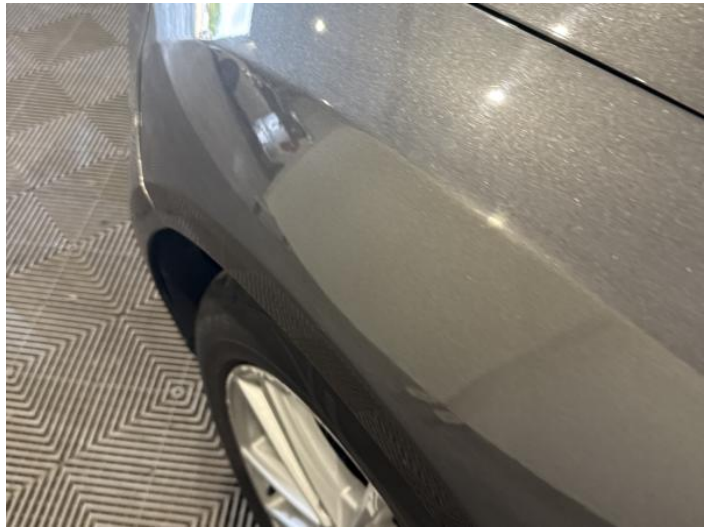
6: Wing nsf  
Dented  
Between 10mm + 30mm

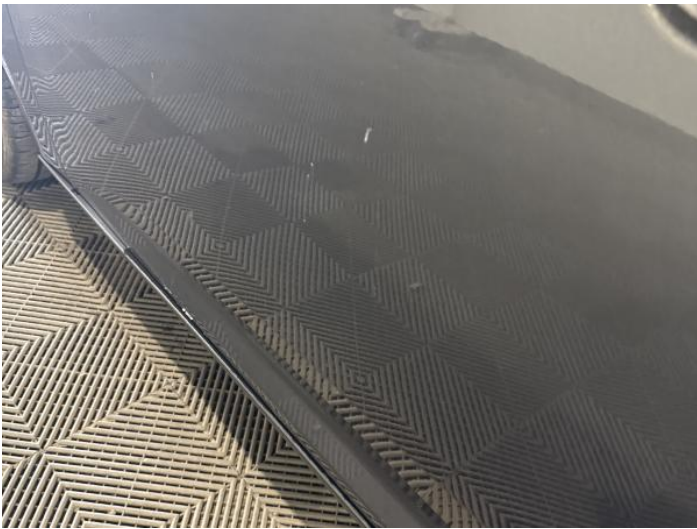
7: Door nsf  
Scratched  
Over 25mm Thru Paint

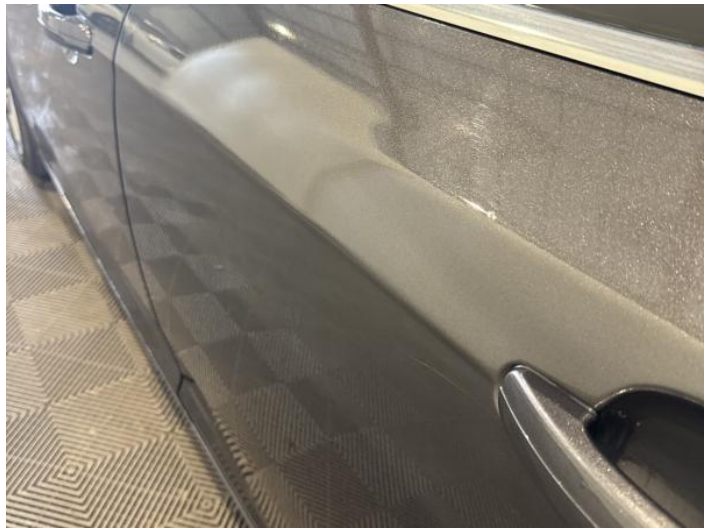
8: Door nsr  
Poor Previous Repair  
Rippled Up To 30%

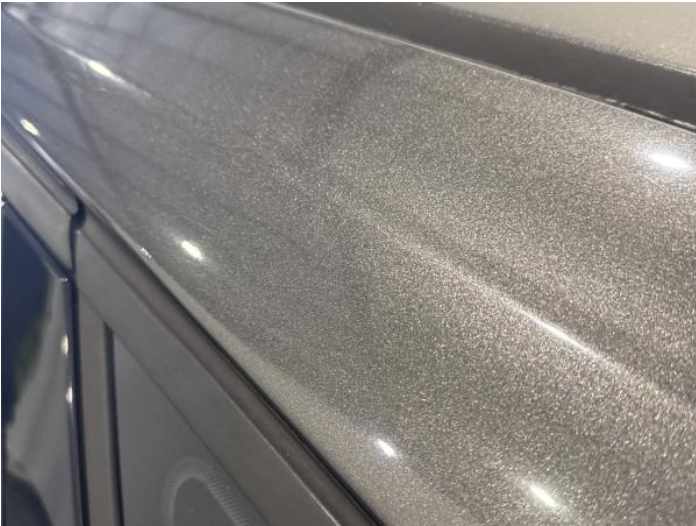
9: C Post ns  
Dented  
Between 10mm + 30mm

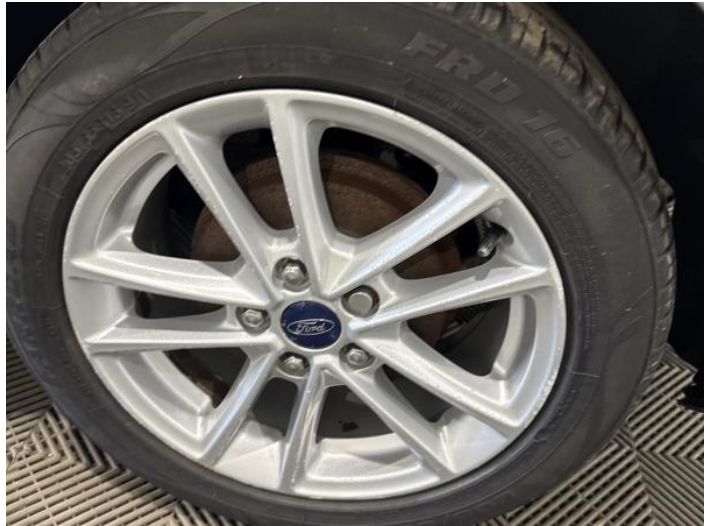
10: Wheel nsr  
Scratched  
Over 50mm

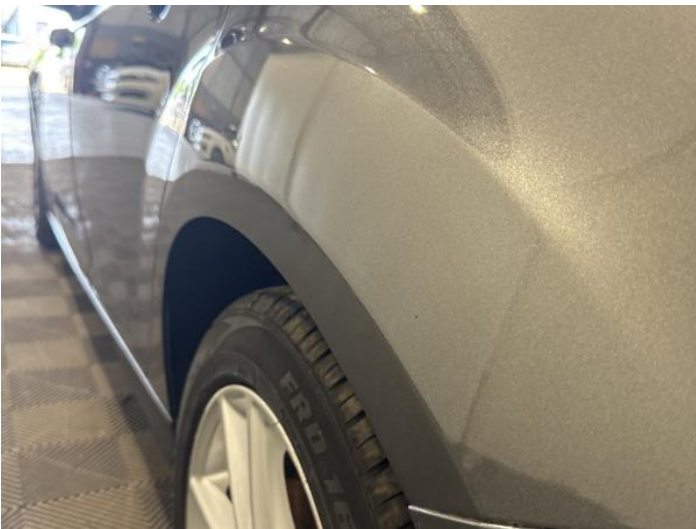
11: Qtr Panel nsr  
Dented  
Over 30mm

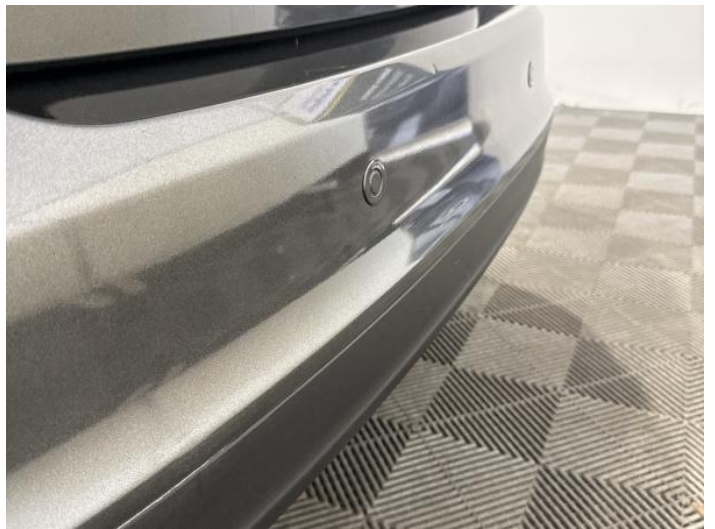
12: Bumper Rear  
Poor Previous Repair  
Poor Paint

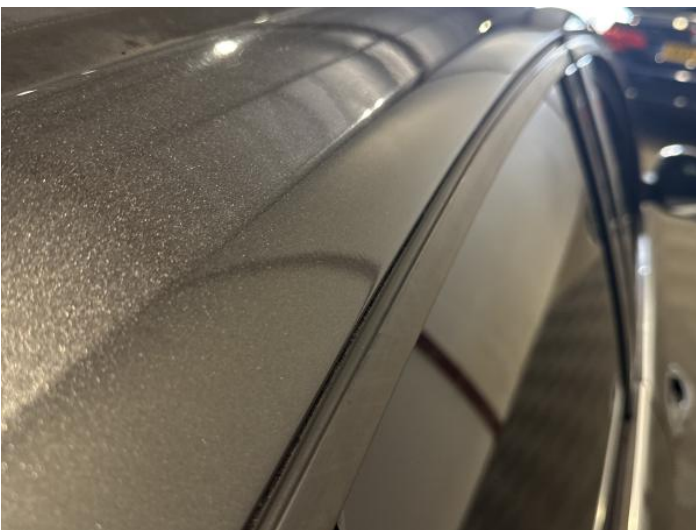
13: B Post os  
Dented  
Over 30mm

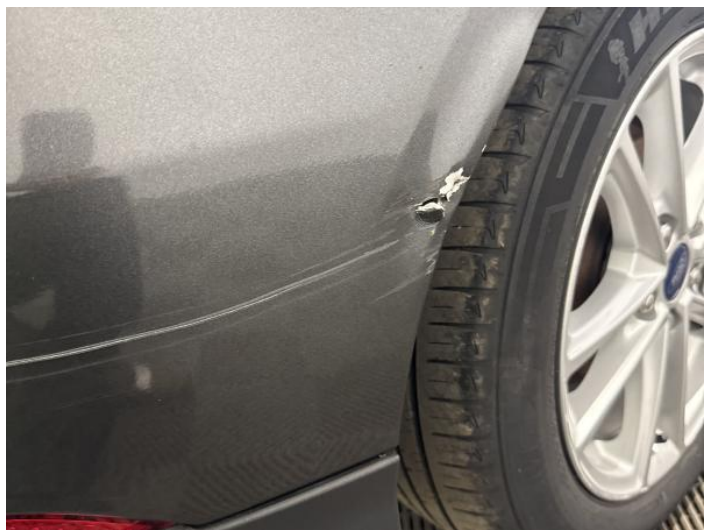
14: Bumper Rear  
Cracked  
Over 25mm

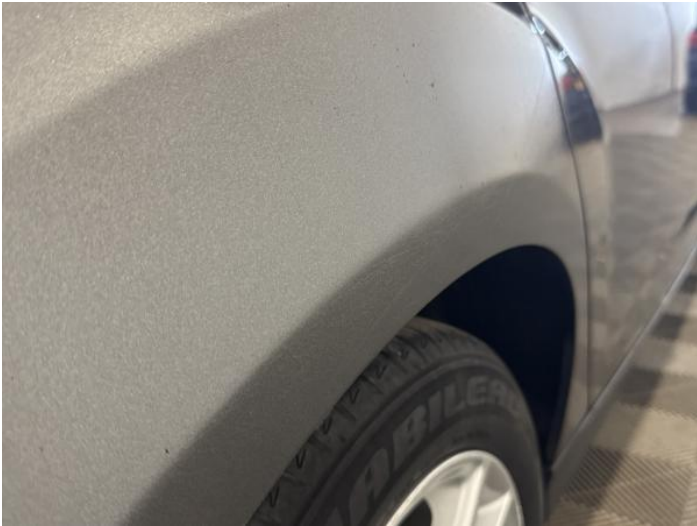
15: Qtr Panel osr  
Poor Previous Repair  
Poor Paint

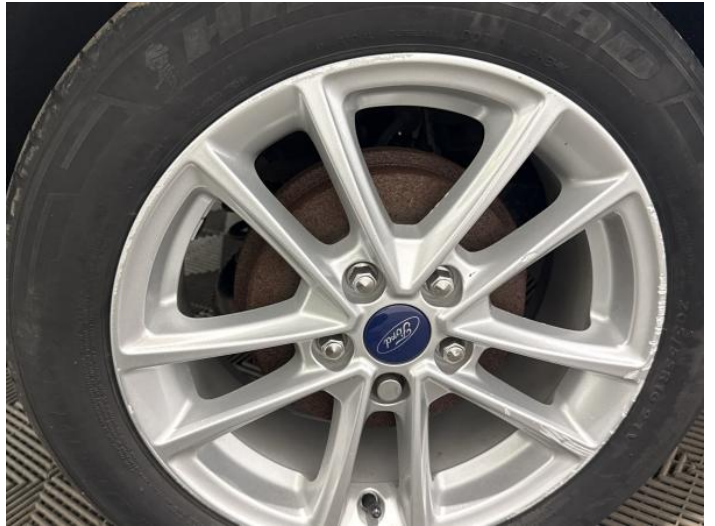
16: Wheel osr  
Scratched  
Over 50mm

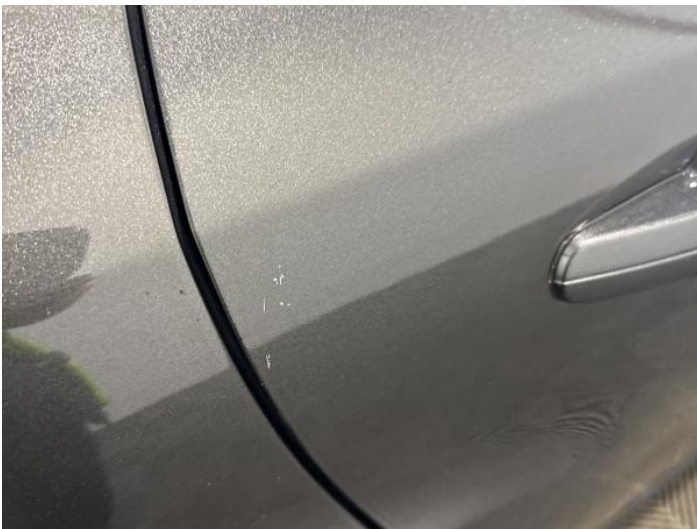
17: Door osr  
Chipped  
1 To 5

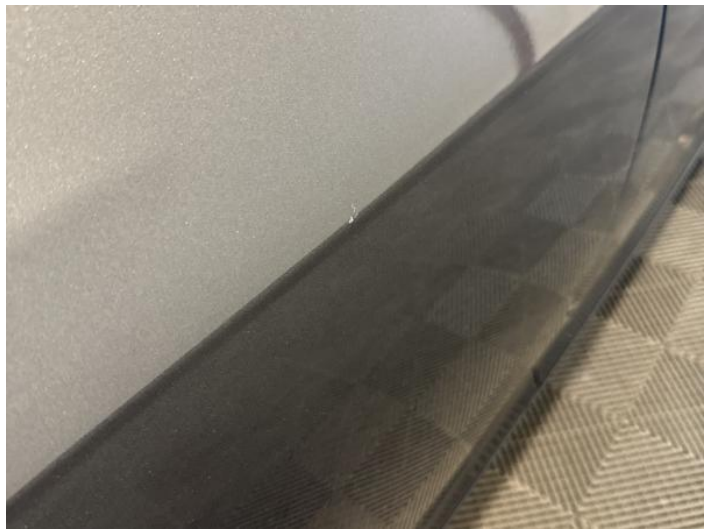
18: Door osr  
Dented  
Between 10mm + 30mm

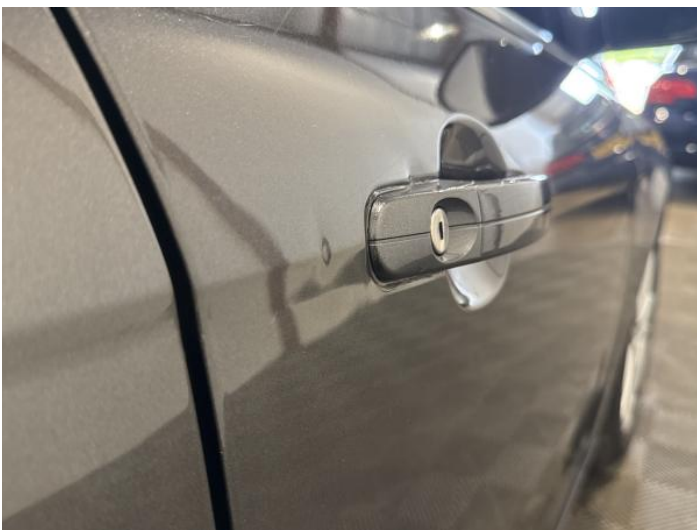
19: Door osf  
Dented  
Between 10mm + 30mm

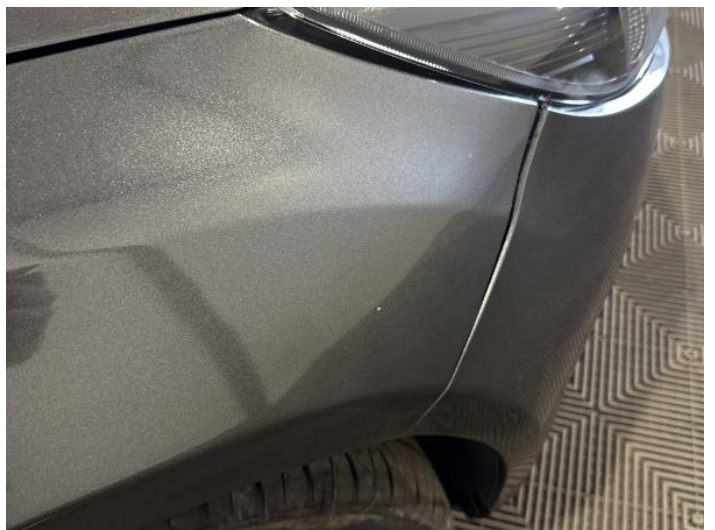
20: Wing osf  
Chipped  
1 To 5

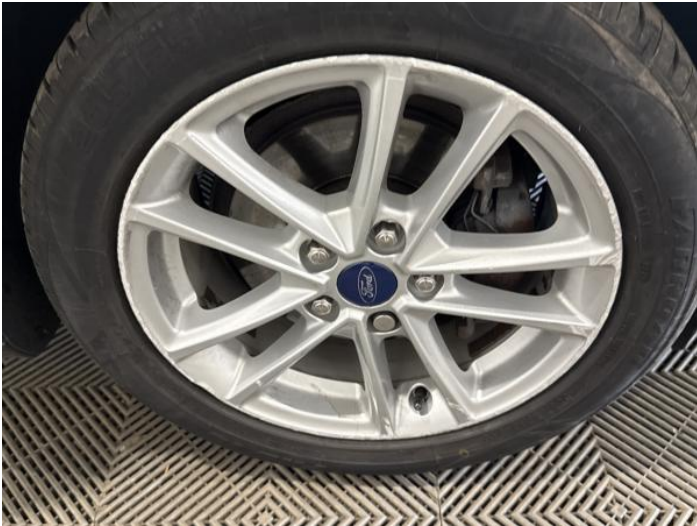
21: Wheel of  
Scratched  
Over 50mm

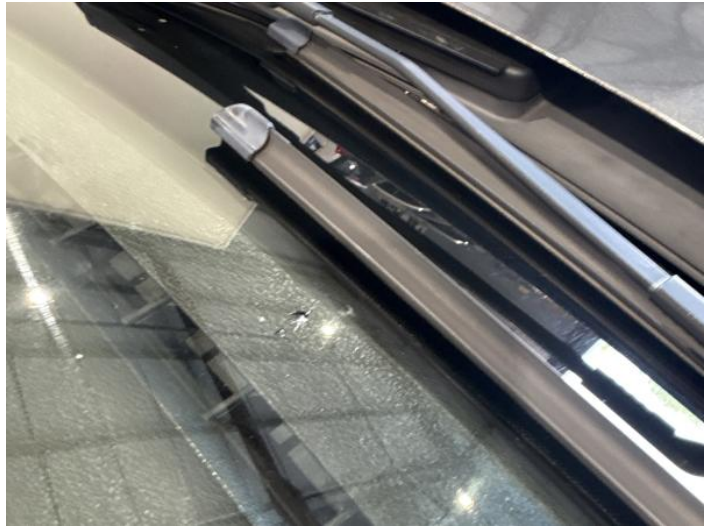
22: Screen Front  
Cracked  
Replace
