VEHICLE INSPECTION REPORT

Land Rover Range Rover 5.0 V8 Supercharged Autobiography LWB 4dr Auto SS

Inspection		Vehicle	
Serious Damage?	No	VAT	Margin
		V5	Buyer To Apply

nama
GRADE
2

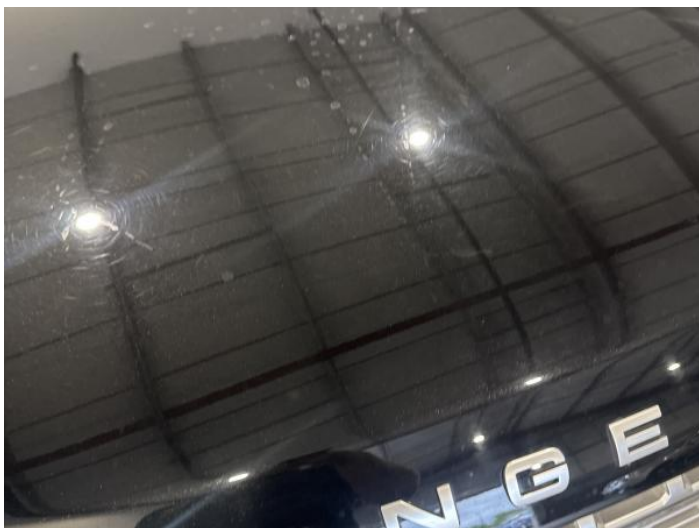
1: Bonnet
Chipped
1 To 5

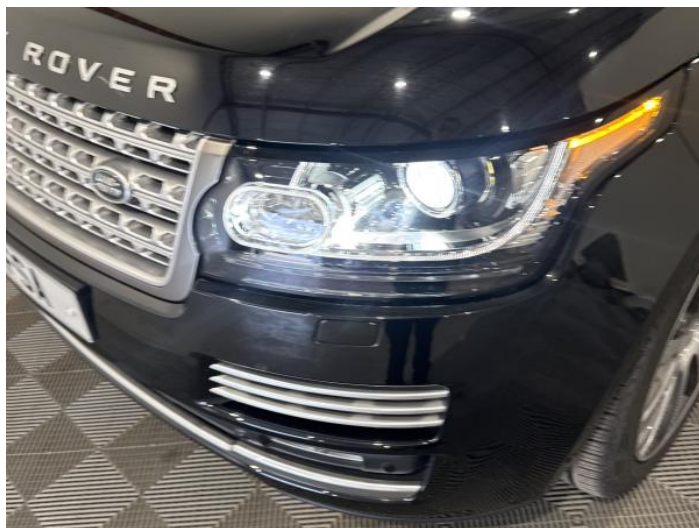
2: Bumper Front
Chipped
Multiple Chips

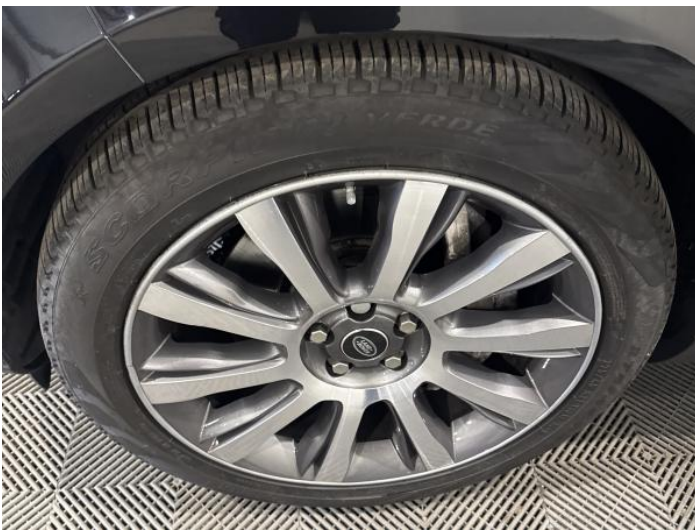
5: Wheel nsf
Scratched
Up To 50mm

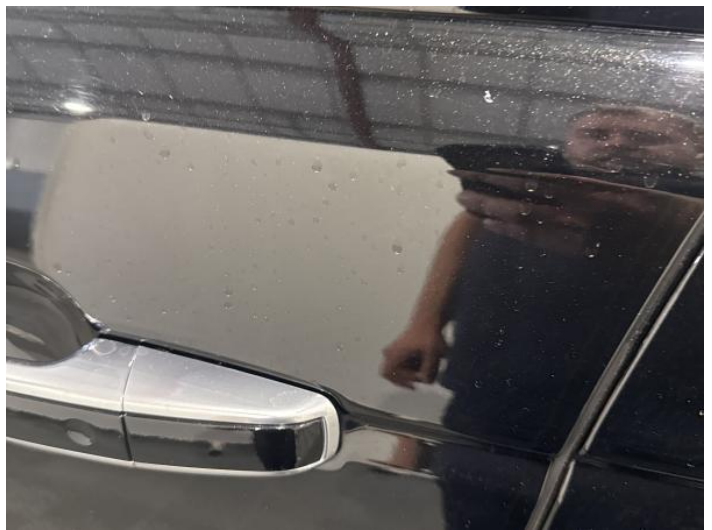
6: Door nsf
Chipped
1 To 5

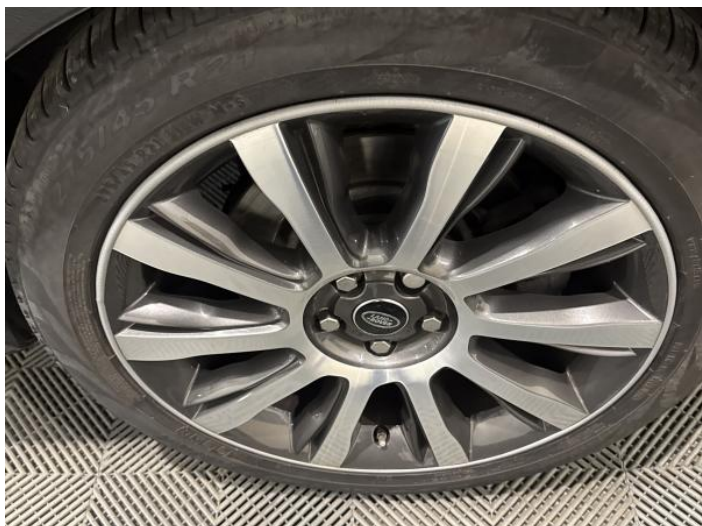
9: Wheel nsr
Scratched
Up To 50mm

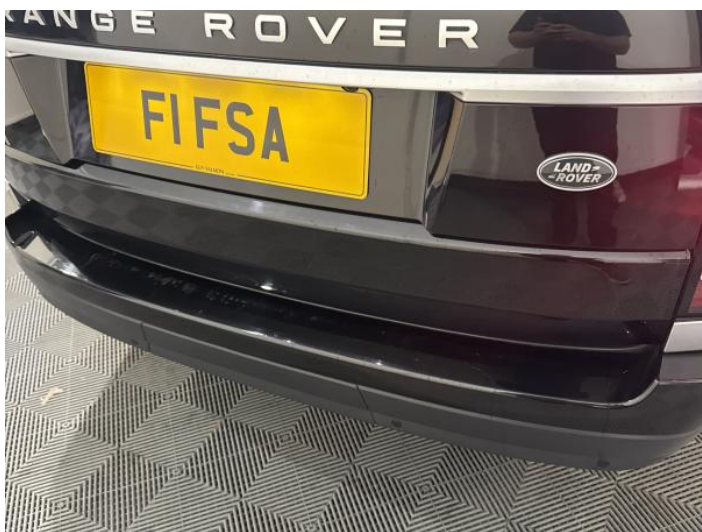
11: Bumper Rear
Chipped
Multiple Chips

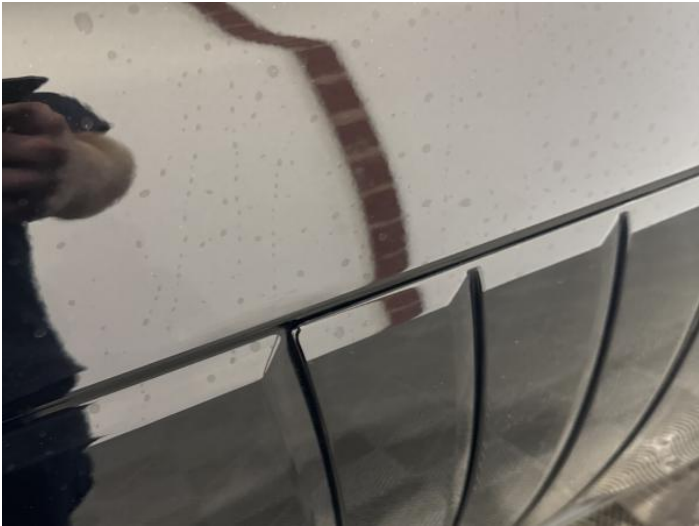
15: Door osf
Dented
Over 2 UpTo 10mm

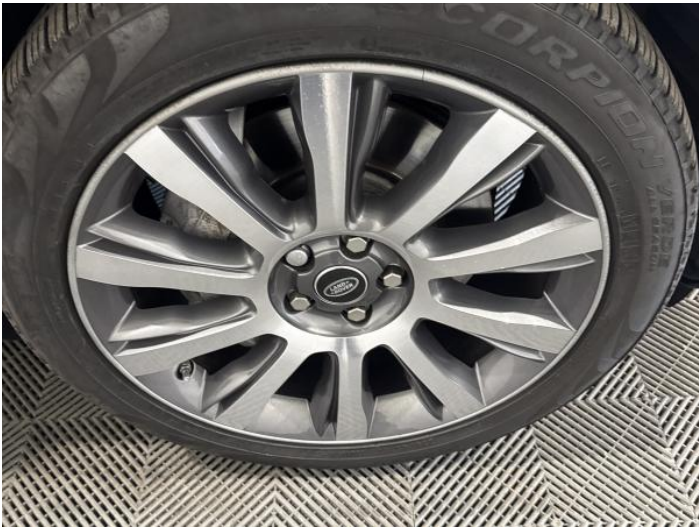
17: Wheel osf
Scratched
Up To 50mm
