# VEHICLE INSPECTION REPORT

**SE14DUA**

## Nissan Qashqai 1.2 DiG-T Tekna 5dr

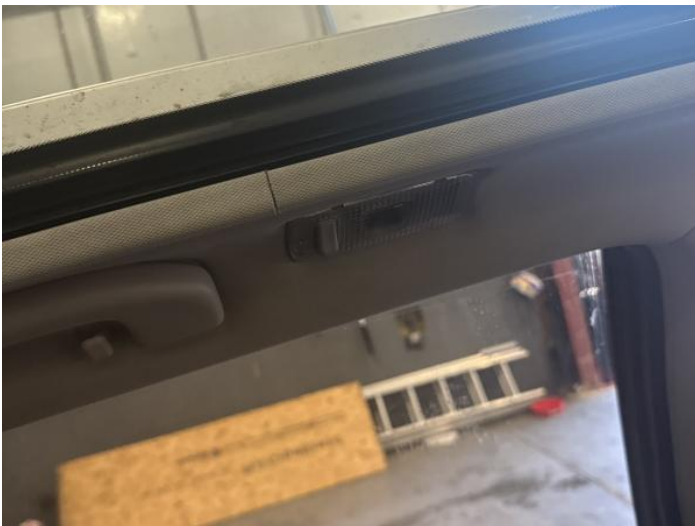
1: Roof Lining  
Scuffed  
Up To 25mm

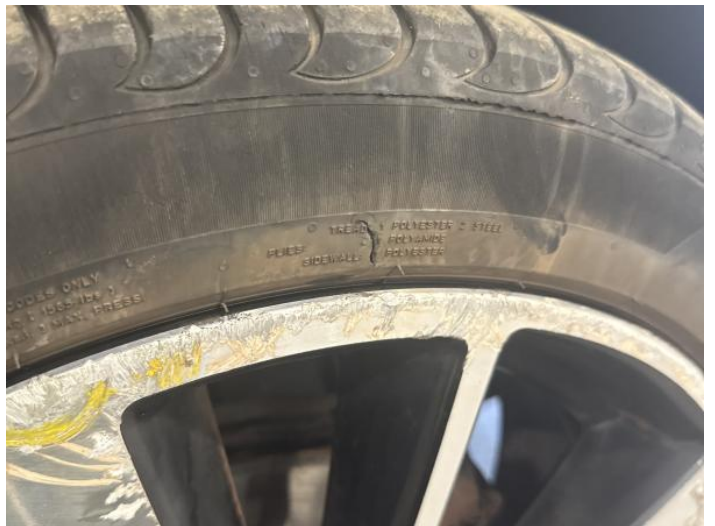
2: Tyre osf  
Damaged  
Replace

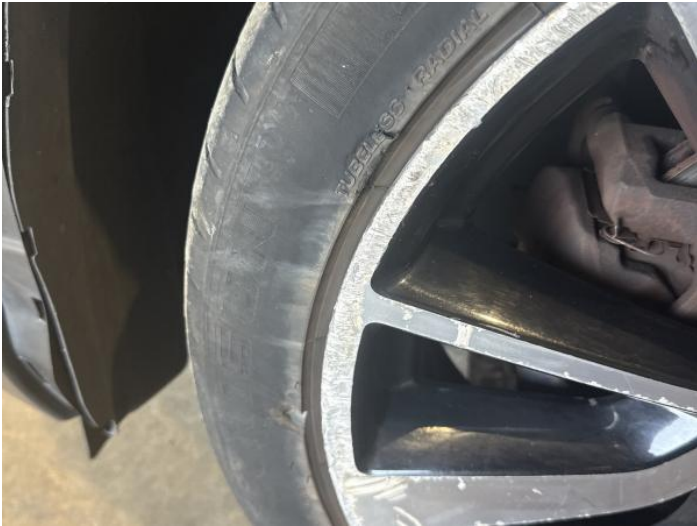
3: Tyre nsf  
Damaged  
Replace

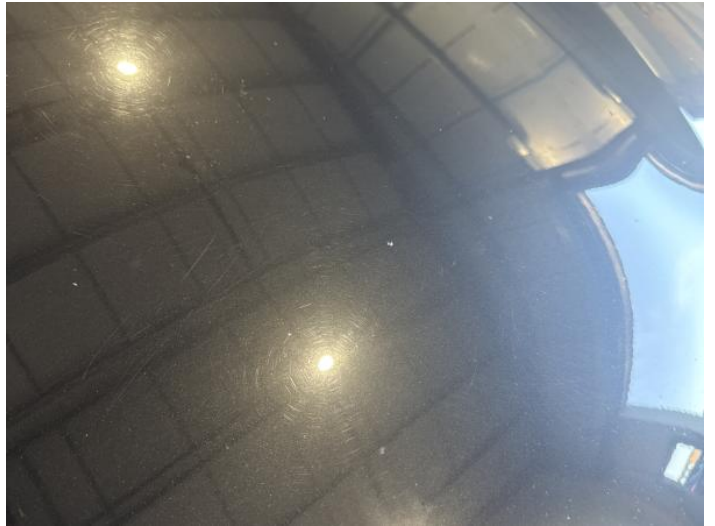
4: Bonnet  
Chipped  
Multiple Chips

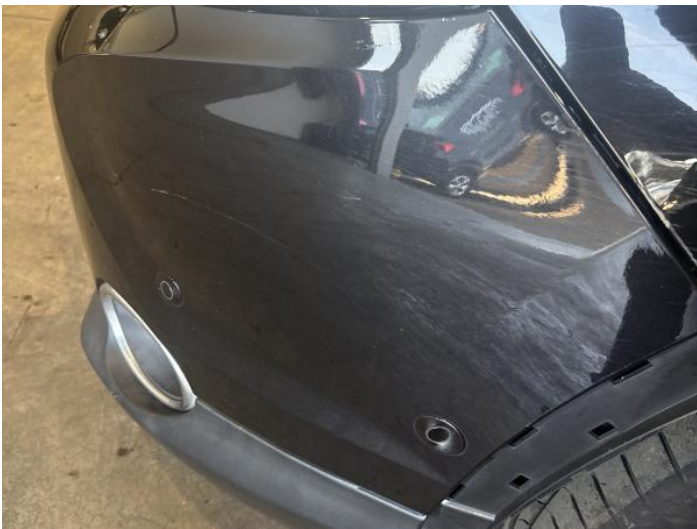
5: Bumper Front  
Scratched  
25 to 100mm Thru Paint

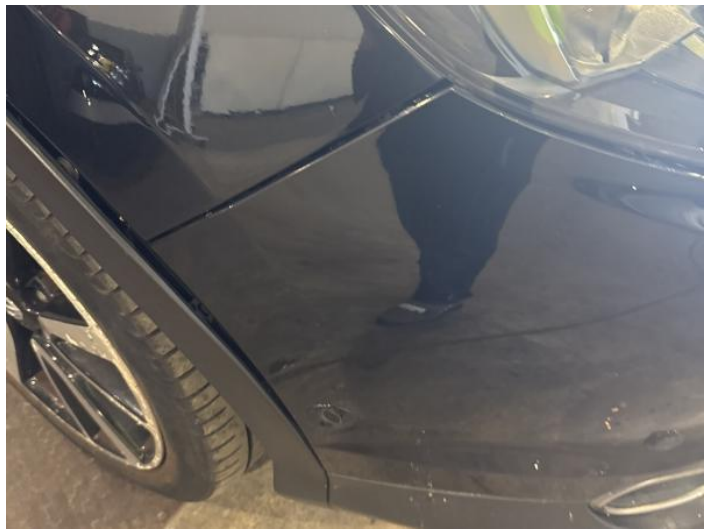
6: Bumper Front  
Insecure  
Action Required

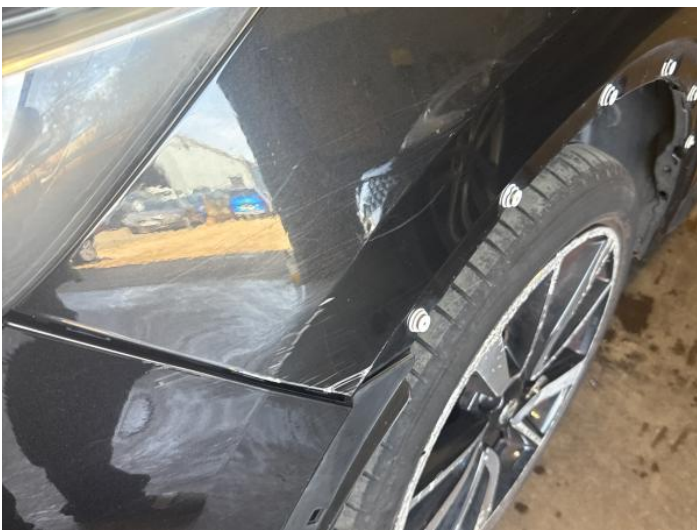
7: Wing nsf  
Dented  
With Paint Damage

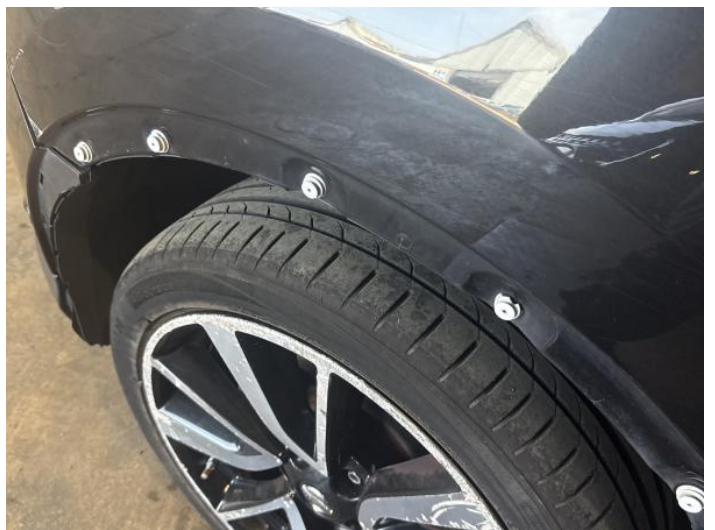
8: Wing Front Arch Extension ns  
Missing  
Replace

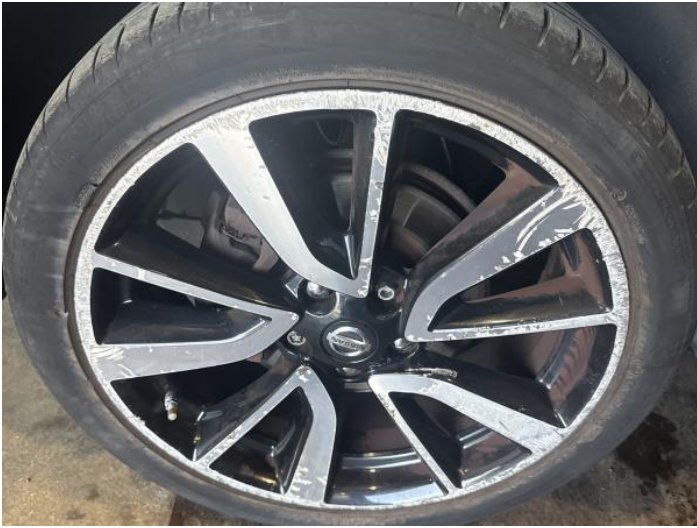
9: Wheel nsf  
Scratched  
Over 50mm

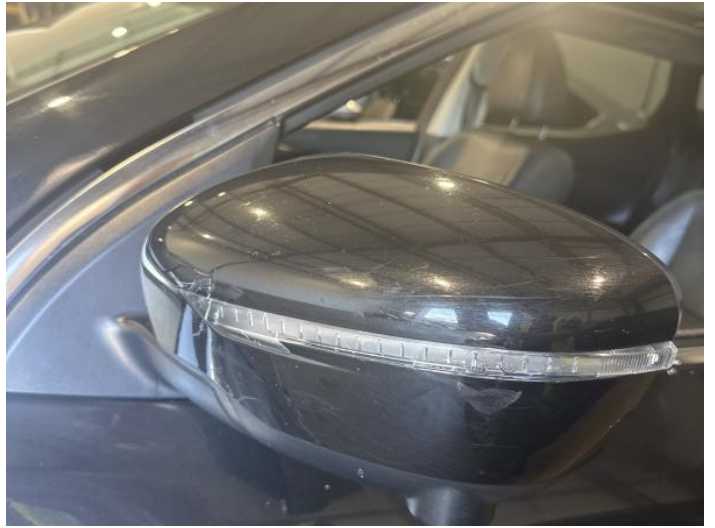
10: Door Mirror Assy nsf  
Broken  
Replace

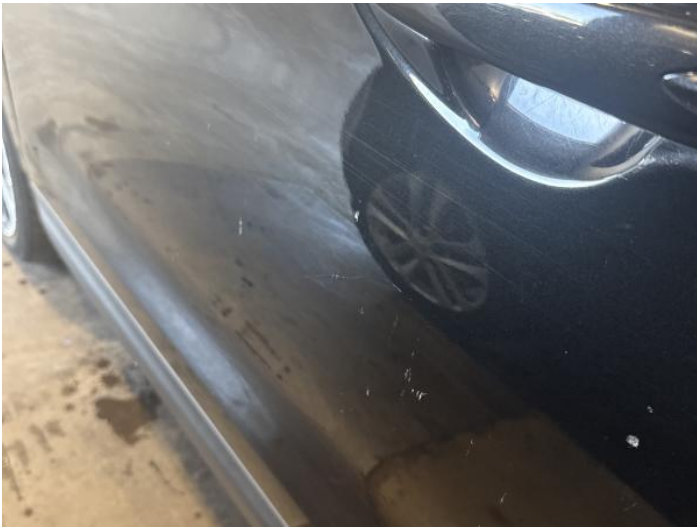
11: Door nsf  
Dented  
With Paint Damage

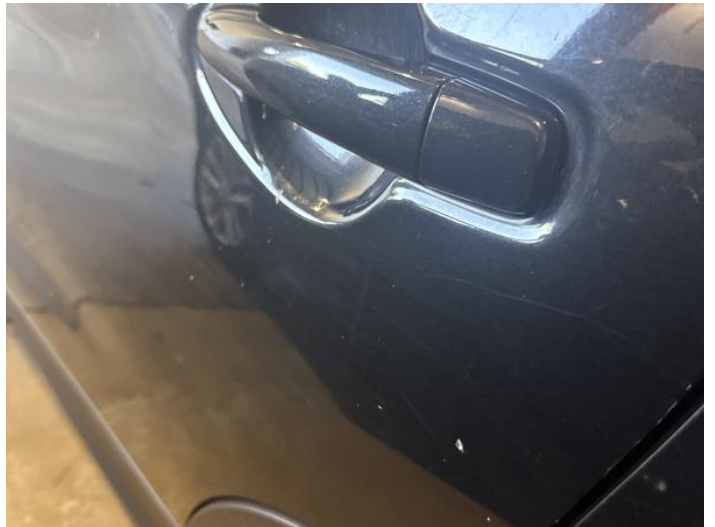
12: Door nsr  
Dented  
With Paint Damage

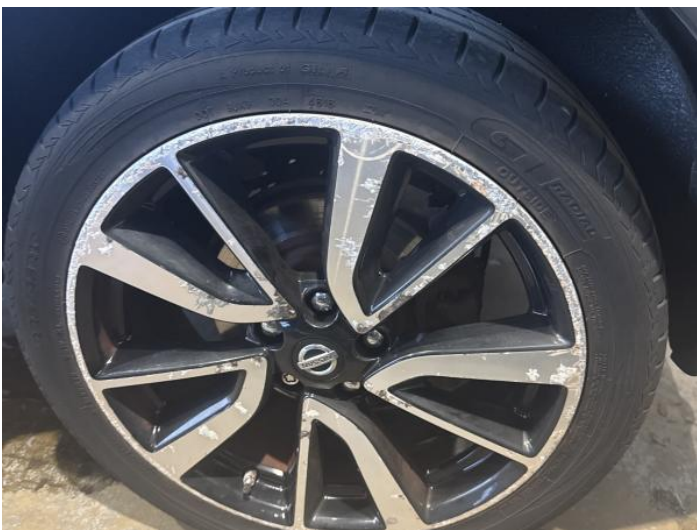
13: Wheel nsr  
Scratched  
Over 50mm

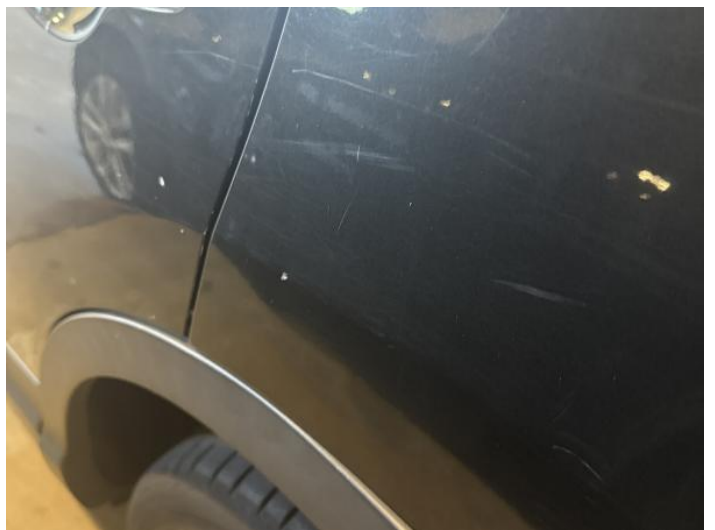
14: Qtr Panel nsr  
Dented  
Between 10mm + 30mm

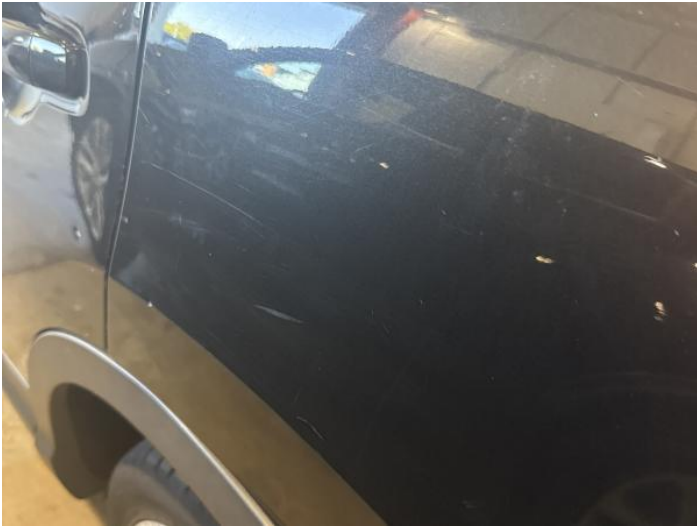
15: Qtr Panel nsr  
Scratched  
Over 25mm Thru Paint

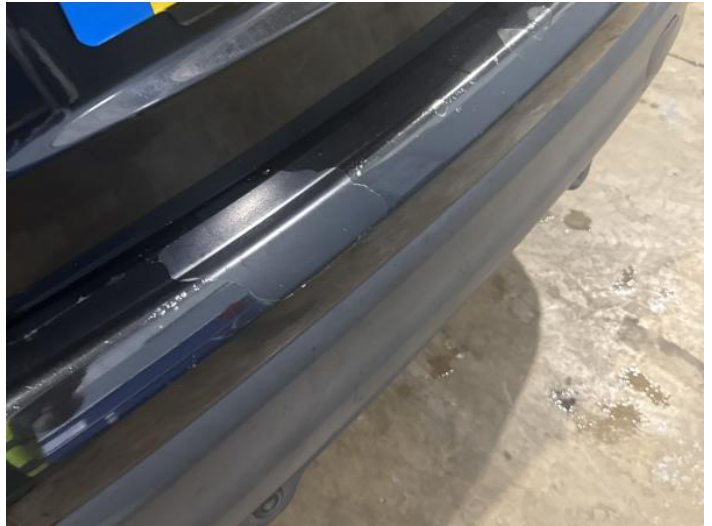
16: Bumper Rear  
Poor Previous Repair  
Paint Flake

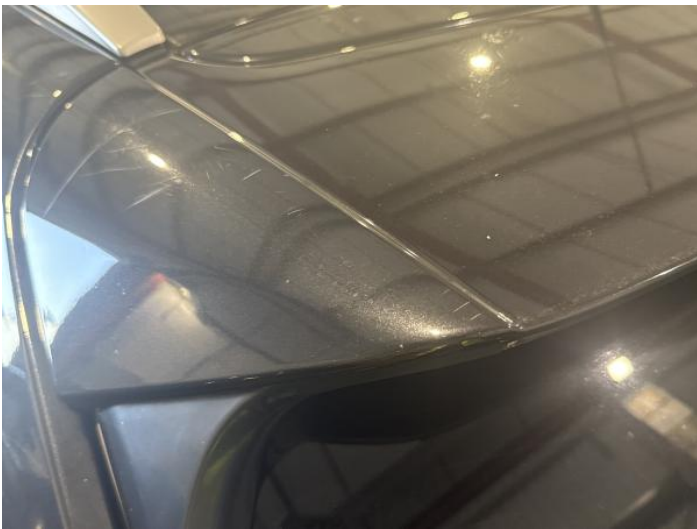
17: Spoiler Rear  
Scratched (Painted)  
Over 25mm Thru Paint

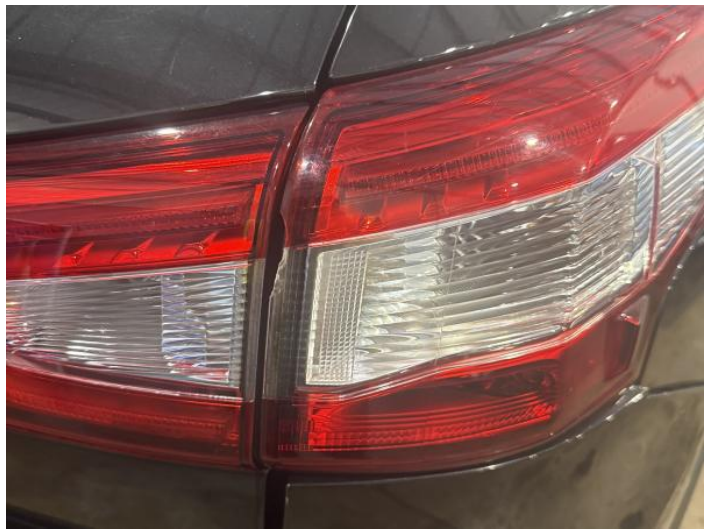
18: Lamp osr  
Broken  
Replace

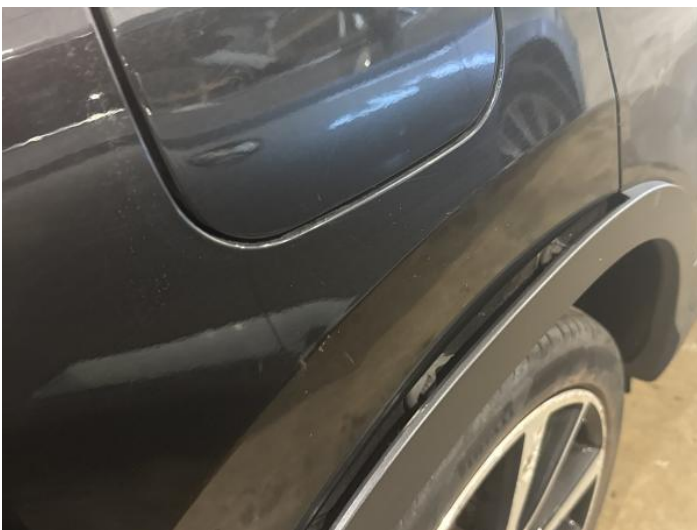
19: Qtr Panel osr  
Dented  
With Paint Damage

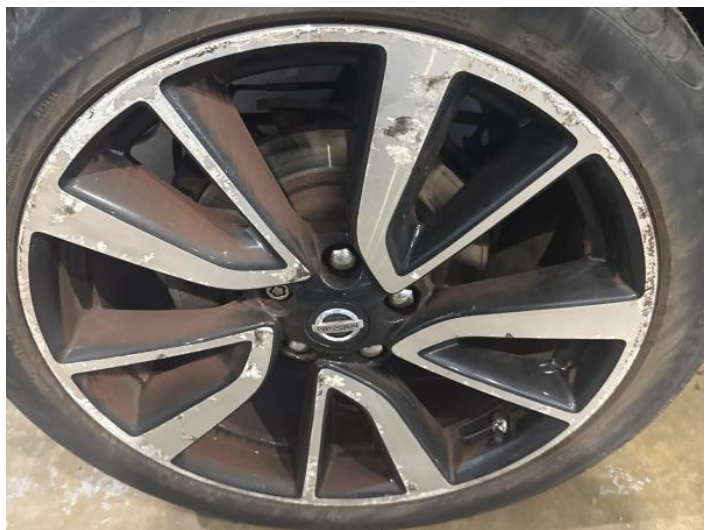
20: Wheel osr  
Scratched  
Over 50mm

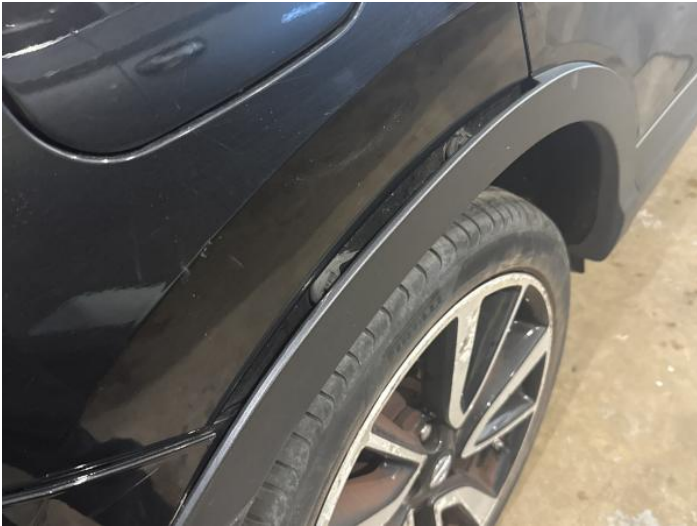
21: Qtr Panel Arch Extension os  
Broken  
Replace

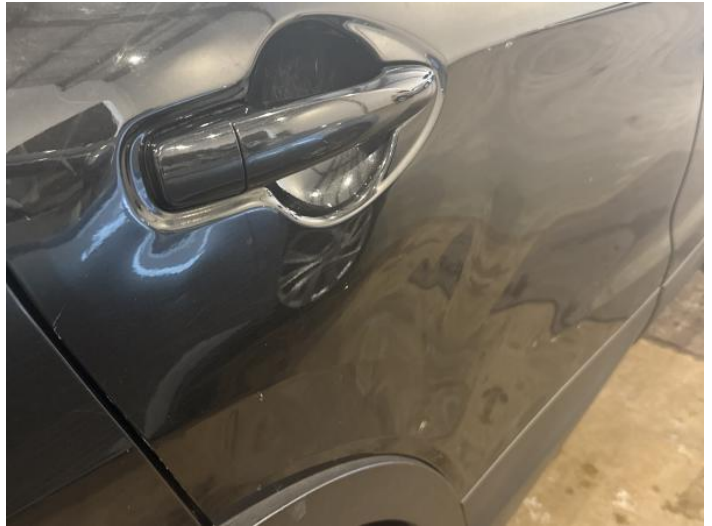
22: Door osr  
Dented  
With Paint Damage

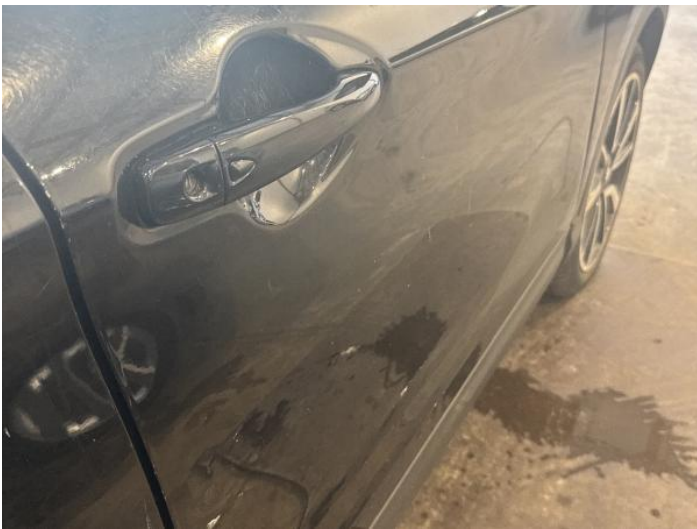
23: Door osf  
Dented  
With Paint Damage

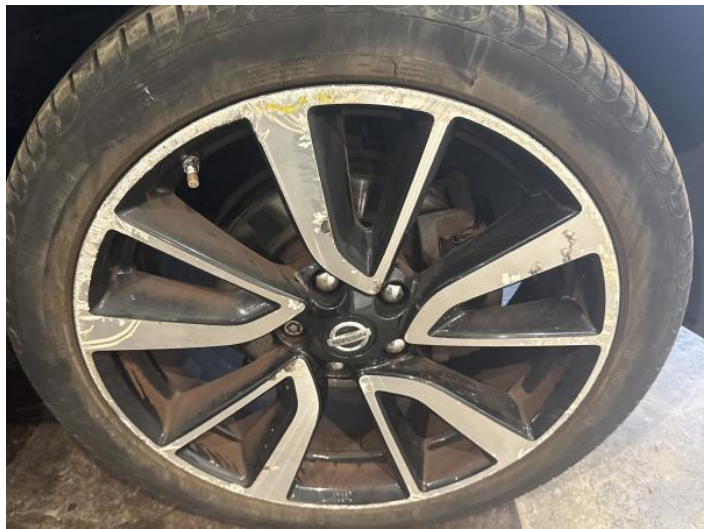
24: Wheel osf  
Scratched  
Over 50mm

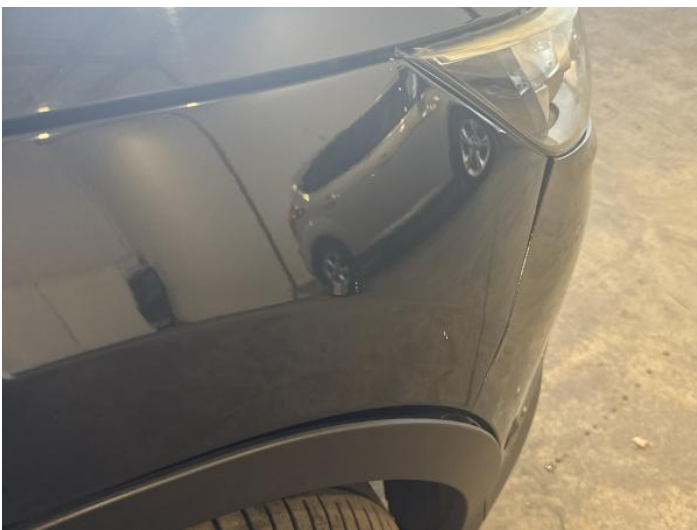
25: Wing osf  
Scratched  
Over 25mm Thru Paint

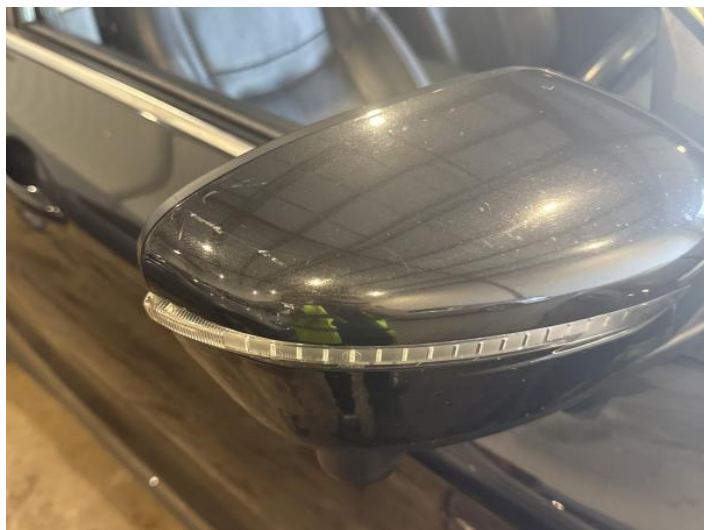
26: Door Mirror Assy osf  
Scratched (Painted)  
Over 25mm Thru Paint

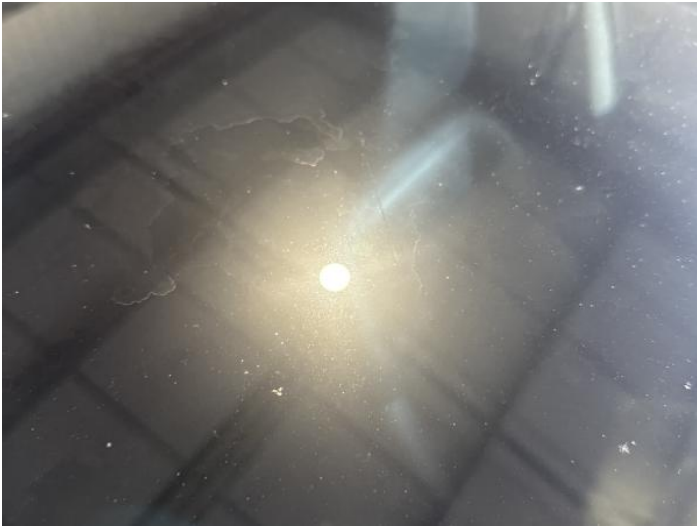
27: Glass Roof  
Scratched  
Over 30mm

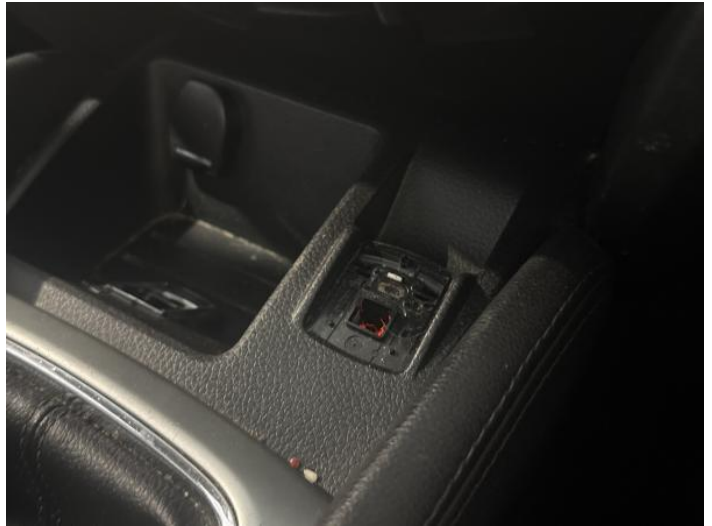
28: Switches And Controls  
Broken  
Replace
