VEHICLE INSPECTION REPORT

GF72JYT

Vauxhall Grandland 1.6 Hybrid GS Line 5dr Auto

nama
 GRADE
3

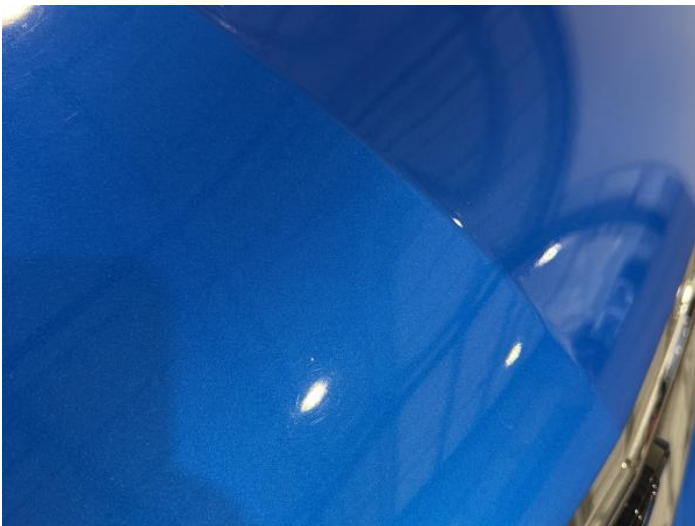
1: Bonnet
Chipped
1 To 5

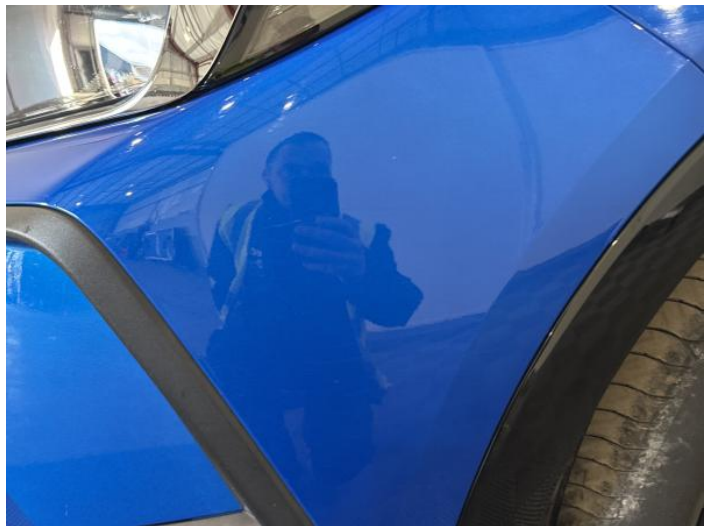
2: Bumper Front
Chipped
1 To 5

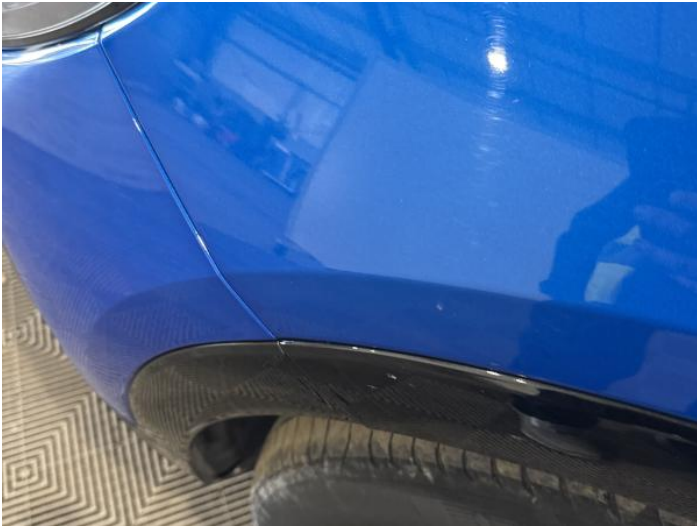
3: Wing nsf
Chipped
1 To 5

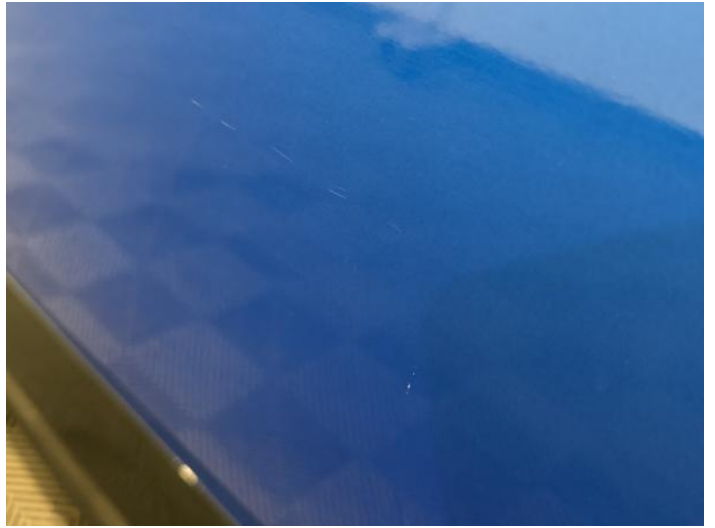
4: Door nsf
Scratched
UpTo 25mm Thru Paint

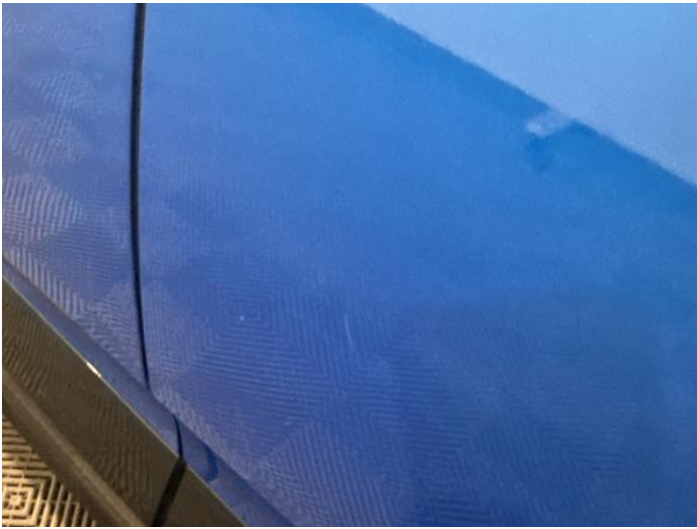
5: Door nsr
Scratched
UpTo 25mm Thru Paint

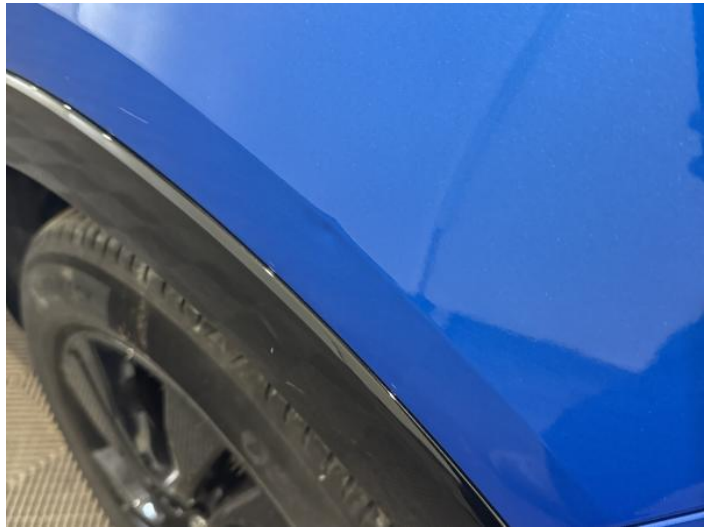
6: Qtr Panel nsr
Dented
Between 10mm + 30mm

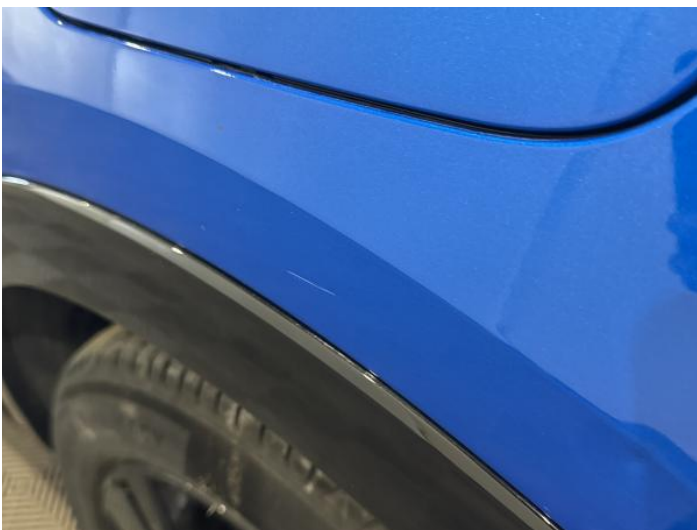
7: Qtr Panel nsr
Scratched
UpTo 25mm Thru Paint

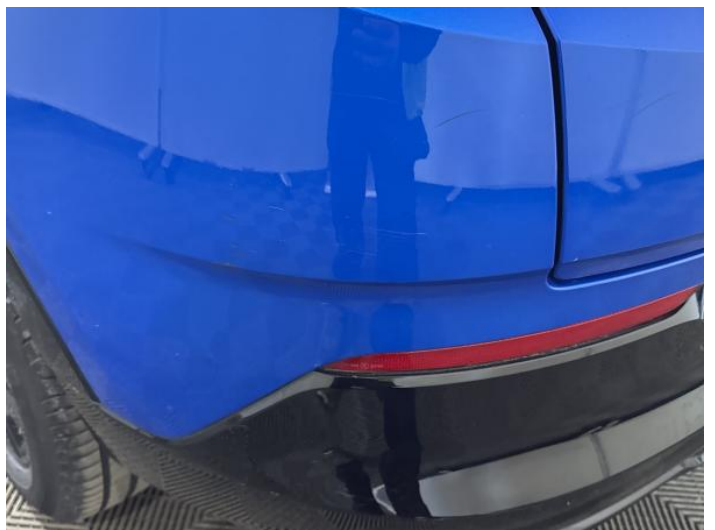
8: Bumper Rear
Scratched
25 to 100mm Thru Paint

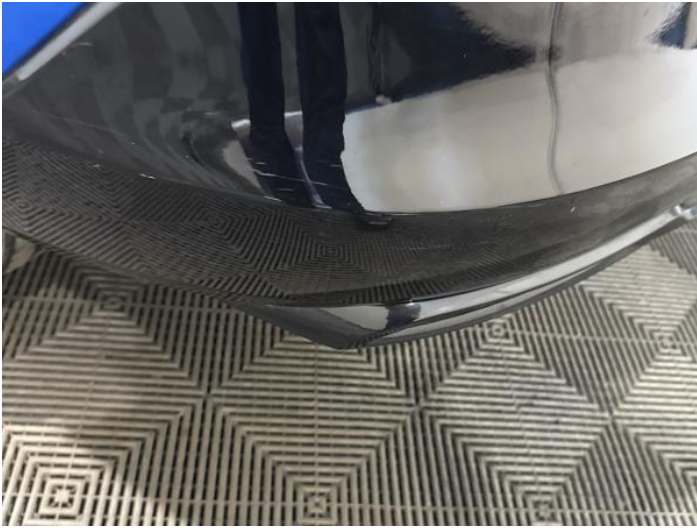
9: Bumper Rear Moulding
Scratched (Painted)
Over 25mm Thru Paint

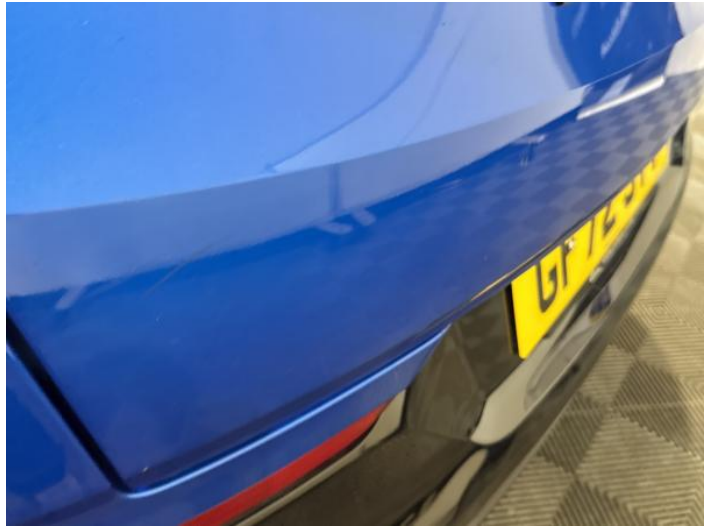
10: Tailgate
Scratched
Over 25mm Thru Paint

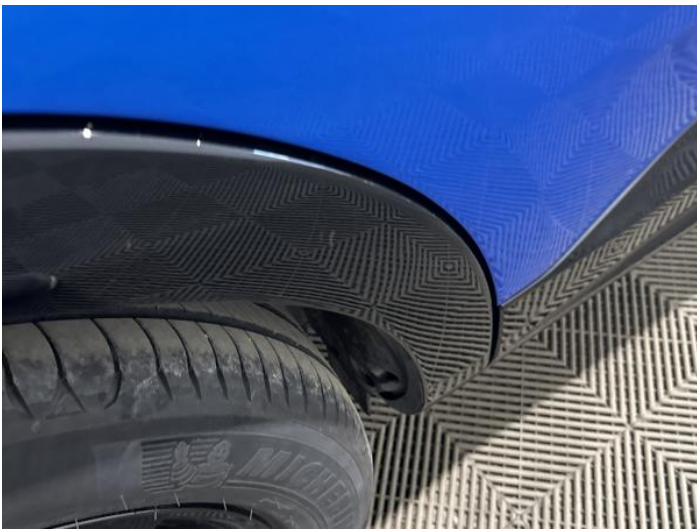
11: Qtr Panel Arch Extension os
Scratched (Painted)
UpTo 25mm Thru Paint

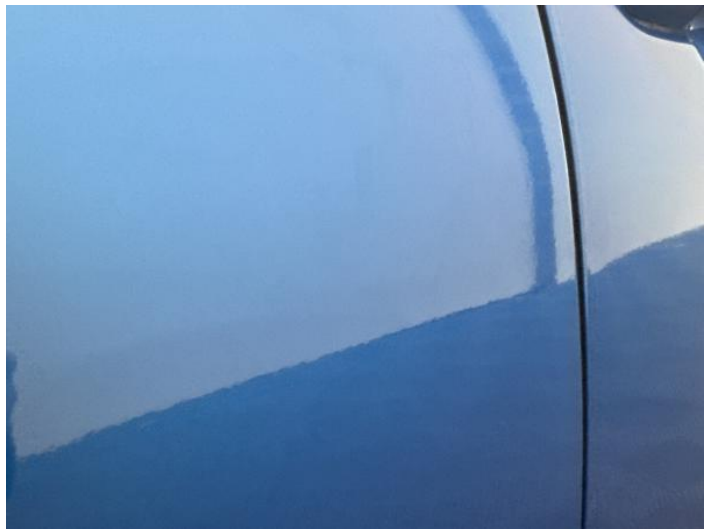
12: Door osr
Chipped
1 To 5

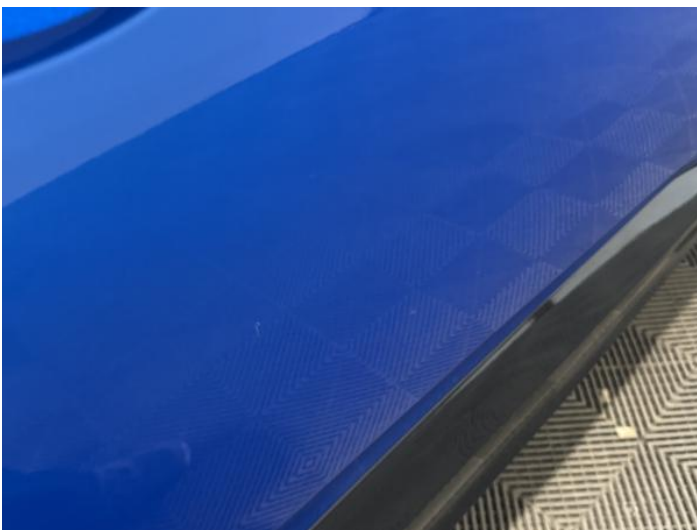
13: Door osf
Chipped
1 To 5

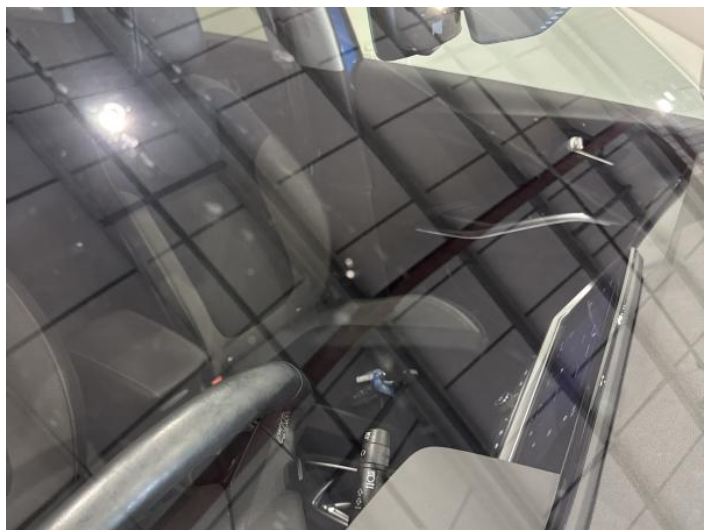
14: Screen Front
Chipped
UpTo 10mm

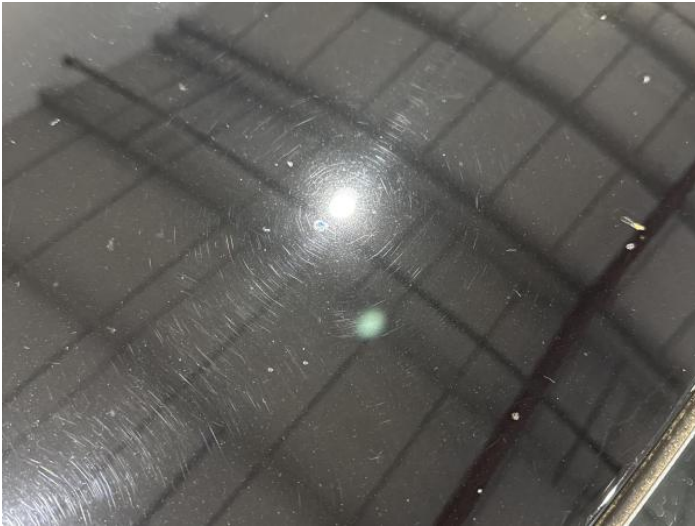
15: Roof
Chipped
1 To 5

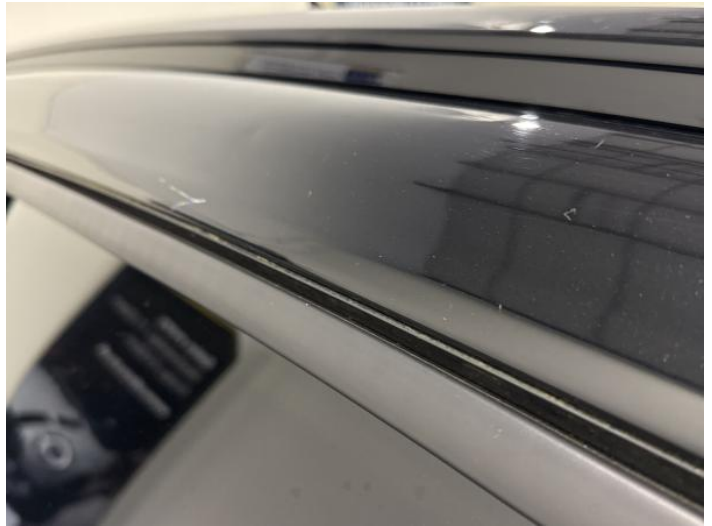
16: B Post os
Dented
Between 10mm + 30mm

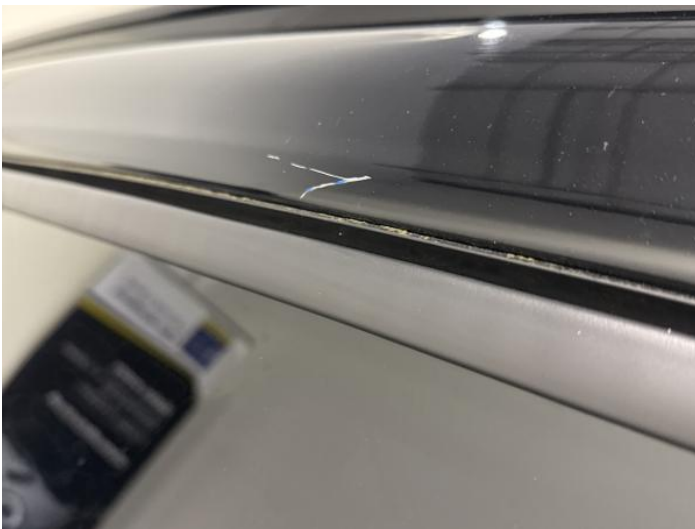
17: B Post os
Scratched
Over 25mm Thru Paint
