VEHICLE INSPECTION REPORT

AK71BVL

MG Mg Hs EXCLUSIVE

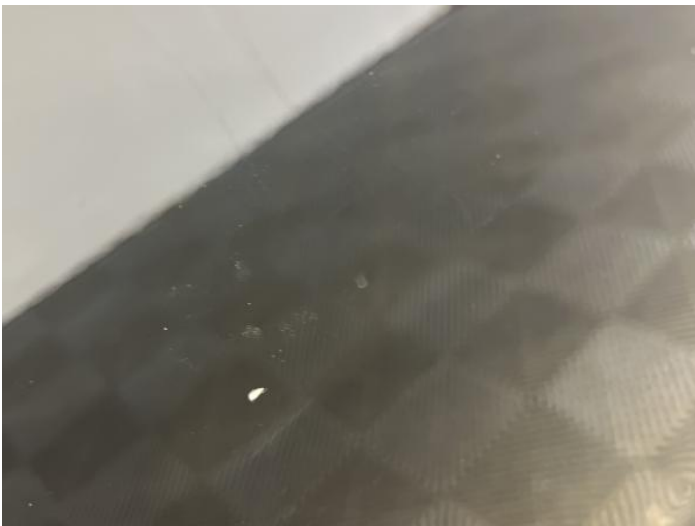
1: Door osf
Dented
With Paint Damage

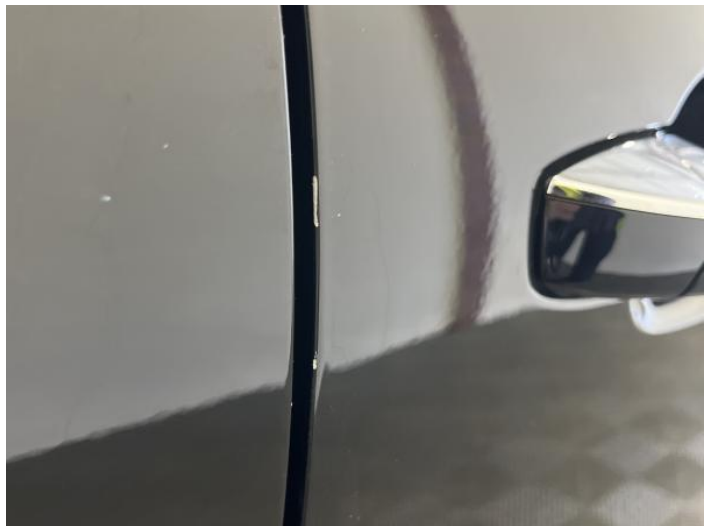
2: Door osf
Chipped
Edge Chip

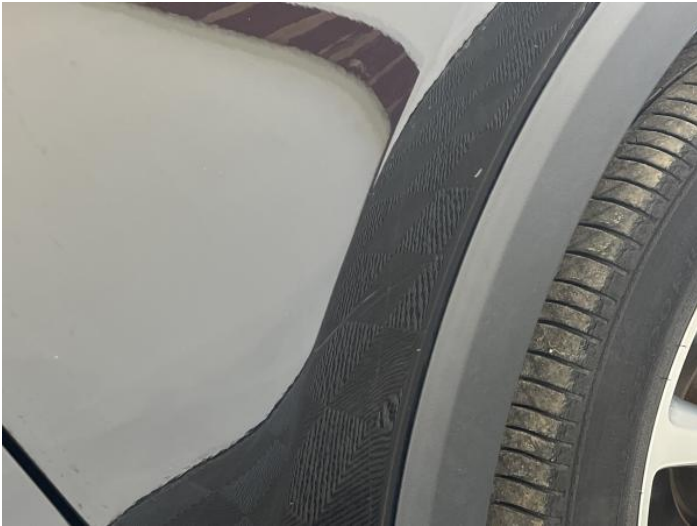
3: Wing osf
Scratched
Over 25mm Thru Paint

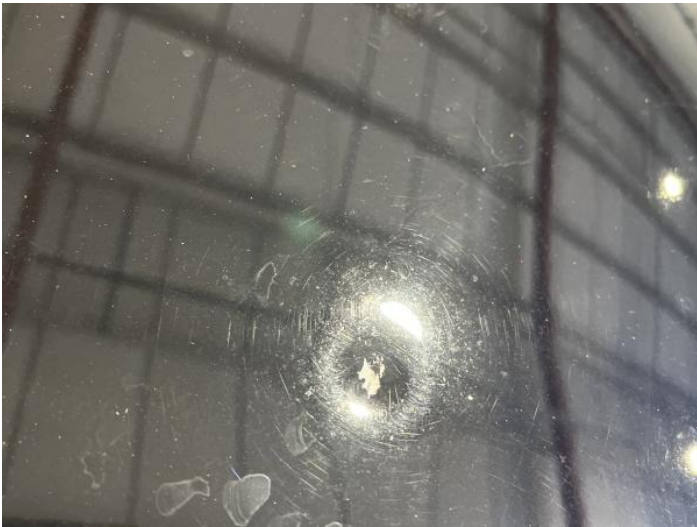
5: Bonnet
Dented
With Paint Damage

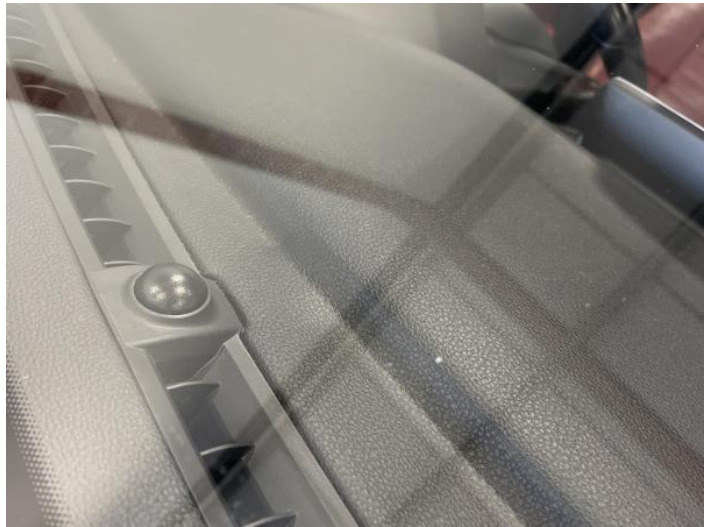
6: Screen Front
Chipped
UpTo 10mm

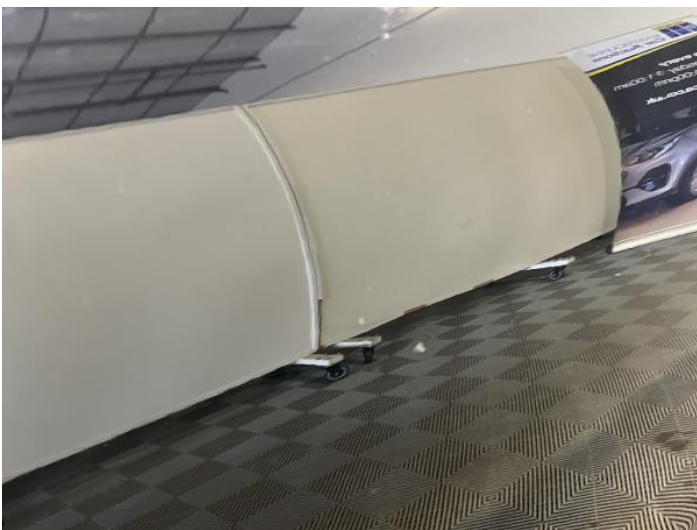
7: Door nsf
Dented
With Paint Damage

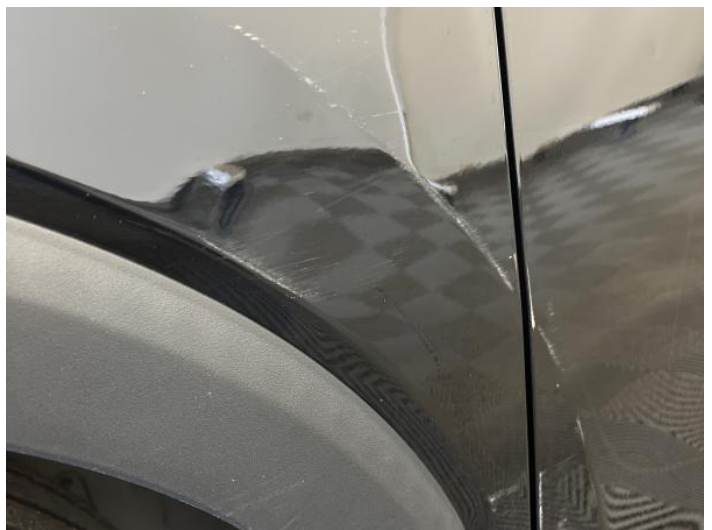
8: Wing nsf
Scratched
Over 25mm Thru Paint

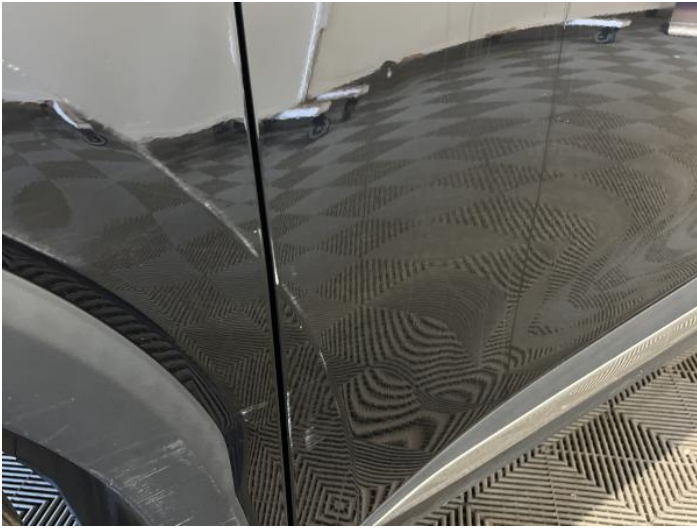
9: Door nsf
Scratched
Over 25mm Thru Paint

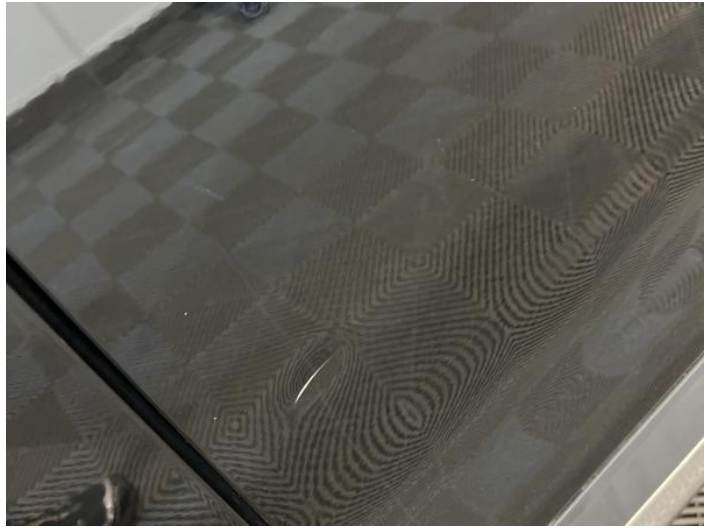
10: Door nsr
Dented
With Paint Damage

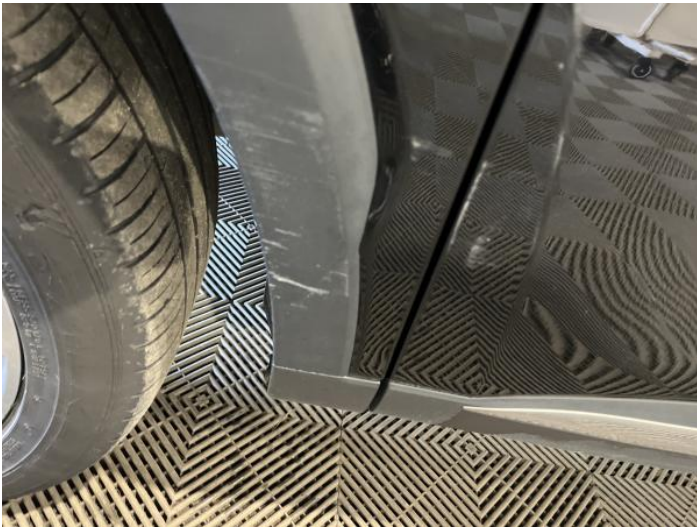
11: Wing Front Arch Extension ns
Scuffed (Unpainted)
UpTo 100mm

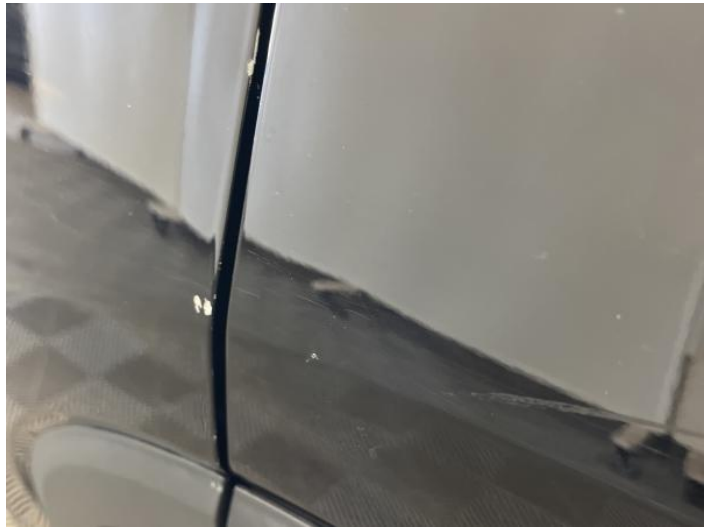
12: Qtr Panel nsr
Dented
Over 2 UpTo 10mm

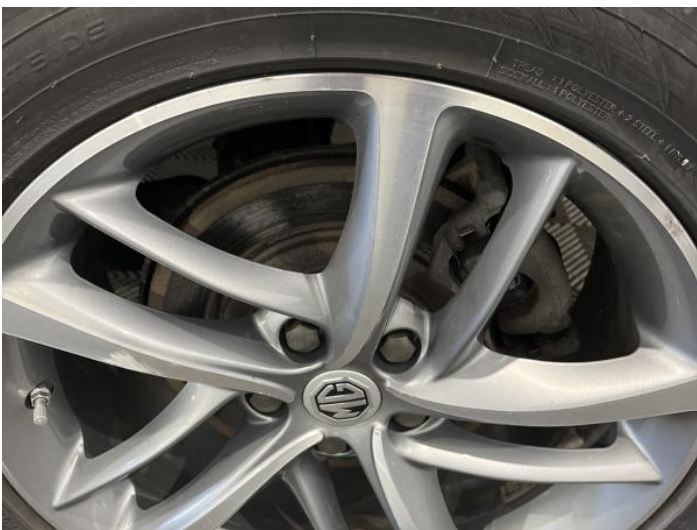
13: Wheel nsr
Corroded
Light

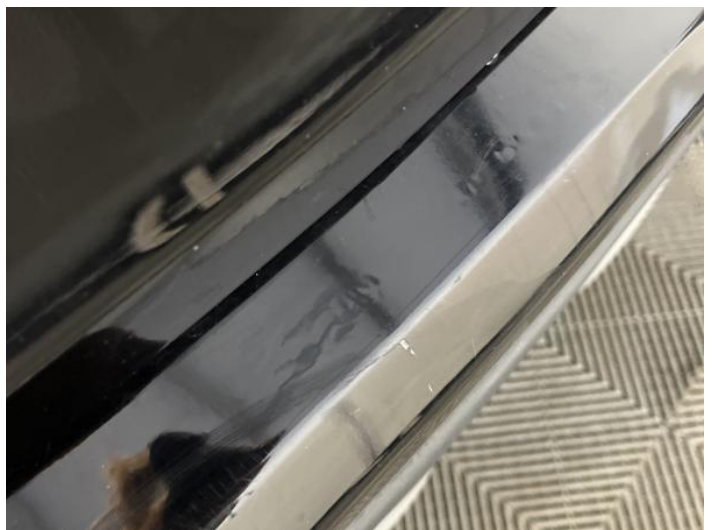
14: Bumper Rear
Poor Previous Repair
Poor Paint

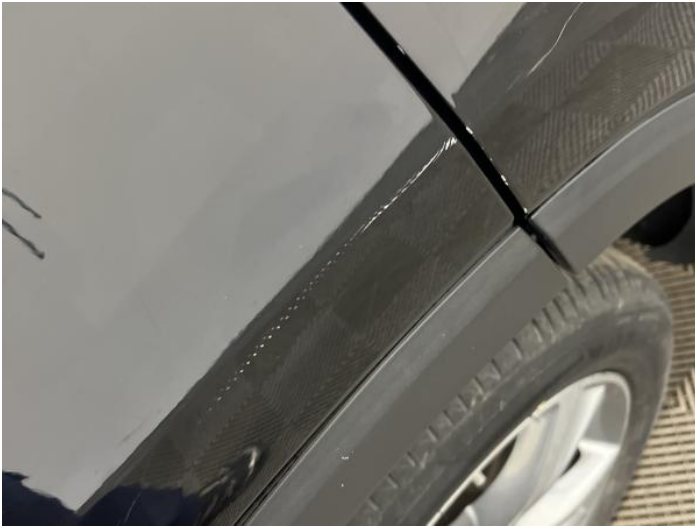
15: Qtr Panel osr
Dented
With Paint Damage

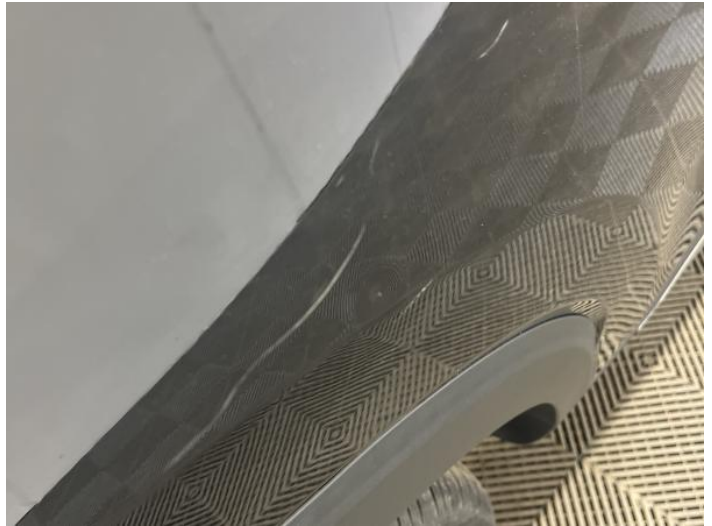
16: Door osr
Dented
With Paint Damage
