VEHICLE INSPECTION REPORT

YD64AAE

Mitsubishi Outlander 2.0 PHEV GX4hs 5dr Auto

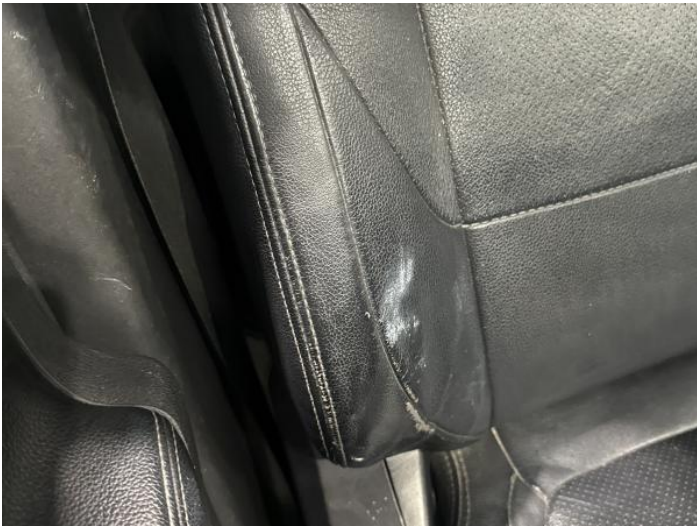
1: Seat Back Cover osf
Scuffed
Over 25mm

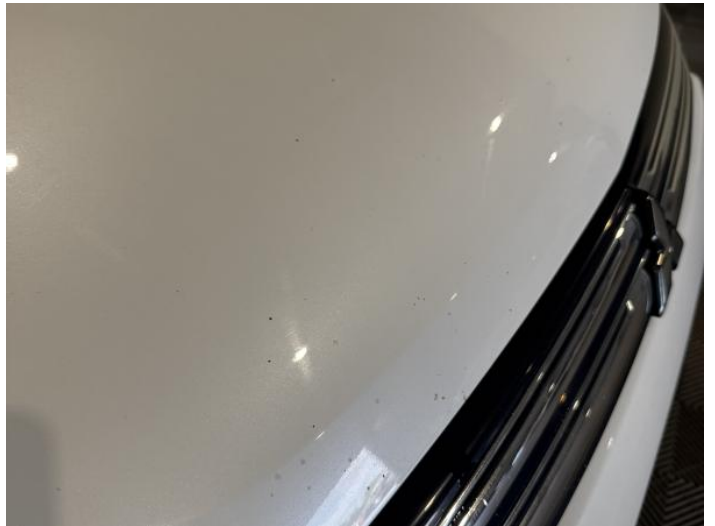
2: Bonnet
Chipped
Multiple Chips

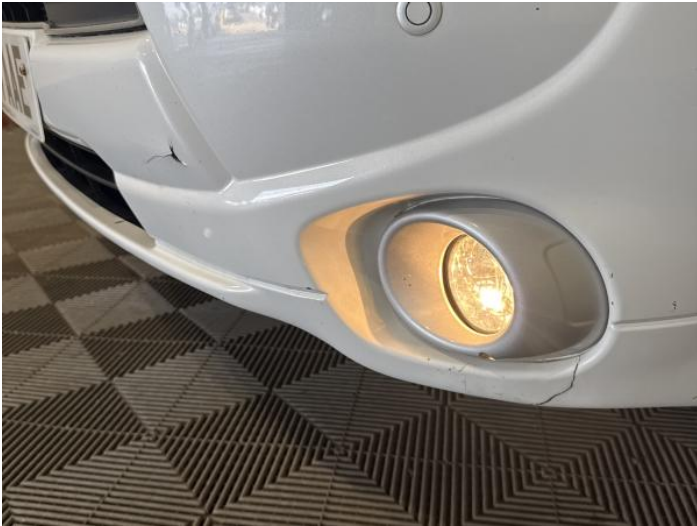
3: Bumper Front
Cracked
Over 25mm

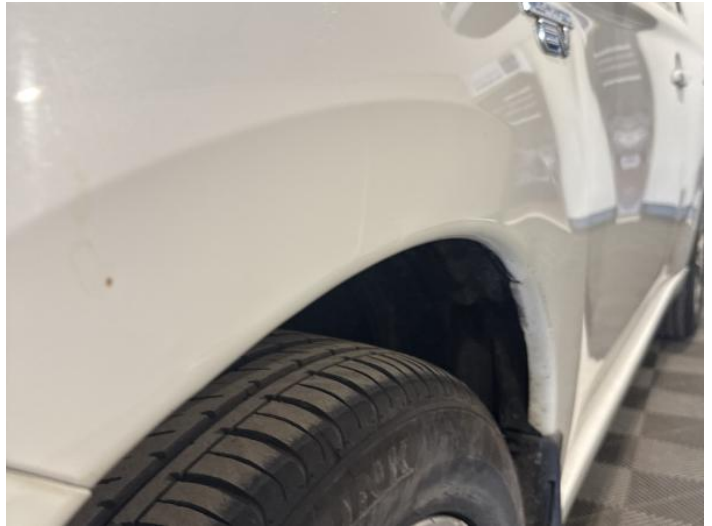
4: Wing nsf
Dented
Between 10mm + 30mm

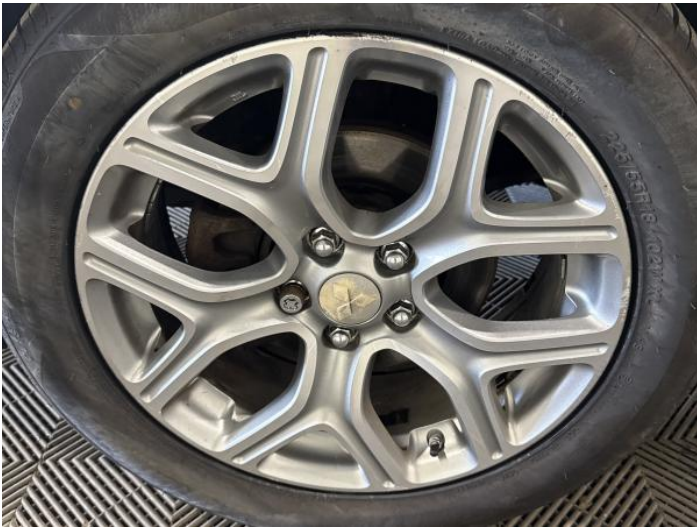
5: Wheel nsf
Scratched
Over 50mm

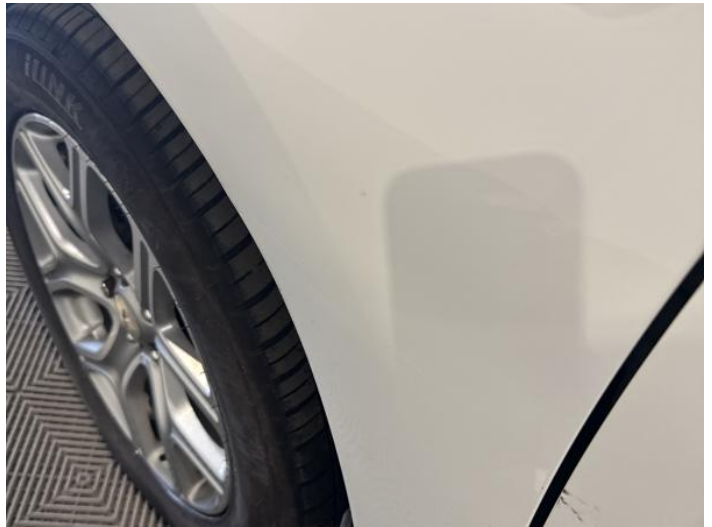
6: Wing nsf
Scratched
Over 25mm Thru Paint

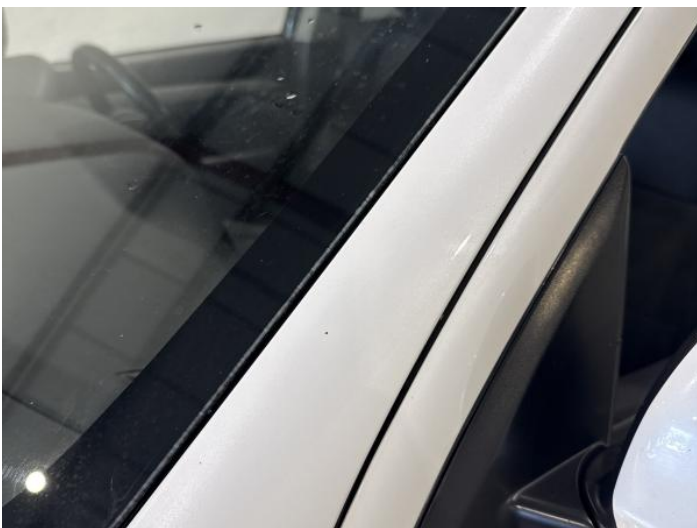
7: A Post ns
Chipped
1 To 5

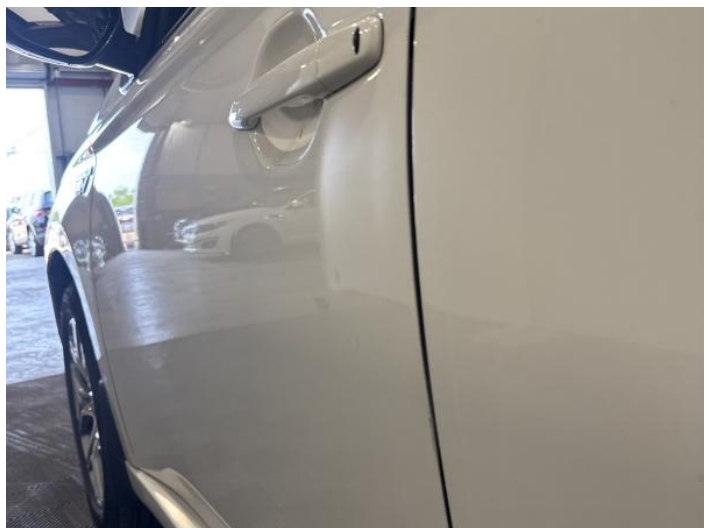
8: Door nsf
Dented
Over 30mm

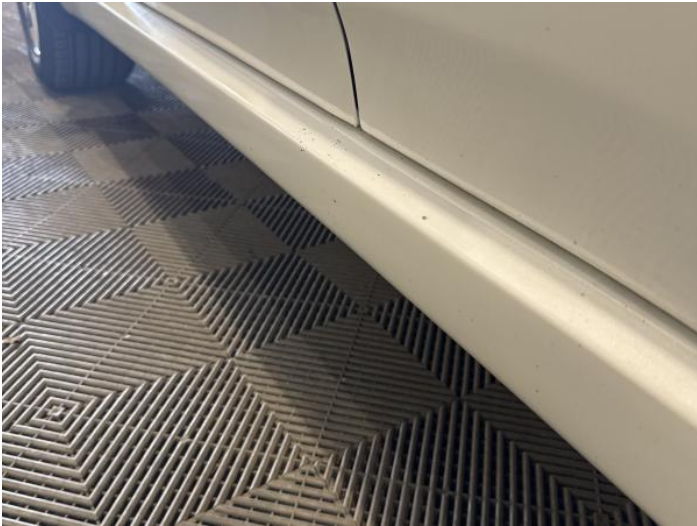
9: Sill Panel Trim ns
Scratched (Painted)
Over 25mm Thru Paint

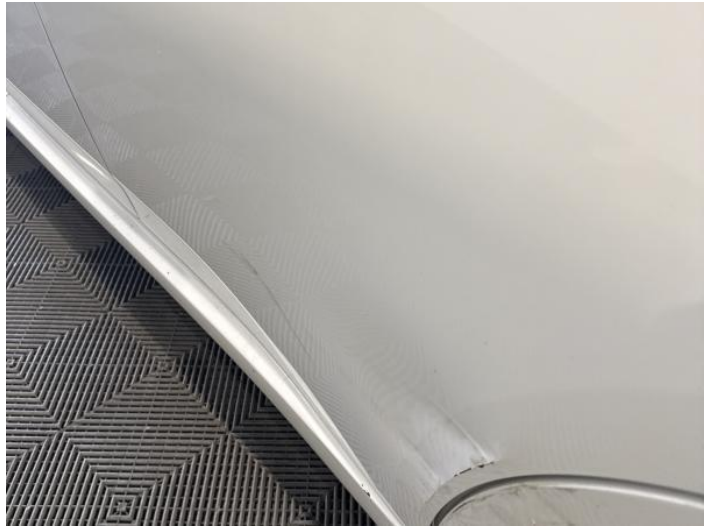
10: Door nsr
Dented
With Paint Damage

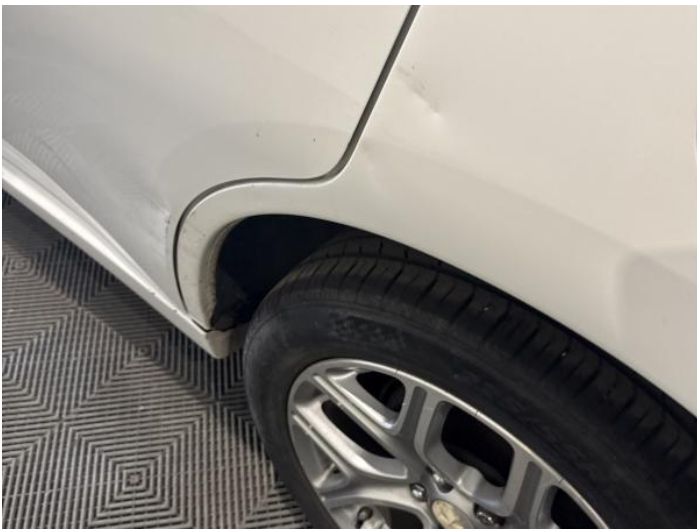
11: Qtr Panel nsr
Dented
With Paint Damage

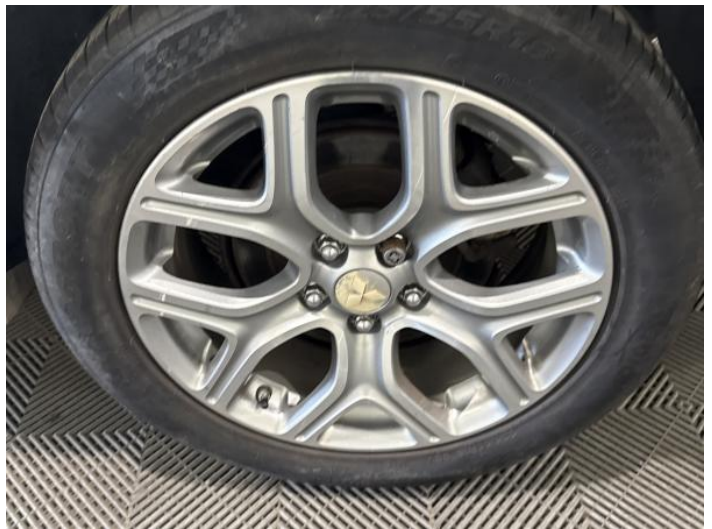
12: Wheel nsr
Scratched
Over 50mm

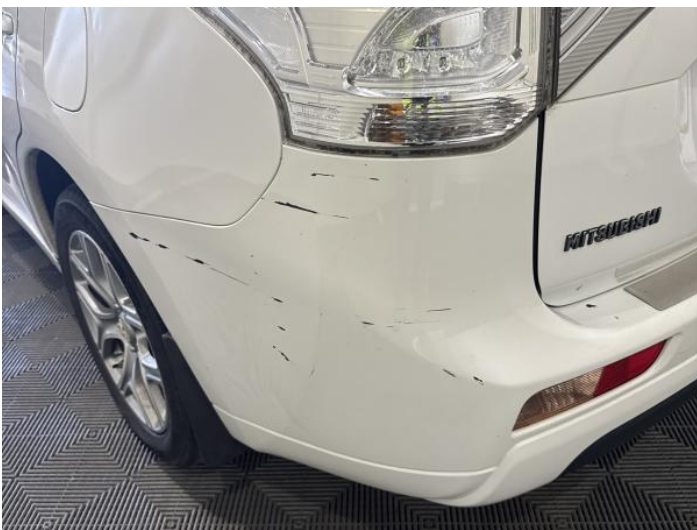
13: Bumper Rear
Scratched
25 to 100mm Thru Paint

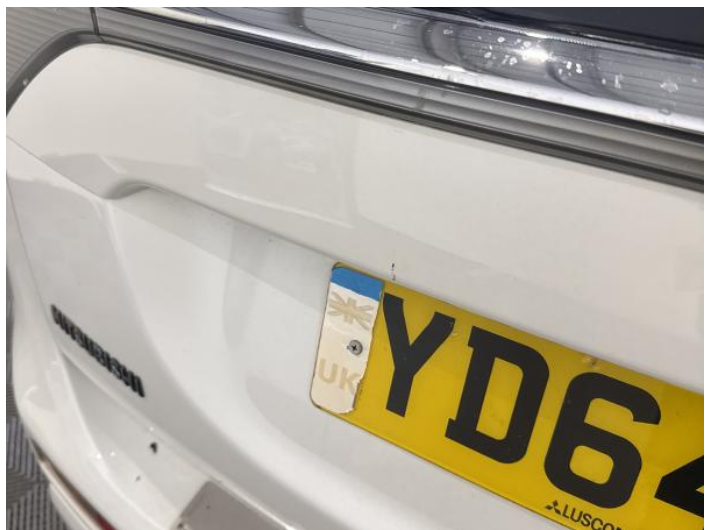
14: Tailgate
Scratched
Up To 25mm Thru Paint

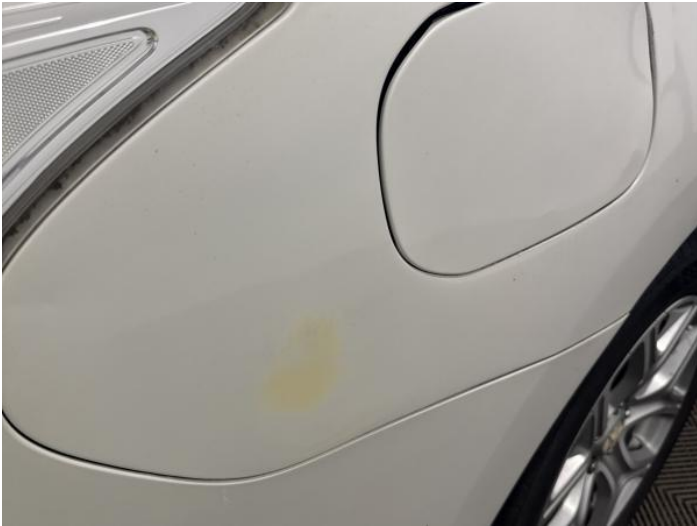
15: Qtr Panel osr
Scratched
Over 25mm Thru Paint

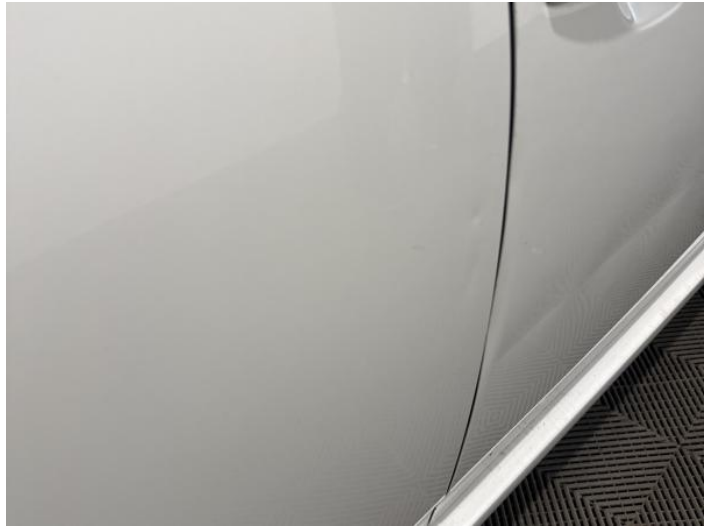
16: Door osr
Dented
Over 30mm

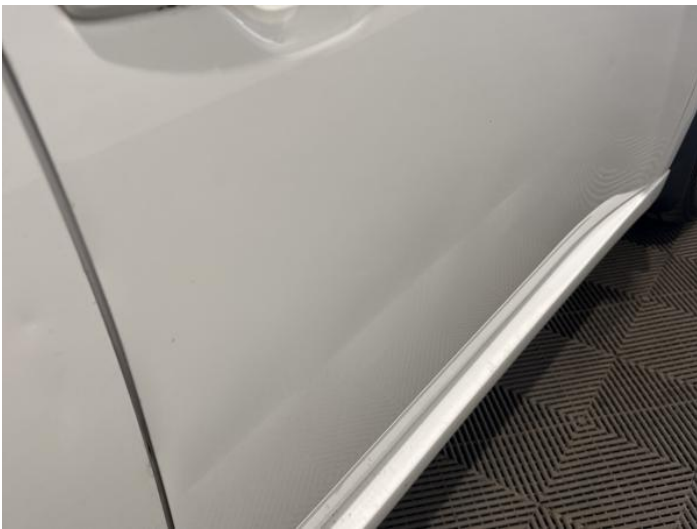
17: Door osf
Dented
Over 30mm

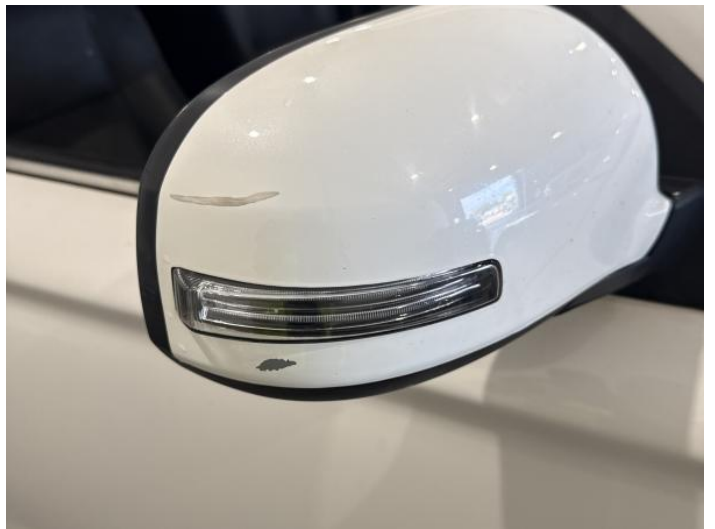
18: Door Mirror Assy osf
Scratched (Painted)
UpTo 25mm Thru Paint

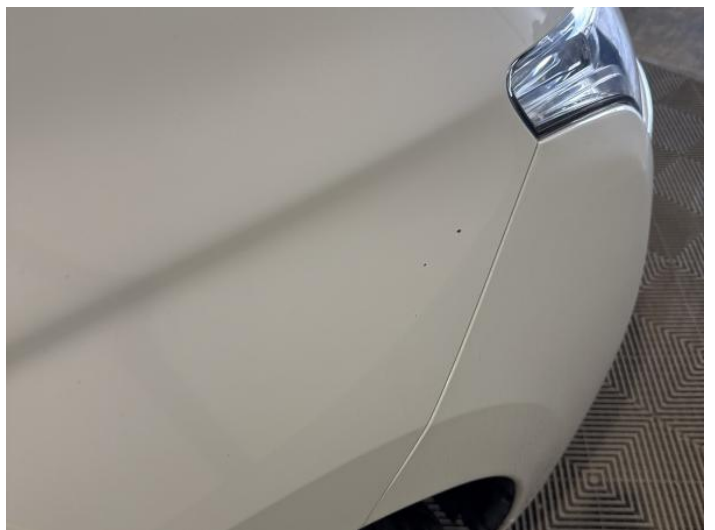
20: Wing osf
Chipped
1 To 5

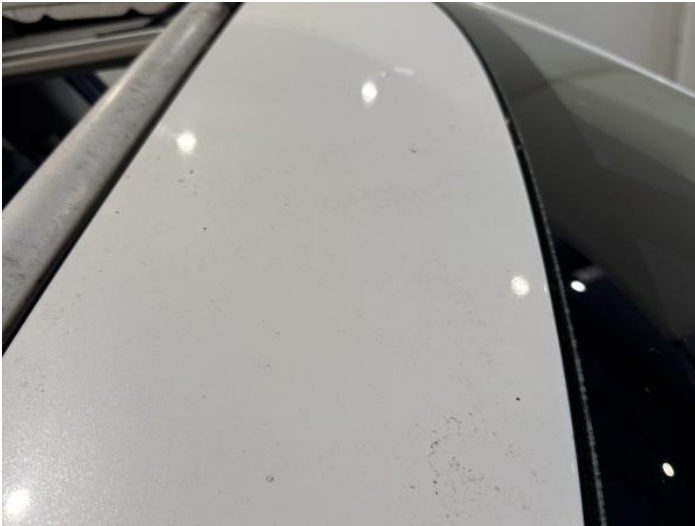
21: Roof
Chipped
Multiple Chips

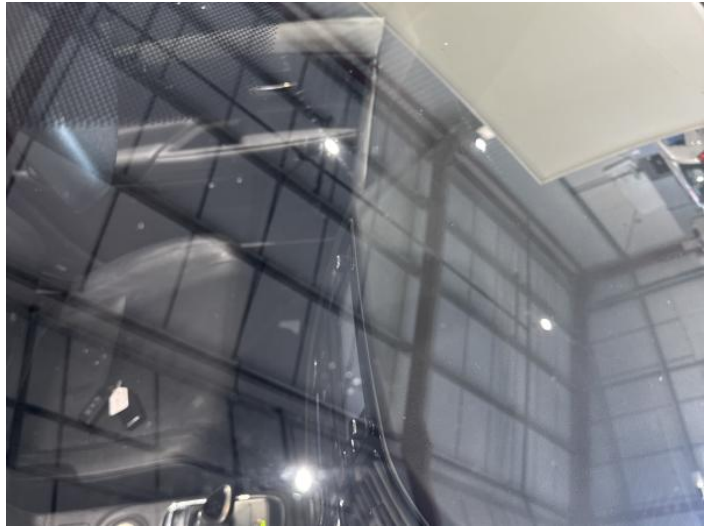
22: Screen Front
Chipped
Over 10mm
