VEHICLE INSPECTION REPORT

AK58LAO

Nissan Note 1.6 Tekna 5dr Auto

nama
GRADE
5

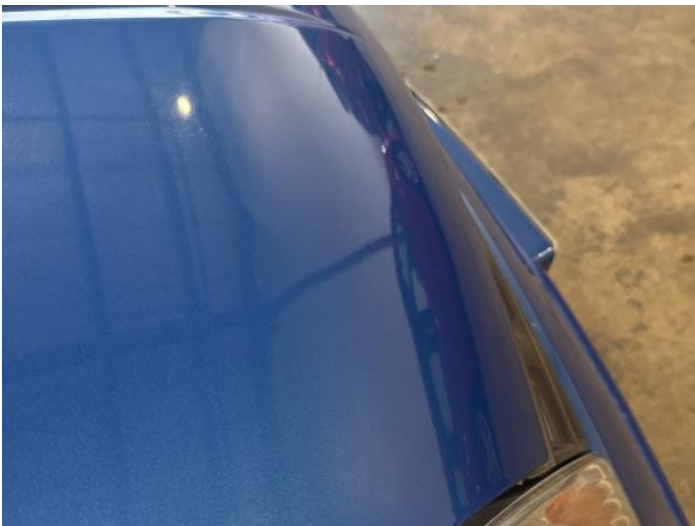
1: Bonnet
Dented
Over 30mm

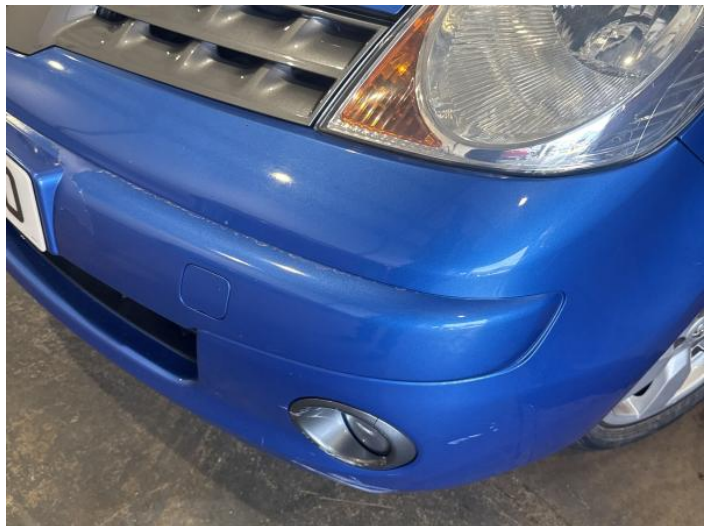
2: Bumper Front
Poor Previous Repair
Paint Flake

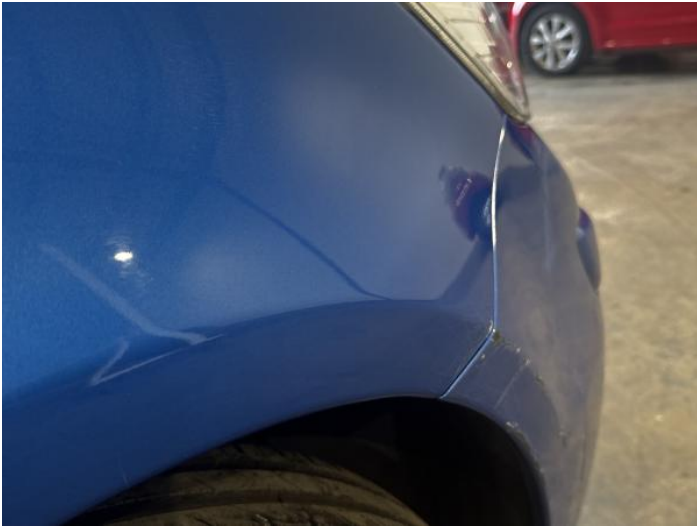
3: Wing osf
Scratched
Over 25mm Thru Paint

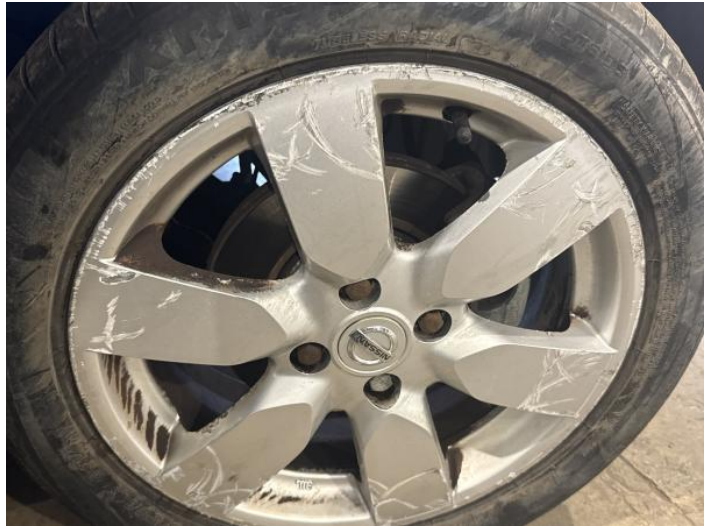
4: Wheel osf
Scratched
Over 50mm

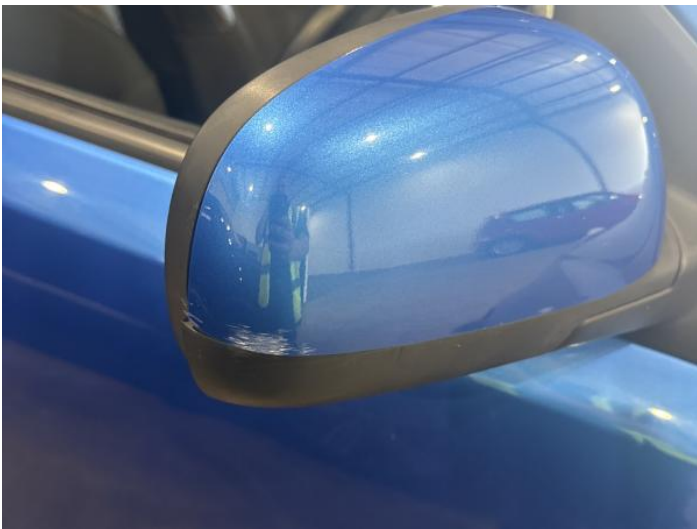
5: Door Mirror Assy osf
Scratched (Painted)
UpTo 25mm Thru Paint

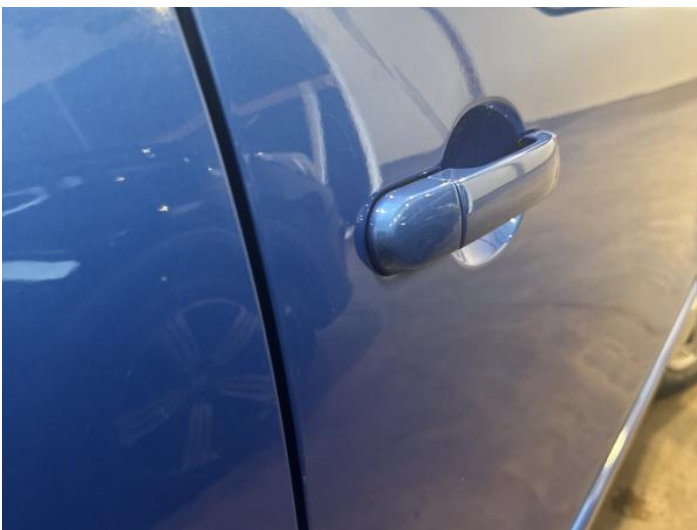
7: Door osf
Scratched
UpTo 25mm Thru Paint

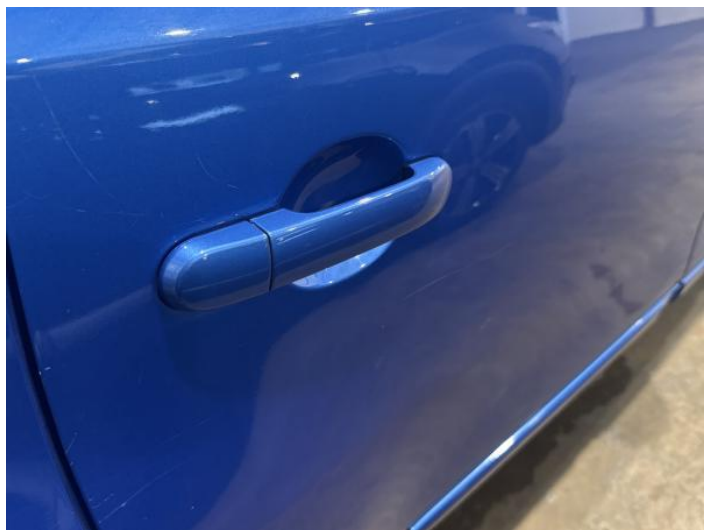
8: Door osr
Scratched
Rusted

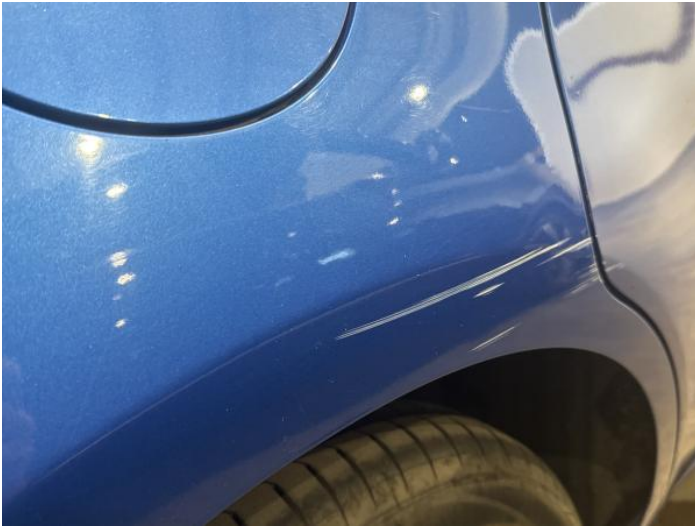
9: Qtr Panel osr
Dented
With Paint Damage

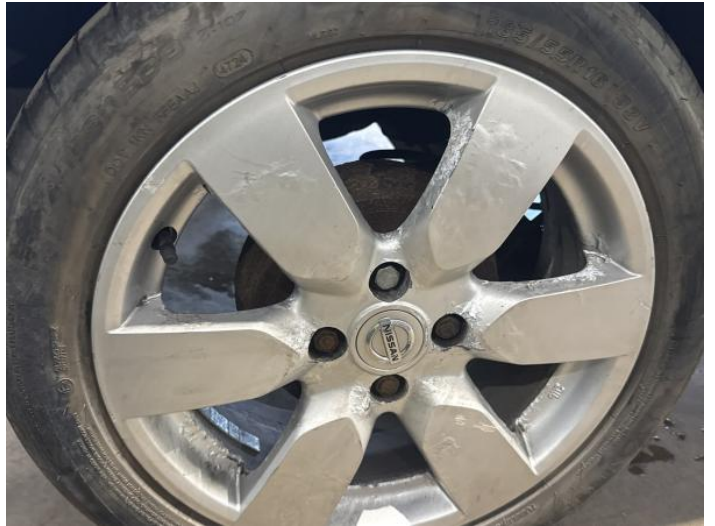
10: Wheel osr
Scratched
Over 50mm

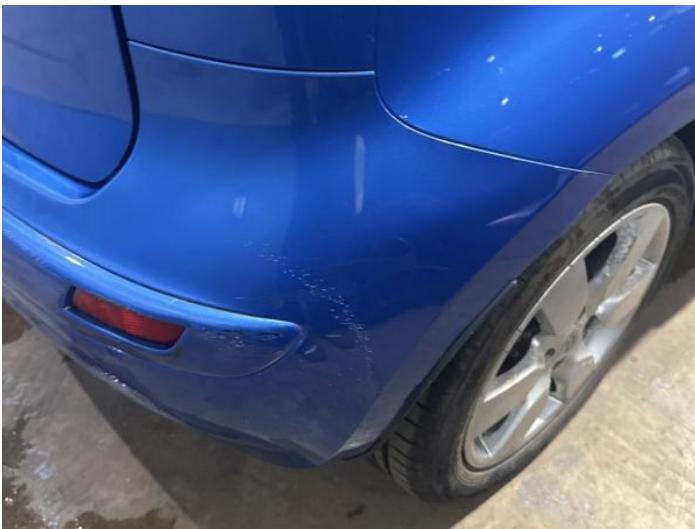
11: Bumper Rear
Scratched
Over 100mm Thru Paint

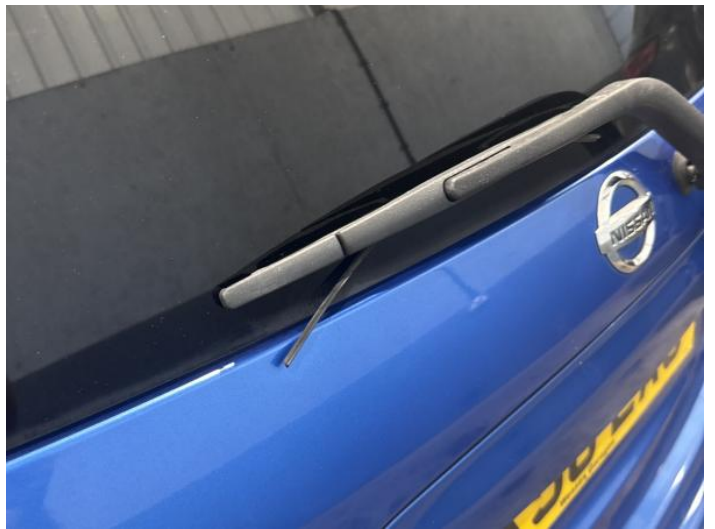
12: Wiper Rear
Broken
Replace

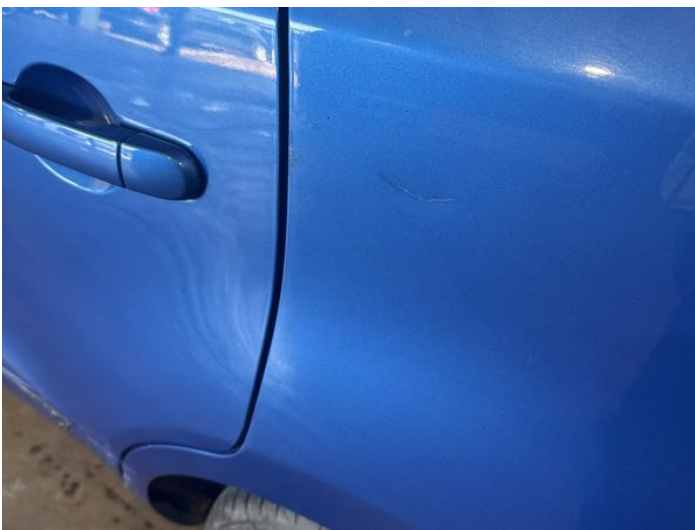
13: Qtr Panel nsr
Dented
With Paint Damage

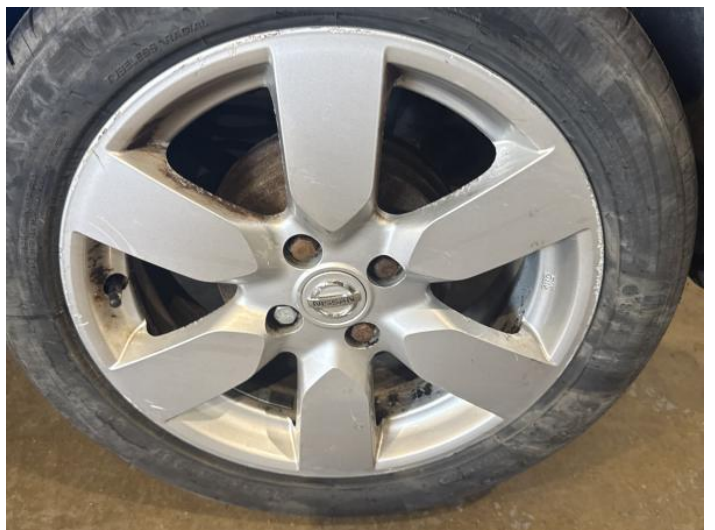
14: Wheel nsr
Scratched
Over 50mm

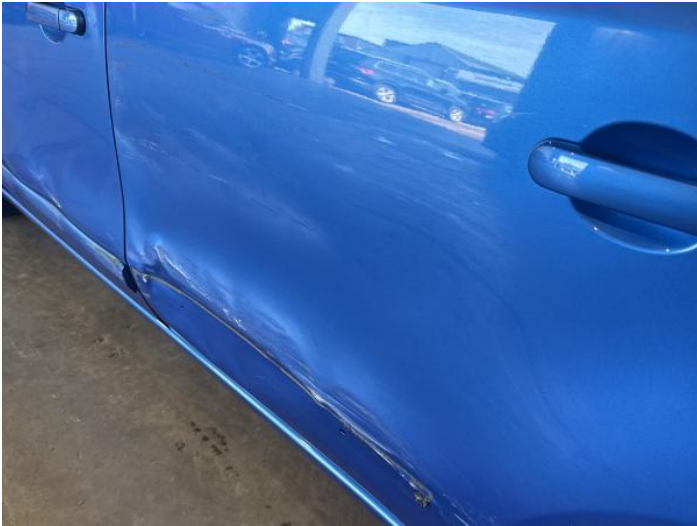
15: Door nsr
Dented
Over 30% Of Panel

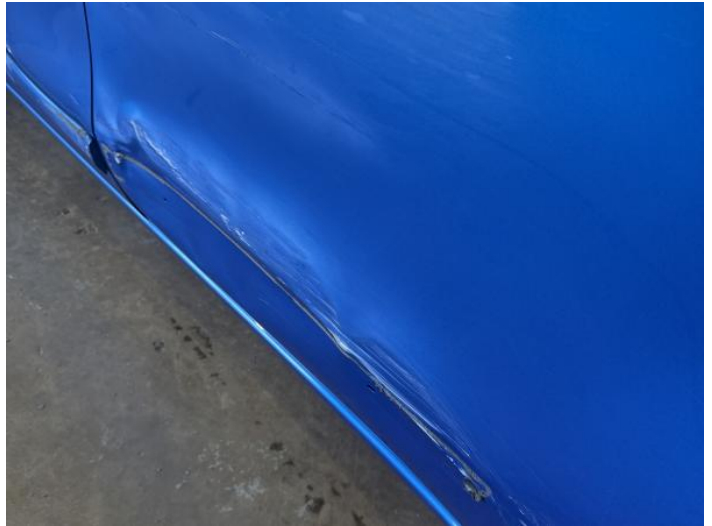
16: Door Moulding nsr
Broken
Replace

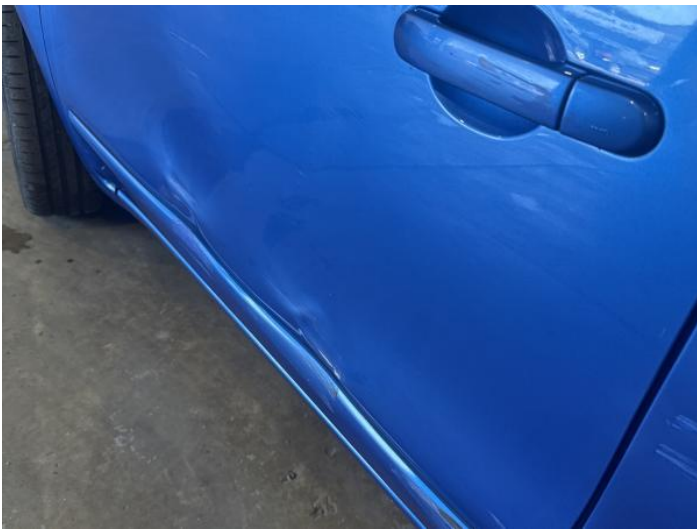
17: Door nsf
Dented
With Paint Damage

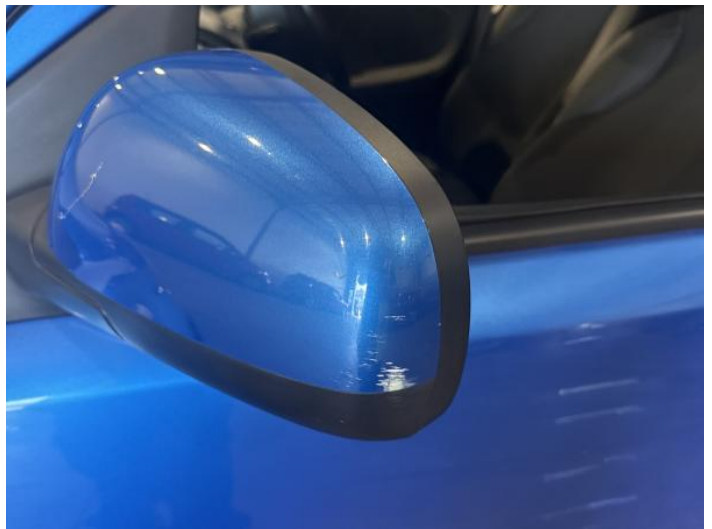
18: Door Mirror Assy nsf
Scratched (Painted)
UpTo 25mm Thru Paint

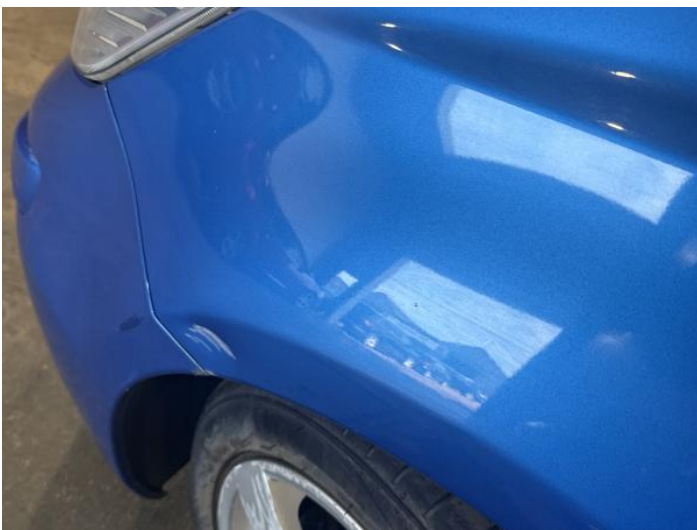
19: Wing nsf
Dented
With Paint Damage

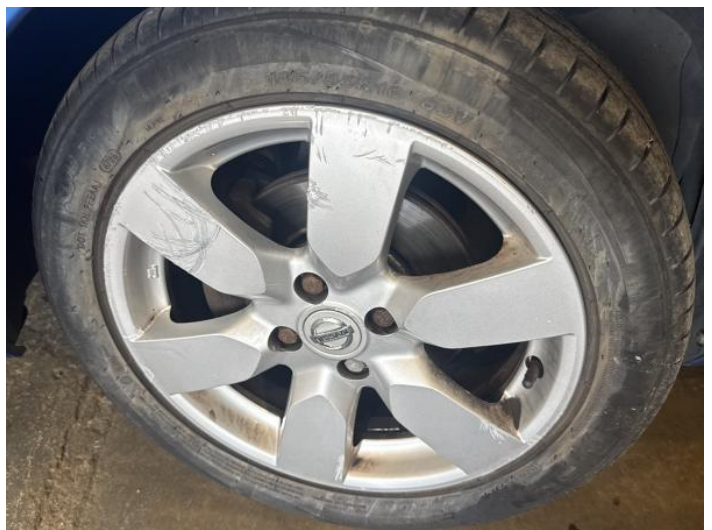
20: Wheel osf
Scratched
Over 50mm

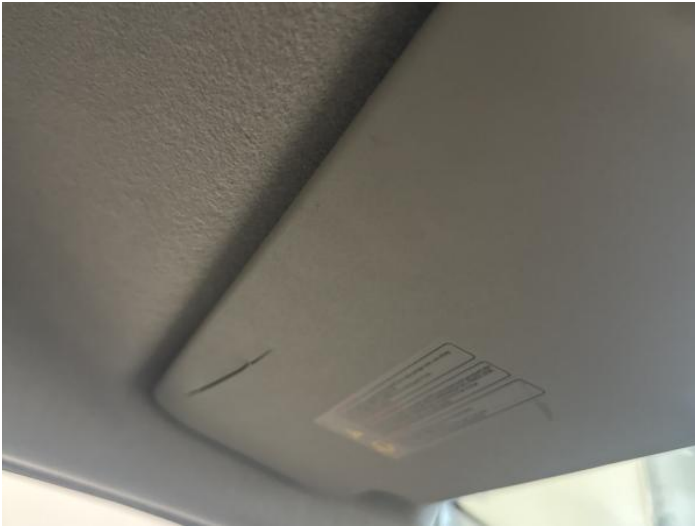
21: Sunvisor ns
Torn
Over 10mm

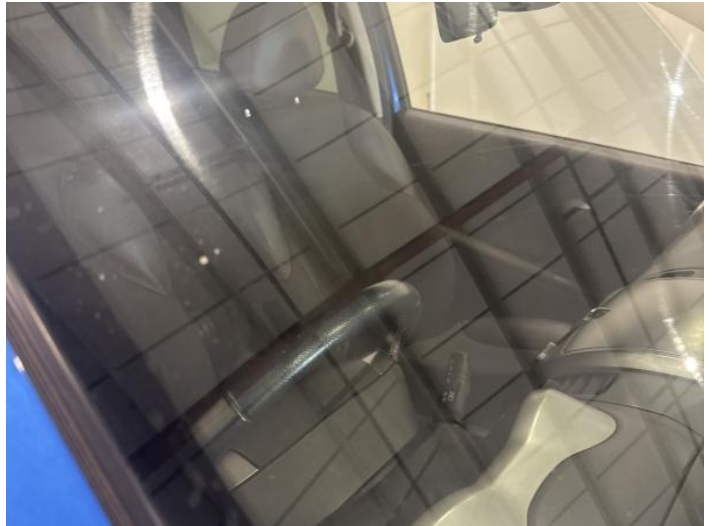
22: Screen Front
Chipped
Over 10mm
