# VEHICLE INSPECTION REPORT

**LB18SYR**

## Peugeot 208 1.6 THP GTi Prestige 3dr

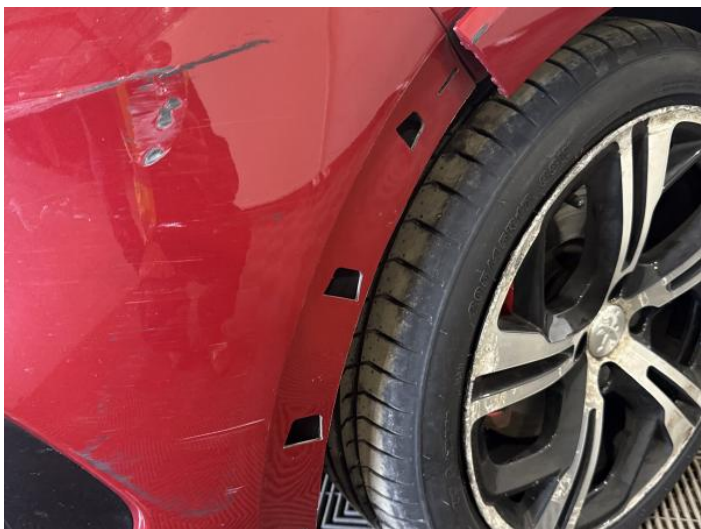
3: Bumper Front Moulding  
Missing  
Replace

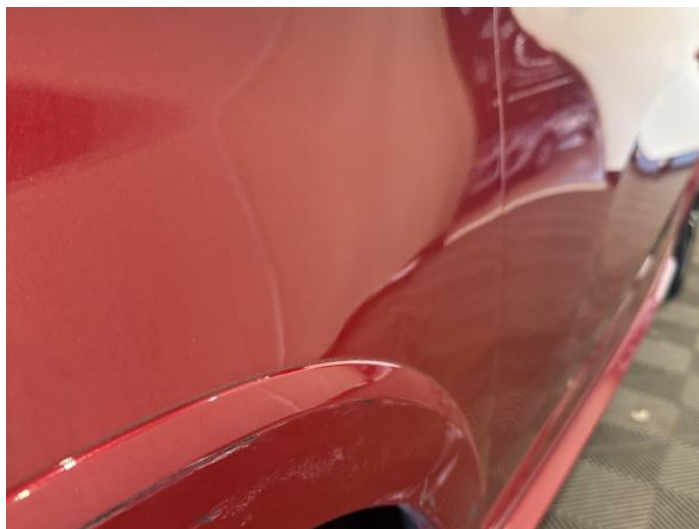
4: Wing nsf  
Dented  
Over 30mm

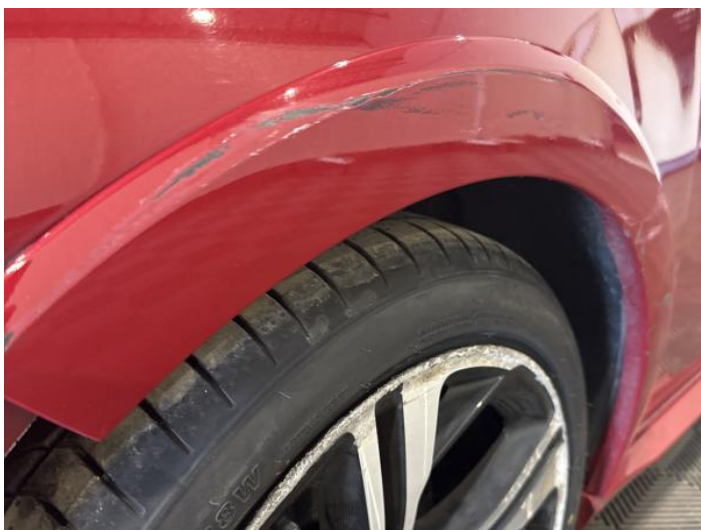
5: Wing Front Arch Extension ns  
Scratched (Painted)  
Over 25mm Thru Paint

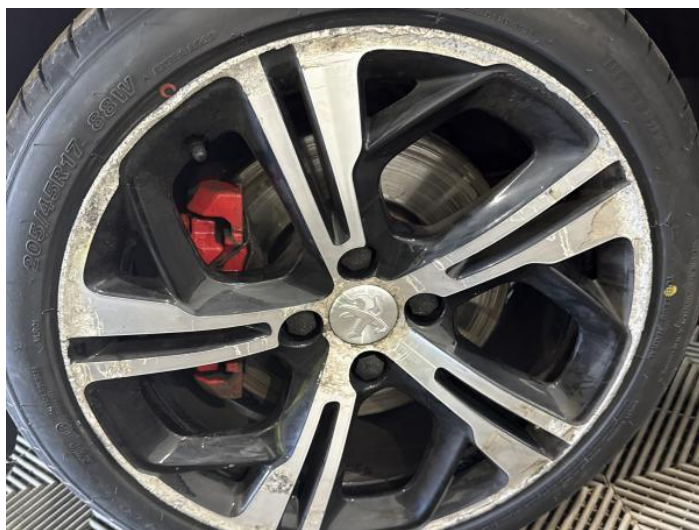
6: Wheel nsf  
Scratched  
Over 50mm

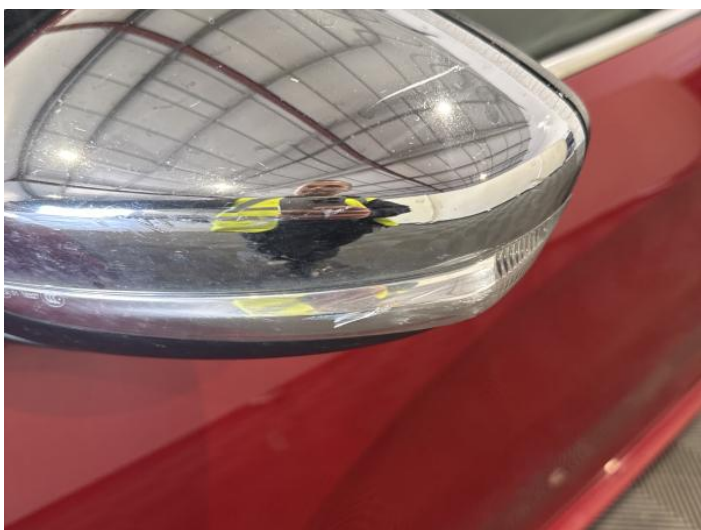
7: Flasher Side Repeater ns  
Broken  
Replace

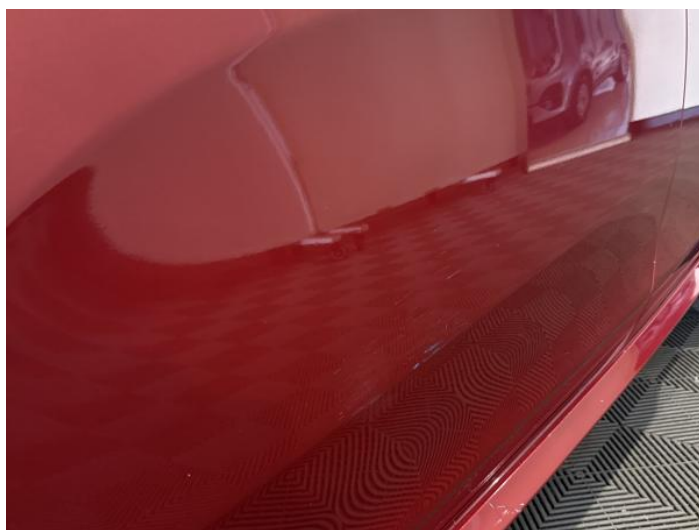
8: Door nsf  
Dented  
With Paint Damage

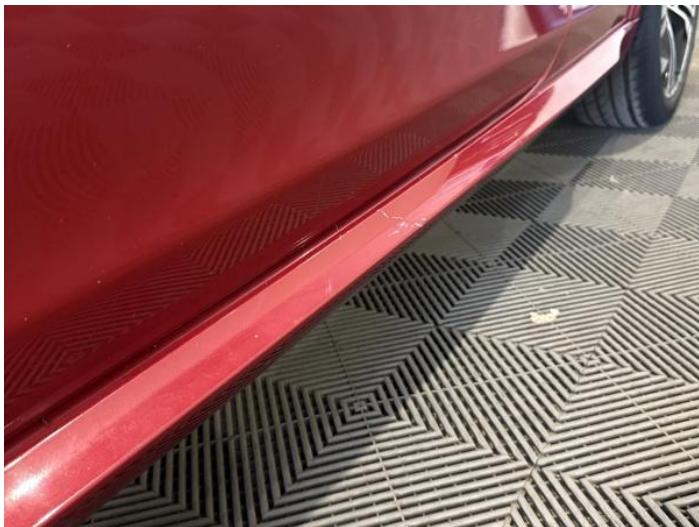
9: Sill Panel Trim ns  
Scratched (Painted)  
Over 25mm Thru Paint

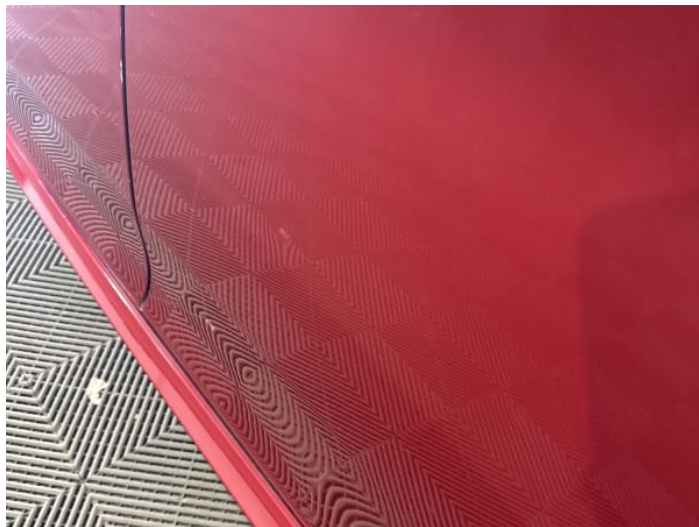
10: Qtr Panel nsr  
Dented  
Between 10mm + 30mm

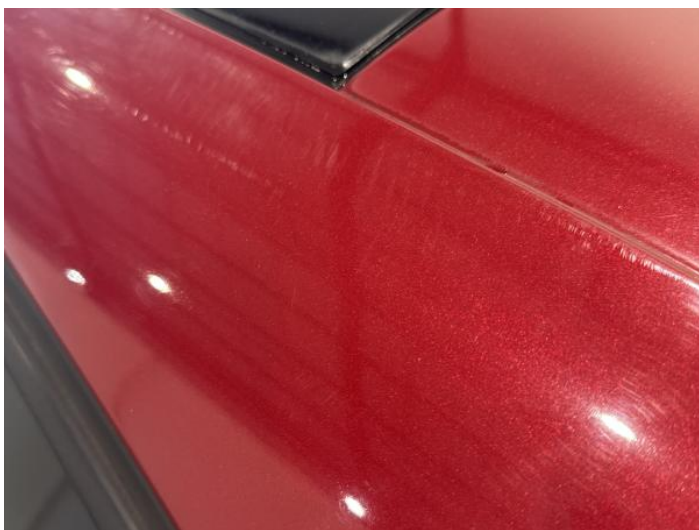
11: Qtr Panel nsr  
Scratched  
Over 25mm Thru Paint

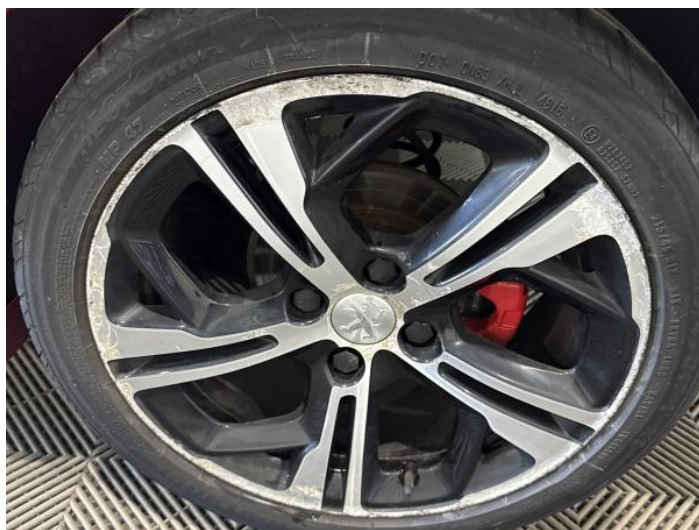
12: Wheel nsr  
Scratched  
Over 50mm

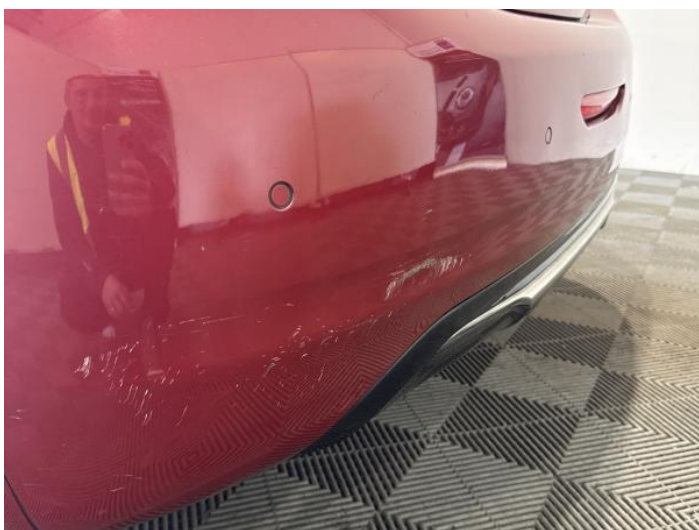
13: Bumper Rear  
Scratched  
Over 100mm Thru Paint

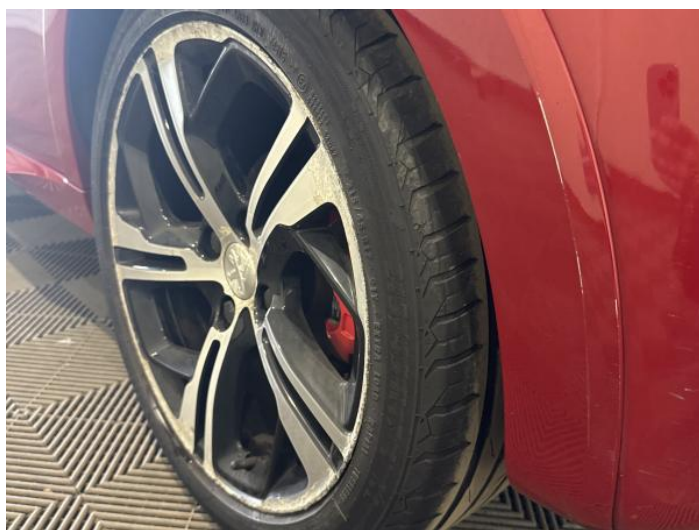
14: Bumper Rear Moulding  
Scratched (Painted)  
Over 25mm Thru Paint

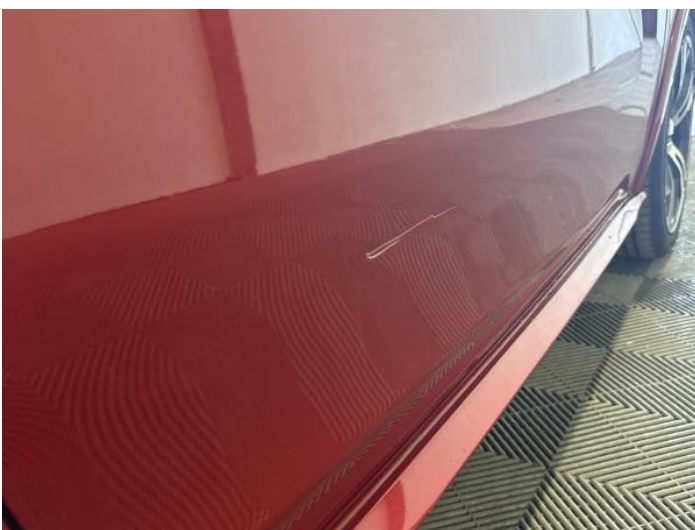
19: Door osf  
Dented  
With Paint Damage

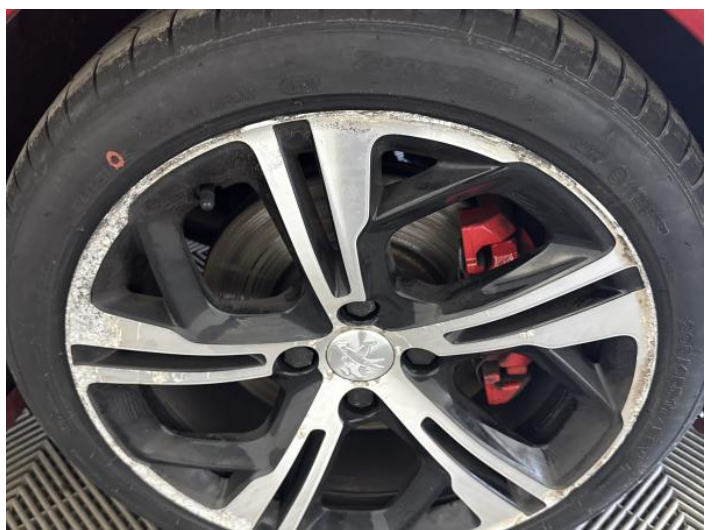
20: Wheel osf  
Scratched  
Over 50mm

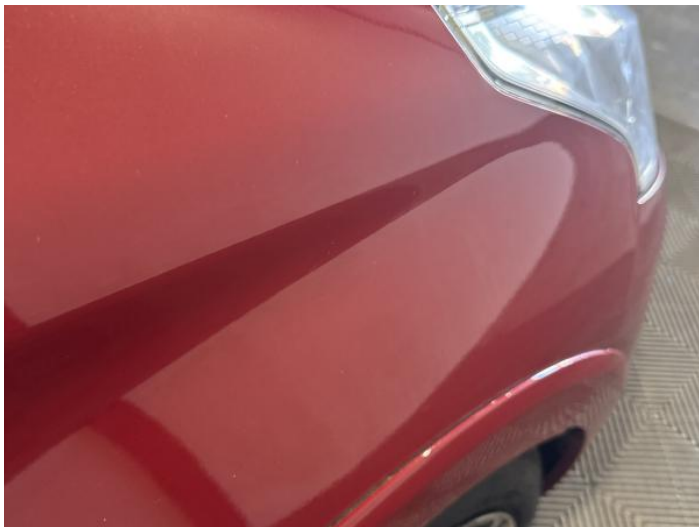
21: Wing osf  
Dented  
2 Or Less UpTo 10mm
