# VEHICLE INSPECTION REPORT

**LG700BJ**

## Ford Focus 1.5 EcoBlue 120 Titanium 5dr

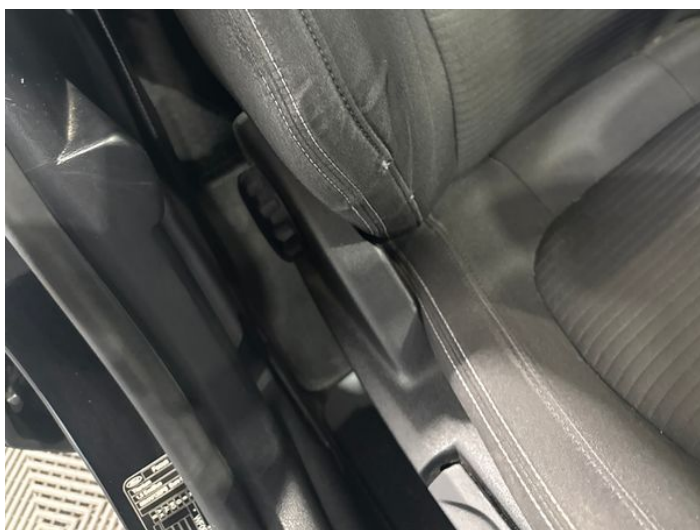
1: Seat Back Cover osf  
Scuffed  
Over 25mm

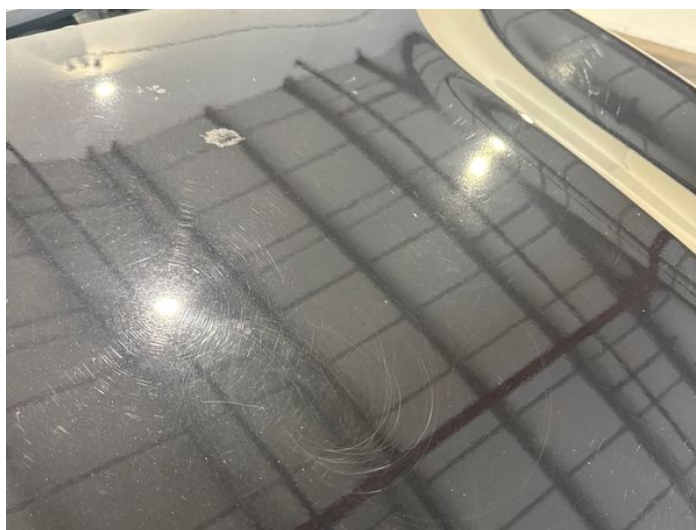
2: Bonnet  
Scratched  
Over 25mm Thru Paint

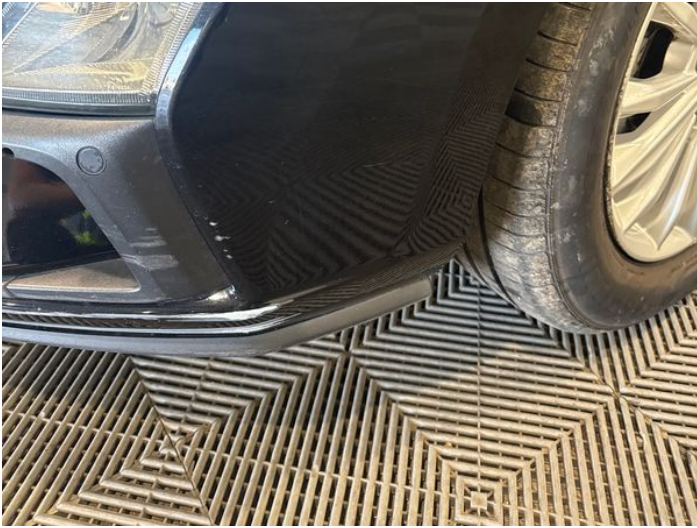
3: Bumper Front  
Scratched  
25 to 100mm Thru Paint

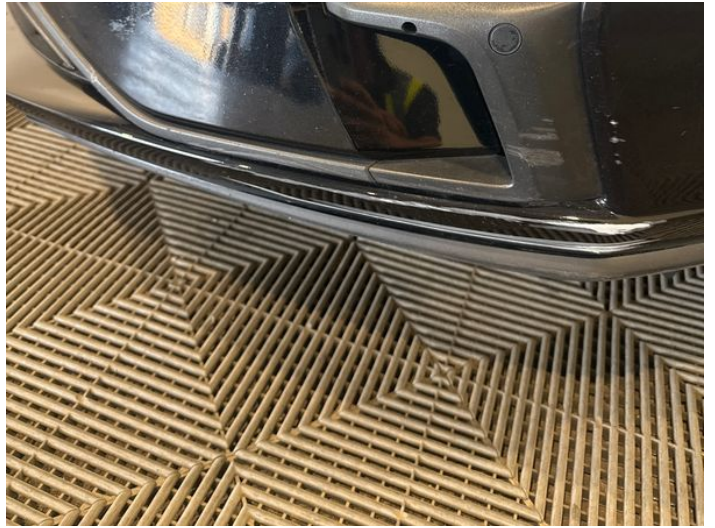
4: Bumper Front Moulding  
Scuffed (Unpainted)  
Over 100mm

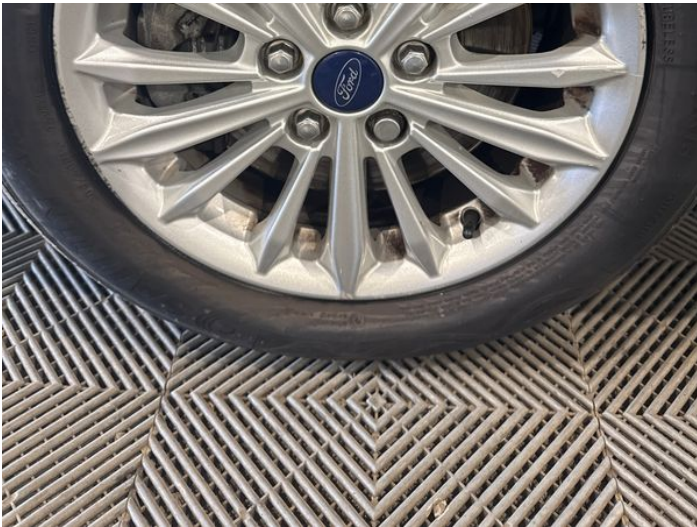
5: Wheel nsf  
Scratched  
Over 50mm

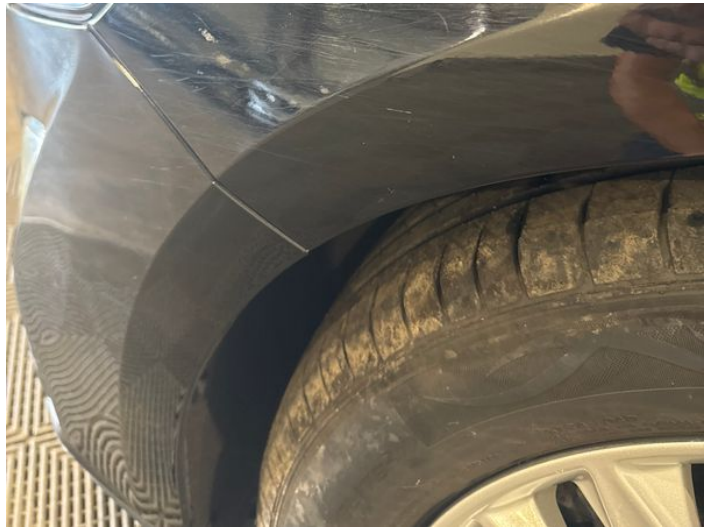
6: Wing nsf  
Scratched  
Over 25mm Thru Paint

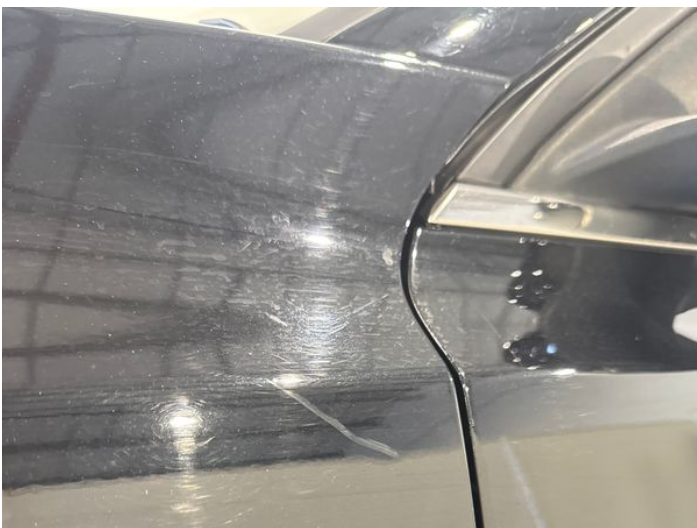
7: Wing nsf  
Dented  
2 Or Less UpTo 10mm

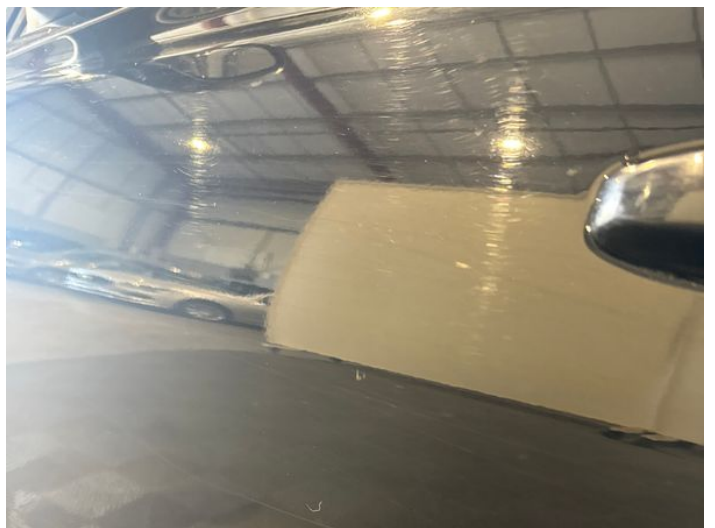
8: Door nsf  
Scratched  
Over 25mm Thru Paint

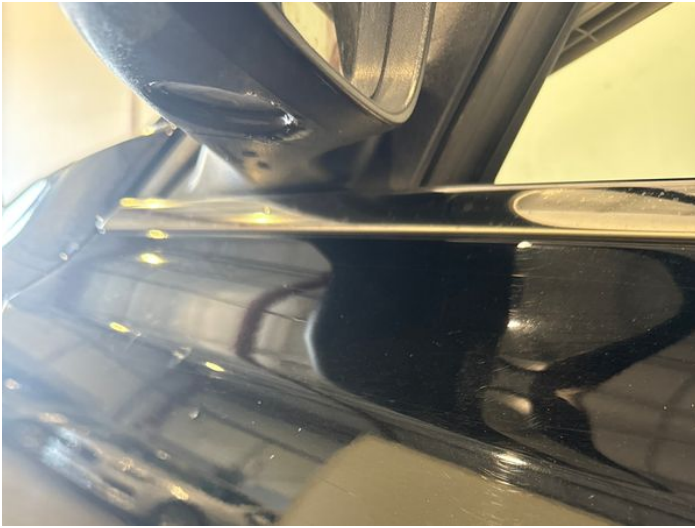
9: Door nsf  
Dented  
Between 10mm + 30mm

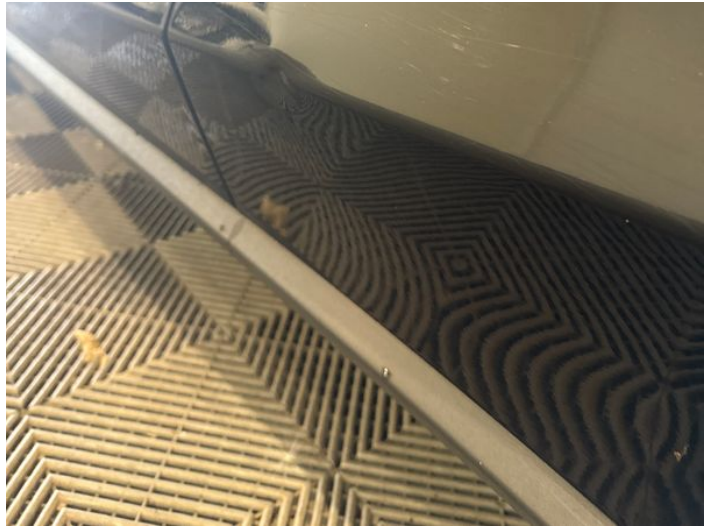
10: Door nsr  
Dented  
Over 30mm

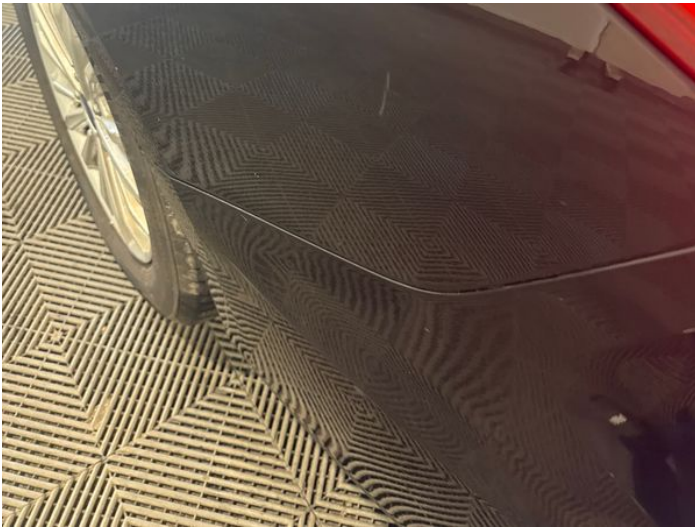
11: Qtr Panel nsr  
Scratched  
Over 25mm Thru Paint

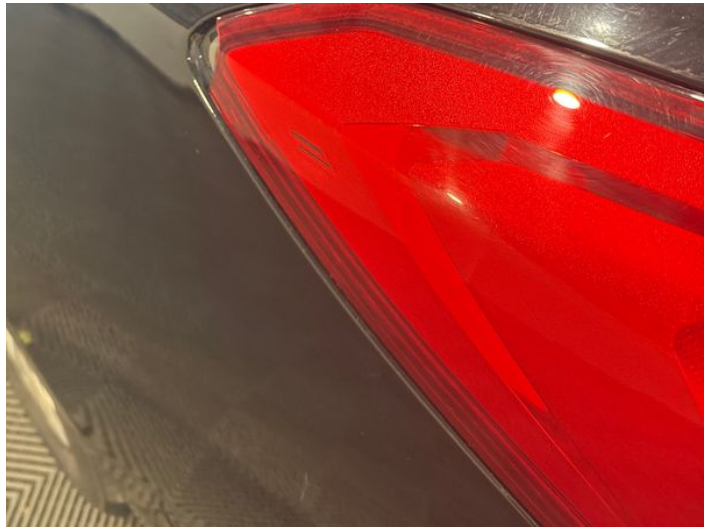
12: Lamp nsr  
Broken  
Replace

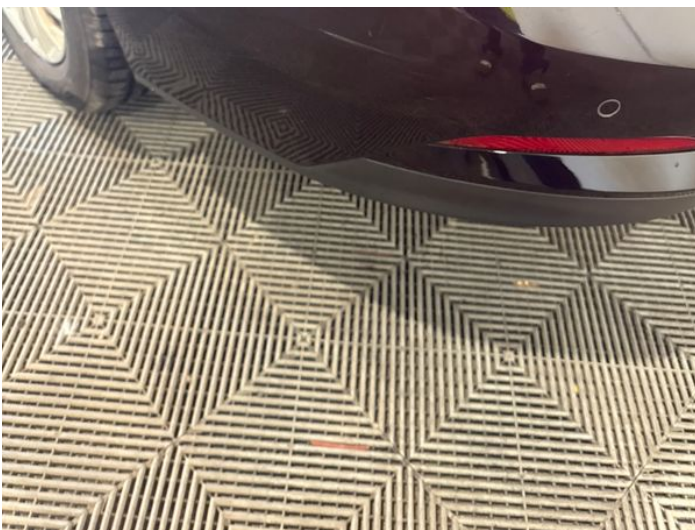
13: Bumper Rear  
Scratched  
Over 100mm Thru Paint

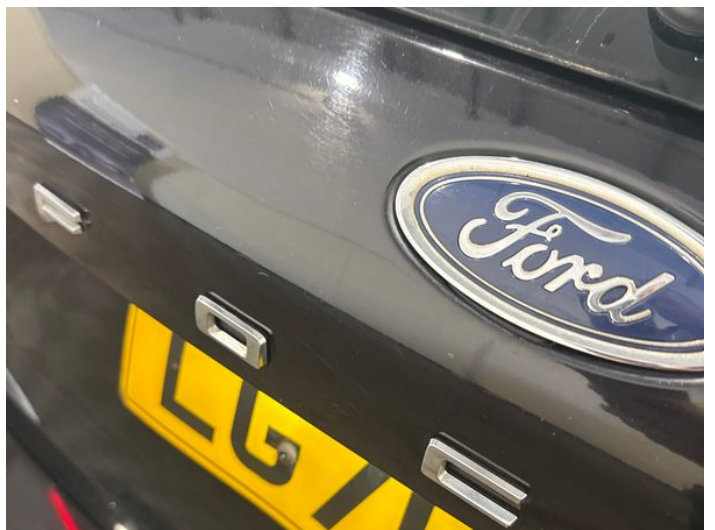
14: Tailgate  
Scratched  
Over 25mm Thru Paint

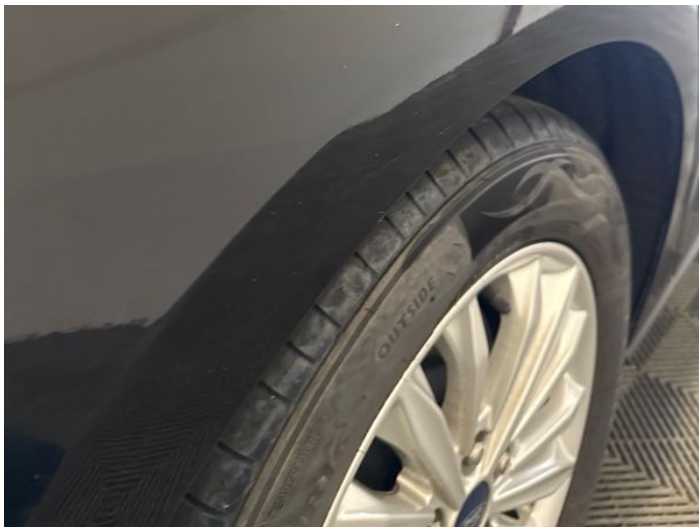
15: Qtr Panel osr  
Scratched  
Over 25mm Thru Paint

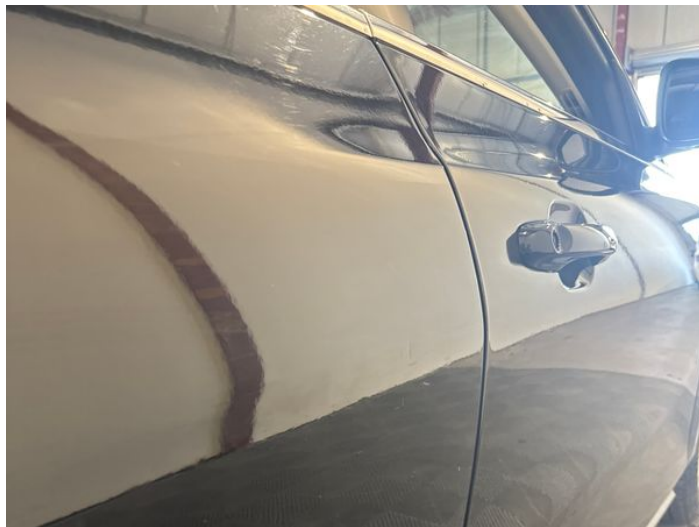
16: Door osr  
Dented  
With Paint Damage

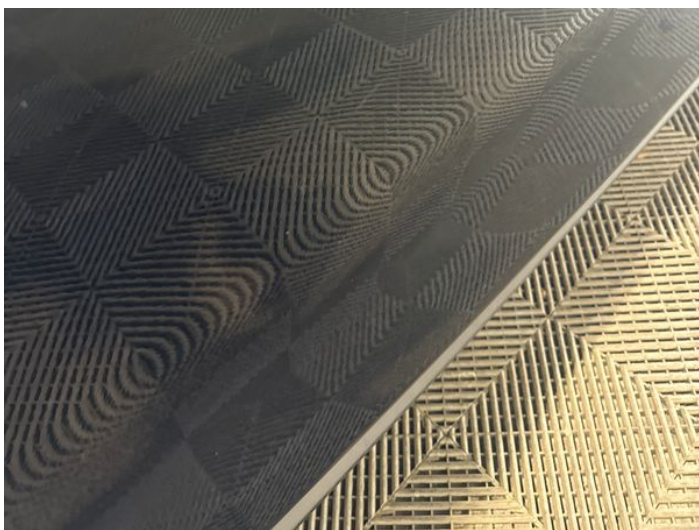
17: Door osf  
Scratched  
UpTo 25mm Thru Paint

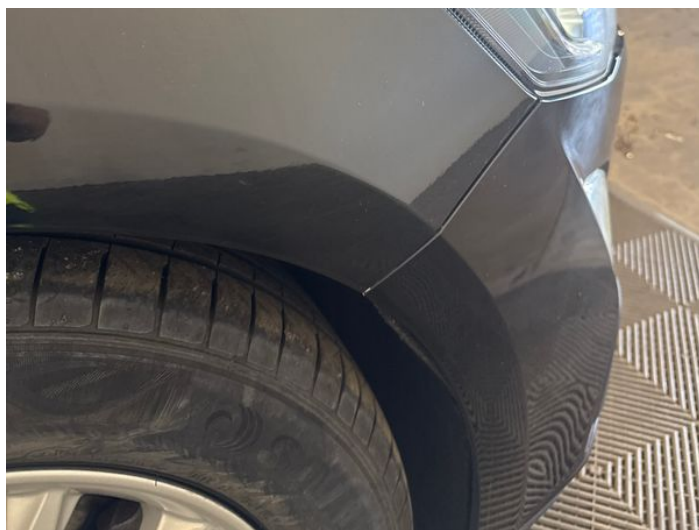
18: Wing osf  
Chipped  
1 To 5

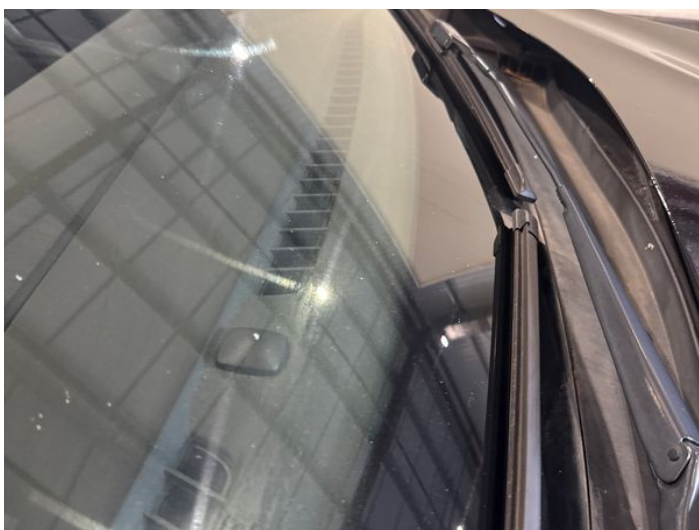
19: Screen Front  
Chipped  
UpTo 10mm
