VEHICLE INSPECTION REPORT

YX68HVL

Volvo XC40 2.0 D3 R DESIGN 5dr

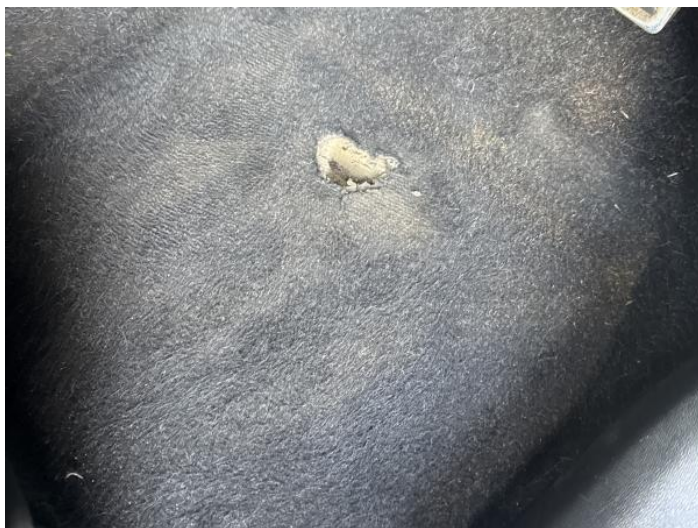
1: Carpets Front
Torn
Over 10mm

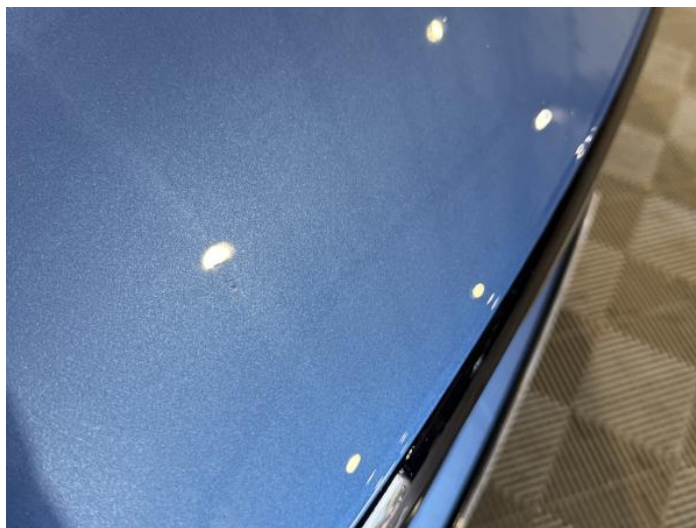
2: Bonnet
Dented
Over 2 UpTo 10mm

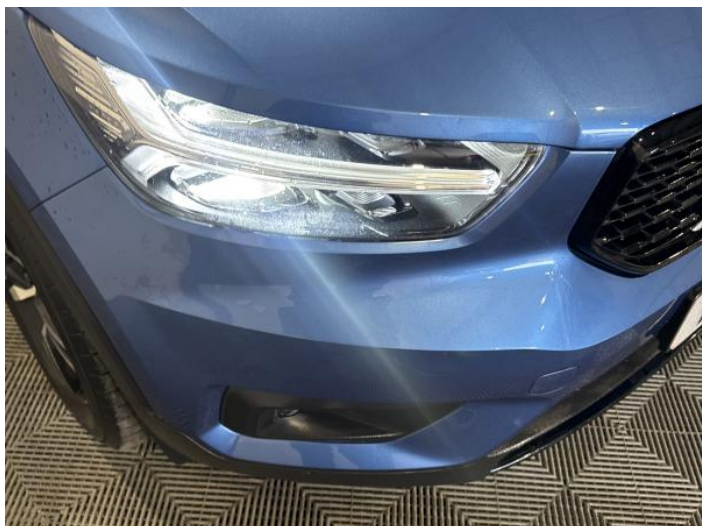
3: Bumper Front
Scratched
25 to 100mm Thru Paint

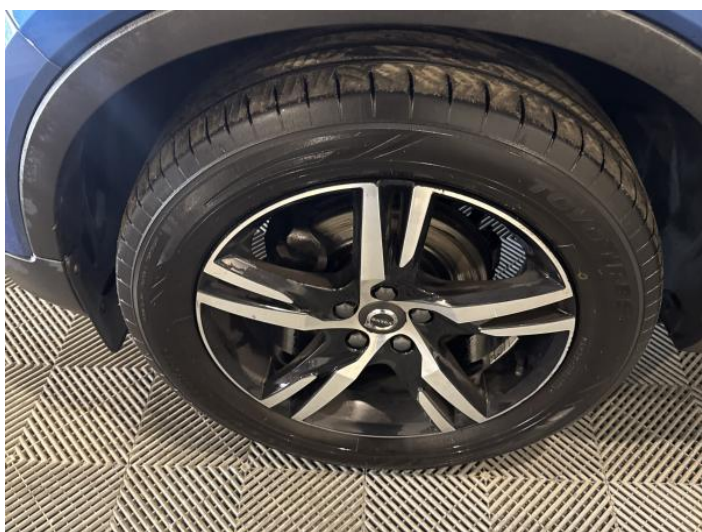
5: Wheel nsf
Scratched
Over 50mm

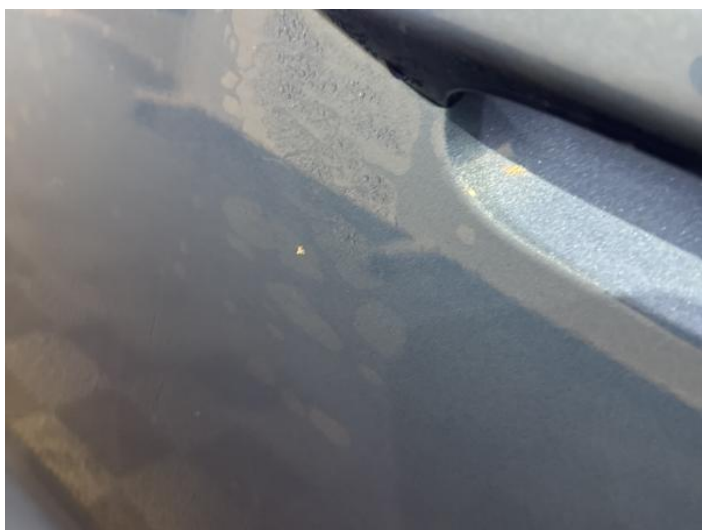
7: Door nsf
Chipped
1 To 5

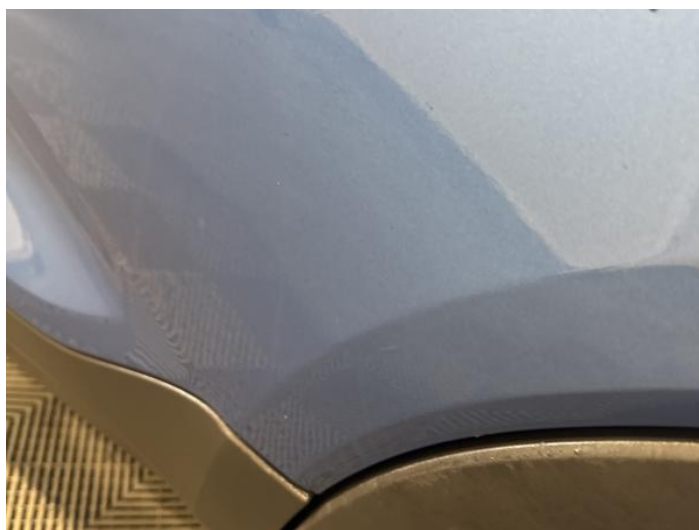
8: Door nsr
Chipped
1 To 5

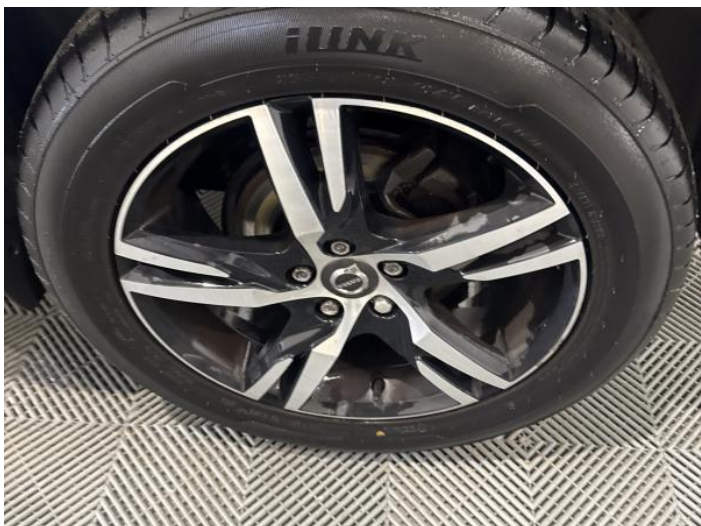
9: Wheel nsr
Scratched
Over 50mm

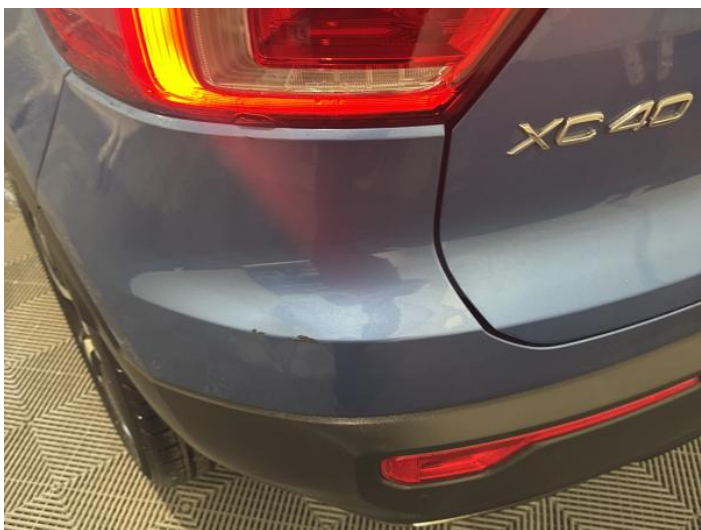
11: Bumper Rear
Scratched
25 to 100mm Thru Paint

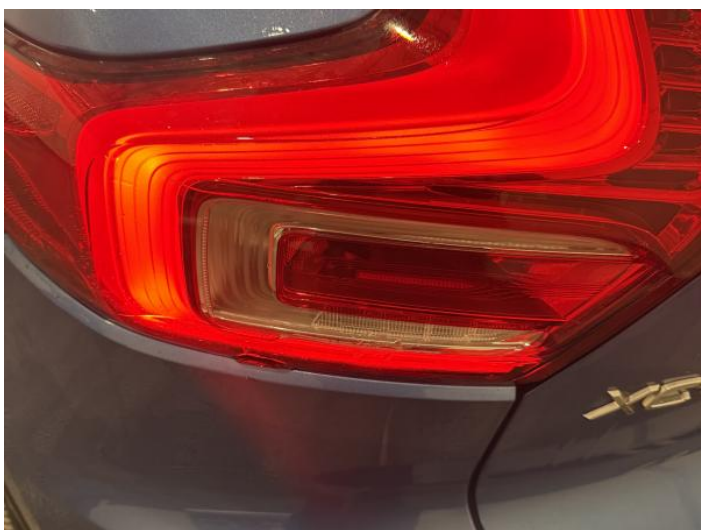
13: Lamp nsr
Broken
Replace

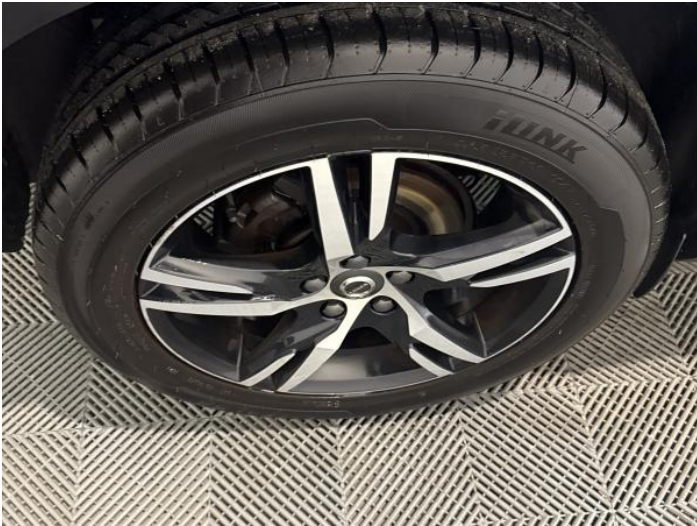
15: Wheel osr
Scratched
Over 50mm

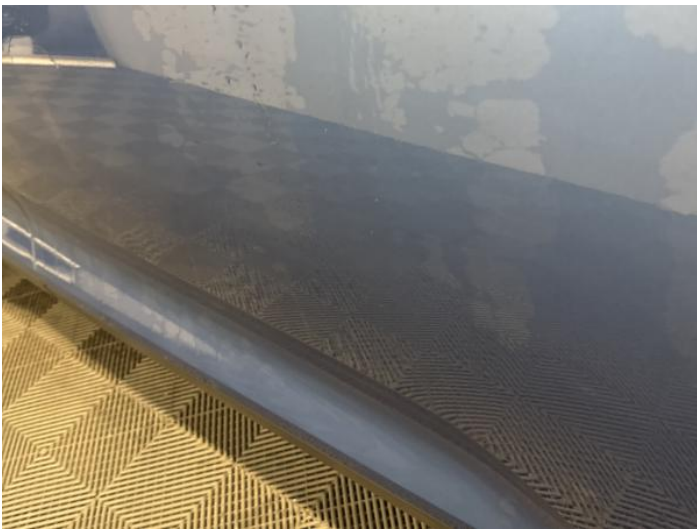
17: Door osf
Chipped
1 To 5

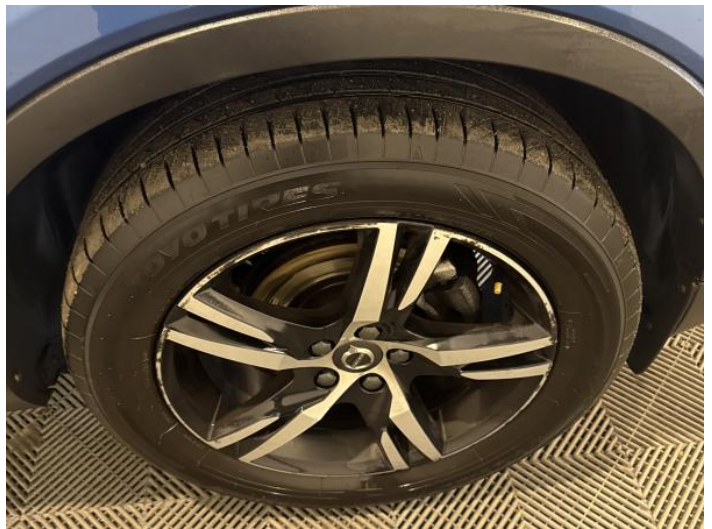
18: Wheel osf
Scratched
Over 50mm
