# VEHICLE INSPECTION REPORT

# Ford Kuga 1.5 EcoBlue ST-Line X Edition 5dr

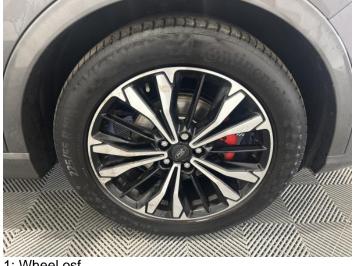
1: Wheel osf Corroded Light

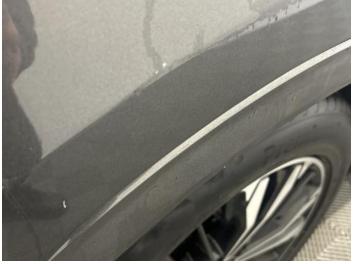
2: Door osf Chipped Edge Chip

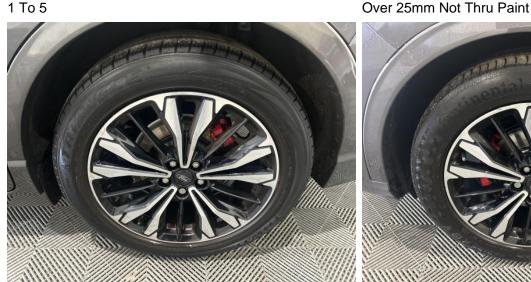
5: Wheel nsr Scratched Up To 50mm
