# VEHICLE INSPECTION REPORT

**LV18KGE**

## Ford KA+ 1.2 Zetec 5dr

**Cat: S**  
**Inspection**

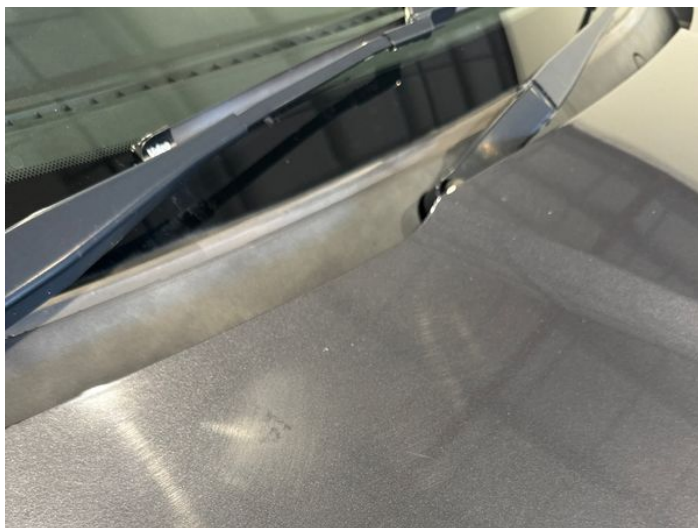
1: Bonnet  
Scratched  
Over 25mm Thru Paint

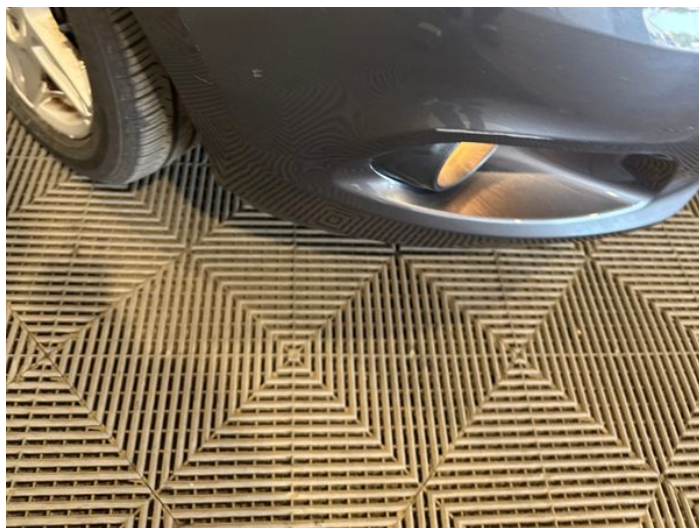
2: Bumper Front  
Scratched  
Over 100mm Thru Paint

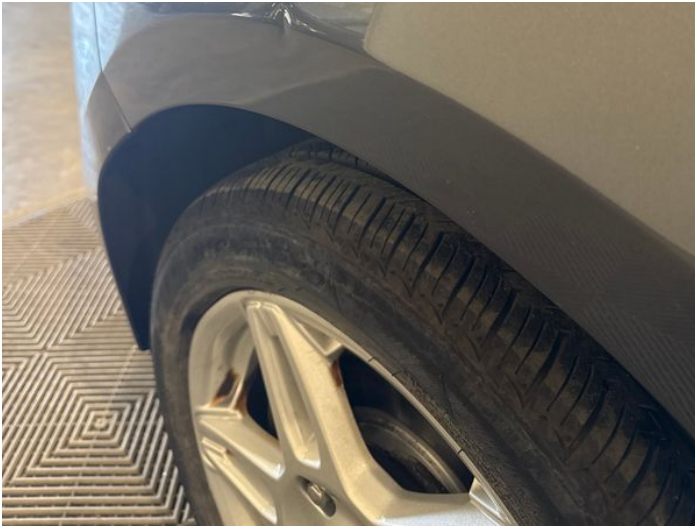
3: Wing nsf  
Dented  
Between 10mm + 30mm

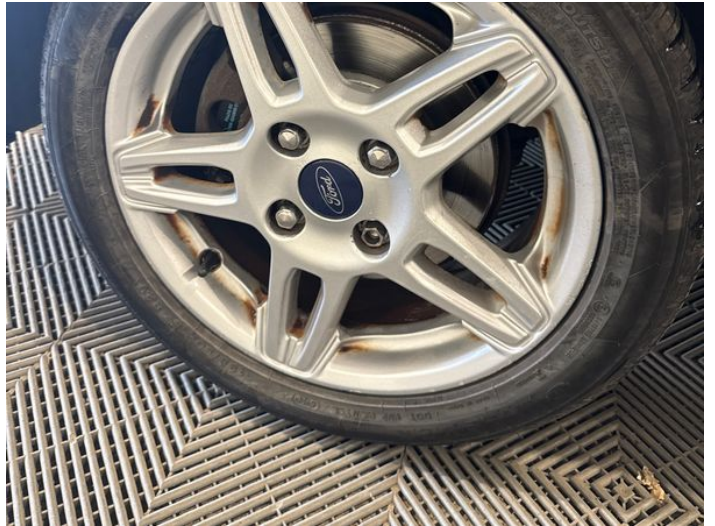
4: Wheel nsf  
Scratched  
Over 50mm

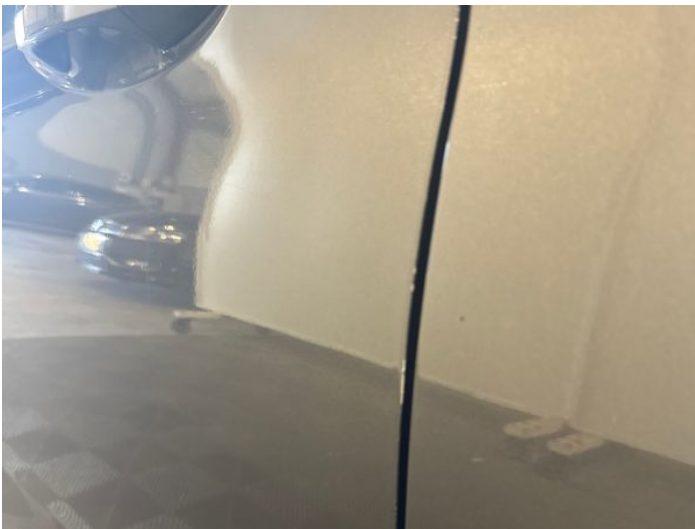
5: Door nsf  
Chipped  
Edge Chip

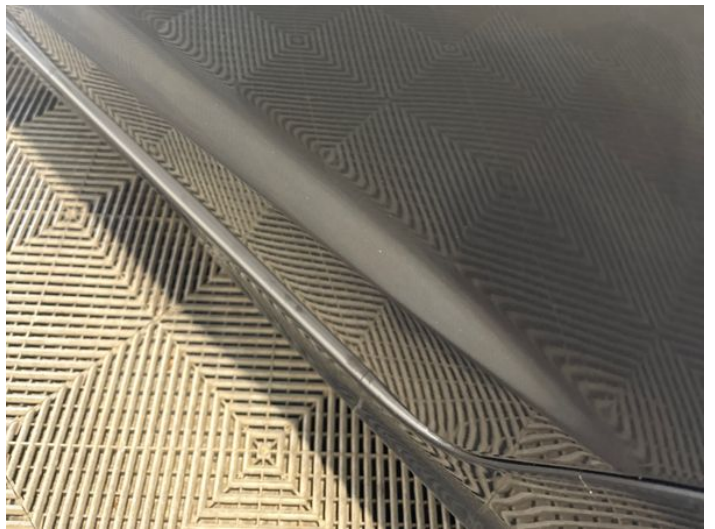
6: Door nsr  
Scratched  
Over 25mm Thru Paint

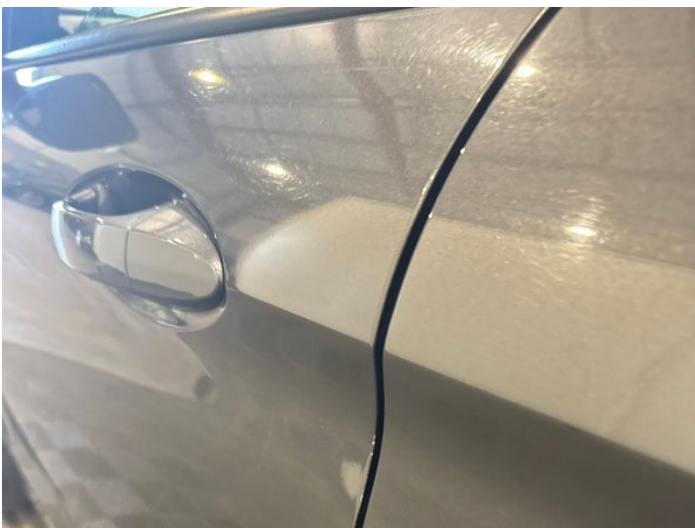
7: Door nsf  
Dented  
Over 30mm

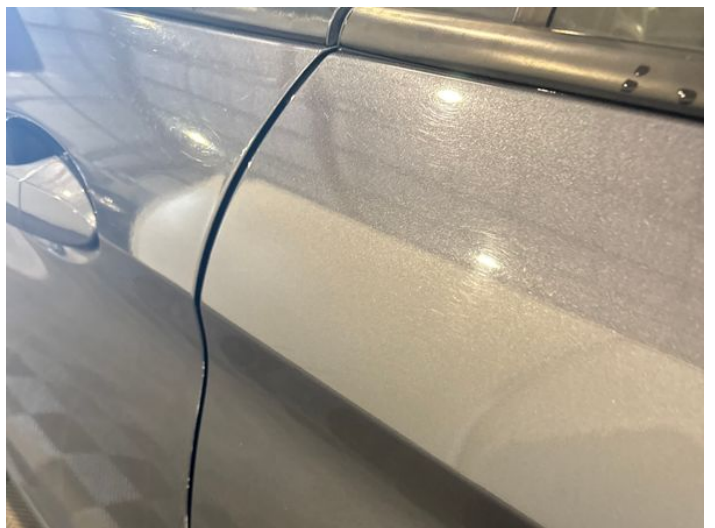
8: Door nsr  
Dented  
Between 10mm + 30mm

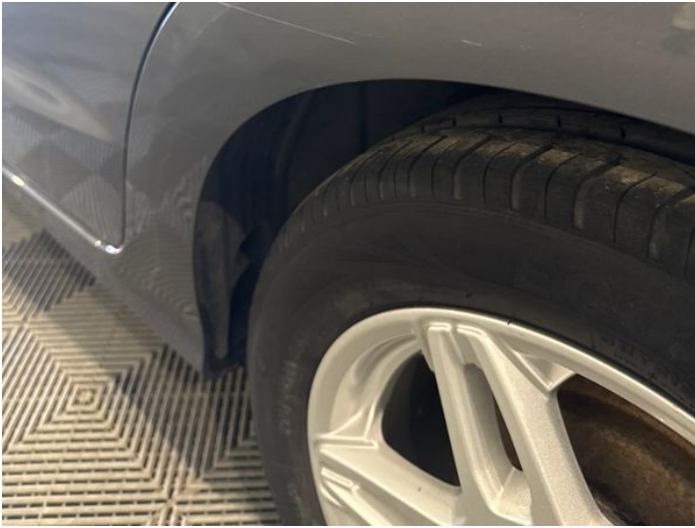
9: Qtr Panel nsr  
Dented  
With Paint Damage

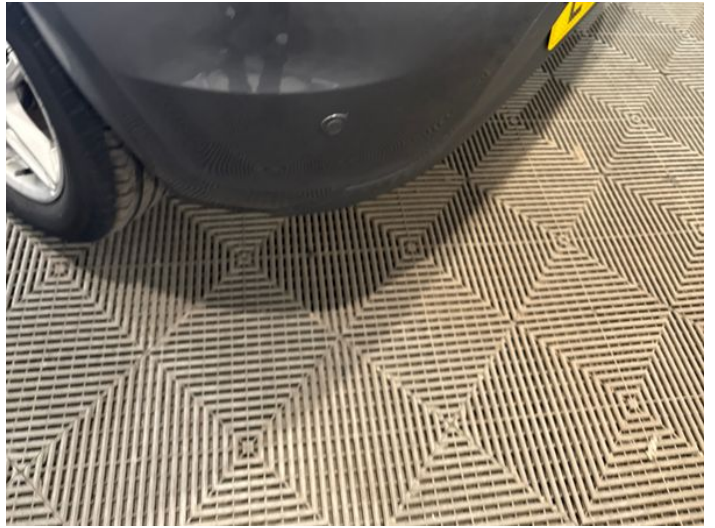
10: Bumper Rear  
Dented  
With Paint Damage

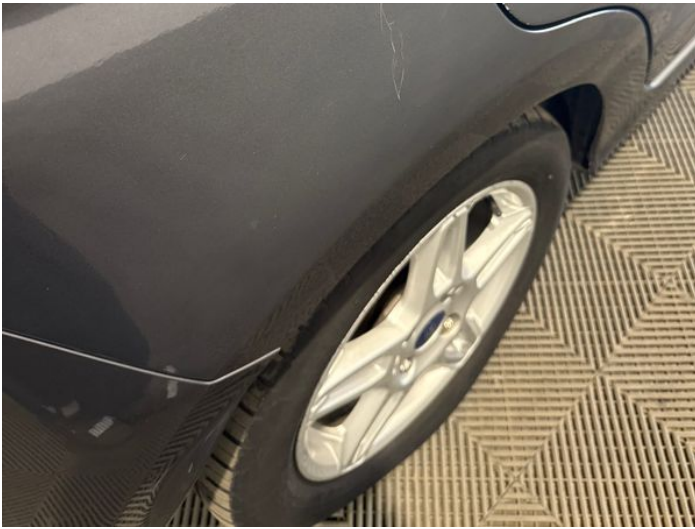
11: Qtr Panel osr  
Dented  
With Paint Damage

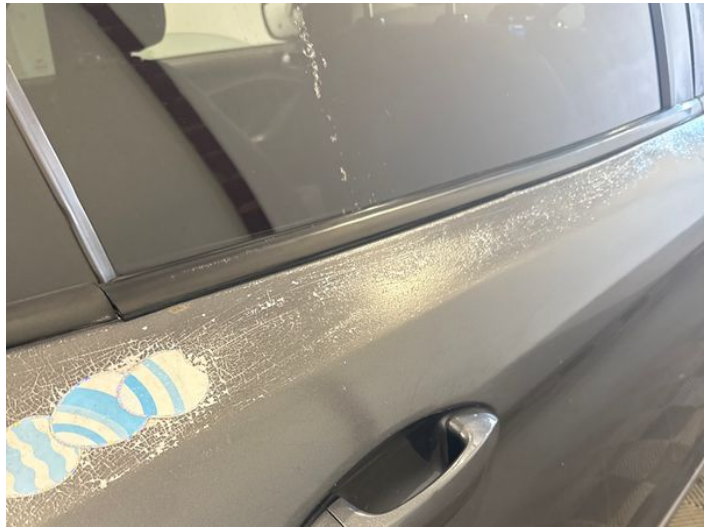
12: Door osr  
Poor Previous Repair  
Poor Paint

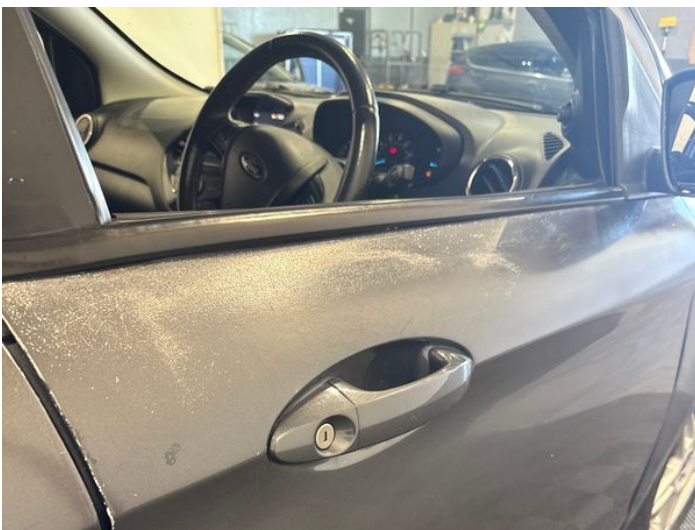
13: Door osf  
Poor Previous Repair  
Rippled UpTo 30%

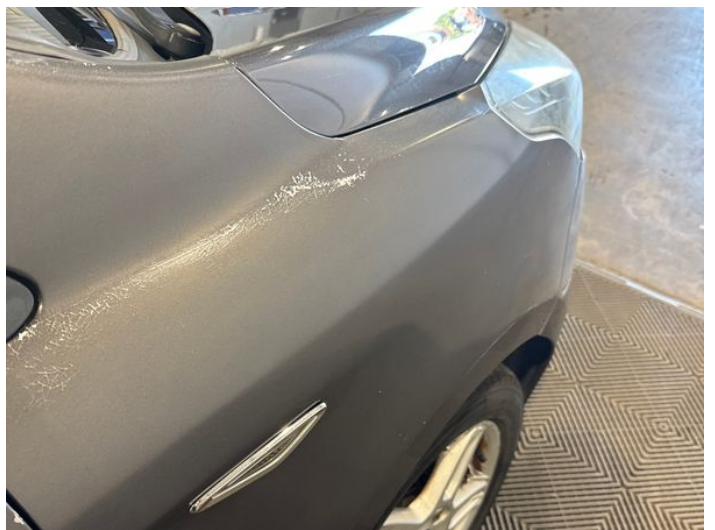
14: Wing osf  
Poor Previous Repair  
Poor Paint

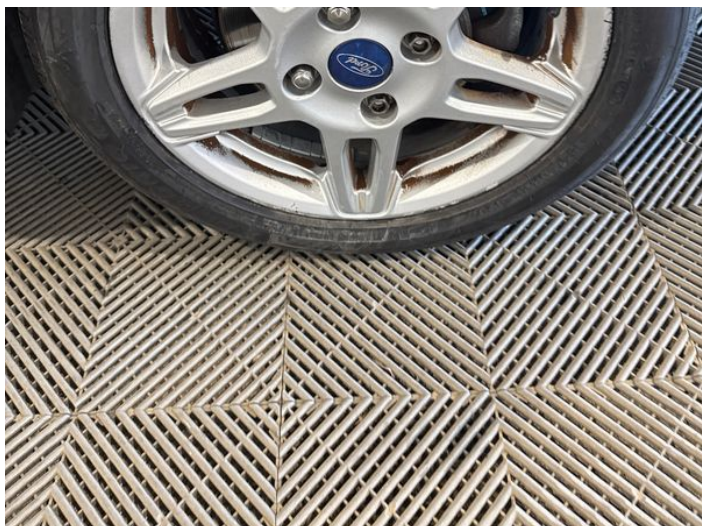
15: Wheel of  
Scratched  
Over 50mm
