# VEHICLE INSPECTION REPORT

VK65O EZ

## Nissan X-Trail 1.6 DiG-T N-Tec 5dr [7 Seat]

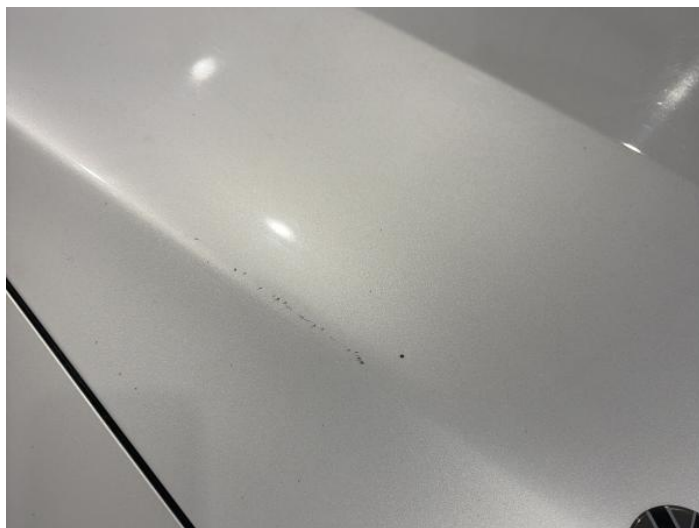
2: Bonnet  
Poor Previous Repair  
Poor Paint

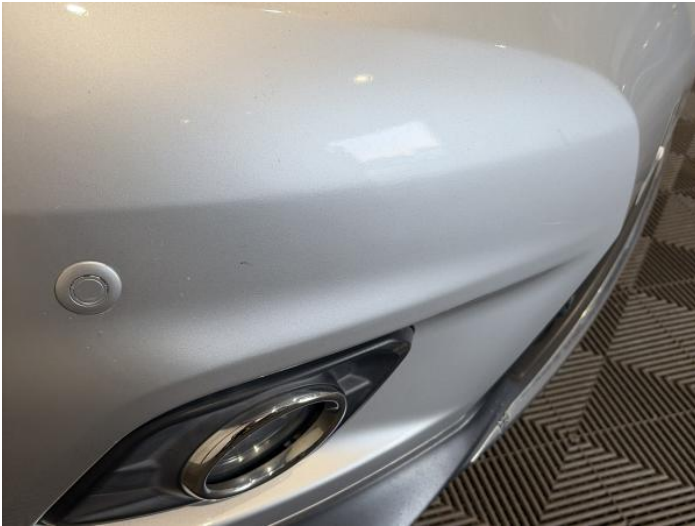
3: Bumper Front  
Chipped  
Multiple Chips

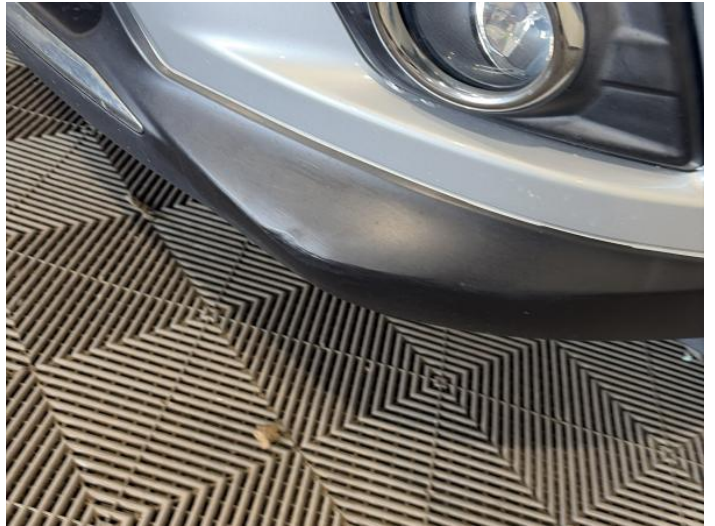
4: Bumper Front Moulding  
Scuffed (Unpainted)  
Over 100mm

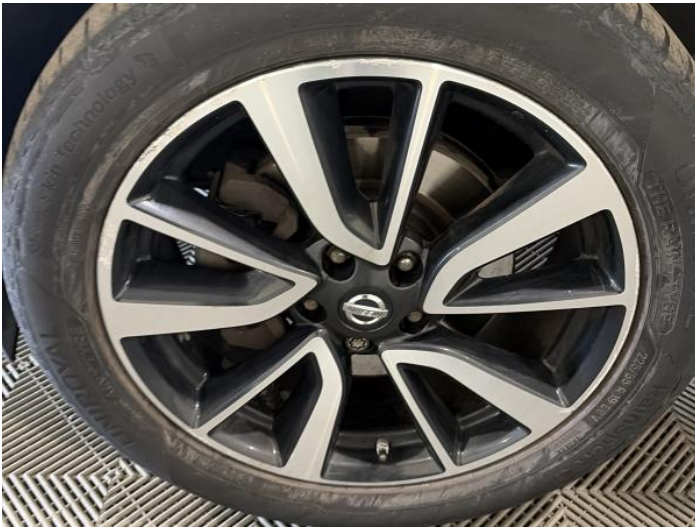
5: Wheel nsf  
Scratched  
Over 50mm

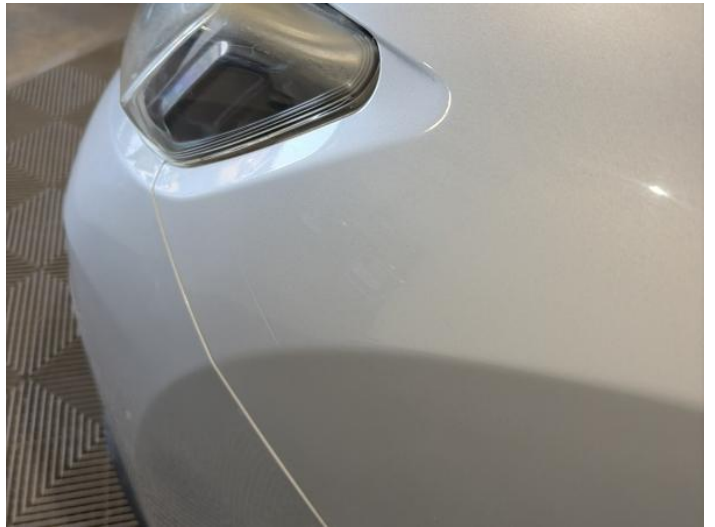
6: Wing nsf  
Scratched  
Over 25mm Thru Paint

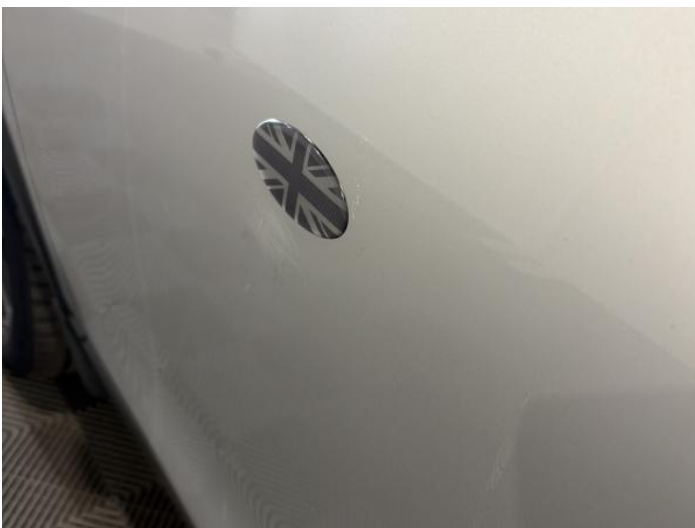
7: Door nsf  
Scratched  
Over 25mm Thru Paint

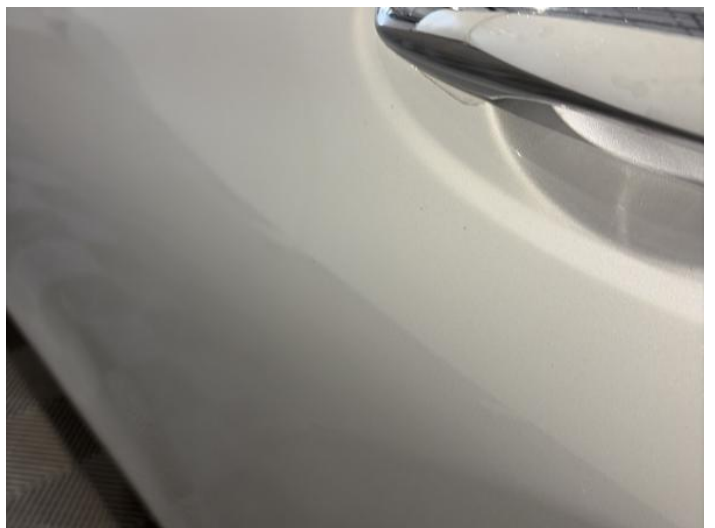
8: Door nsr  
Poor Previous Repair  
Poor Paint

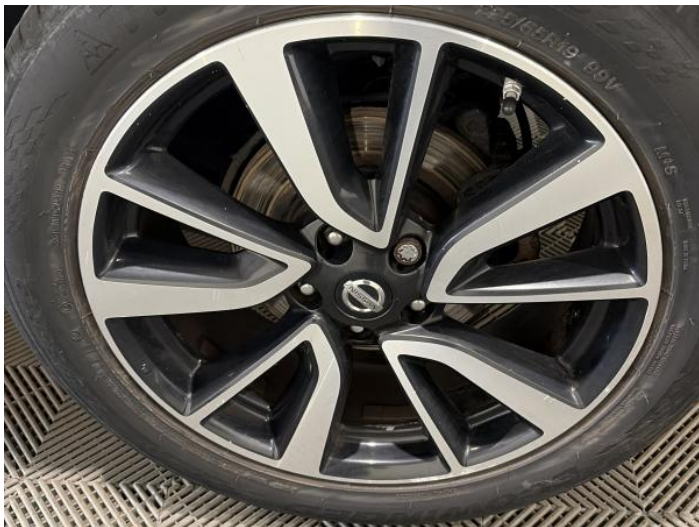
9: Wheel nsr  
Scratched  
Over 50mm

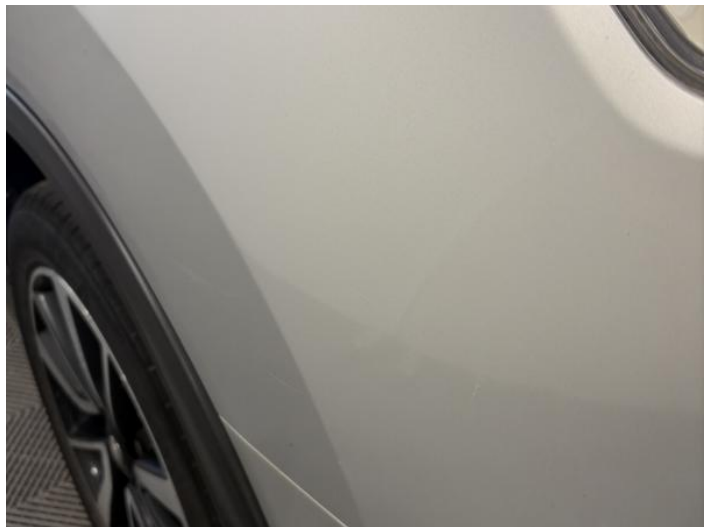
10: Qtr Panel nsr  
Scratched  
Over 25mm Thru Paint

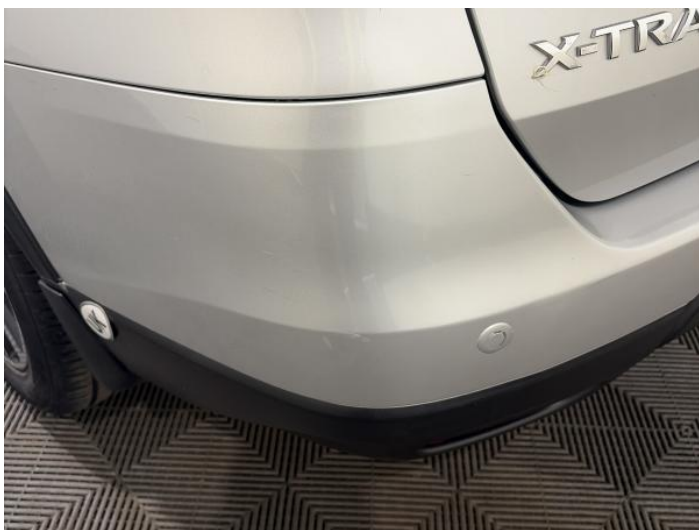
11: Bumper Rear  
Scratched  
Over 100mm Thru Paint

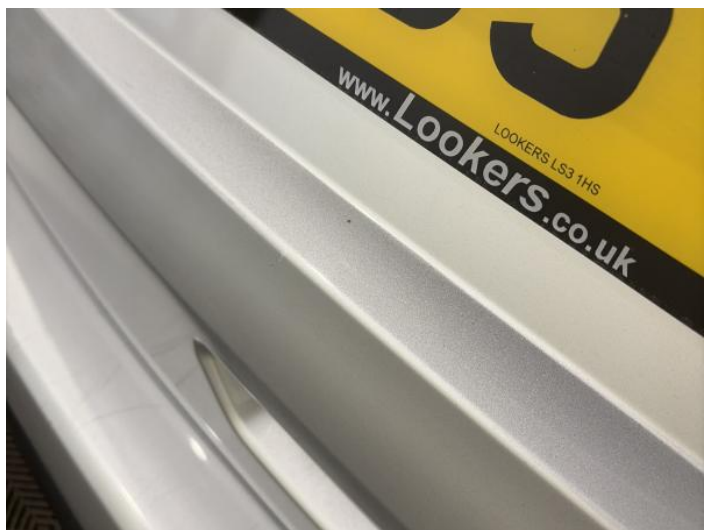
12: Tailgate  
Scratched  
Over 25mm Thru Paint

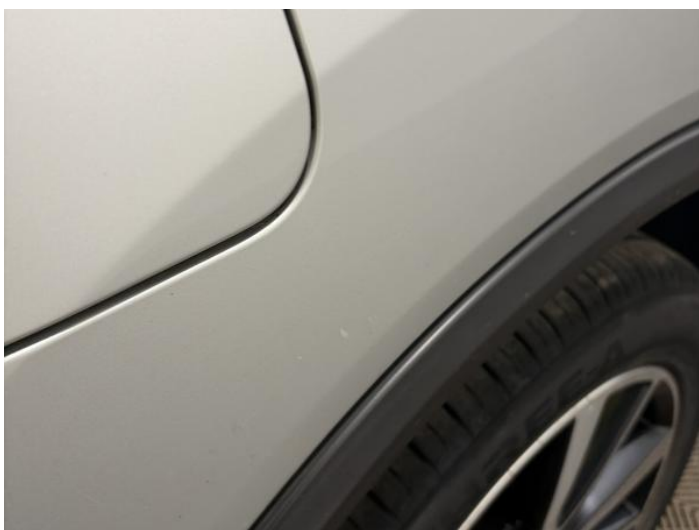
13: Qtr Panel osr  
Scratched  
Over 25mm Thru Paint

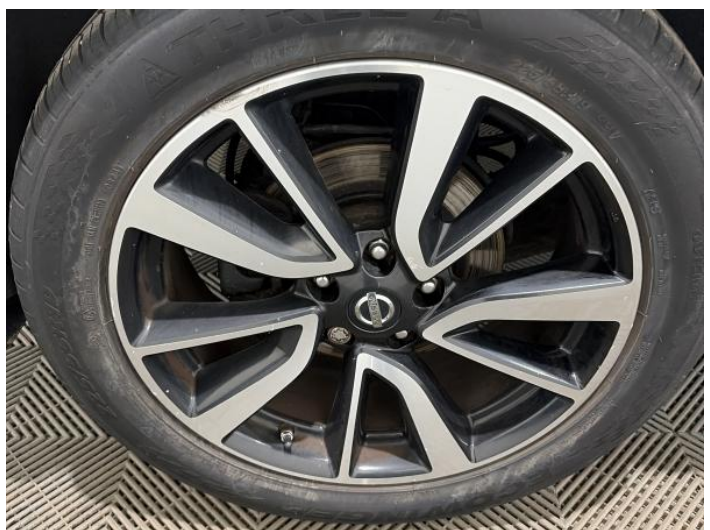
14: Wheel osr  
Scratched  
Over 50mm

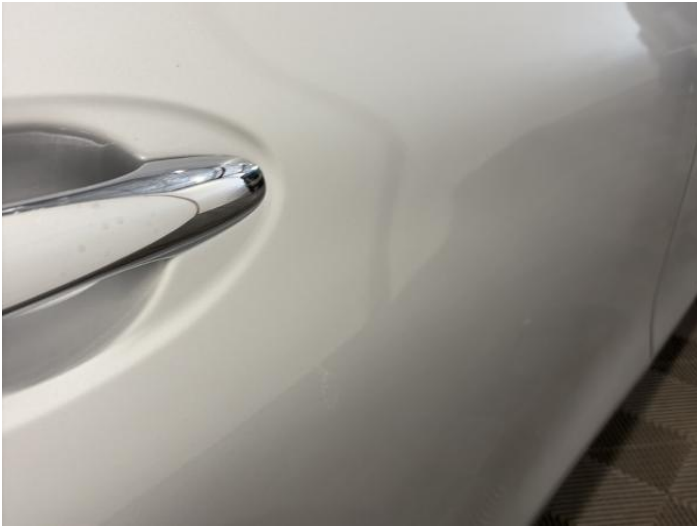
15: Door osr  
Poor Previous Repair  
Rippled UpTo 30%

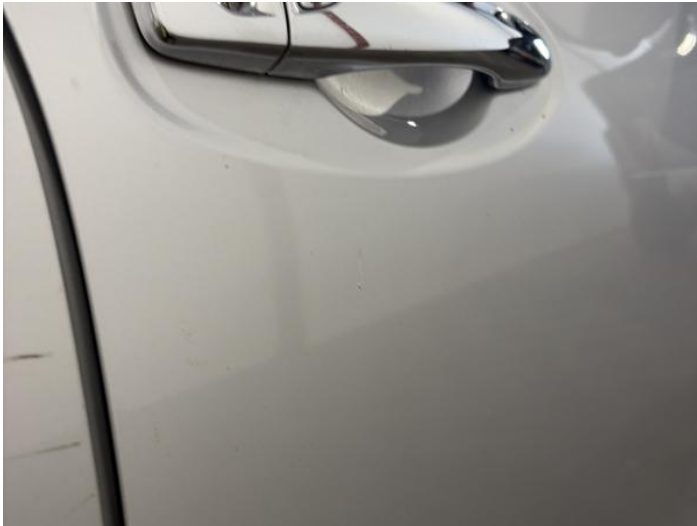
16: Door osf  
Scratched  
UpTo 25mm Thru Paint

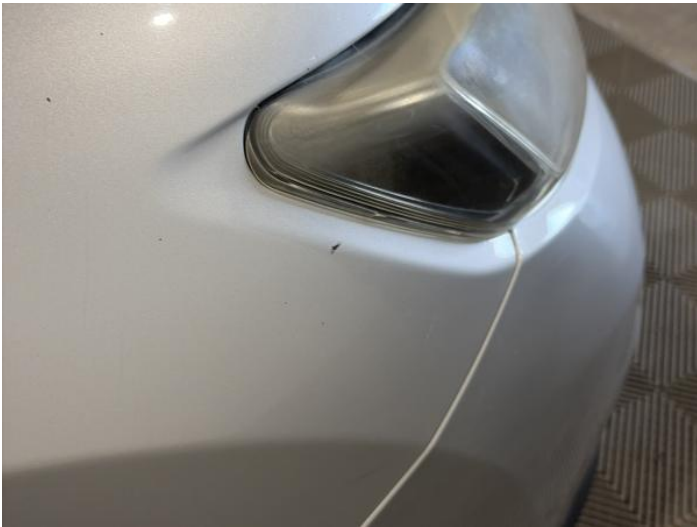
17: Wing osf  
Scratched  
UpTo 25mm Thru Paint

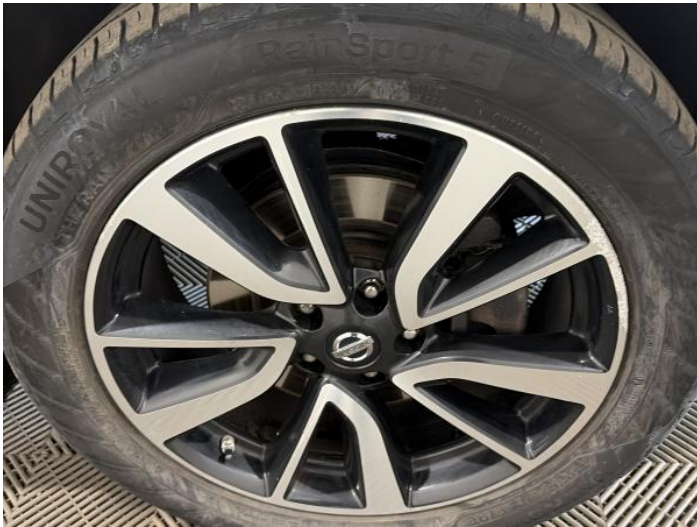
18: Wheel osf  
Scratched  
Over 50mm
